SQ-3226  
SQ-3226

IN-SHUCK-CH 26.5km

2022 Inspection

Crossing Name Tributary to Lillooet Lake

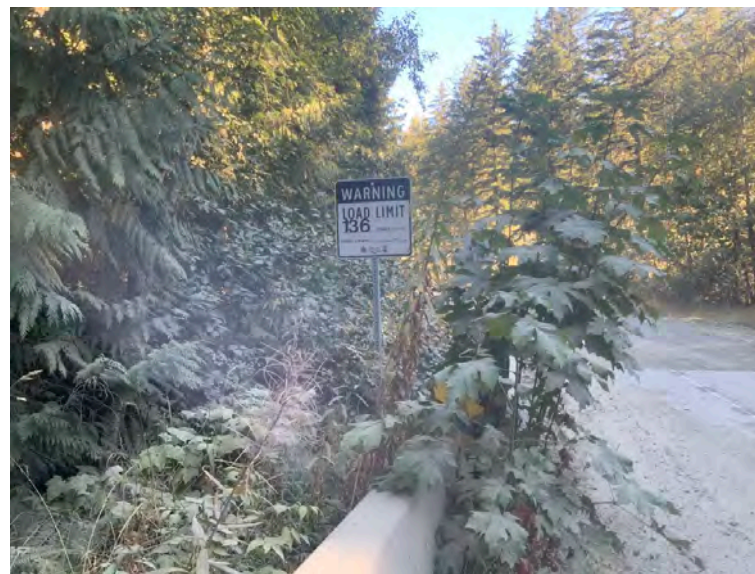
Load Rating Sign

Posted Load Rating **136**

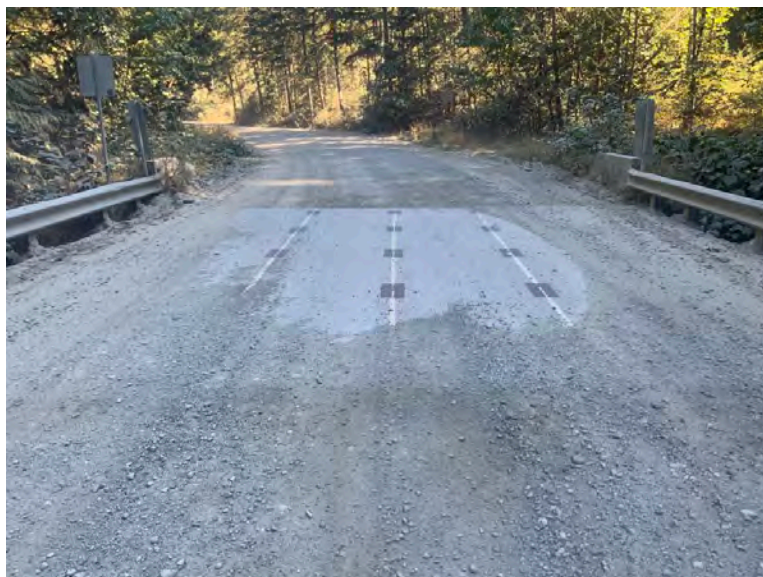
Deck

Running Surface      Good      Grader berm against barriers

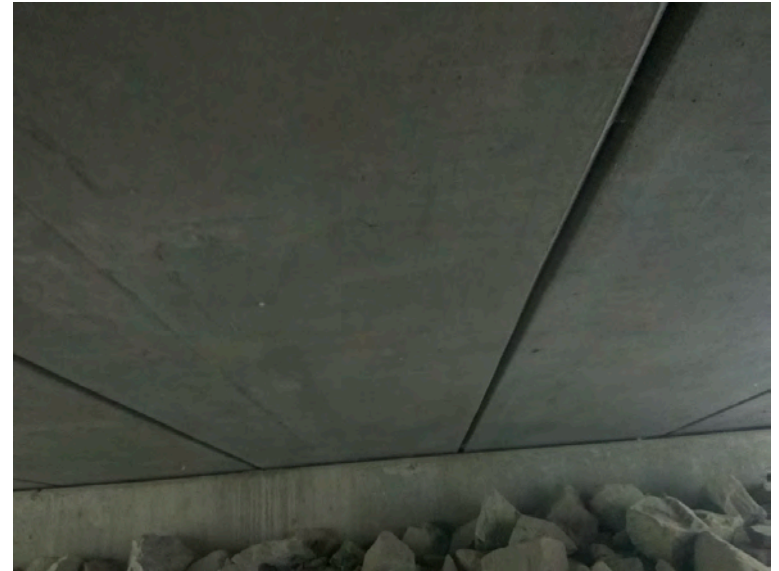
Superstructure

Girders **Good**
