SQ-3227  
SQ-3227-A

IN-SHUCK-CH 28.2km

2022 Inspection

Crossing Name Tributary to Lillooet Lake

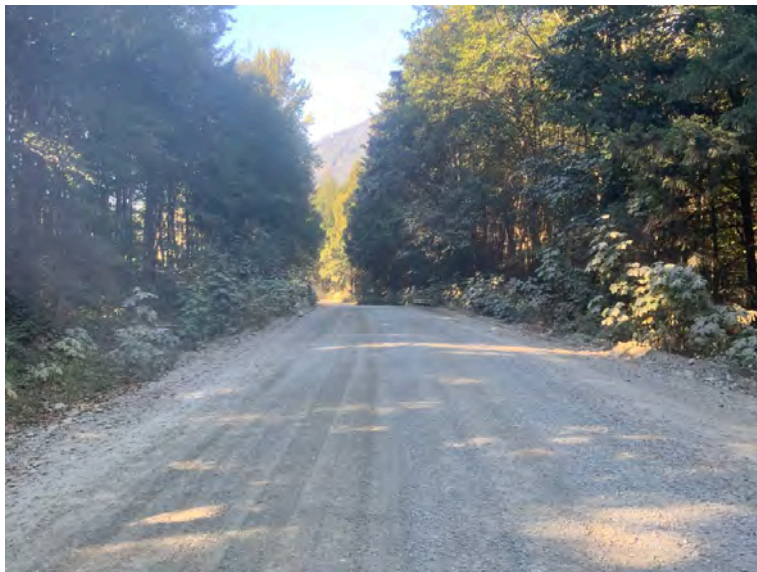
Approach from Right Bank when facing downstream

Road Surface **Good** Grader berm against barriers

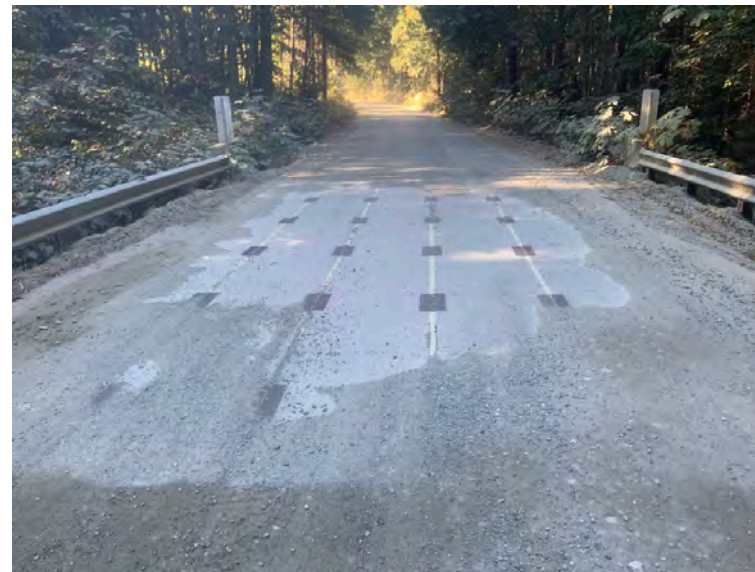
Running Surface      Good      Grader berm against barriers

Deck Joints      Fair      Paraseal wearing in places

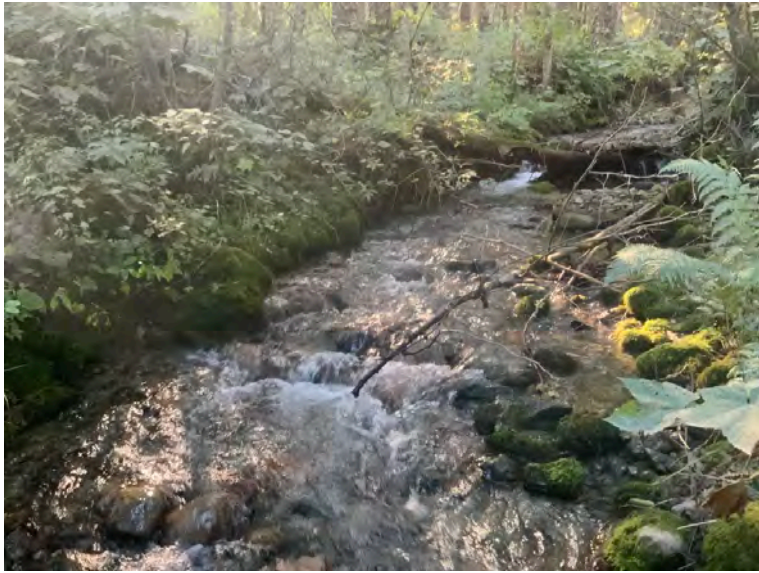
Upstream from Crossing

Comments Scour upstream from crossing
