SQ-3228  
SQ-3228

HURLEY 4.2km

2022 Inspection

Crossing Name Twenty Five Mile (Jim ) Creek

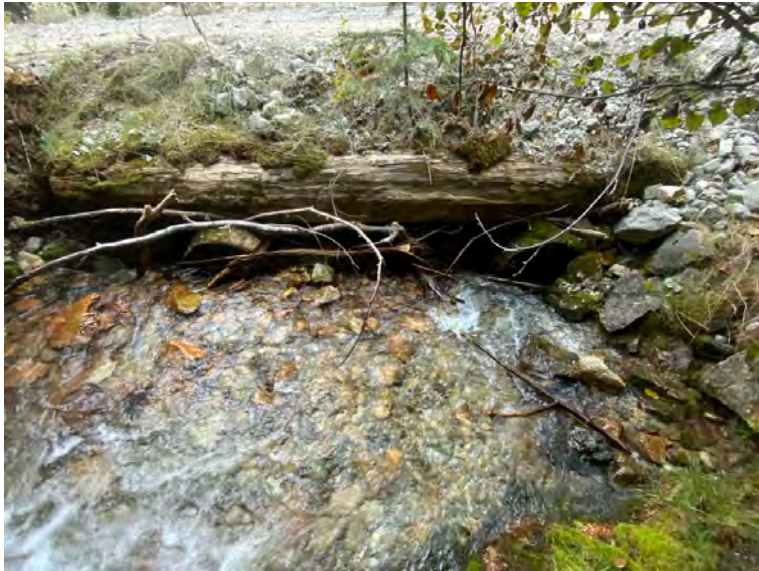
Comments See photo comments. Structure needs to be replaced as it's plugged and sill erosion is occurring.

Inlet 50% plugged

Comments: Replace WBC with 1800 dia. CSP culvert. Install with 3m x 3m x 1m deep inlet sump, with riprap protection at both inlet and outlet slopes, minimum 500 cover.

| Repair Item | Repair Description |
|---|---|
| 1 Structure. . . Priority:High | Replace with cmp. |

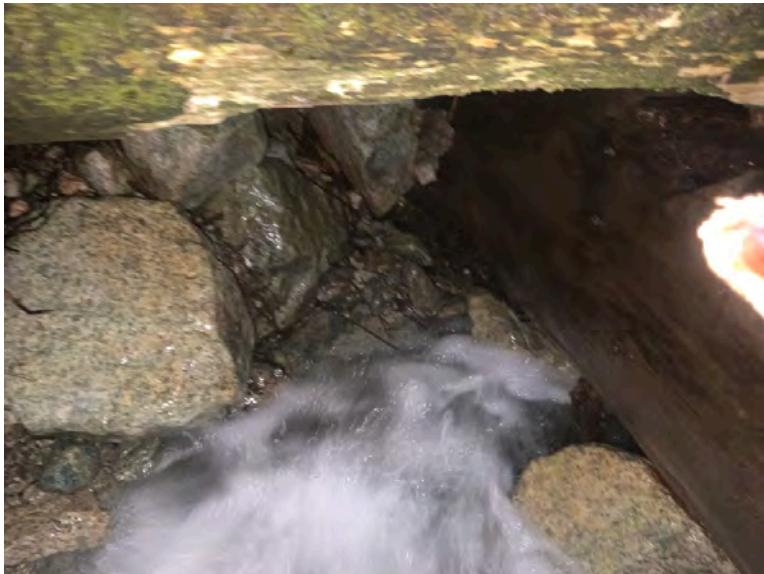
Inlet erosion behind sill log upstream left side
