SQ-3233  
SQ-3233

GREEN RIVER 16.5km

2022 Inspection

Crossing Name Ure Creek

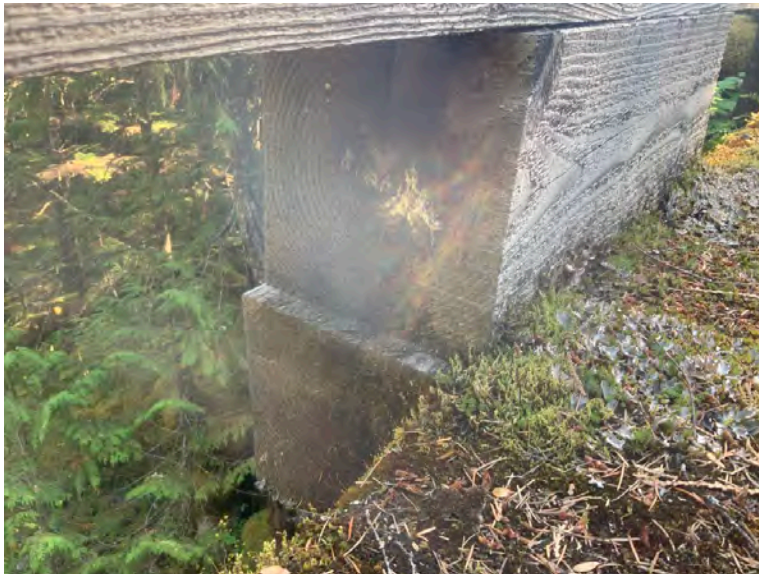
Guard Rail

Curb Rail/Blocks/Posts      **Fair**      Wood rails solid, risers starting to show signs of rot

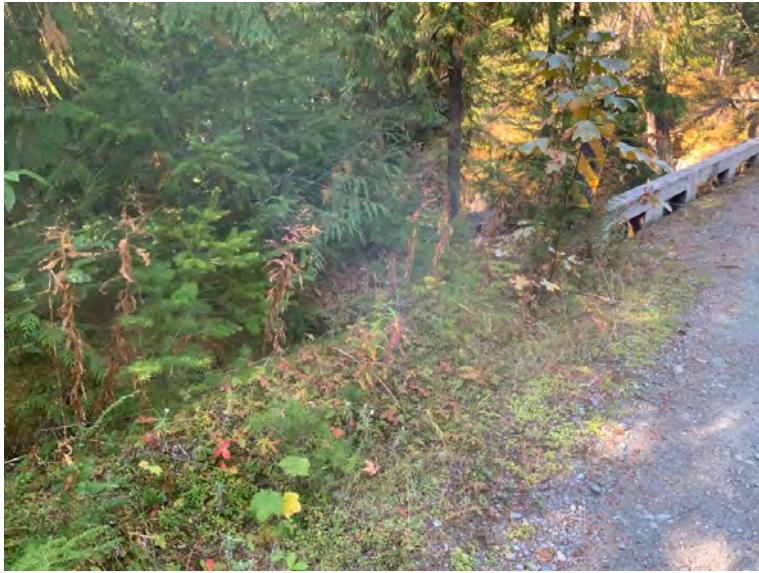
Approach Barrier

Fender Condition Poor Logs and large rocks, undersized upstream woods

1 Approach. Approach fenders (install). 1 # of units.  
Priority:Medium

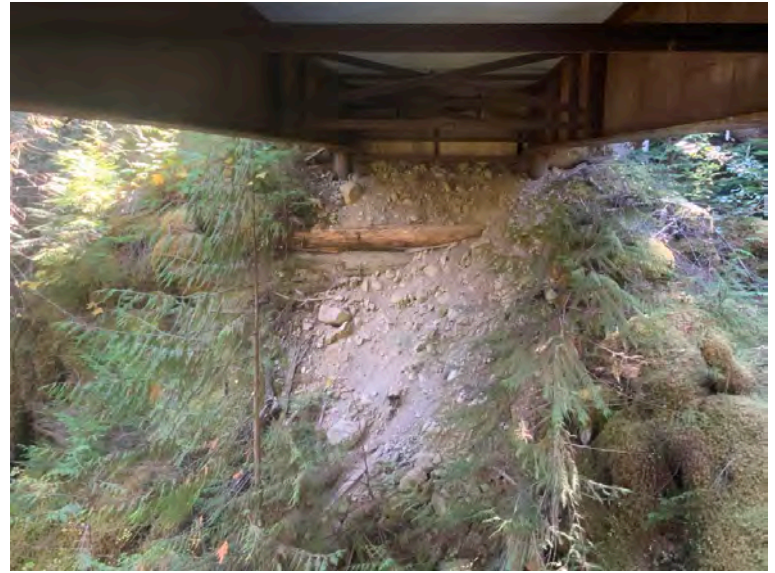
Right Bank Abutment when facing downstream

Log/Timber Crib Fair Old crib on right bank, retaining fill

Fill Fair Behind rotting crib on woods side

1 Old crib for rot. Currently retaining fill. Not sure how deep footings are installed.

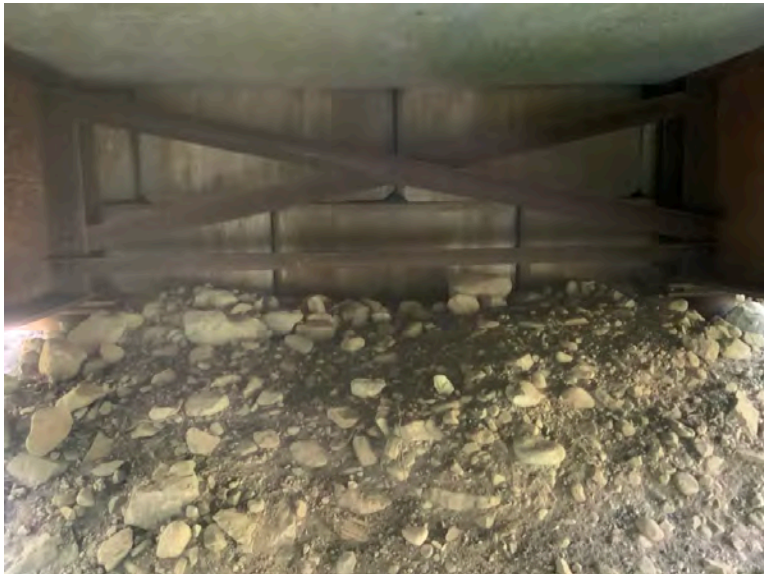
Left Bank Abutment when facing downstream

Piles or Posts Fair Corrosion

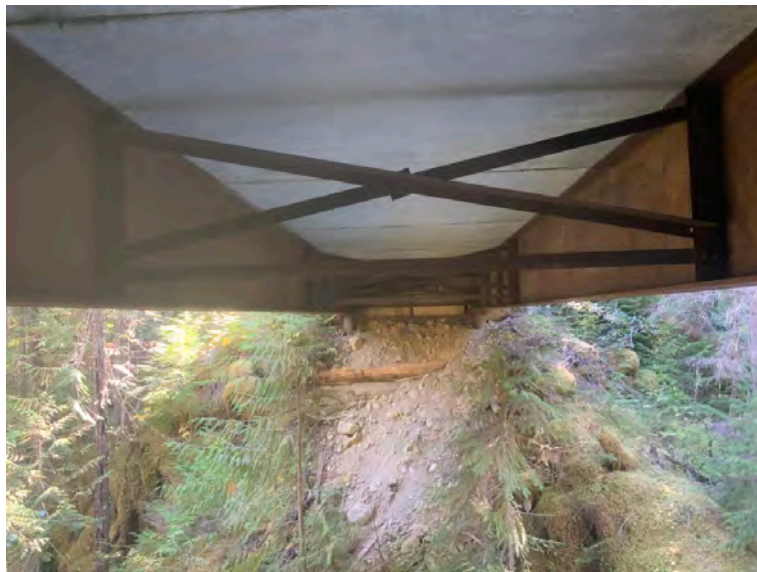
Superstructure

Girders Fair

All steel rusting. Not major.

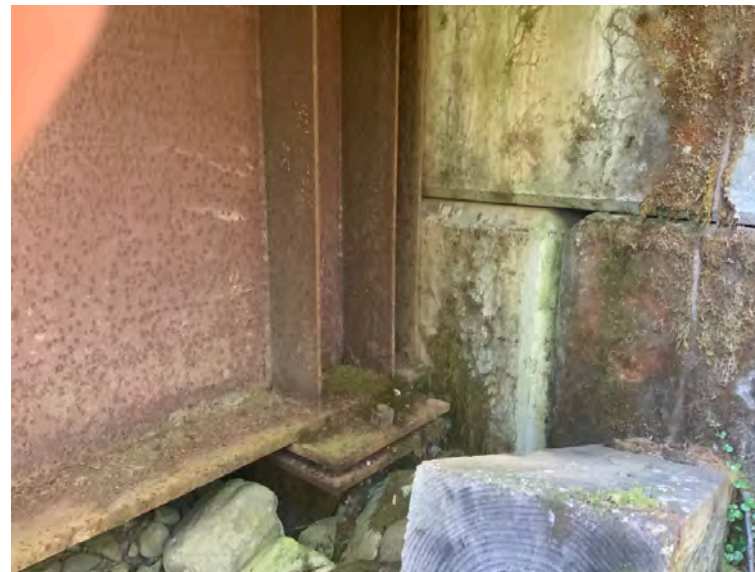
Bearing

Bearings Fair
