SQ-3235  
SQ-3235A

LILLOOET WEST 70.4km

2022 Inspection

Crossing Name Trib to lillooet lake

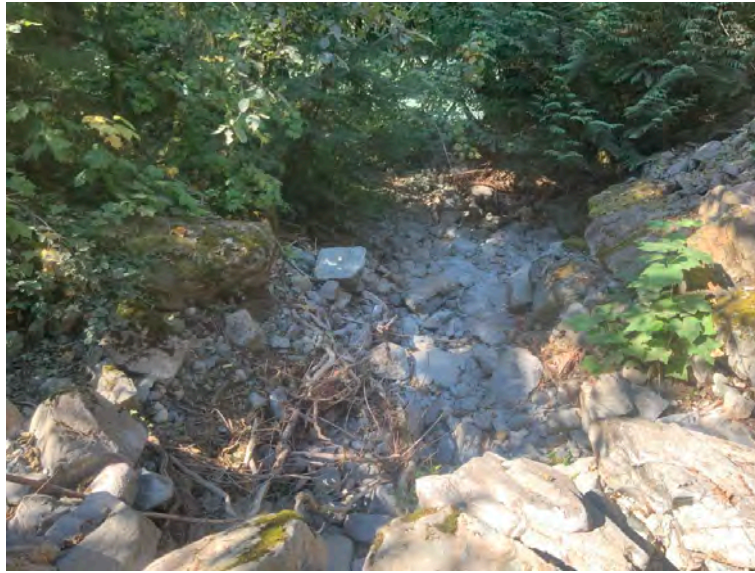
Downstream from Crossing

Comments Scour downstream from crossing
