SQ-3248  
TCH-1203

SQ\_MAM1000 0.4km

2022 Inspection

Crossing Name Trib to Mamquam River

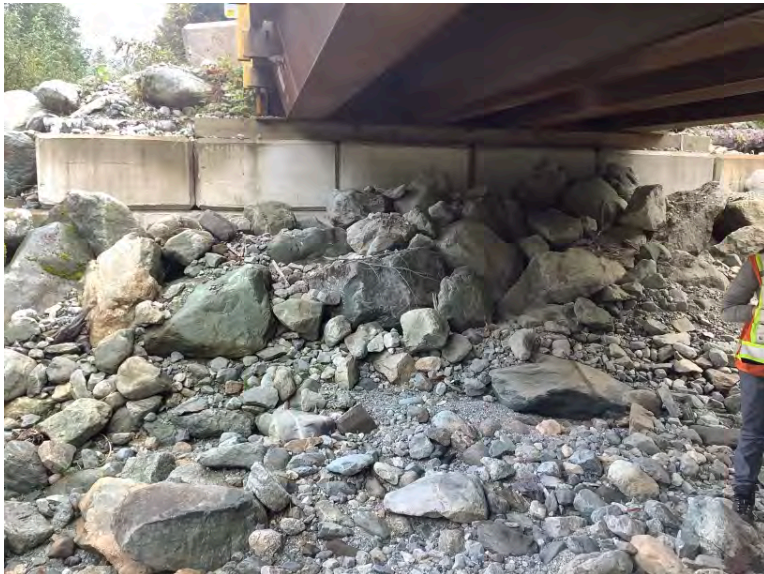
Right Bank Abutment when facing downstream

Shim the downstream river right timber. Lock block is starting to crack.

1 Monitor right bank bearing.
