SQ-3250  
SQ-3250

SWIFT CREEK 01 0.01km

2022 Inspection

| Crossing Name | Swift Creek |

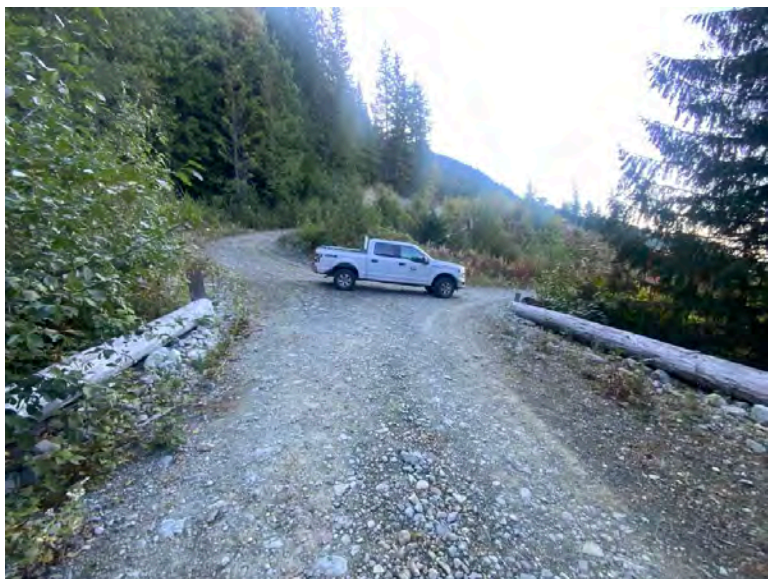
Approach from Left Bank when facing downstream

Sharp corner and blind from riparian trees
