SQ-3251  
SQ-3251A

IN-SHUCK-CH 54.1km

2022 Inspection

Structure Class Major Culvert

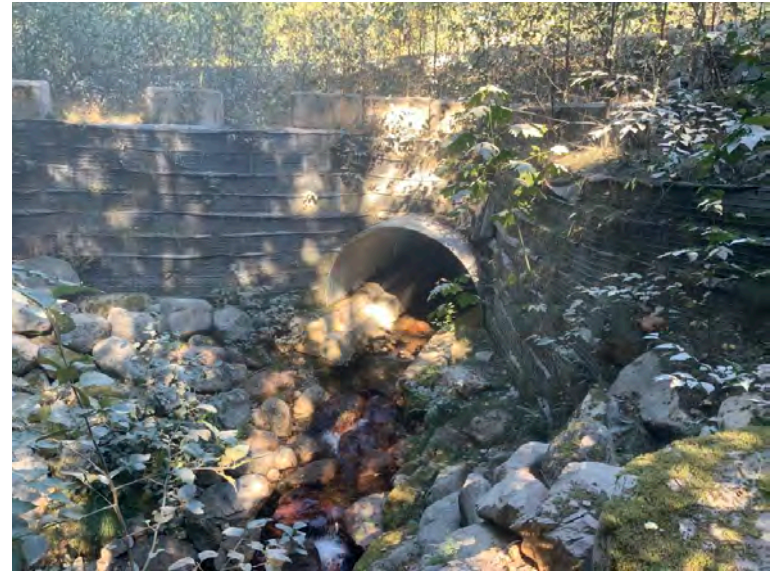
Arch matches dimensions. 9high grs retaining wall on outlet, looks good. Footings scouring, 5m or so from outlet. Roughly 0.5m high and deep at worst, Looks like cast in place concrete has been placed in front of lock blocks to prevent scour. Second site roughly 40m to town. No structure ID. Photos taken manually. Check records in office.

Outlet      Fair      Scoured footings

Comments: add more scour protection along scoured section of footing. Possible protect using smaller rock wrapped in geogrid with mechanical clasps to close the geogrid. The idea of wrapped rock is that this material will remain as a mass and will adjust and settle into place if further scour occurs.

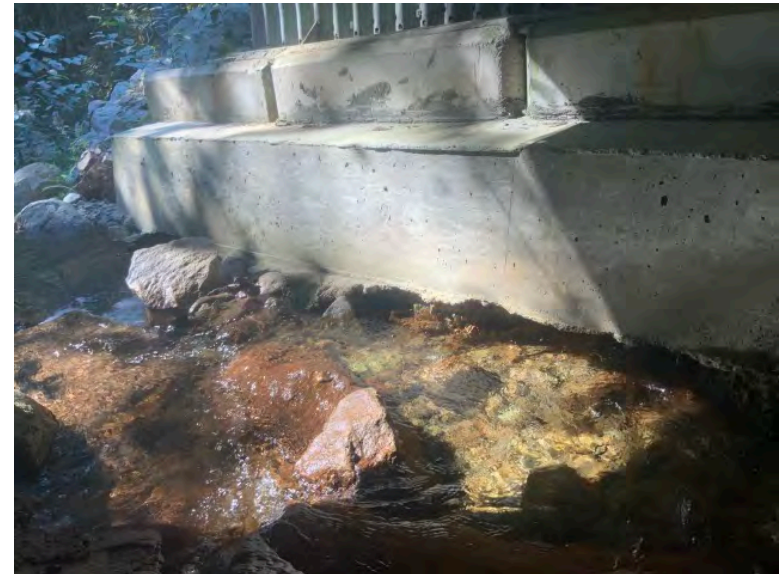
Right Bank Abutment when facing downstream

Footing      Fair      Scour. Arch footing rusting

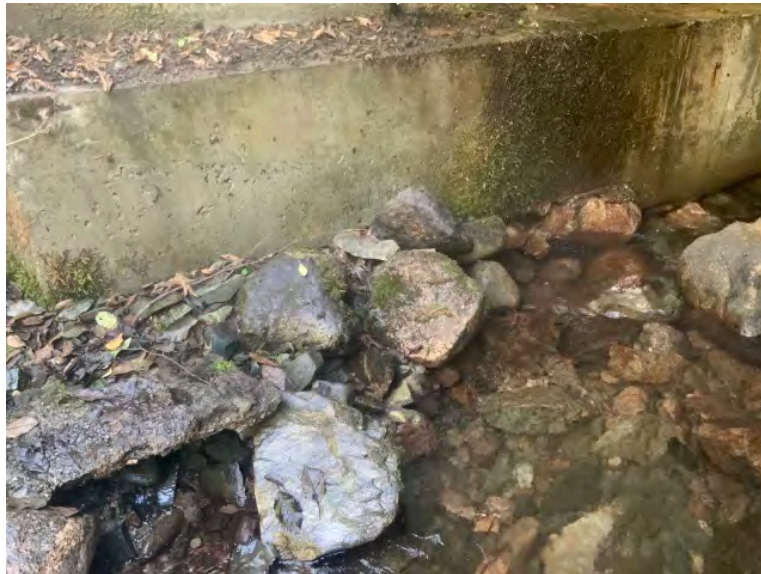
Inlet      Good
