In-shuck-ch 54km

2022 Inspection

Structure Class Major Culvert

Culvert Type Open Bottom

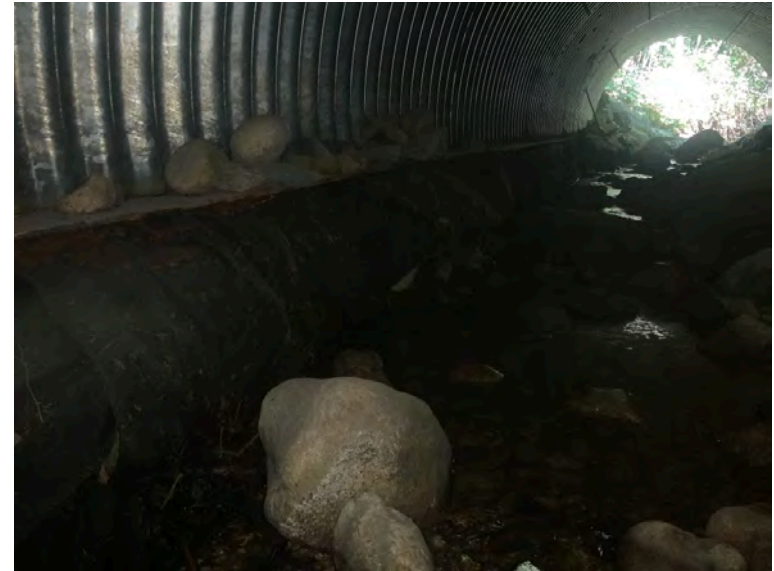
Left Bank Abutment when facing downstream

No pin for this site. 50m to town from 3251. Both footings entire length scoured, and undermined. Culvert sitting on material wrapped in geotextile, fully exposed. Major repairs required.

Comments: No SQ-XXX siteID or data on this arch culvert site. Arch culvert needs foundation work and potential downstream weir added to control bedload movement. Likely manual intervention is needed to protect the footing or the structure could fail.

| Repair Item | Repair Description |
|---|---|
| 1 Structure. Multiplate/culvert maintenance. m³.<br>Priority:High | Address exposed footings. |
