***Gitanyow Fisheries  
Authority***

**Gitanyow Village and Surrounding Area Fish  
Habitat Restoration Feasibility Study – 2016/17**

Submitted to: Fisheries and Oceans Canada  
200 – 401 Burrard Street  
Vancouver, BC V6C 3S4

Date: June 26, 2017

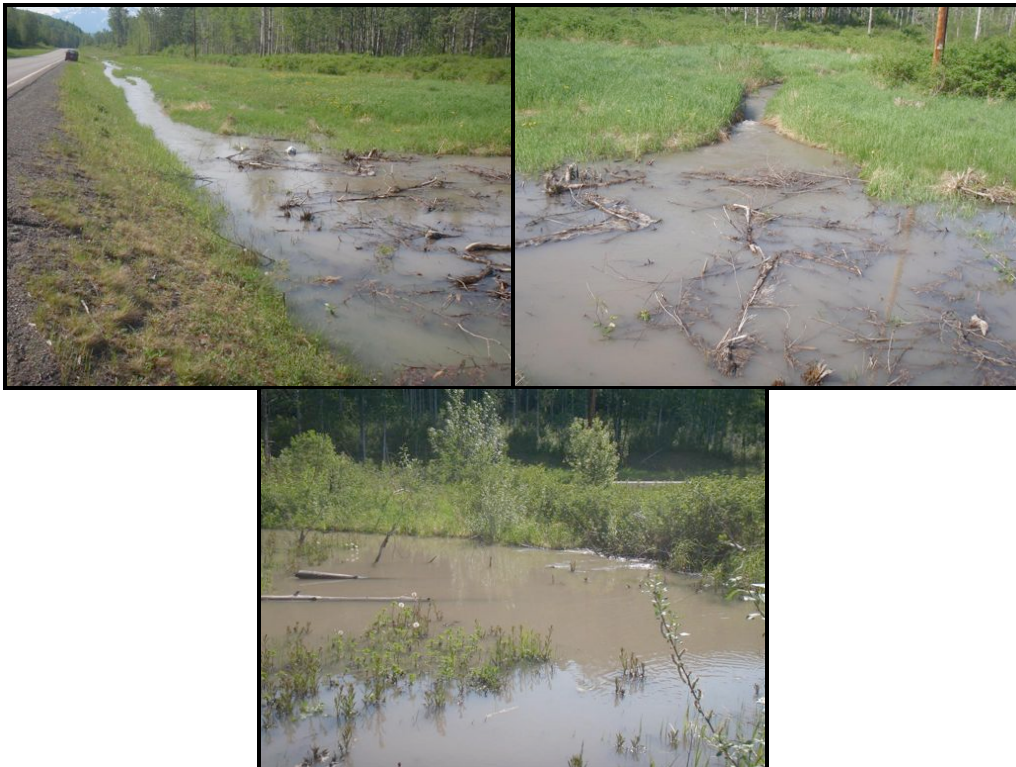
Figure 2: Task 1 Overflow – Annual runoff down Hwy 37N ditch (left); source of overflow over abandoned beaver dam (right) and abandoned beaver dam (lower middle). Photo taken by GFA on May 25<sup>th</sup>, 2015.

Works completed by GFA during the 2015/16 FHRI resulted in intensive investigation and ground truthing. GFA determined that an abandoned beaver dam along a distinct side channel had caused this Hwy37N ditch overflow during high-water periods. The GFA breached the abandoned beaver dam in the fall of 2015 to track flow that had been cut off from its natural course by the dam. This proved viable as flow into the Hwy 37N ditchline discontinued. Following breaching, this side channel was tracked using a GPS for its entire length of about 800m. This channel offers excellent summer rearing habitat for juvenile salmonids as it contains an abundance of deep pools, instream woody debris, and overstream vegetation cover. Juvenile fish trapping using Gee trap was also carried out in the fall of 2015, which yielded large numbers of coho salmon, and lesser numbers of chinook salmon, Dolly Varden char/bull trout, rainbow/steelhead trout, and rocky mountain whitefish (McCarthy 2016).

Later in the fall of 2015, McElhanney Consulting Services Ltd. (Terrace BC) produced an engineered site plan for an 80m-long channel diversion to prevent any flow from touching the highway at a single point along the reinstated natural channel (presented in a supplemental file entitled “2015-12-23 - Gitanyow Fisheries Improvements Conceptual Design Report”).

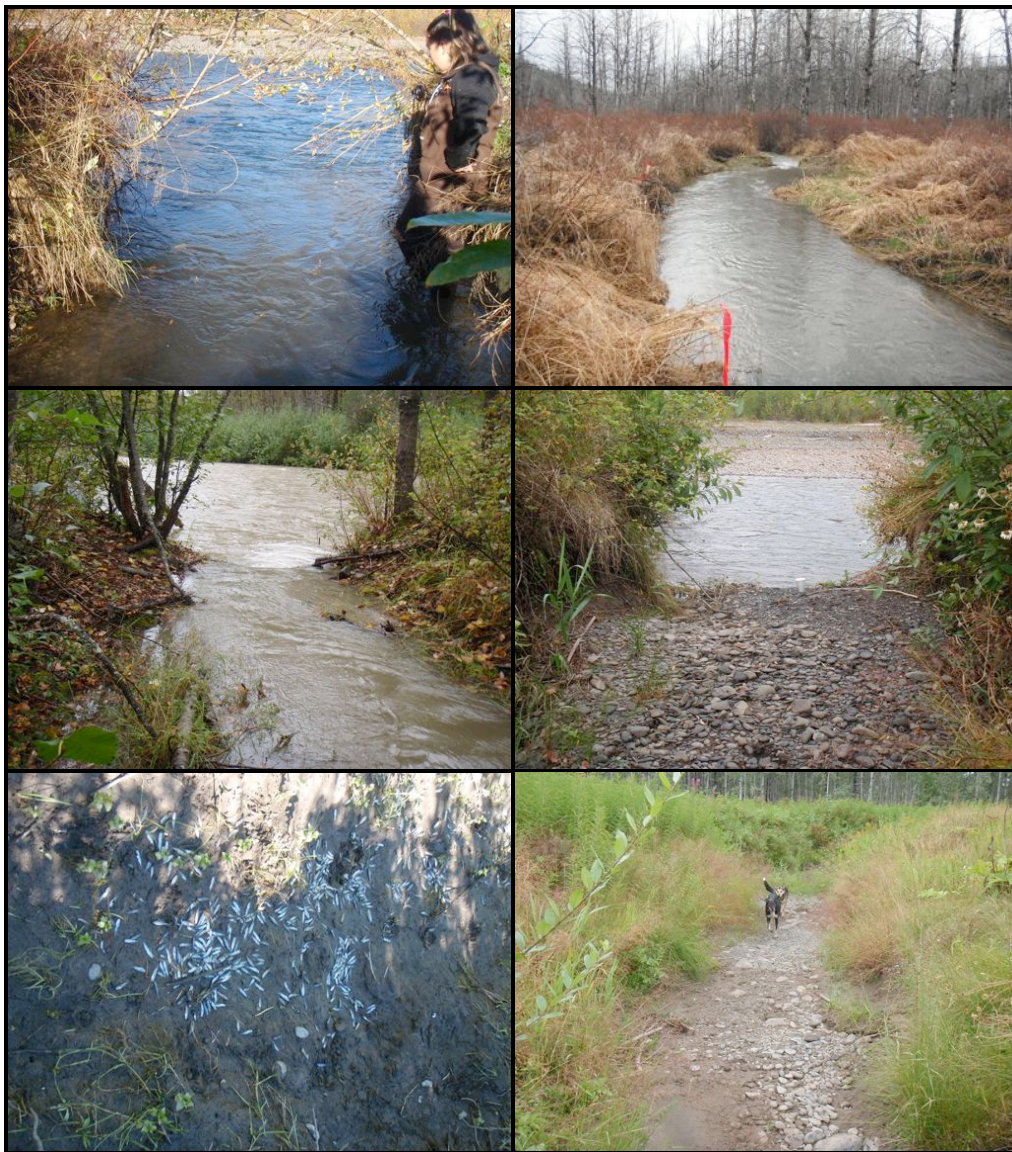
This side channel was largely influenced by the water level of the Kitwanga River at the side channel inlet. The inlet channel bottom is suspended above the Kitwanga River channel bottom due to an accumulation of gravel, cobble and sand, therefore during low-water periods in the Kitwanga River, the channel frequently dried up (Figure 4). This occurred frequently during the summer and winter months of the 2016/17-study period and conversely this channel was flowing during spring and fall freshets or heavy rain events during the late summer (Table 1).

Figure 4: Photo Series showing examples of wetted channel for Task 1 (top left, right and middle left) and dry channel (middle right and bottom left and right including stranded coho fry). Top left and middle right show inlet in relation to the Kitwanga River in the background.

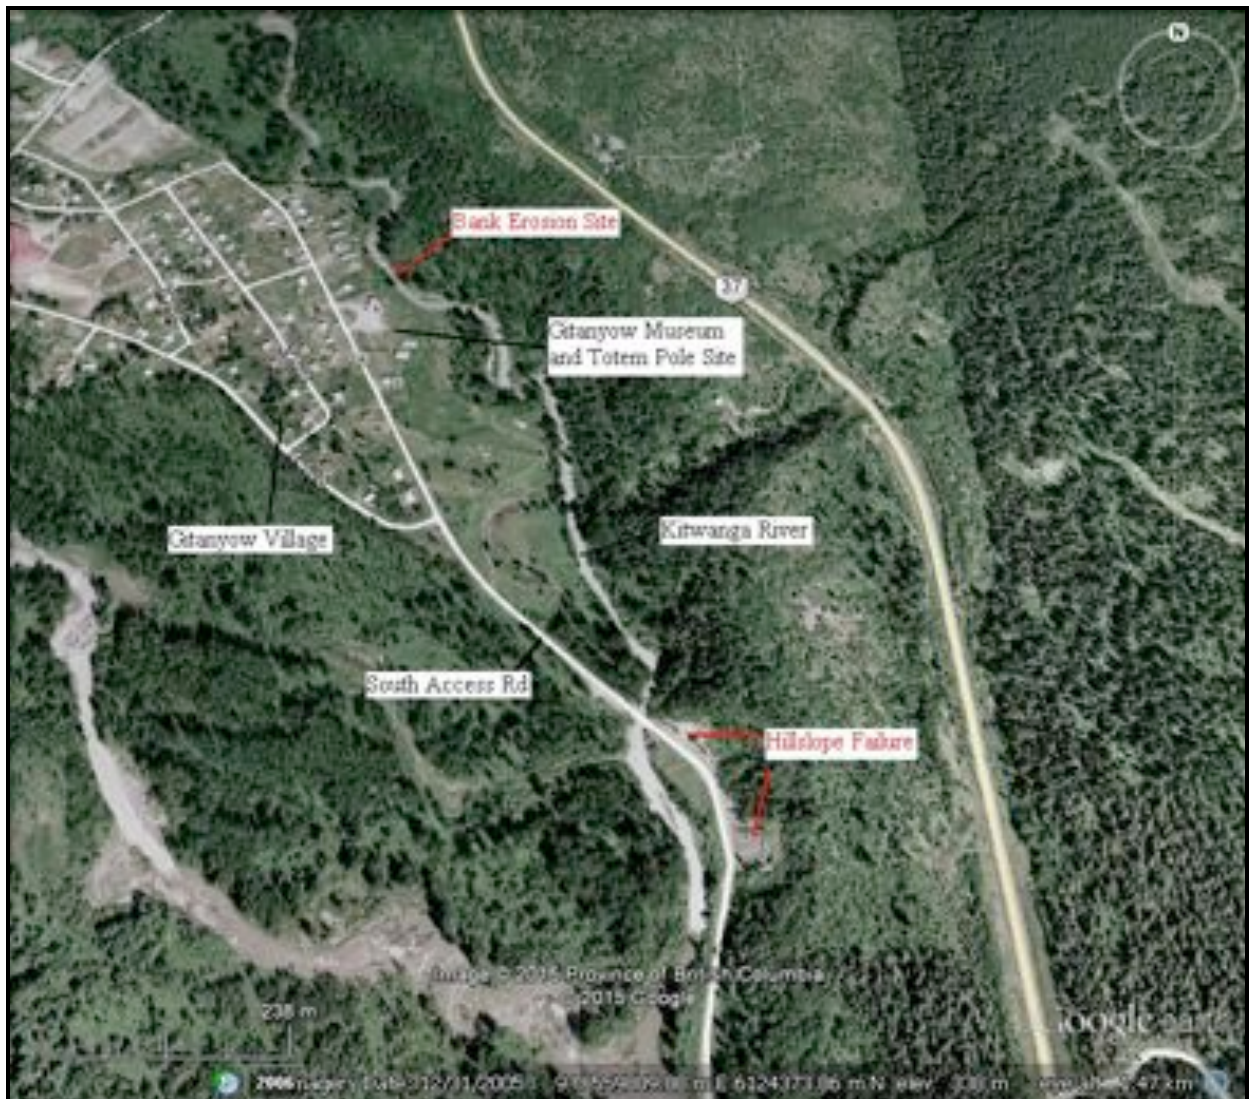
In 2015, the GFA identified two large-scale erosion and sedimentation issues surrounding the Gitanyow Village that has been ongoing for decades (Figure 8). Firstly, two large slide areas located adjacent to each other along the Gitanyow South Access Road has been eroding and introducing sediment directly into the Kitwanga River since the road was constructed (Figure 9). GFA deemed this issue as outside the scope of FHRI and has been deferred to MOTI for resolution (see McCarthy and Cleveland 2016 for background information including restoration costs prepared by McElhanney Consulting Services Ltd.)

Figure 8: Aerial view of slide along the Gitanyow South Access Road in relation to the Kitwanga River and Gitanyow Village (Source: Google Earth 2015).

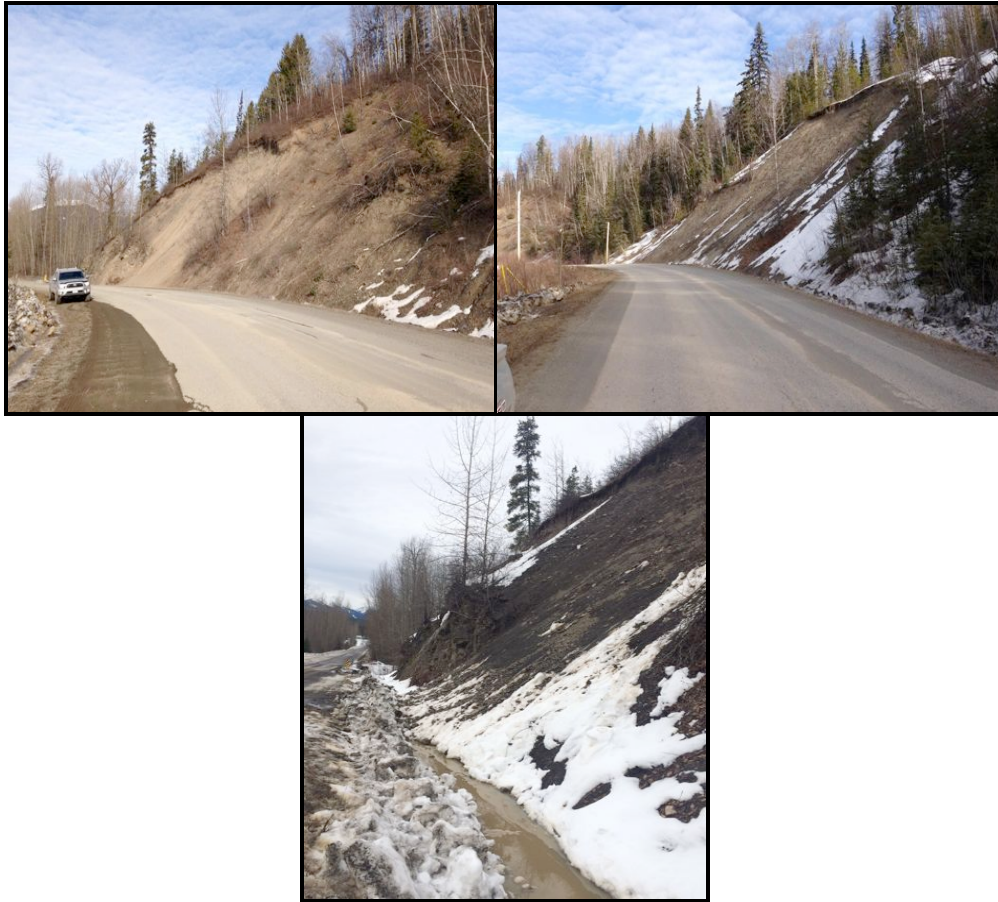
Figure 9: Failing hillslopes and turbid water flowing through ditch into the Kitwanga River looking north along the Gitanyow South Access Road (Photos taken February 2015).

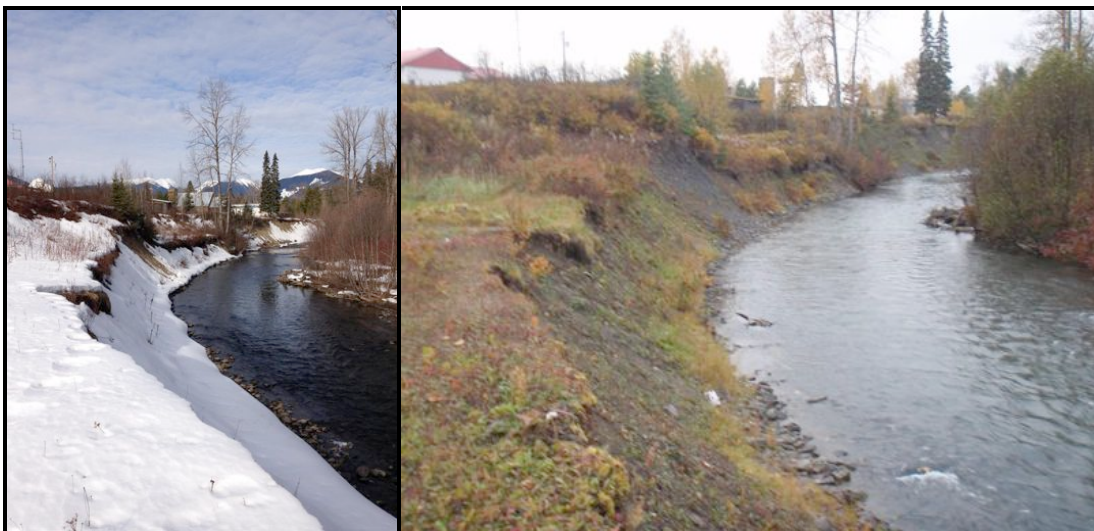
In addition to these slides, significant erosion is ongoing on the Kitwanga River right bank (facing downstream) and is gradually removing land adjacent to the Gitanyow Totem Pole and Historical Museum site and introducing significant amounts of sediment into the river system (Figure 10). The nearest totem pole structures are currently about 30m and the Gitanyow Historical Museum is about 50m away from the river's edge. In the fall of 2015, McElhanney Consulting Services Ltd. estimated the cost of reducing bank erosion behind the Gitanyow Historical Museum/Totem Pole/Cemetery site at about \$550,000 including engineering, construction, and GFA support to armour the riverbank with geotextile and boulder rip-rap (see McCarthy and Cleveland 2016 for background information including restoration costs prepared by McElhanney Consulting Services Ltd.).

Figure 10: Eroding Kitwanga River bank adjacent to the Gitanyow Totem Pole and Historical Museum site.

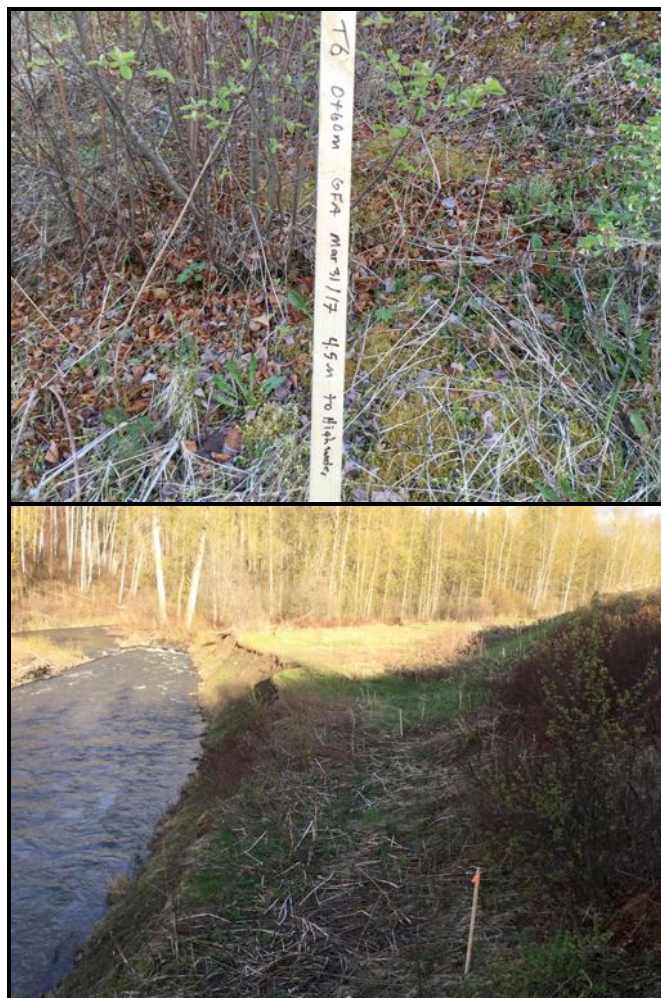
Figure 11: Stake-out area to measure rate of erosion of the Kitwanga River bank adjacent to the Gitanyow Totem Pole and Historical Museum site. On March 31<sup>st</sup>, 2017, stakes were placed 3m from the sloughing bank at 10m intervals.

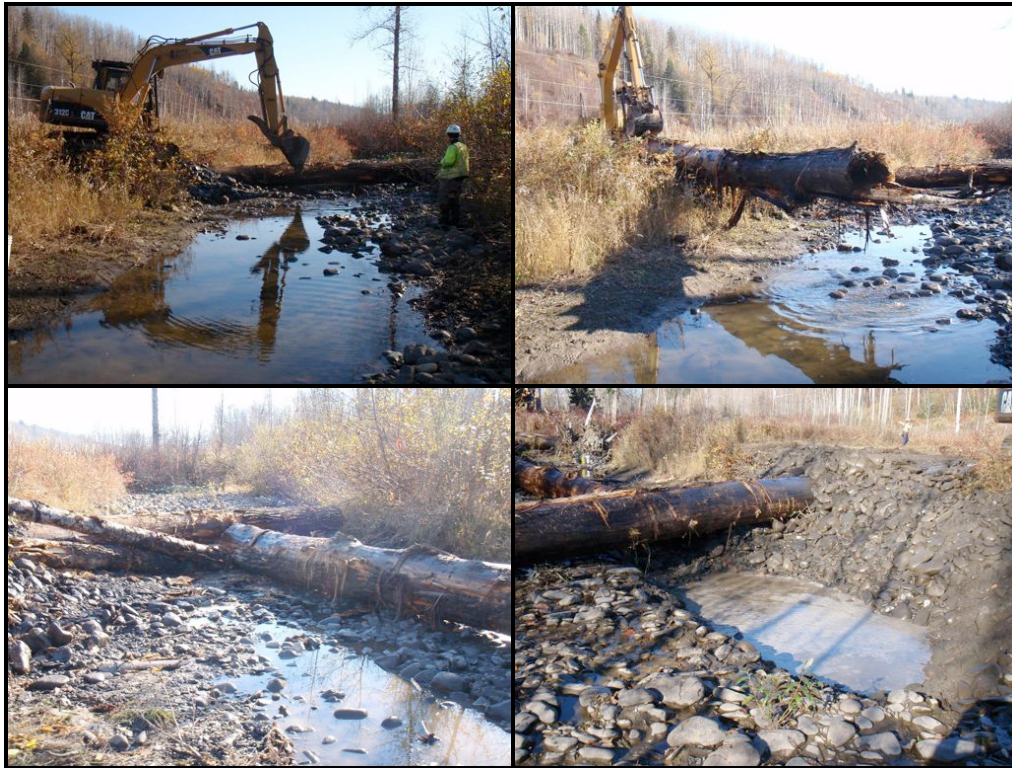
The lowermost LWD cluster was installed about 80m upstream from the channel outlet (or about 30m downstream of the natural LWD jam) and consisted of a “V” shape configuration pointing downstream (Figure 15; labelled LWD and Deep Pool Placement #1 in attached PDF map). The middle LWD cluster was installed about 145m upstream from the channel outlet and was set at a slight angle pointing downstream (Figure 16; labelled LWD and Deep Pool Placement #2 in attached PDF map). The upstream LWD cluster was installed about 170m upstream from the channel outlet and was set perpendicular to the channel (Figure 17; labelled LWD and Deep Pool Placement #3 in attached PDF map).

Figure 15: Photo Series showing the installation of the downstream LWD cluster on October 11, 2016.

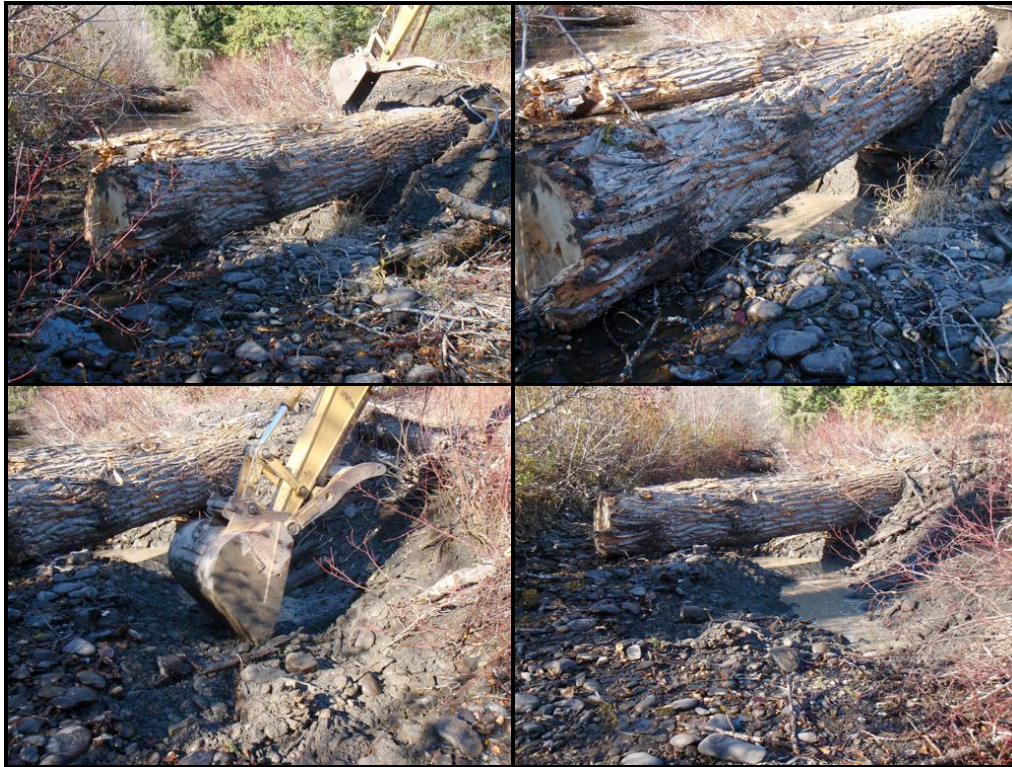
Figure 16: Photo Series showing the installation of the middle LWD cluster on October 11, 2016.
