## BRIDGE INSPECTION

**BRIDGE NO./NAME** 61 – 010: Cunningham Pass FSR (38.0 KM)

**Inspection Date:** September 10<sup>th</sup> 2012

## Permanent Bridge Inspection Report

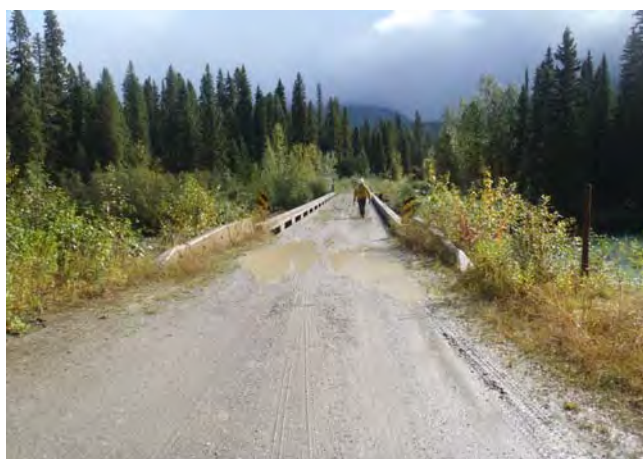
- The deck is generally in fair condition.
- Typical longitudinal checks in the curb rail.
- The 4<sup>th</sup> & 5<sup>th</sup> upstream sections of curb rail from the Likely end are loose.
- Coring the wearing planks identified no rot.
- Structural planks were cored and found to be saturated with initial signs of rot at the interface with the ties.
- Ties were cored and found to be saturated with initial signs of rot at the interface with the structural planks.
- Debris is accumulating on bridge deck at Wells end.
- Water ponding noted at numerous locations on the wearing planks.

**Figure 1-3: Looking towards likely end, not ponding water.**

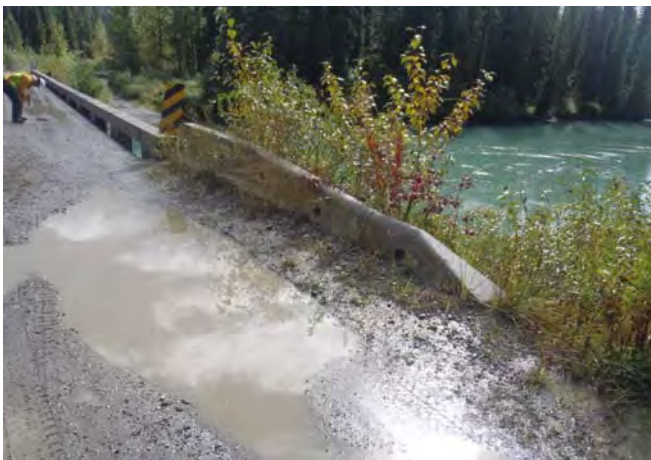
| Fender Condition | Good | The bull noses of the concrete barriers are misaligned at the Likely end. The concrete barriers at the Wells end are slightly misaligned. Debris is accumulating against the concrete barriers. |

**Figure 1-9: Typical misaligned barrier, wells end downstream shown.**

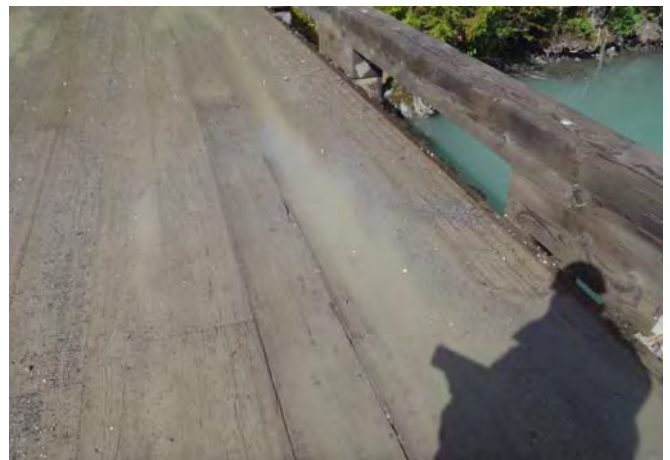
| Curb Rail/Blocks/Posts | Good | Typical longitudinal checks in the curb rail. The 4th & 5th upstream sections of curb rail from the Likely end are loose. |

**Figure 1-10: Typical curb rail condition, note ponding water.**

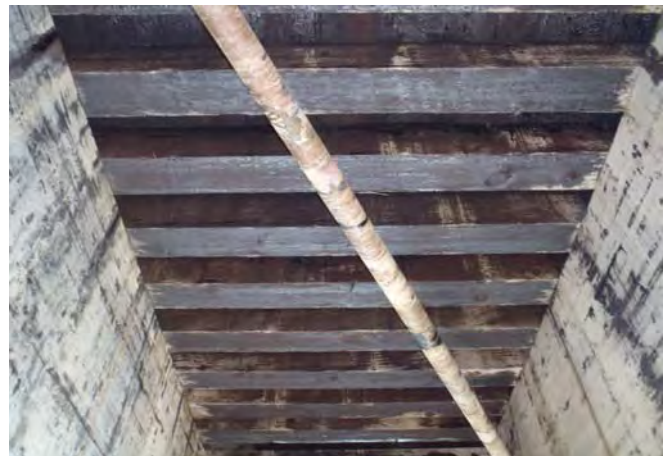
| Sub Deck | Fair | Structural planks were cored and found to be saturated with initial signs of rot at the interface with the ties. |
| Ties | Fair | Ties were cored and found to be saturated with initial signs of rot at the interface with the structural planks. |

**Figure 1-12: Typical sub deck condition, span 2 shown.**

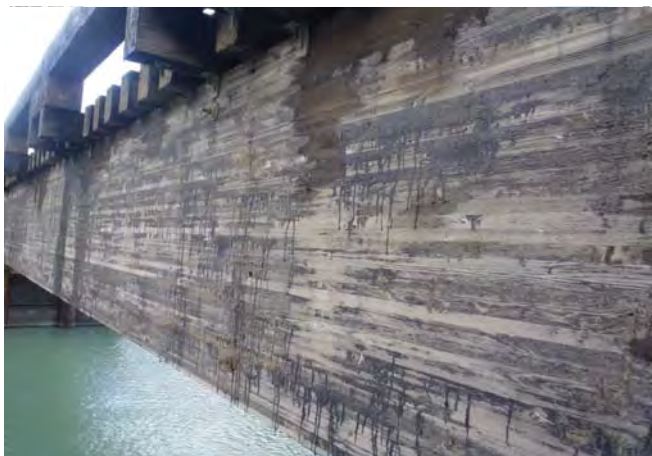
- Creosote leaching noted, 50-75% of face exposed.
- Moderate checking.

| Tag Type | Check Start | Check End | Length (mm) | Max. Depth (mm) | Max. Width (mm) | Location (mm) | Condition |
|---|---|---|---|---|---|---|---|
| Existing | AE152 | - | - | - | - | - | Not propagated. |

**Figure 1-13: Span 2 girder 1 upstream face condition.**

1. Continue monitoring checks in girders.
2. Monitor the scour at the base of the Likely abutment.

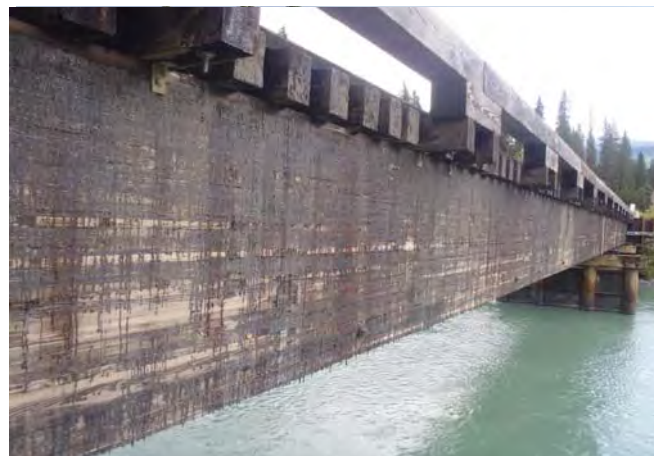
- Creosote leaching noted, 25-50% of face exposed.
- Moderate checking, a few checks noted generally up to 20 mm deep in places; some are 50 mm deep in places.
- We do not believe the checks affect the capacity of the girder.

| Tag Type | Check Start | Check End | Length (mm) | Max. Depth (mm) | Max. Width (mm) | Location (mm) | Condition |
|---|---|---|---|---|---|---|---|
| New | Hanger | AE1251 | 6800 | - | 4 | 910 from top | Extends 1650 mm past pier into span 1. Drilled, no rot was found. |
| New | AE48 | AE1252 | 3200 | 75 | 3 | 450 from top | - |
| New | AE1303 | AE1743 | 6400 | 100 | 1.5 | 800 from top | - |
| New | AE882 | AE1744 | 2800 | 100 | 1 | 560 from top | - |

**Figure 1-14: Span 2 girder 4 downstream face condition.**

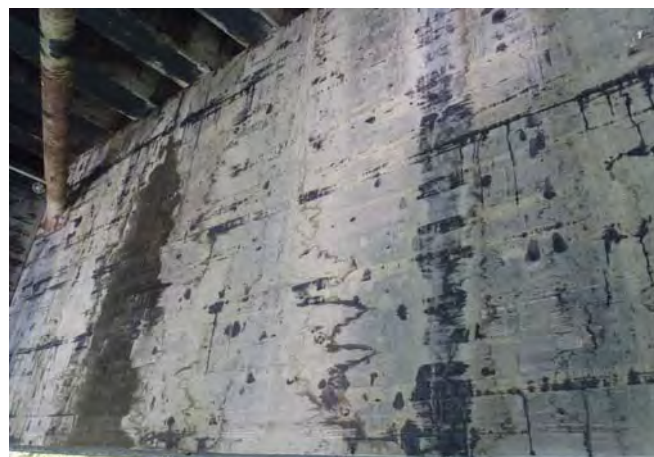
- Creosote leaching through laminated joints.
- Minor checking, a few checks noted up to 25 mm deep in places.

| Tag Type | Check Start | Check End | Length (mm) | Max. Depth (mm) | Max. Width (mm) | Location (mm) | Condition |
|---|---|---|---|---|---|---|---|
| Existing | AE151 | - | - | - | - | - | Not propagated. |

**Figure 1-16: Typical interior girder condition, span 2 girder 2 downstream face shown.**

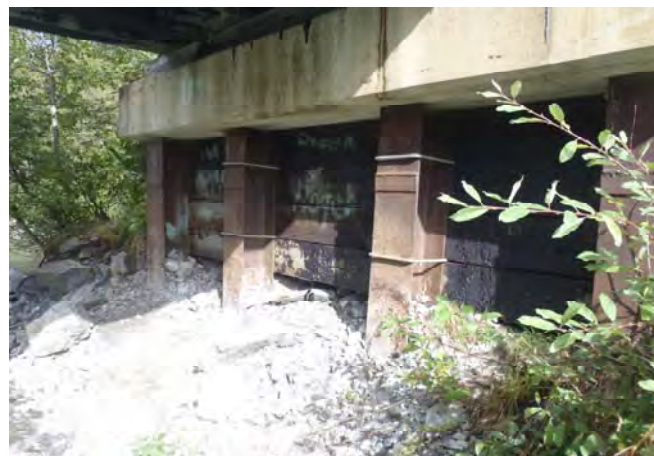
The bridge is generally in fair condition. The previous inspection report, dated June 2012, identified water levels reach the toe of the Likely end breast wall, which has no rip rap slope protection. We recommend the Ministry monitors the scour at the Likely abutment and considers installing riprap.

- The abutments are generally in good condition.
- The timber sills are sound at both abutments; debris accumulating at the ends of the sills.
- Minor concrete spall at downstream corner of Wells end abutment and hairline vertical crack full height of the breast wall.
- Minor scour noted at the toe of Likely end ballast wall.
- Limited riprap at the Likely end abutment.
- Wells end abutment is founded on bed rock.

| | <b>Comment:</b> | Minor scour noted at Likely end abutment. | | | | | | | | |

**Figure 1-18: Likely end abutment, minor scour at toe of breast wall.**

| Items | Description | Priority |
|---|---|---|
| 3. | Consider installing riprap at the base of the Likely abutment. | Low |

| | 3 | Recommended | Low | \$6,000.00 | Consider installing rip rap at the base of the Likely abutment. | | | | | |
| | 2 | Monitor the scour at the base of the Likely abutment. | | | | | | | | |

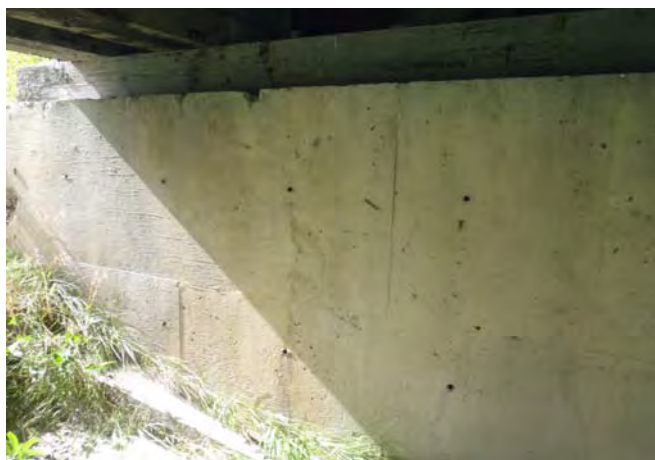
| Ballast Wall | Good | Minor concrete spall at downstream corner of Wells end abutment and hairline vertical crack full height of the breast wall. Minor scour noted at the toe of Likely end ballast wall. |

**Figure 1-21: Wells end abutment, breast wall crack.**

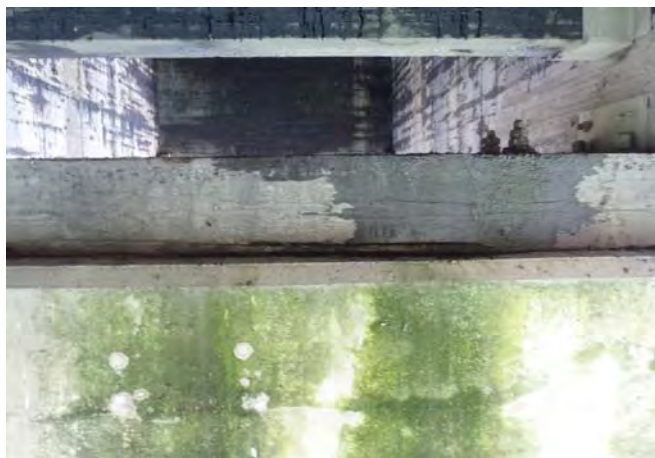
**Figure 1-23: Pier sill, minor damage and moisture noted.**

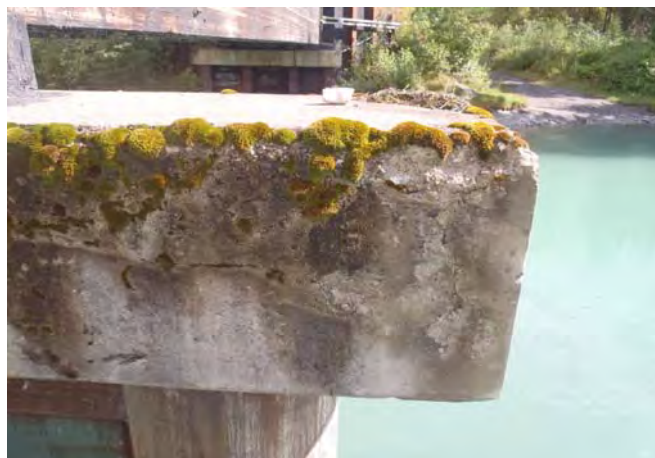
- The Pier is generally in fair condition.
- There is a concrete spall & localized deterioration at the ends of the cap with water staining & moss growth noted.
- The timber sill is in good condition.

| Caps | Fair | Concrete spall & localized deterioration at the ends of the cap with water staining & moss growth noted. The timber sill is in good condition. |

**Figure 1-24: Pier cap downstream corner, minor spall and moss growth.**
