| Structure # | Crossing Name | Forest Service Road | User km | CBR km | | |
| 61-046 | Coglistiko River | Michelle-Coglistiko | 23 | 23.2 | | |

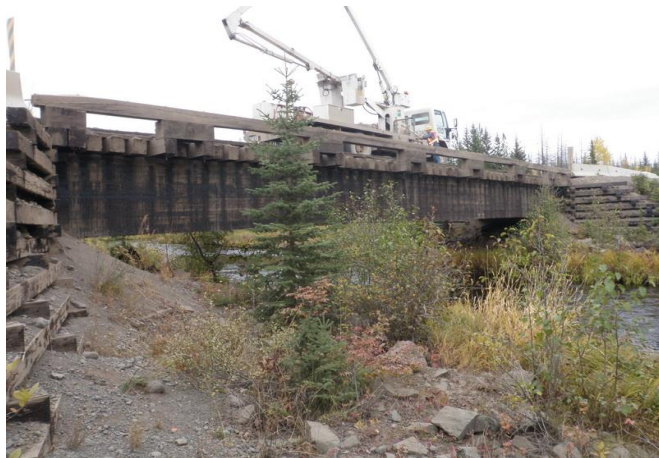
**Figure 1-1: Upstream elevation.**

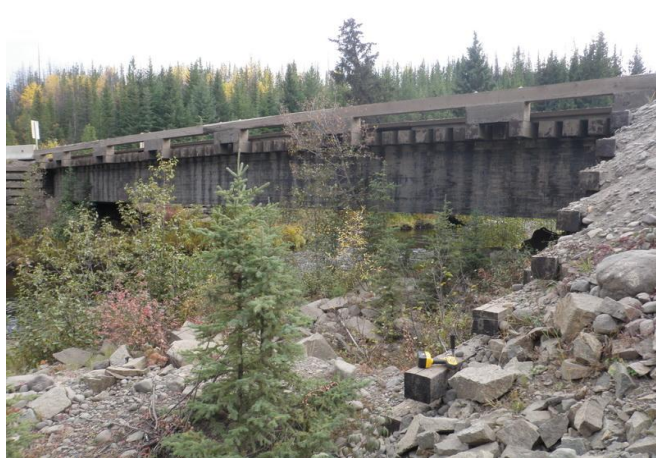
**Figure 1-2: Downstream elevation.**

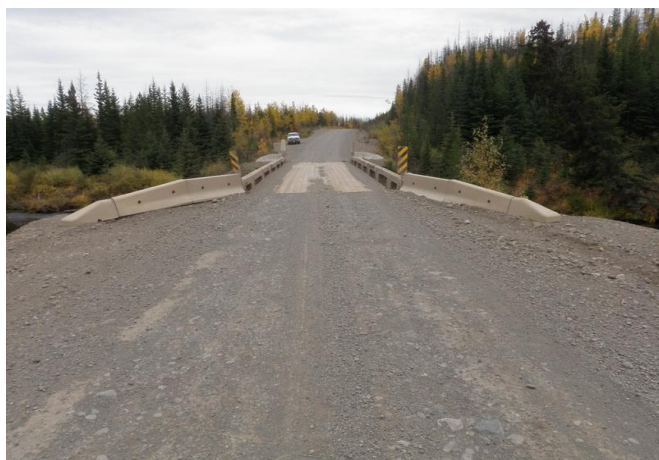
**Figure 1-3: Looking towards camp end.**

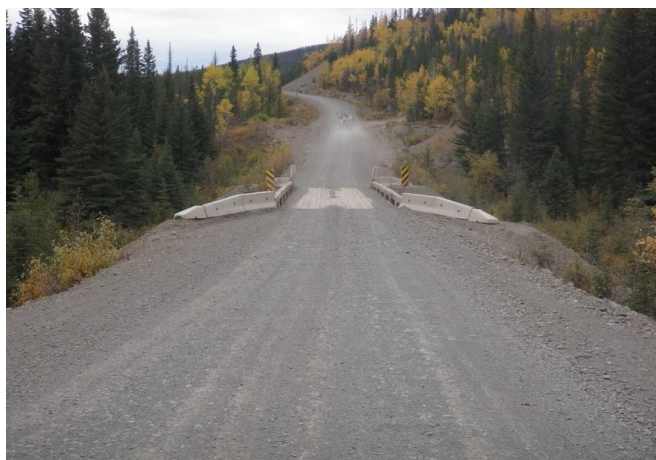
**Figure 1-4: Looking towards woods end.**

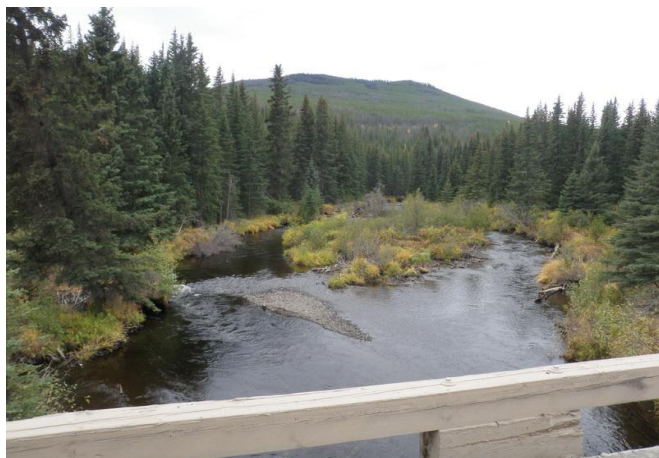
**Figure 1-5: Looking upstream.**

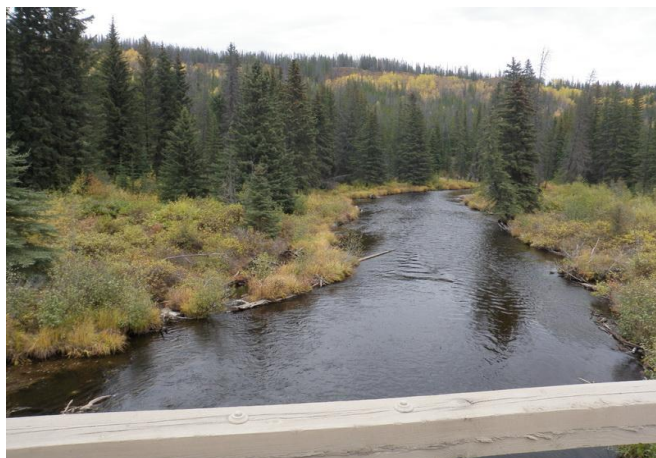
**Figure 1-6: Looking downstream.**

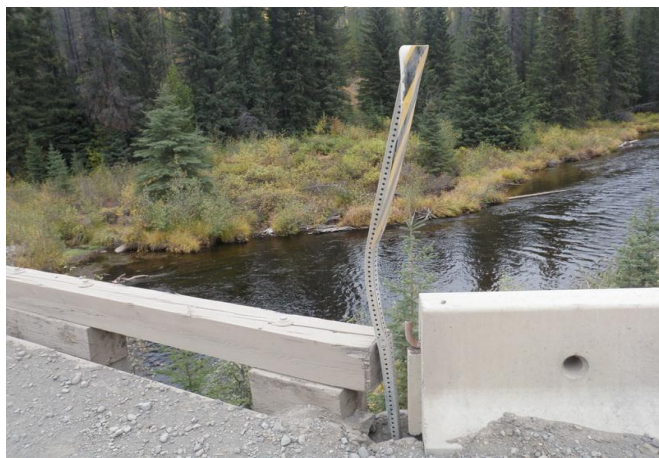
**Figure 1-7: Damaged camp end downstream delineator.**

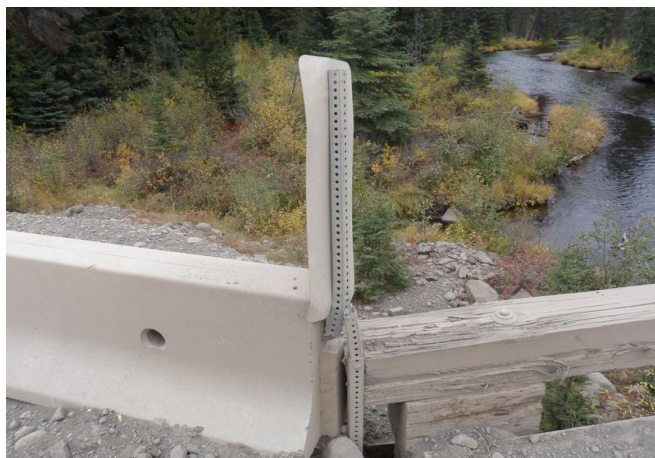
**Figure 1-8: Woods end downstream delineator.**

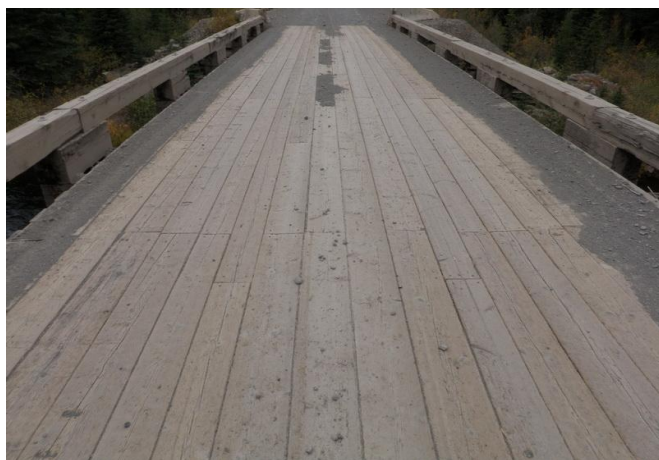
**Figure 1-9: Typical deck condition.**

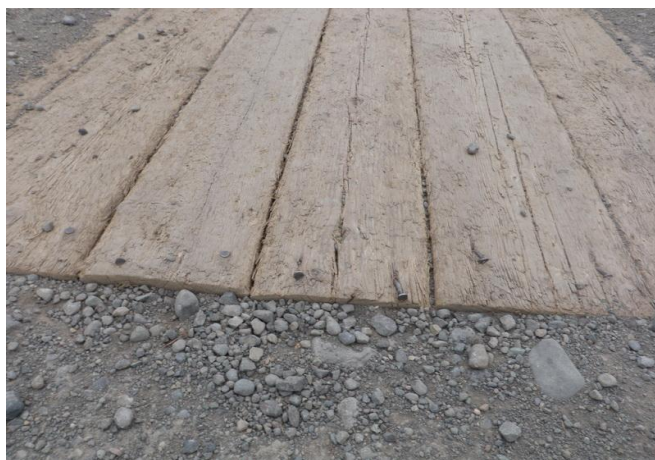
**Figure 1-10: Typical end of deck condition.**

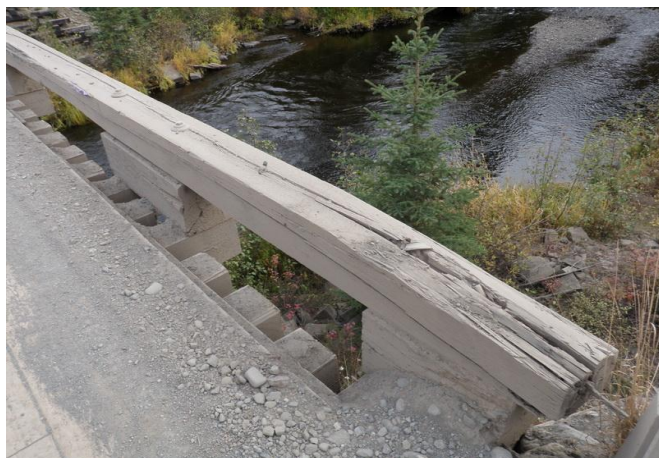
**Figure 1-11: Woods end upstream curb damaged.**

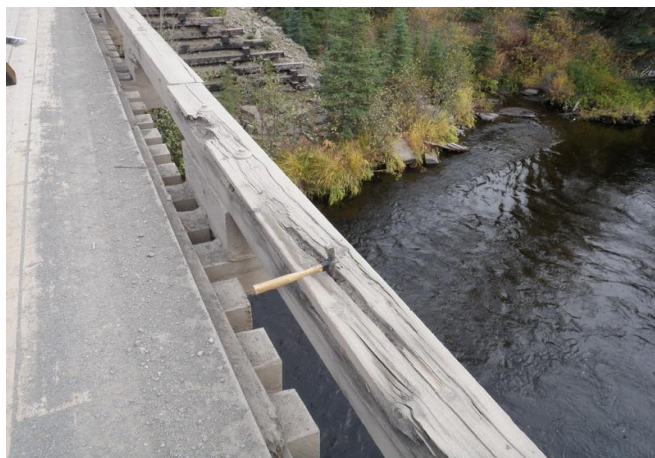
**Figure 1-12: Typical pockets of rot on bridge curb; upstream curb shown.**

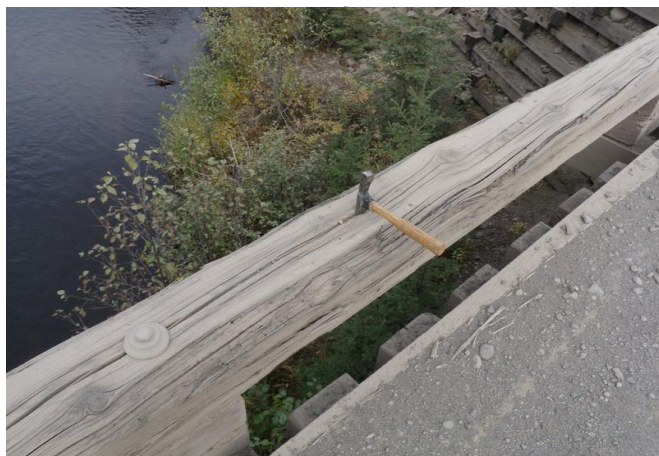
**Figure 1-13: Typical longitudinal checks on bridge curb; downstream curb shown.**

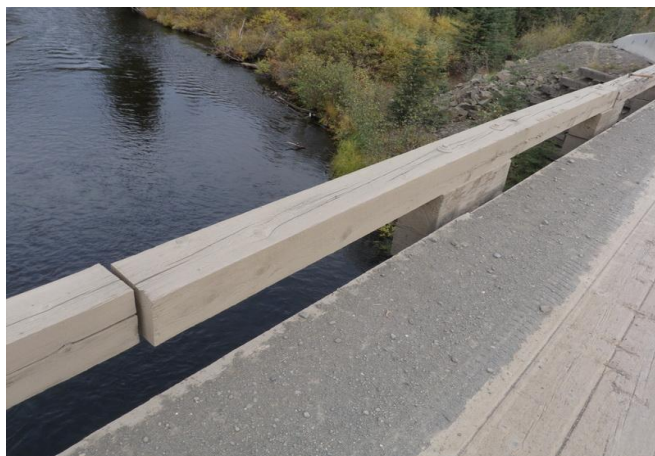
**Figure 1-14: Middle bridge curb rail with one unsupported end; typical on both curbs.**

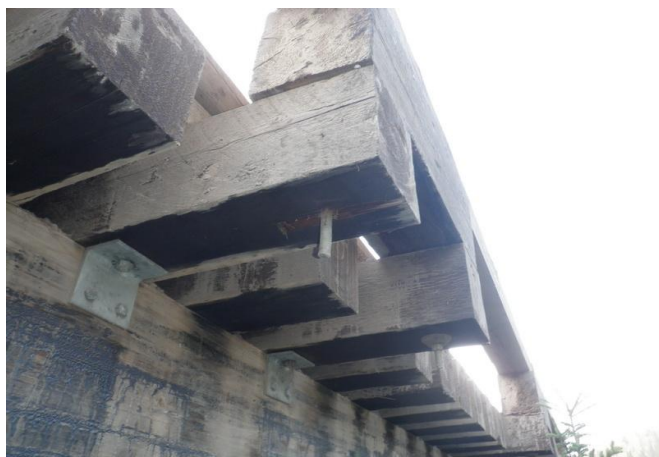
**Figure 1-15: Downstream curb anchor near camp end missing nut and washer.**

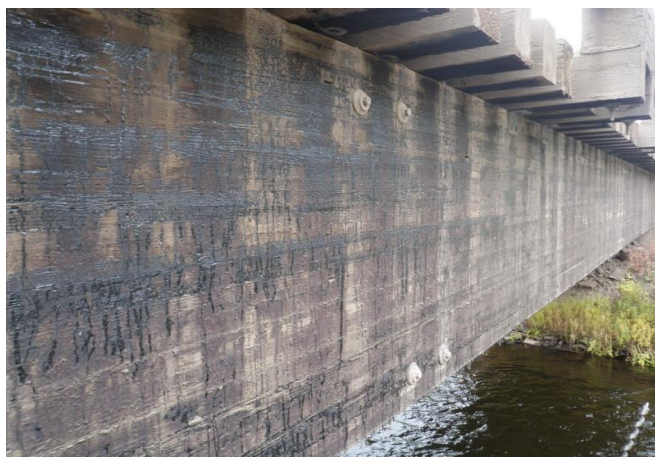
**Figure 1-16: Girder 1 upstream face.**

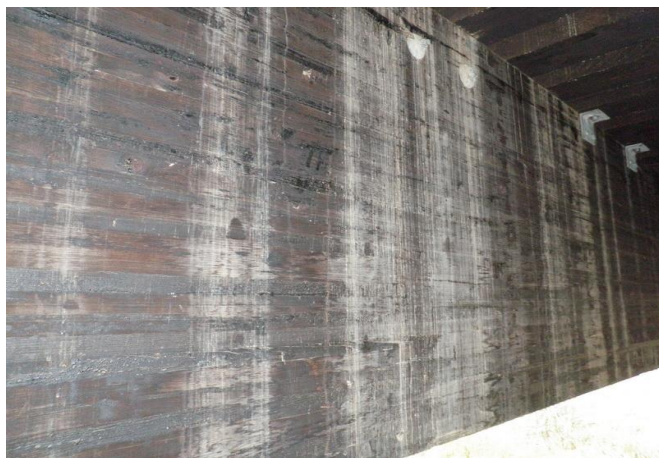
**Figure 1-17: Girder 2 downstream face.**

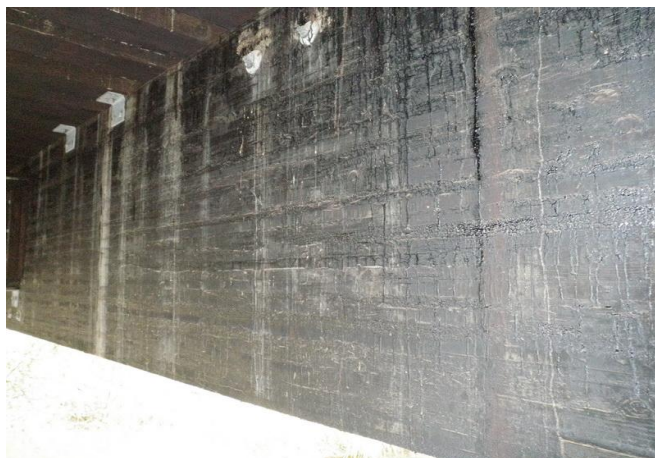
**Figure 1-18: Girder 3 upstream face.**
