| Structure # | Crossing Name | Forest Service Road | User km | CBR km | | |
| 61-046 | Coglistiko River | Michelle-Coglistiko | 23 | 23.2 | | |

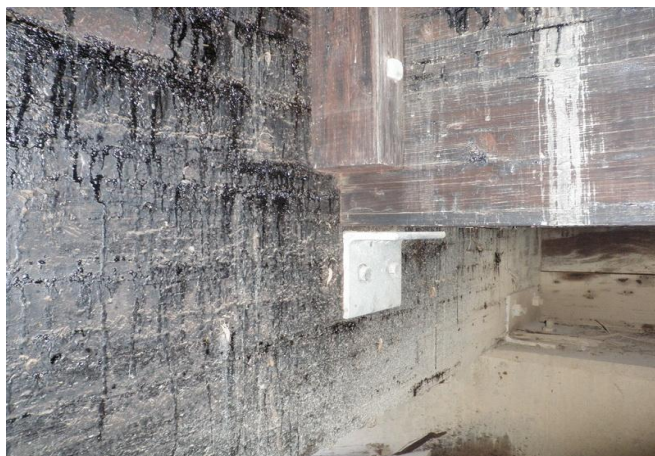
**Figure 1-20: Typical downstream connection of diaphragm.**

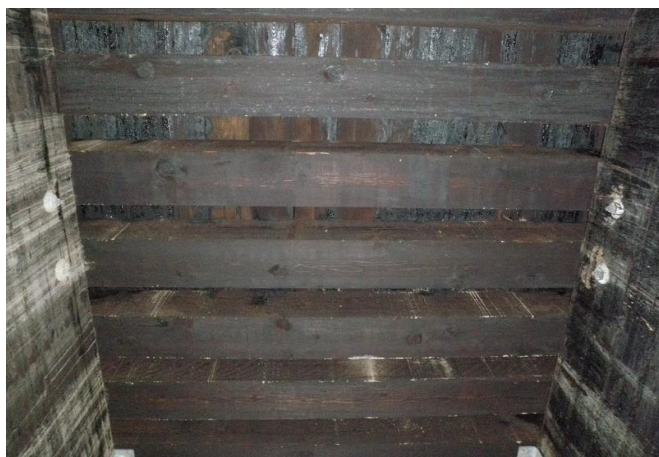
**Figure 1-21: Typical underside of deck condition.**
