## BRIDGE INSPECTION

**62- 003A: Farwell Canyon  
FSR (21.00 KM)**

**Inspection Date:** September 12<sup>th</sup> 2012

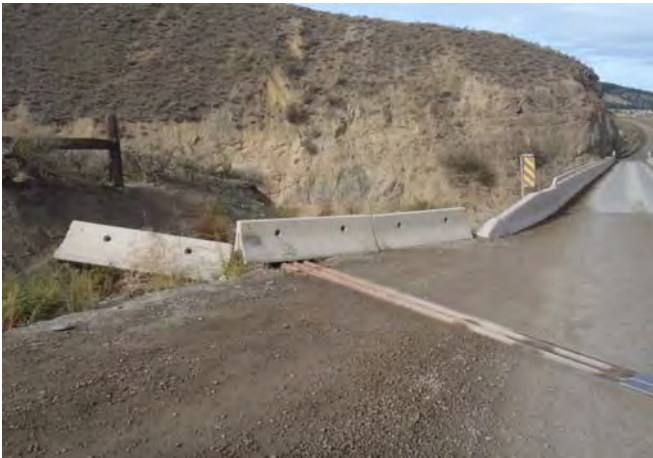
| Fender Condition | Fair | Concrete approach barriers are typically not connected to the parapet. Minor spalls on the camp end barrier and a downstream section has overturned. Spall in woods end downstream barrier at the interface with the parapet, and the upstream barrier bull nose is not connected. |

**Figure 1-7: Camp end downstream barrier overturned.**

| Items | Description | Priority |
|---|---|---|
| 4. | Realign and connect approach barriers as required. | Low |

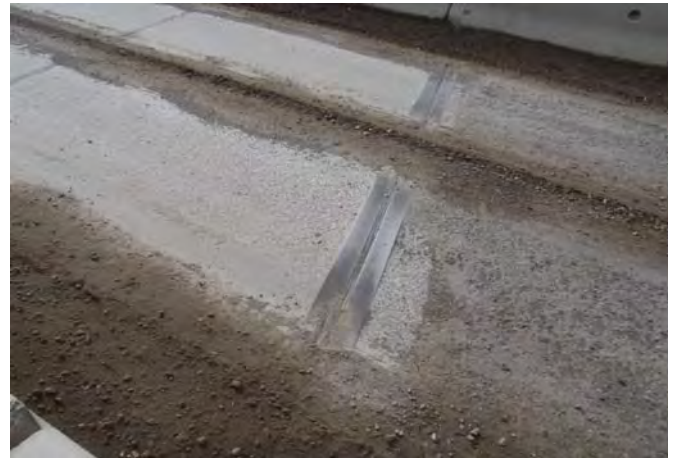
| Deck Joints | Poor | The woods end abutment joint is filled with debris. | | | | | |

**Figure 1-8: Woods end abutment joint.**

| Items | Description | Priority |
|---|---|---|
| 3. | Flush abutment joints. | Low |

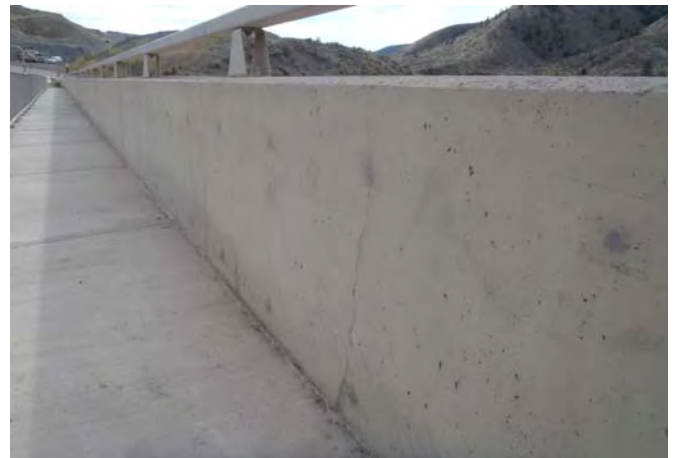
| Curb Rail/Blocks/Posts | Good | There are typical hairline cracks in the parapet at approximately 1 m spacing. A few spalls were noted in the parapet. | | | | | |

**Figure 1-10: Typical parapet condition, note vertical crack.**

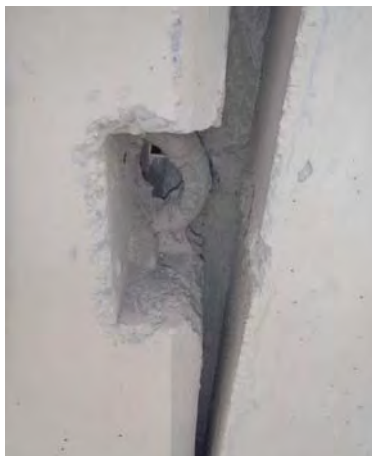
**Figure 1-11: Typical connection between approach barrier and parapet, woods end upstream shown.**

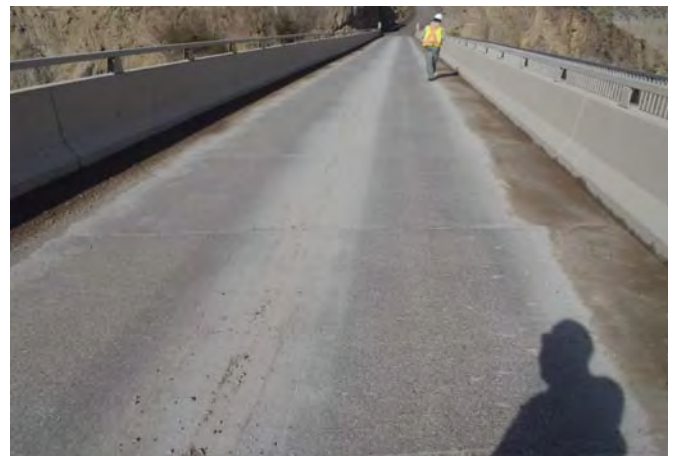
| Concrete Deck | Fair | Typical longitudinal hairline cracks extend from the downstream grout pockets on a number of panels. Minor spalls & wear was noted at the transverse grouted deck panel joints. | | | | | |

**Figure 1-12: Typical deck condition.**

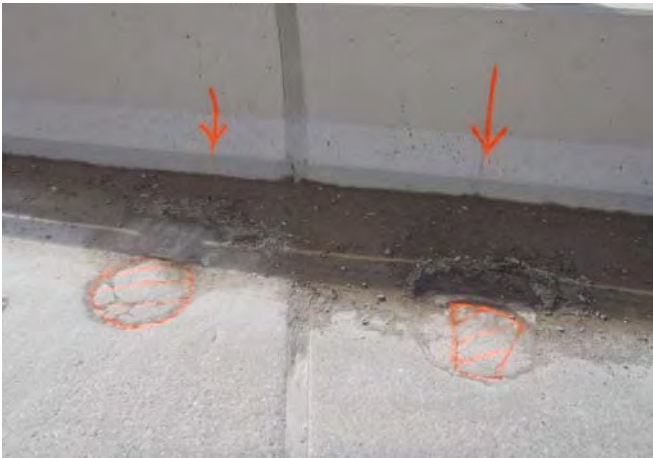
The bridge is generally in good condition. The 3 delaminating grout pockets were noted in the concrete deck. We recommend these grout pockets are repaired in order to ensure composite action between the deck and girders is maintained.

**Figure 1-13: Marked delaminating grout pockets.**

| Items | Description | Priority |
|---|---|---|
| 1. | Repair delaminated deck panel grout pockets. | High |

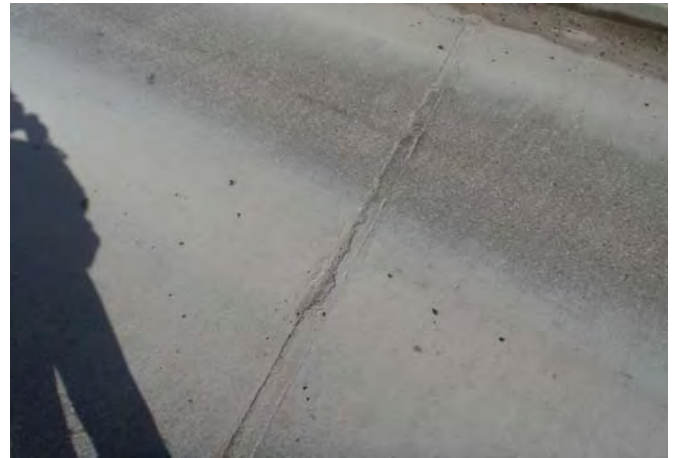
**Figure 1-14: Typical deck panel joint condition.**

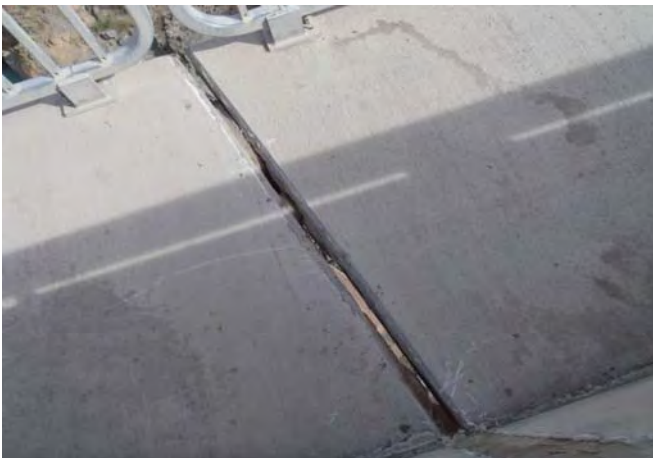
The deck joints at the camp end as well as at piers 1 & 2 have failed. We recommend replacing these joints to prevent deterioration of the steel superstructure and substructure, which will experience increased rates of corrosion when exposed to runoff from the deck.

| Deck Joints | Poor | The joint seals at Piers 1 & 2 have debonded and are damaged in roadway and have failed in the sidewalk. | | | | | |

**Figure 1-15: Pier 1 sidewalk joint, failed.**

| Items | Description | Priority |
|---|---|---|
| 2. | Replace damaged/failed deck joints. | Medium |

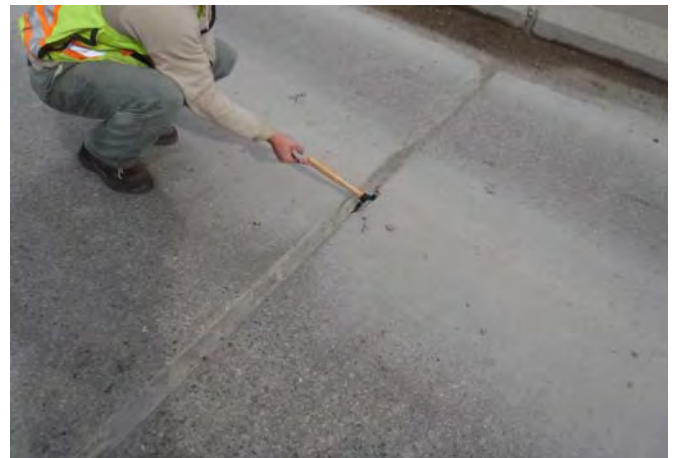
**Figure 1-16: Pier 2 joint sealant debonded.**

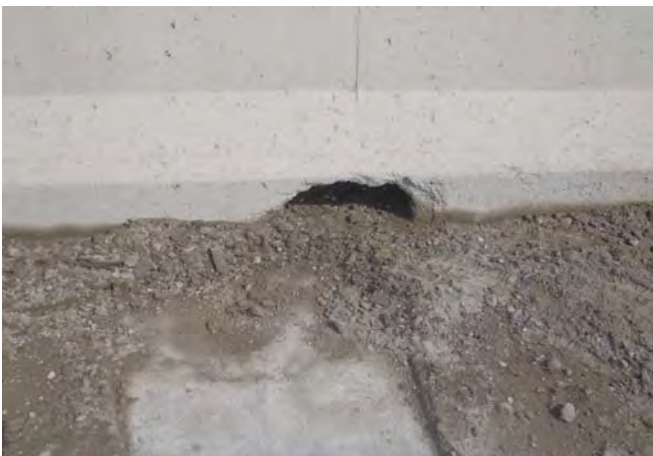
Debris is accumulating on the bridge deck with light wear in the wheel tracks. The scupper in the parapet at the woods end is partially blocked and the drain below the scupper is also blocked.

**Figure 1-17: Woods end upstream drain blocked.**

| Items | Description | Priority |
|---|---|---|
| 5. | Clear deck drain and scuppers. | Low |

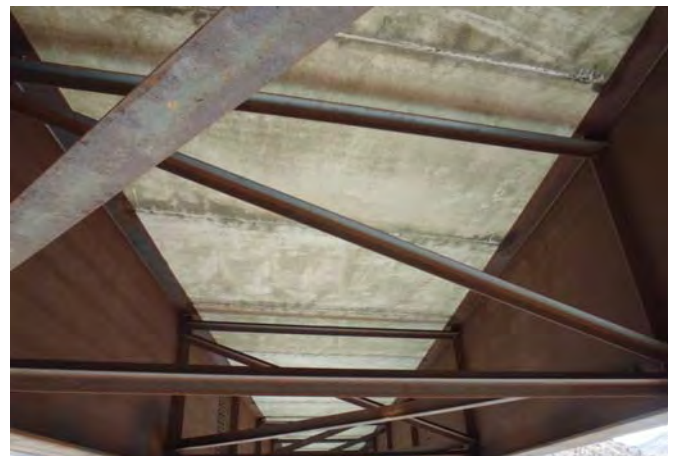
**Figure 1-18: Typical sub deck and bracing condition, note staining around panel joints.**

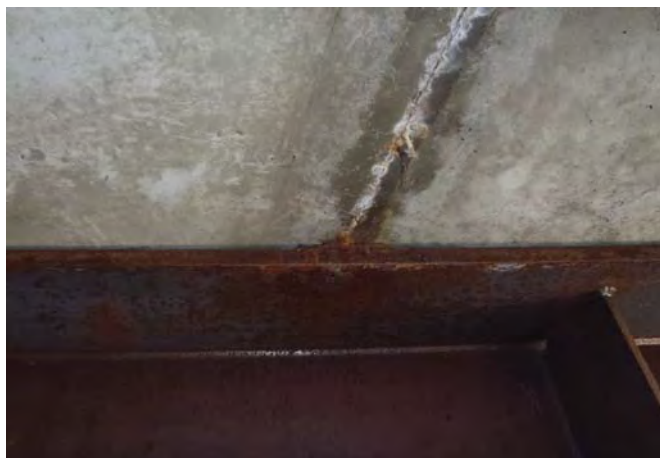
Light corrosion was noted on the top flange at grouted panel joints, with flaking and pitting noted at two locations. Water dripping from the grouted panel joints is causing light surface corrosion of bottom flange in places.

**Figure 1-19: Typical corrosion of top flange at panel joint.**

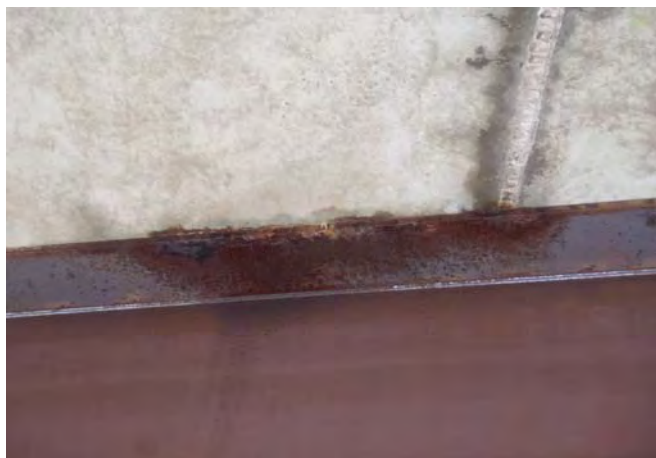
**Figure 1-20: One location of steel flaking and pitting of top flange adjacent to grouted joint.**

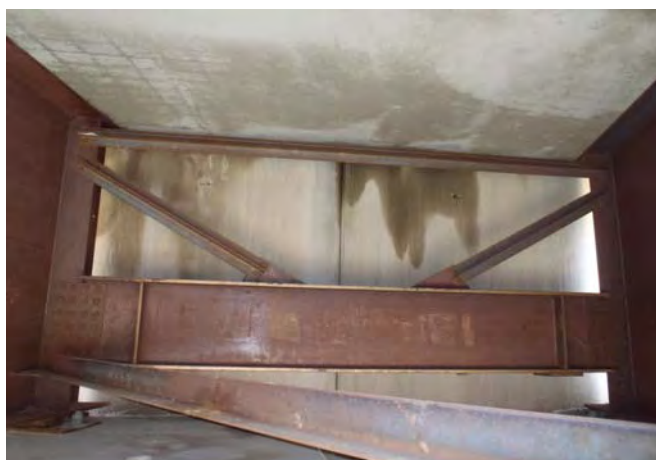
| Ballast Wall | Good | Staining noted on the camp end ballast wall from the leaking deck joint. |

**Figure 1-22: Camp end abutment, water staining of ballast wall.**

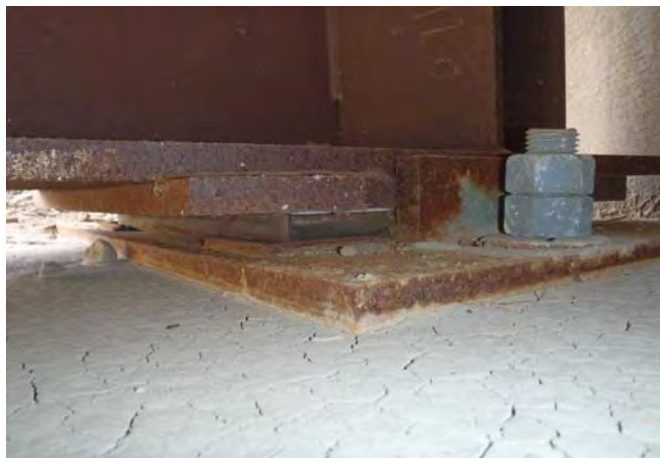
| Caps or Sills | Good | Signs of pooling water on the camp end bearing seat. There is a 0.5 mm wide vertical crack noted extending full height of the woods end breast wall, with minor scour noted under upstream corner of the footing. |

**Figure 1-23: Camp end upstream bearing, note signs of water accumulation on bearing seat.**

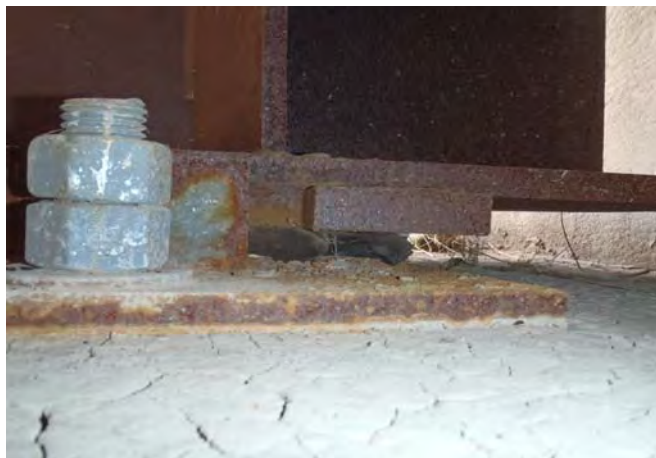
| Bearings | Fair | Minor bulging and deformation of the camp end bearings with the keeper bars cutting into the bearings. The woods end bearings are slightly deformed and bulging. |

**Figure 1-24: Typical deformation of camp end bearings.**

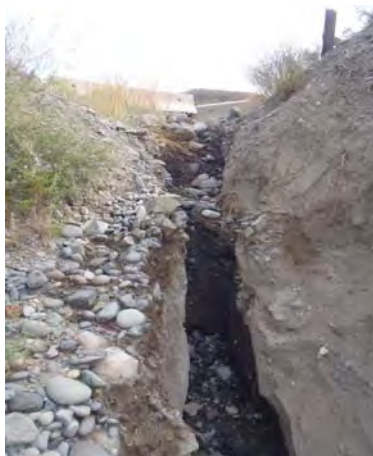
| Fill | Good | Minor erosion of the camp end embankment fill. A large drainage channel from the roadway was noted at the downstream corner of camp end abutment. |

**Figure 1-25: Drainage channel adjacent to camp end abutment.**

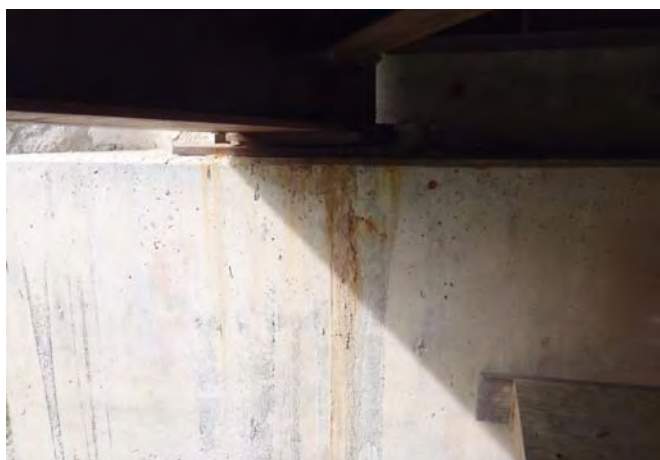
**Figure 1-27: Woods end downstream bearing, corrosion staining on breastwall.**

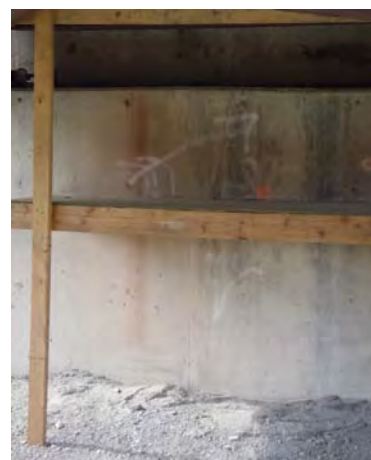
**Figure 1-28: Woods end abutment, full height crack.**

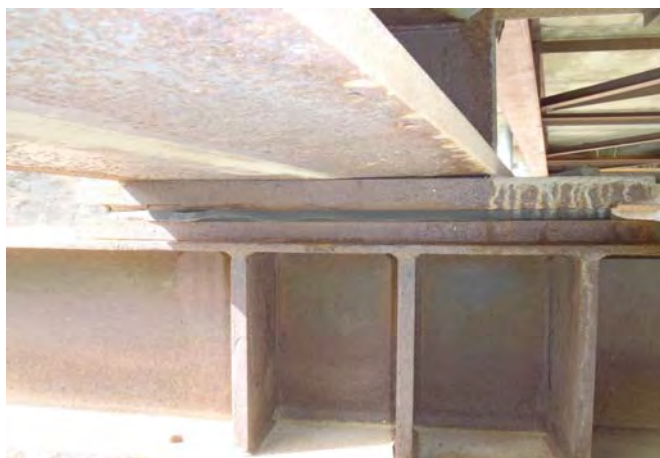
The downstream bearing is spilt and bulging/deformed.

**Figure 1-29: Typical bulging and deformation of pier 2 bearings, downstream shown.**

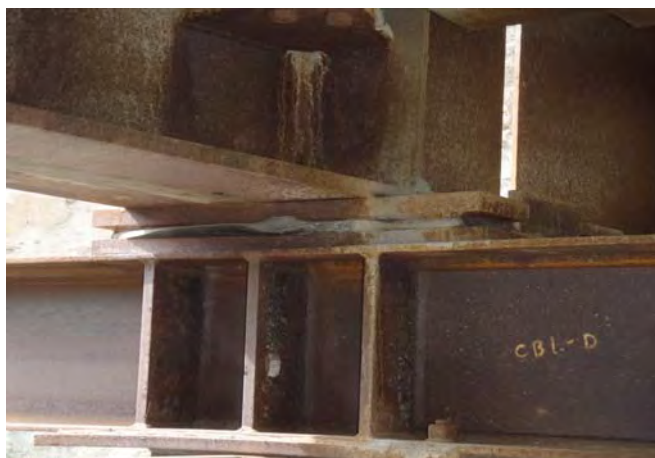
The bearings are bulging and deformed.

**Figure 1-30: Typical bulging and deformation of pier 1 bearings, downstream shown.**
