## BRIDGE INSPECTION

**BRIDGE NO./NAME**                      **62- 035: Black Creek- Bosk Lk FSR (1.00 KM)**

**Inspection Date:**                      September 11<sup>th</sup> 2012

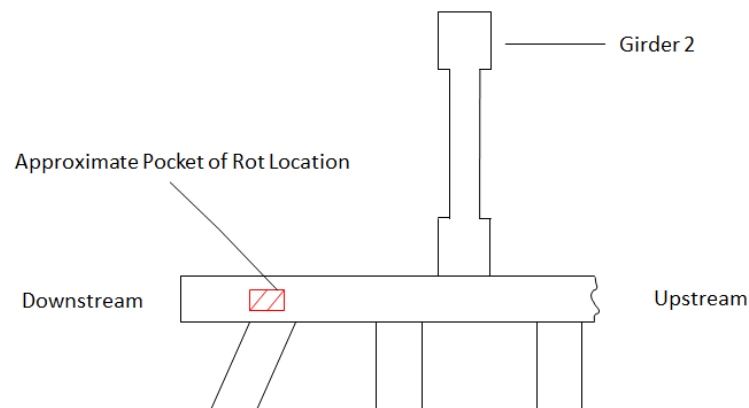
**Pier 2 Woods End Cap**

- Generally in fair condition.
- The camp end cap beam is sound, good condition; minor weathering at both ends, end check noted. Minor debris accumulation and moss growth was noted in the check.
- The woods end cap beam is in fair condition, vertical end split noted in the downstream face with an adjacent check on the top of the cap approximately 1 m long, see photo sheet figure 1-29. Minor debris accumulation and moss growth was noted in the check.
- We identified heartwood rot with 150 mm of shell remain at the check in the downstream end of woods end cap above downstream pile; the capacity of woods end cap does not appears to be affected by the decay, no bulging or crushing noted.

| Caps | Fair | The camp end cap beam is sound and is in good condition, minor weathering of end with debris accumulation. The woods end cap beam is in fair condition, a vertical end split noted in the downstream face with minor debris accumulation and moss growth on ends of cap. Coring through check in woods end cap identified 150 mm shell with heartwood rot above downstream pile, See AE Inspection Summary for details. Capacity of woods end cap not affected by rot; no bulging or crushing noted. |

| | 2 | Monitor condition of Pier 2 cap beams. |

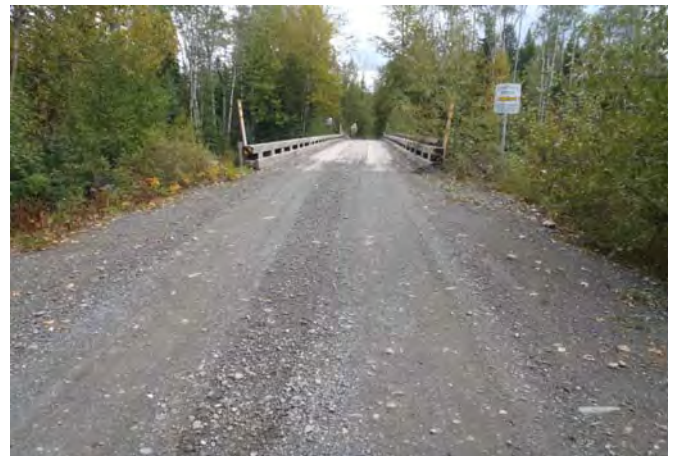
- The approaches are generally in fair condition.
- Loose gravel was noted on the approaches.
- There are no approach barriers in place.
- The camp end delineators are missing and the woods end upstream delineator is damaged.
- The bridge deck is higher than the road surface at the woods end.
- Both Bridge Ahead signs are missing.

**Figure 1-6: Looking towards woods end, note no delineators.**

| | 2 | Recommended | High | \$750.00 | Replace/install damaged or missing delineators. |

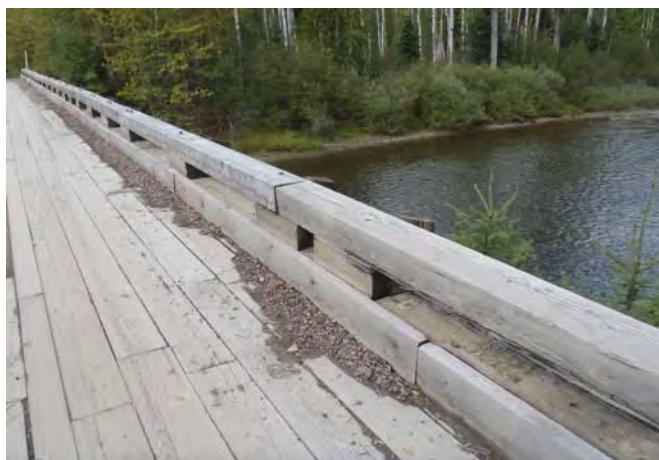
- Additional posts are attached to the upstream curb rail. Posts are in poor condition; 14 damaged, 4 missing, end rot in a few remaining posts.
- Debris accumulation along deck edge.

**Figure 1-9: Upstream curb rail condition.**

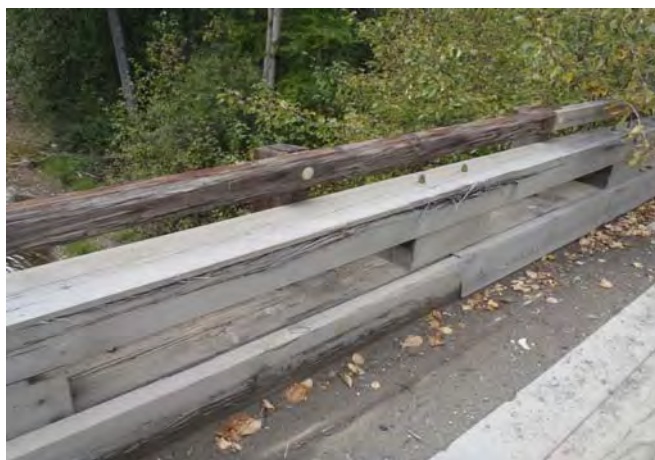
- The curb rail is in fair condition, observed longitudinal checks, rub damage and pockets of rot.
- The curb rail anchor bolts are missing in a number of places.

**Figure 1-10: Downstream curb rail condition, note rub damage.**

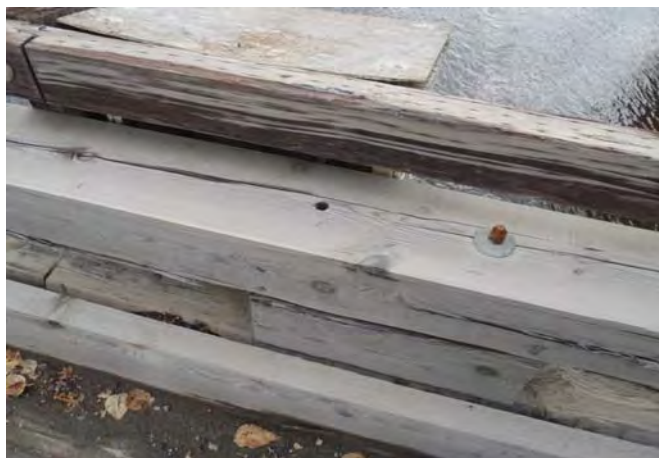
| Hardware | Fair | Curb rail anchor bolts are missing in a number of places. | | | | | |

**Figure 1-11: Typical missing curb rail anchor bolt.**

| | 1 | Recommended | High | \$1,500.00 | Install curb rail anchor bolts as required. |

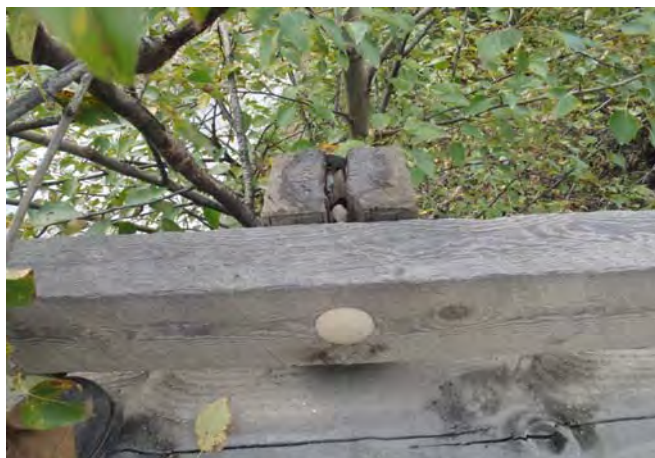
- The deck is generally in fair condition.
- A hand rail is in place on the downstream face.
- Hand rail damage noted near the camp end, a few posts have end splits.

**Figure 1-12: Typical end split in downstream hand rail.**

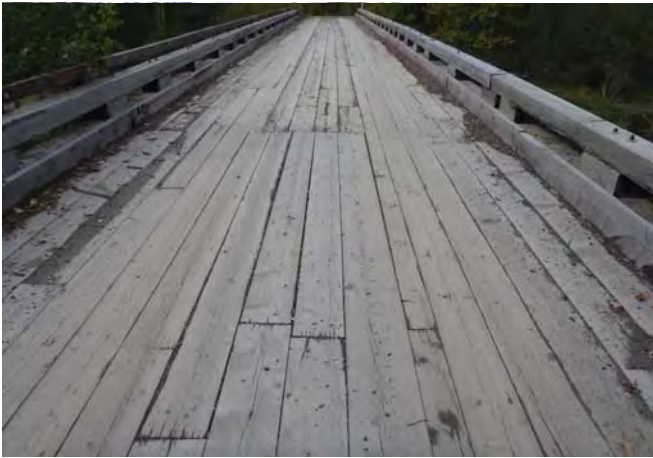
- The planks in the wheel tracks appear to have been recently replaced. The remaining planks are in fair condition showing signs of wear with longitudinal checks and small pockets of rot.

**Figure 1-13: Typical deck condition.**

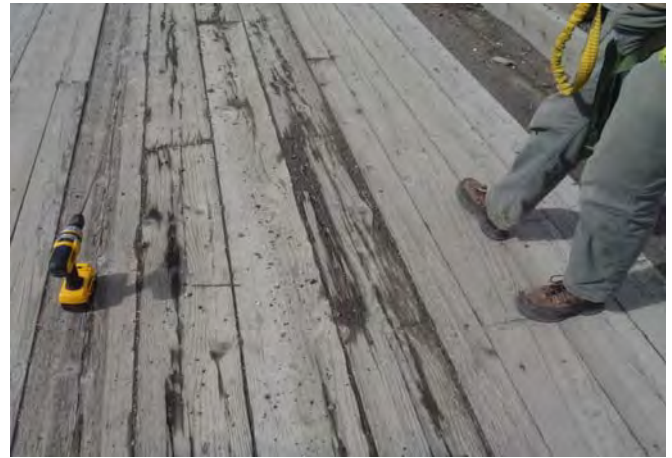
| Running Planks | Fair | The planks in the wheel tracks appear to have been recently replaced. The remaining planks are in fair condition and showing signs of wear with longitudinal checks and small pockets of rot. Coring the wearing planks identified moisture at the interface with the structural deck. | | | | | |

**Figure 1-14: Pocket of rot in old planks, note condition of wearing planks.**

| | 3 | Recommended | Medium | \$7,200.00 | Replace wearing planks as required. |

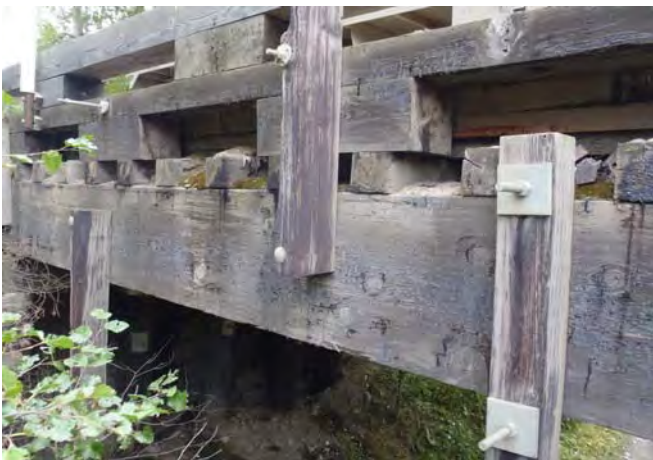
**Figure 1-15: Span 1, stringer 1, upstream face.**

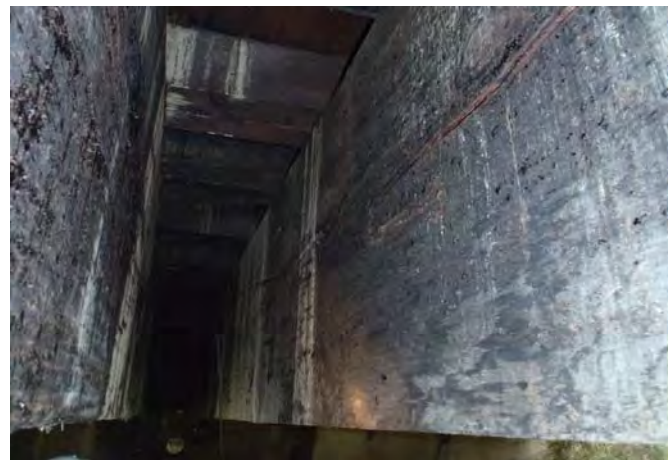
| Stringer | Check Start | Check End | Max. Depth (mm) | Max. Width (mm) | Location (mm) | Condition |
|---|---|---|---|---|---|---|
| 5, upstream face | Pier 1 | Mid span | 10 | | 280 mm from bottom | Series of checks |

**Figure 1-16: Span 1, typical interior stringer condition, stringer 5 downstream face shown.**

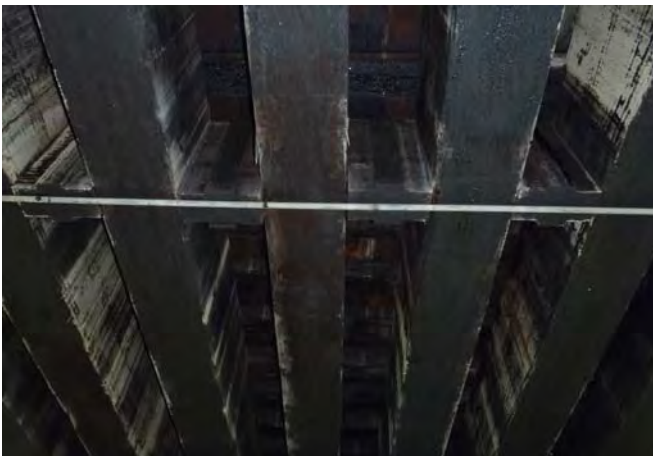
| Sub Deck | Good | Coring the structural planks identified moisture but no signs of rot. | | | | | |

**Figure 1-17: Typical span 1, 3 & 4 sub deck condition, span 1 shown.**

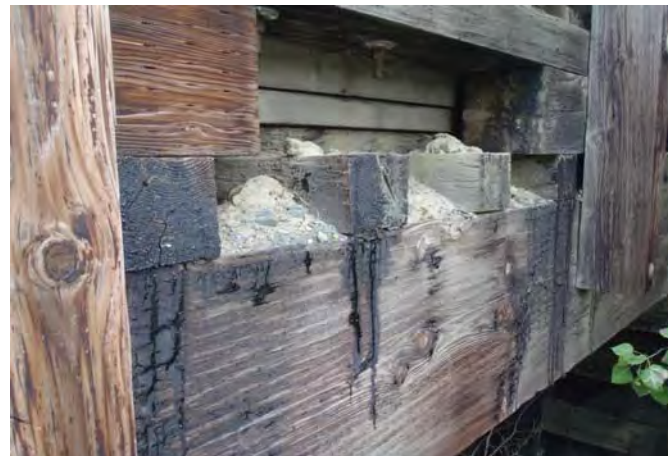
| Stringer | Check Start | Check End | Max. Depth (mm) | Max. Width (mm) | Location (mm) | Condition |
|---|---|---|---|---|---|---|
| 9, downstream face | | | 90 | | Mid depth. | Series of checks; drilled below the check, no rot. |

**Figure 1-18: Span 1 stringer 9, downstream face condition, note debris accumulation.**

| | 6 | Recommended | Low | \$500.00 | Remove debris from cap beams and exterior stringers. |

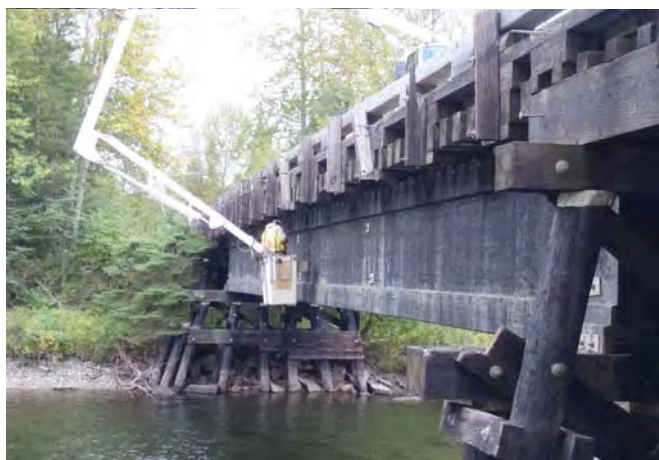
- Creosote leaching covering face, some checks noted typically 40 mm deep in the top flange, 75 mm deep in places.

| Tag Type | Check Start | Check End | Length (mm) | Max. Depth (mm) | Max. Width (mm) | Location (mm) | Condition (mm) |
|---|---|---|---|---|---|---|---|
| Existing | AE1265 | AE1266 | 4800 | 50 | 3 | Upstream face. 60 from top flange. | Previously tagged ND Lea 424 to ND Lea 423. Propagated 300 towards Camp end & 730 to Woods end. |

**Figure 1-19: Span 2, girder 1, upstream face condition.**

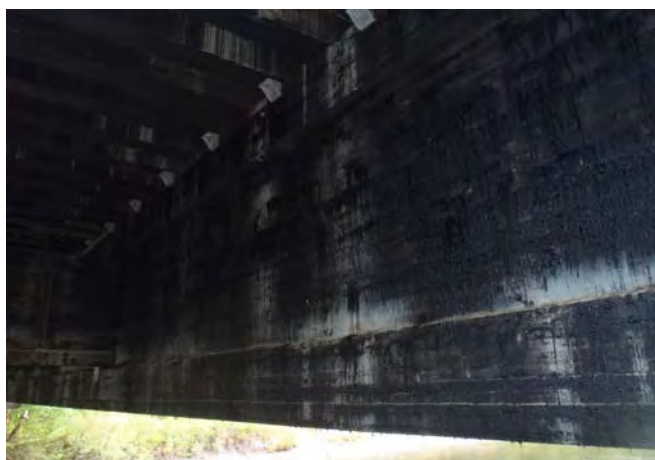
- Creosote leaching through laminated joints, some checks noted.

**Figure 1-20: Span 2, typical interior girder face, girder 3 shown.**

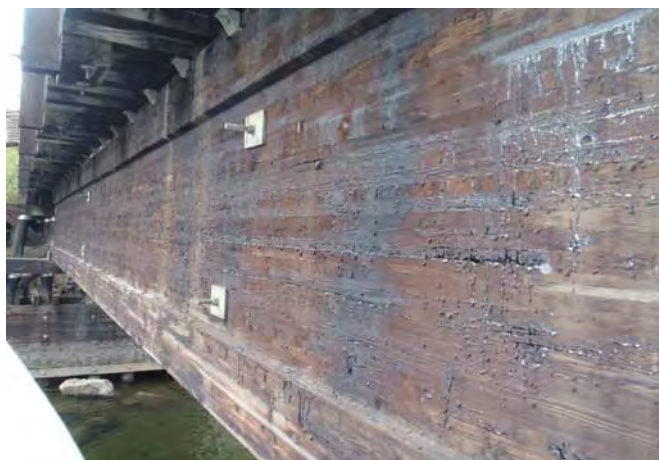
- Creosote leaching out of laminated joints, <25% of face exposed, some checks noted typically <15 mm deep 30 mm in places.

| Tag Type | Check Start | Check End | Length (mm) | Max. Depth (mm) | Max. Width (mm) | Location (mm) | Condition (mm) |
|---|---|---|---|---|---|---|---|
| New | AE1270 | AE1269 | 4000 | 35 | | Downstream face. 1000 from top flange. | Series of checks. |

**Figure 1-21: Span 2, girder 2, downstream face condition.**

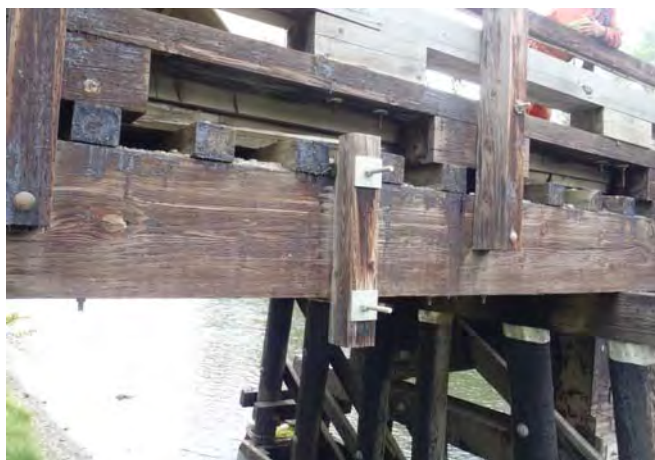
- Upstream face of stringer 1 has creosote leaching with some checks noted.
- Interior stringer faces are 100% covered by creosote with minimal creosote leaching.
- Downstream face of stringer 9 has visible creosote on <25% of stringer face, some checks noted.
- We observed a series of short diagonal checks near the mid-depth of stringers 1, 4, 5, 6, 7 & 9. The checks do not appear to affect the capacity of the stringers.

**Figure 1-22: Span 3, stringer 9, downstream face.**

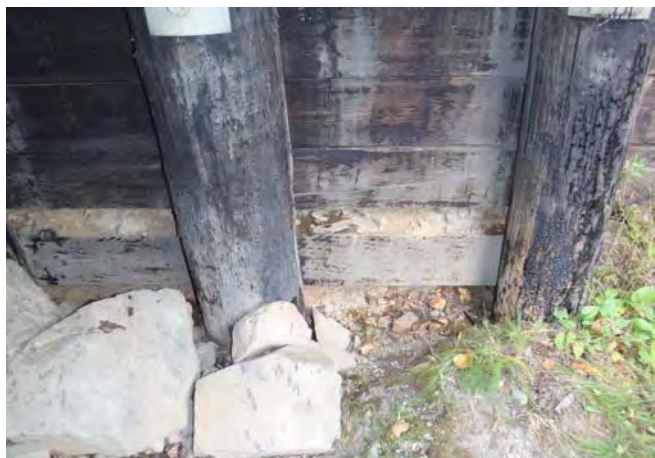
| Ballast Wall | Good | There are 130 mm and 75 mm wide gaps between the bottom breast wall planks of the camp end and woods end abutments respectively. The toe of the camp end breast wall is exposed in places. Minor scour and limited fill loss was noted from behind both abutment breast walls. |

**Figure 1-24: Camp end abutment ballast wall, gap between planks and sign of scour.**

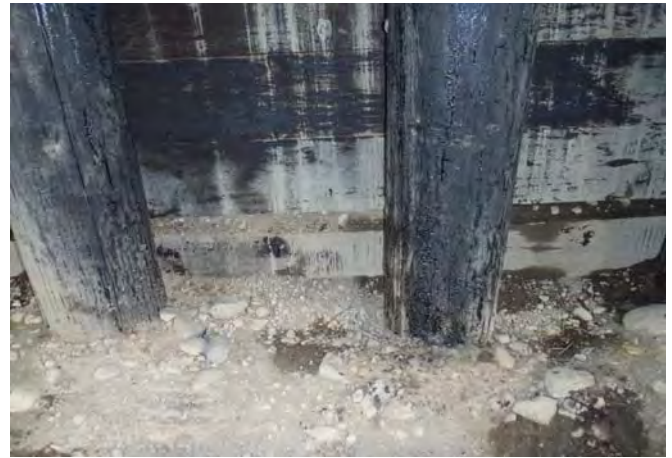
**Figure 1-26: Woods end abutment ballast wall, gap between planks and minor scour.**

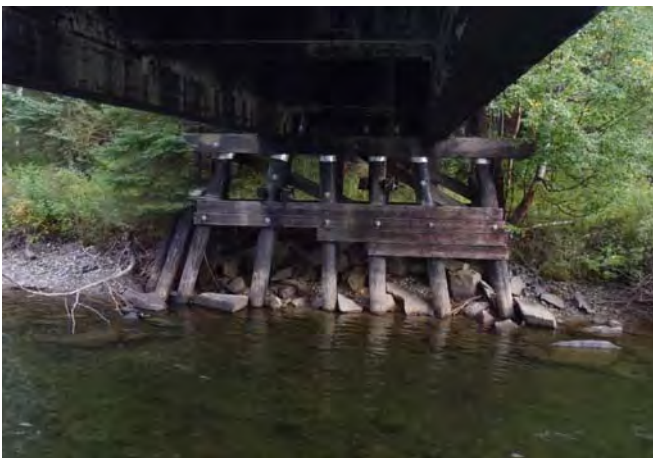
- Generally in good condition.
- The cap beam is sound.
- Debris accumulation on the cap beam.
- Drilled camp end pile 1; No rot, moisture noted.
- Drilled woods end pile 4; No rot, moisture noted.

**Figure 1-27: Pier 1 camp end face.**

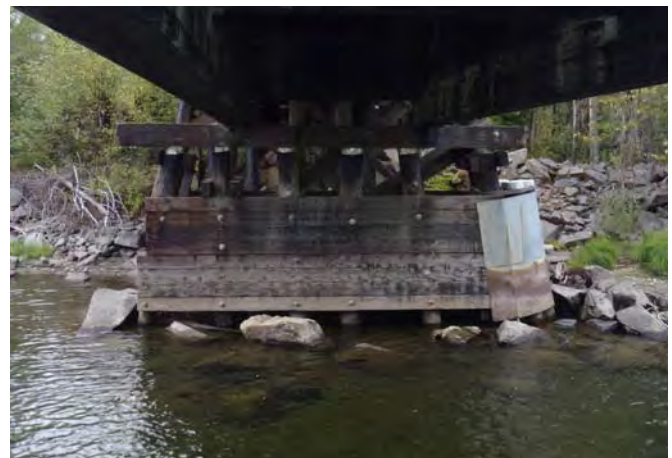
- Deterioration of two piles identified, heartwood rot in places.
- Drilled camp end pile 2; No rot, moisture noted.
- Drilled camp end pile 3; heartwood rot noted with 75 mm of shell remain.
- Drilled the bottom of camp end pile 6; heartwood rot noted with 100 mm of shell remain.
- Drilled woods end pile 6; No rot, moisture noted.

| Piles or Posts | Fair | Deterioration of two piles identified, heartwood rot in places. See AE Inspection Summary for details. |

**Figure 1-28: Pier 2, woods end face.**

| | 1 | Monitor deterioration of Pier 2 piles. |

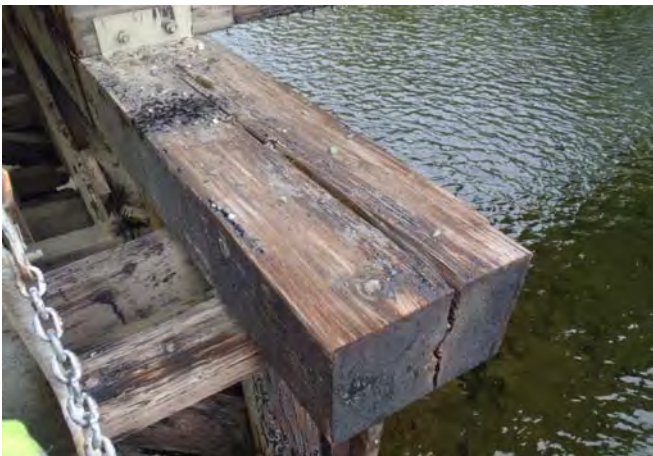
**Figure 1-29: Pier 2 woods end cap, downstream end split.**

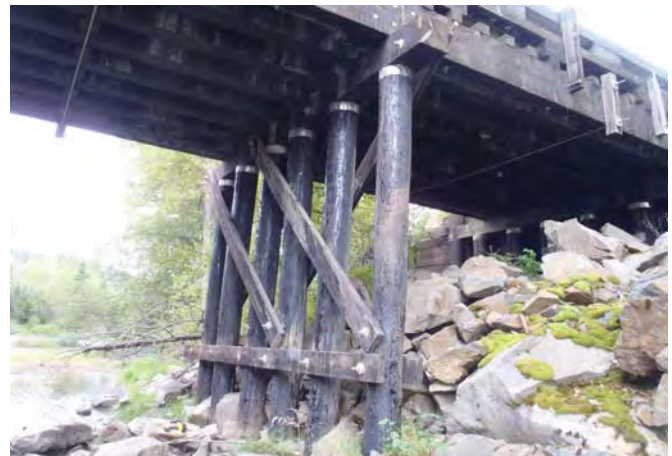
- Generally in good condition.
- The cap beam is sound.
- Minor debris accumulation on the cap beam.
- Creosote leaching and minor weathering of cap ends.
- A vertical check 12 mm wide and 85 mm deep was noted on the camp end face of the 5<sup>th</sup> pile.
- Drilled pile 4; No rot noted.

**Figure 1-30: Pier 3, woods end face.**
