## BRIDGE INSPECTION

| <b>BRIDGE</b> | <b>62 – 039: Cariboo River</b> |
| <b>NO./NAME</b> | <b>FSR (0.75 KM)</b> |

**Inspection Date:** September 10<sup>th</sup> 2012

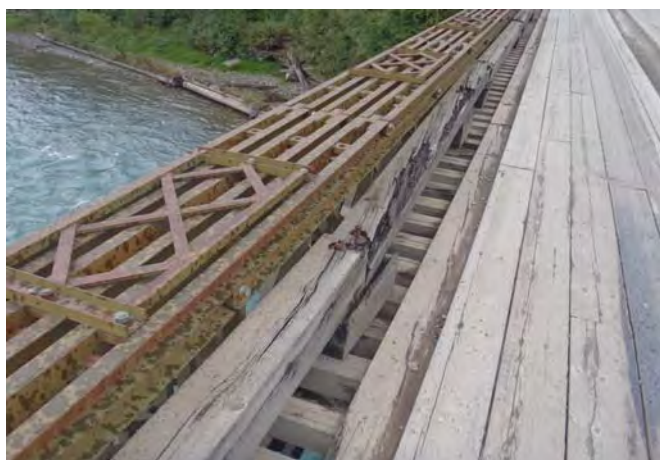
| Structure #: | 62-039 | Site #: | 62-039 | Road Name: | CARIBOO RIVER | Inspection Date: | 2012/09/10 |
|---|---|---|---|---|---|---|---|
| <b>Curb Rail/Blocks/Posts</b> | Poor | The majority of curb rail sections are loose. Insect decay noted in a number of sections. Longitudinal checks in the curb rail with pockets of rot. A few risers have rub damage; some are broken. | | | | | |

**Figure 1-9: Pocket of rot on curb rail, upstream shown.**

| Items | Description | Priority |
|---|---|---|
| 1. | Replace curb rail. | High |

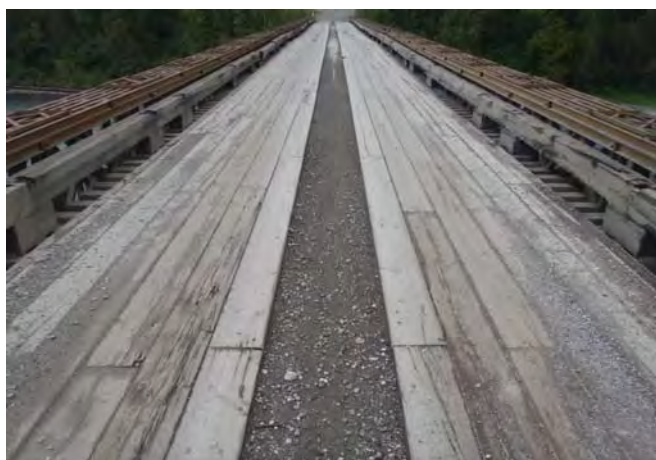
| Structure #: | 62-039 | Site #: | 62-039 | Road Name: | CARIBOO RIVER | Inspection Date: | 2012/09/10 |
|---|---|---|---|---|---|---|---|
| <b>Sub Deck</b> | Fair | Coring identified rot in the bottom half of the structural planks, with the initial signs of rot noted at interface with the ties. | | | | | |

**Figure 1-10: Typical deck condition.**

| Items | Description | Priority |
|---|---|---|
| 8. | Schedule the structural planks and ties for replacement. | Medium |

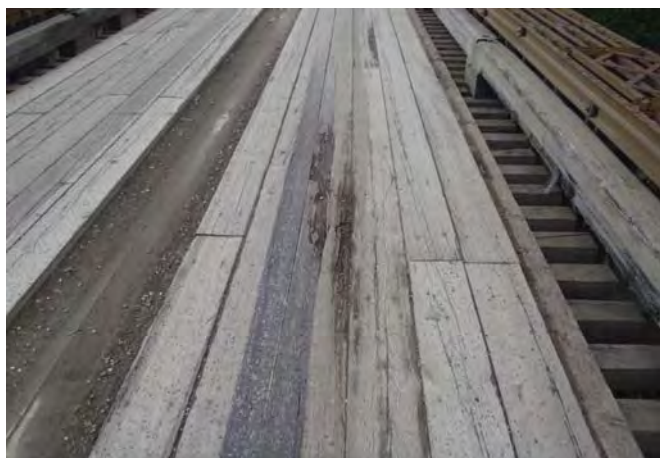
| Structure #: | 62-039 | Site #: | 62-039 | Road Name: | CARIBOO RIVER | Inspection Date: | 2012/09/10 |
|---|---|---|---|---|---|---|---|
| <b>Running Planks</b> | Fair | Minor wear in the running planks. Longitudinal checks and a number of pockets of rot noted in the running planks. | | | | | |

**Figure 1-11: Pocket of rot in running strip.**

| Items | Description | Priority |
|---|---|---|
| 6. | Replace running planks as required. | Medium |

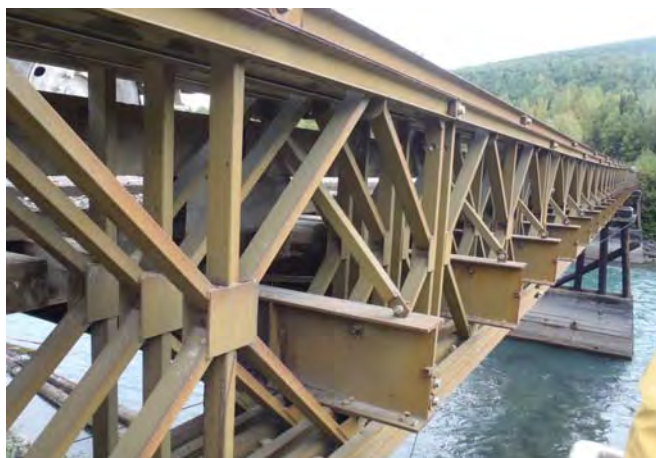
**Figure 1-12: Typical panel condition, span 3 downstream shown.**

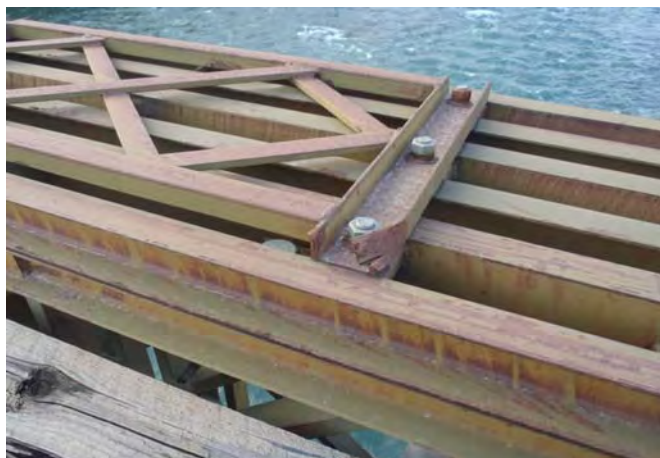
**Figure 1-13: Typical impact damage to bracing frame.**

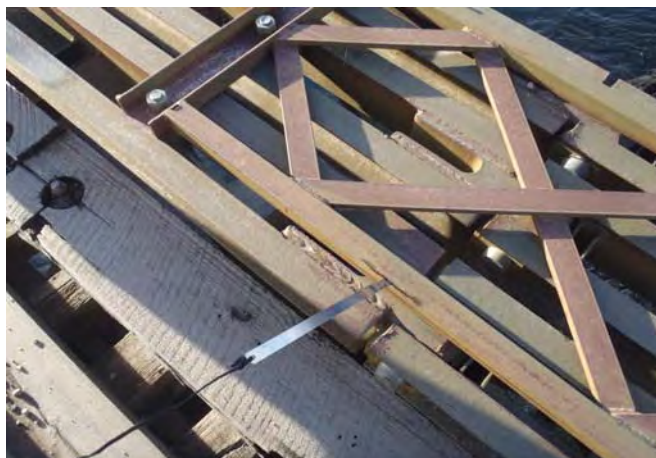
- 4 small isolated cracks noted on the top bracing frame elements of the upstream and downstream panels; minor impact damage to interior end post at Wells end upstream corner.
- The minor defects noted should not have significant effect on the capacity of the bridge.

**Figure 1-14: Typical crack in span 1 bracing frame, upstream panel 4 shown.**

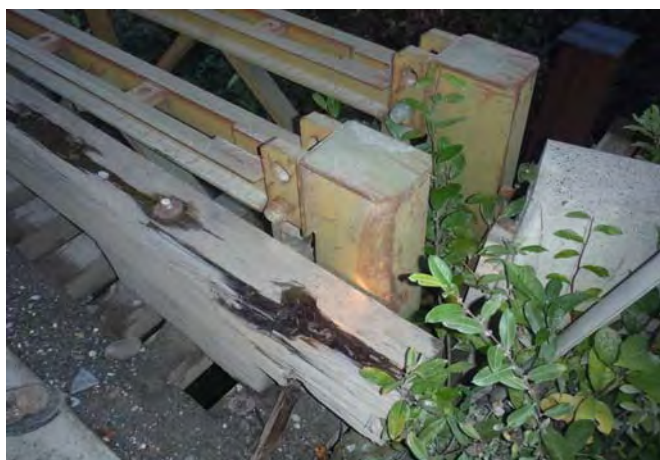
**Figure 1-15: Typical impact damage to end post, Wells end upstream shown.**

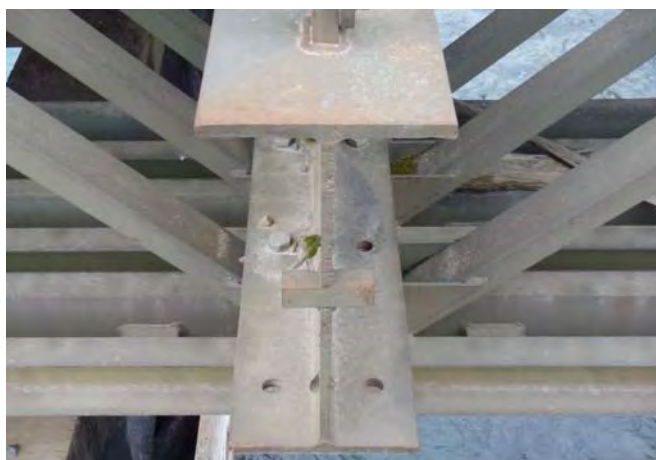
- Localized loss of paint and minor surface corrosion on all members, no measurable section loss.
- Localized damage on corners of a number of truss elements.
- A few bolts connecting the transom to the bottom chord of the panels are missing. We do not believe this affects the capacity of the bridge.
- A number of panel pins along the centre panels are missing safety clips; some pins are displaced and are held in place by adjacent pins.
- First and last bays between transoms in each span have two X shaped lateral braces. Remaining bays have chevron shaped lateral bracing.

**Figure 1-16: Typical missing transom bolts, span 3 panel 1 shown.**

| Items | Description | Priority |
|---|---|---|
| 4. | Install missing transom bolts. | Medium |

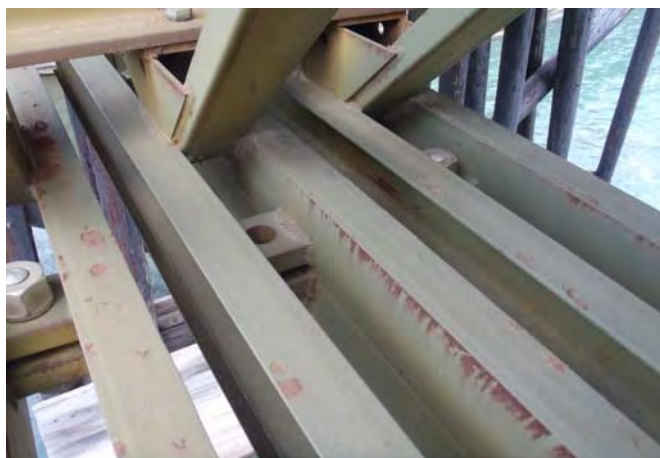
- 3 bottom chord reinforcing connection bolts missing in downstream panel 9. We do not believe this significantly affects the capacity of the bridge.

**Figure 1-17: Typical missing reinforcing connection bolt in span 2 downstream panel 9.**

| Items | Description | Priority |
|---|---|---|
| 3. | Replace missing panel reinforcing connection bolts in span 2 panel 9. | Medium |

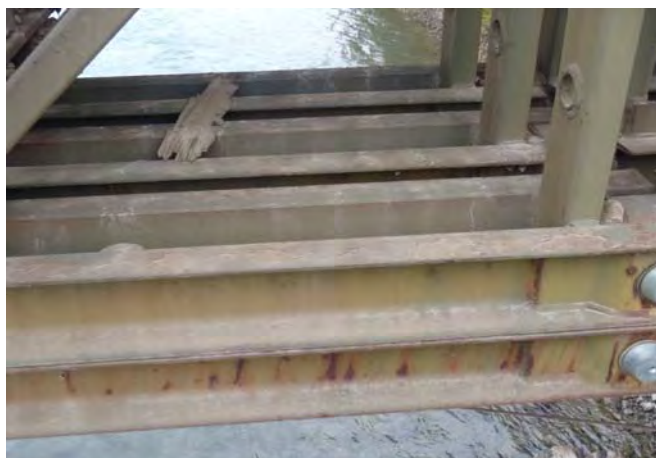
**Figure 1-18: Typical peeling paint and minor surface corrosion of panel.**

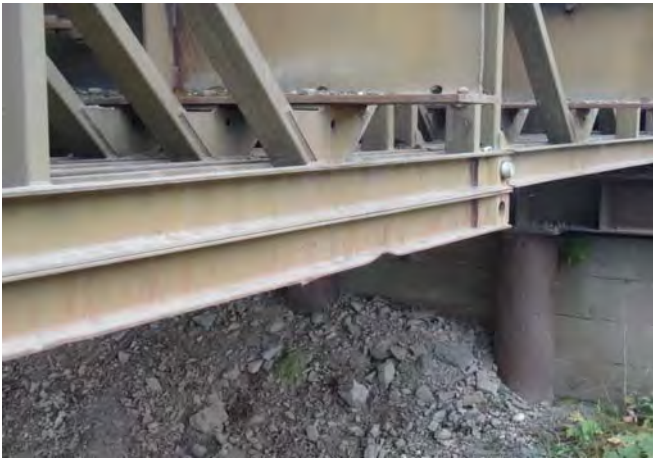
- A minor isolated crack was noted on the end bracing frame of the upstream end panel above Pier 2.
- Minor mechanical damage to bottom chord reinforcing in upstream panel 9.
- Impact damage to end post at Likely end downstream corner.
- The minor defects noted should not have significant effect on the capacity of the bridge.

**Figure 1-19: Minor damage to bottom chord reinforcing in span 3 panel 9 upstream.**

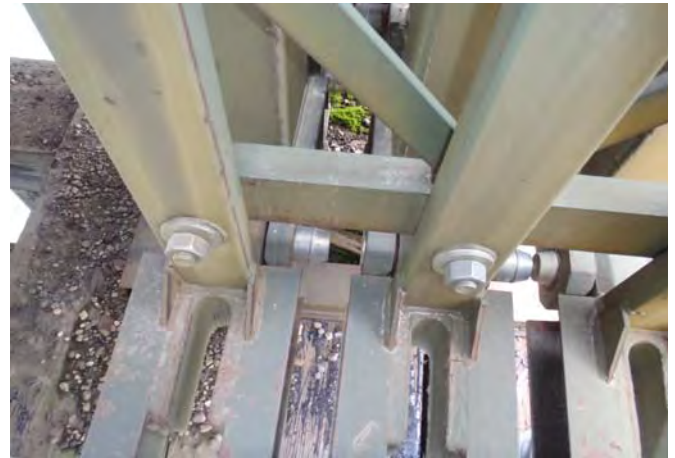
| <b>Hardware</b> | Fair | A number of panel pins along the centre panels are missing safety clips; some pins are displaced and are held in place by adjacent pins. |

**Figure 1-20: Typical protruding panel pin due to missing safety clip.**

| Items | Description | Priority |
|---|---|---|
| 2. | Reinstall displaced panel pins and install missing safety clips as required. | Medium |

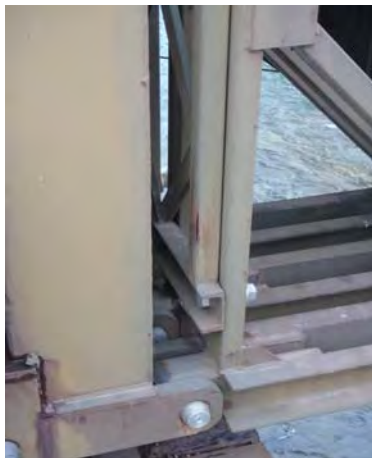
**Figure 1-21: Span 3 pier 2 upstream panel, crack in end post.**

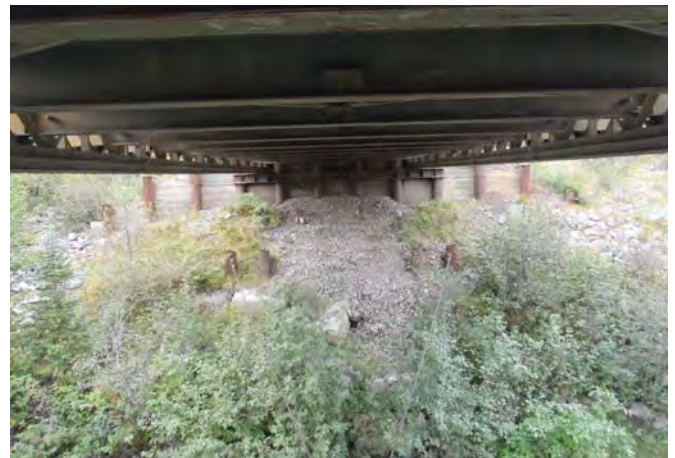
| Fill | Fair | Observed displaced lock blocks at base of Likely abutment. Embankment appears stable. |

**Figure 1-22: Likely end abutment, note over turned lock blocks.**

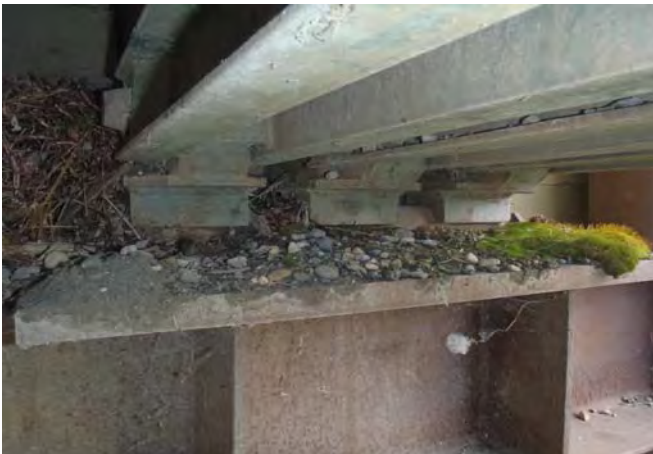
| Caps or Sills | Good | Debris accumulation on the cap beams at both abutments. |

**Figure 1-23: Typical abutment bearing condition debris accumulation Likely end upstream shown.**

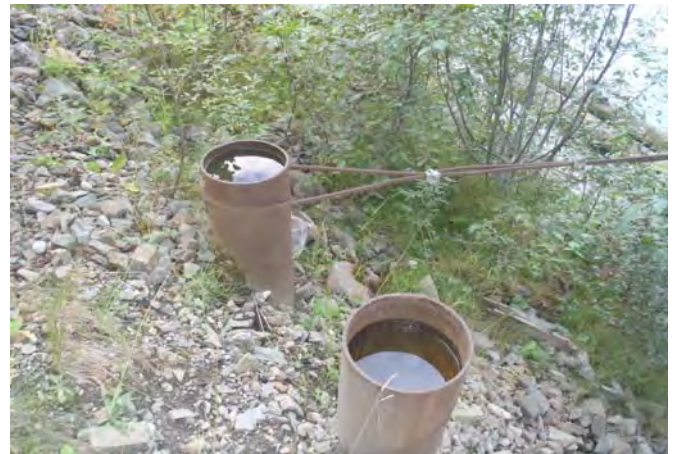
**Figure 1-24: Pier 2 Likely end dead man piles, full of water.**

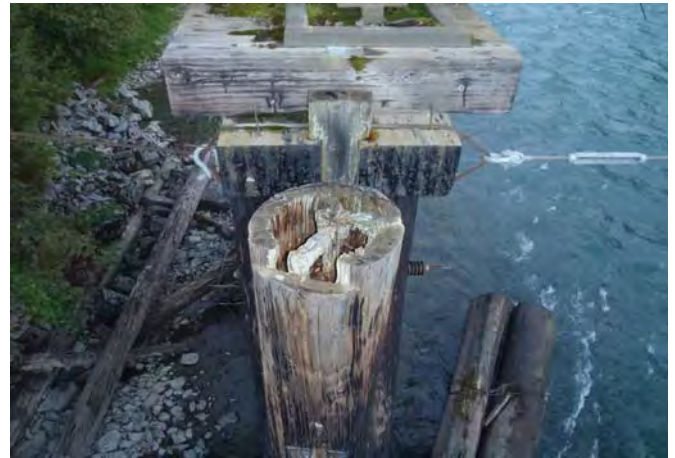
| Dolphins | Fair | A 1500 mm section of heartwood rot was noted in the top of the dolphin pile. |

**Figure 1-26: Pier 1 dolphin pile, heartwood rot.**

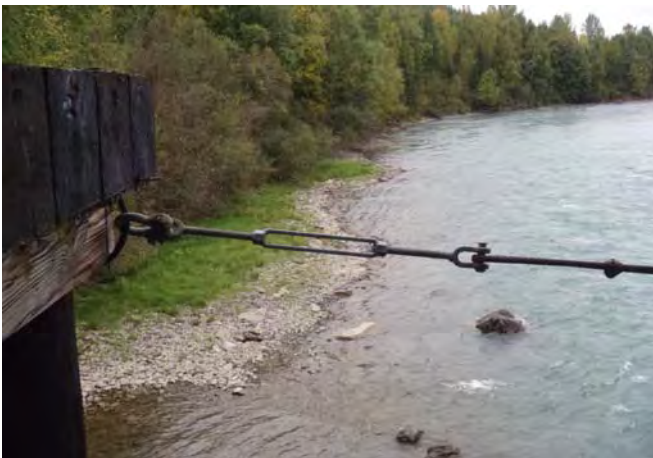
| Bracing or Sheathing | Fair | Bracing: fair, upstream log bracing has heartwood rot, 60 mm of shell remains.<br>Sheathing: good. Longitudinal cable sway braces are sagging. |

**Figure 1-27: Typical loose cable sway brace, Pier 1 downstream shown.**

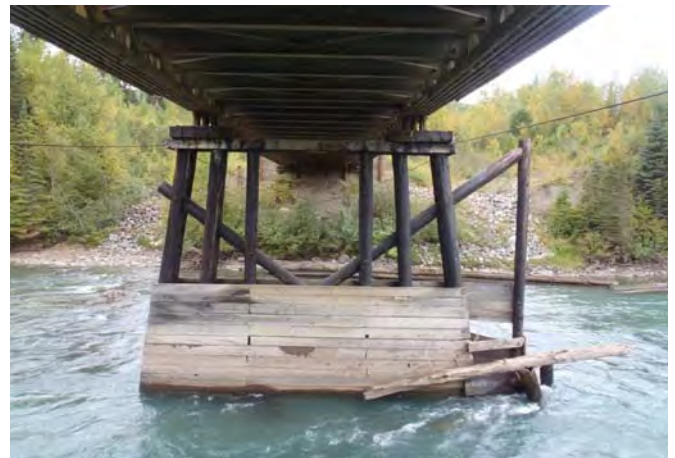
| Bracing or Sheathing | Fair | Bracing: good. Sheathing: poor, upstream sheathing planks broken. Tie back cables are sagging. |
| Dolphins | Fair | A log jam was noted at the upstream end of the pier. Two broken dolphin piles were noted. |

**Figure 1-28: Pier 2 Wells end face, log jam and missing sheathing panels.**

| Items | Description | Priority |
|---|---|---|
| 5. | Replace damaged sheathing planks on pier 2 | Medium |

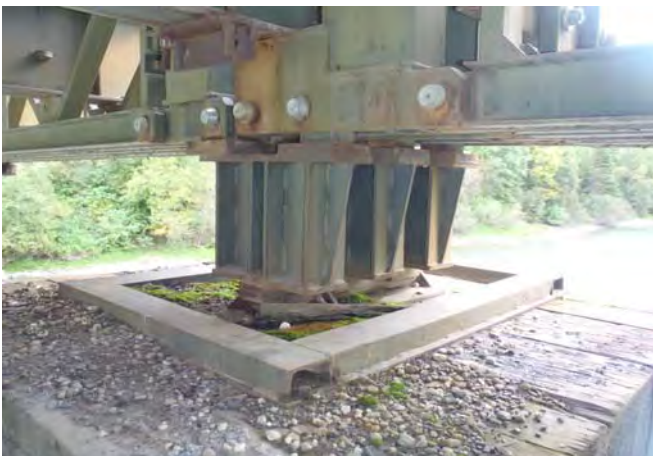
| Bearings | Good | Debris accumulating on the bearing plates. |

**Figure 1-29: Typical pier bearing condition, Pier 2 downstream shown, note debris accumulation.**

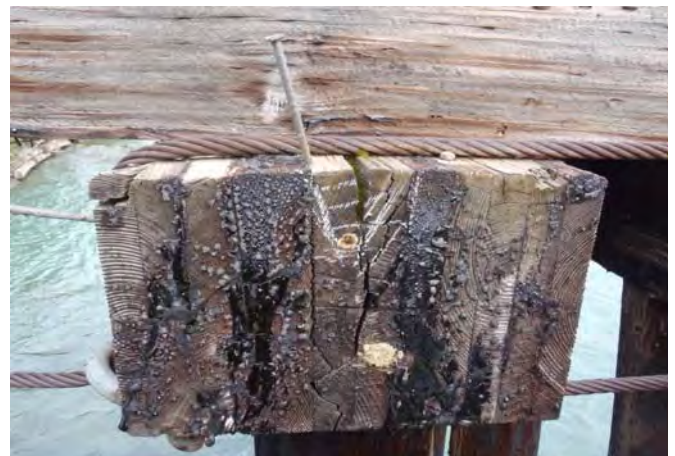
- Pier 2 is generally in fair condition.
- Debris accumulating on the bearing plates.
- Debris accumulating on the cap beam.
- Wide vertical end splits were noted at the downstream end of both the Likely and Wells end caps.

- Moss growth along the mid check on top of the downstream end timber corbel, no rot noted.
- Likely End Cap Beam:
  - Coring identified rot localized to the downstream end split, with 100 mm of shell. No rot was found below the split. The rot is in the end of the cap with no signs of crushing noted; hence we do not believe it significantly affects the capacity of the cap.

**Figure 1-30: Typical end check in cap, Pier 2 likely end downstream shown.**

- Monitor the decay of the cap beams at both piers.
