| Bridge No. | CK-2196 | Road Name | Nahatlatch FSR | | | | | | | | | | Inspection Date | 2014-08-12 | | |
| Comments | Three span steel girder bridge with precast concrete deck. (Ray Washtock Bridge) | | | | | | | | | | | | | | | |

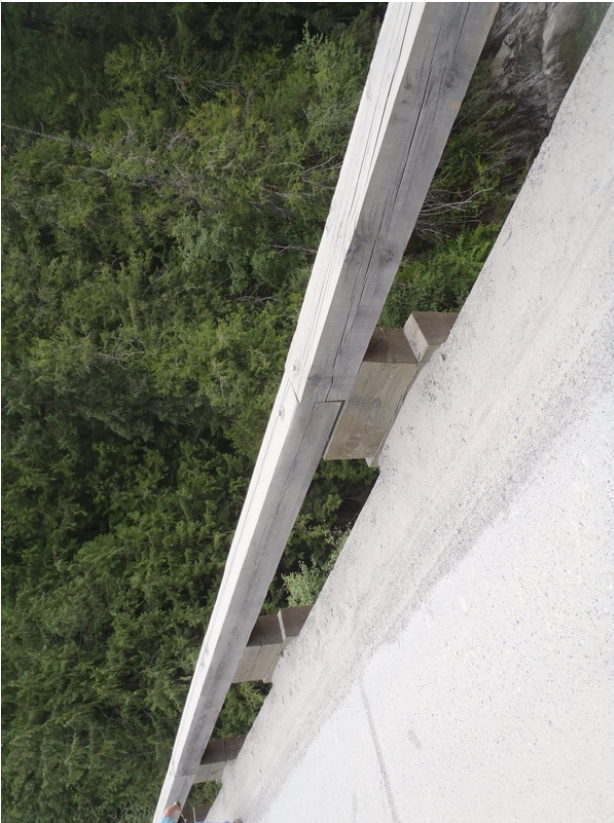
| Curb Rails and Risers | Fair | | | All timber curbs and risers sounded and some cored. Initial signs of decay noted in risers. | | | | | | | | | | | | |

Figure 10: Downstream curb.

| 3 | Monitor condition of timber curbs and risers. Plan to replace in 5 years. | | | | |

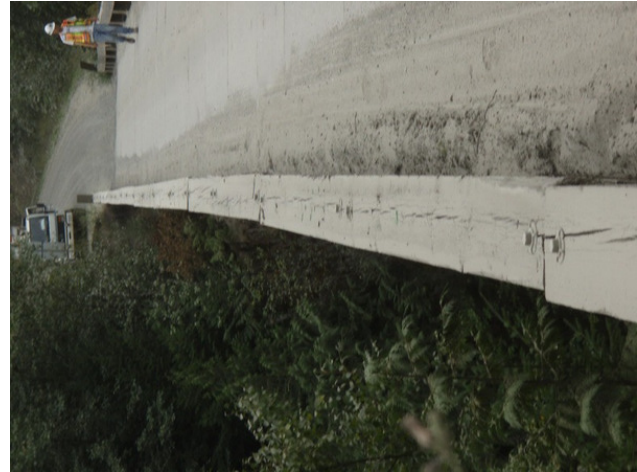
| Bridge No. | CK-2196 | Road Name | Nahatlatch FSR | Inspection Date | 2014-08-12 |
|---|---|---|---|---|---|
| Hardware | Poor | 3 of 4 anchor bolts for span 1 connection have failed (shear failure) likely due to thermal expansion.<br><br>Span 2 anchor bolts in fair condition. | | | |

Figure 12: Span 1 looking toward the right abutment (North Bend). Kink in downstream curb at Pier #1; due to failure of 3 of 4 Span 1 anchor bolts at Pier #1.

| 2 | Repair 3 failed anchor bolts at Pier 1. | High | \$5,000.00 | | |

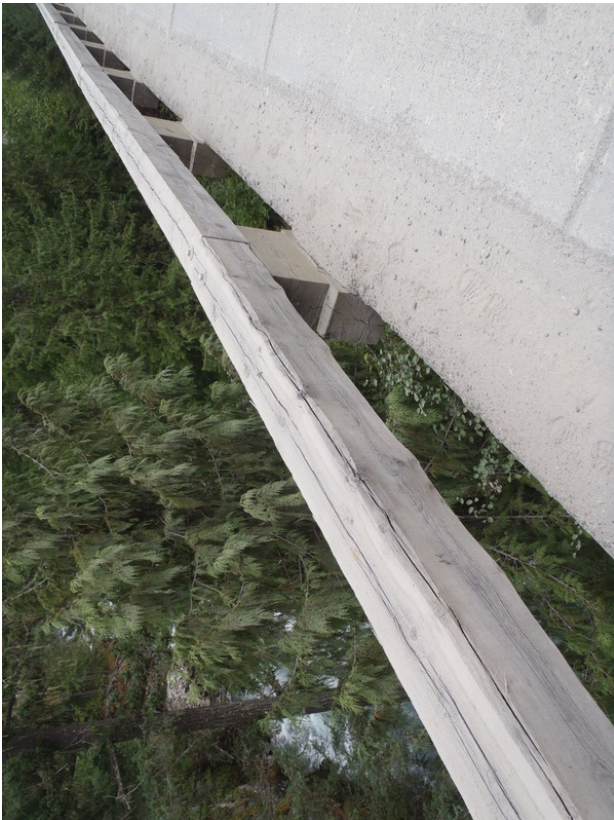
Figure 9: Upstream curb.

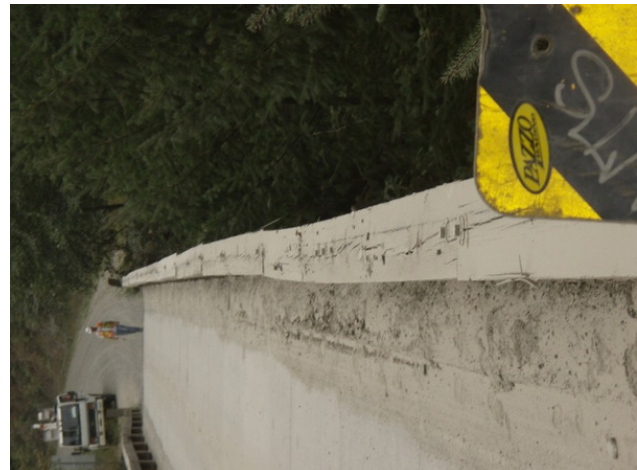
Figure 11: Span 1 looking toward the right abutment (North Bend). Kink in upstream curb at Pier #1; due to failure of 3 of 4 Span 1 anchor bolts at Pier #1.

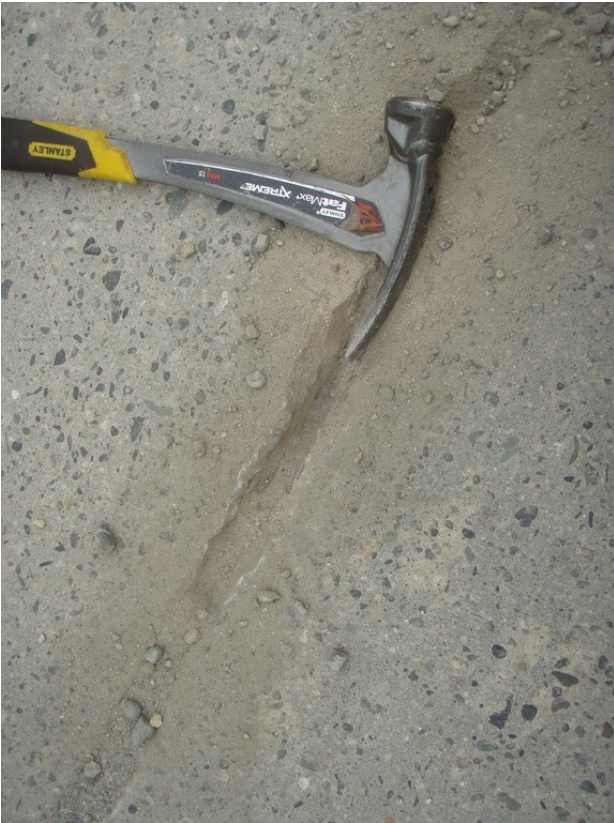
| Deck Joints | Poor | | | No compression seals at Pier 1 and 2 expansion joints, deck dropping through gaps onto bearings.<br>Degradation of grouted joints to depth of 50 mm.<br>Minor cracks throughout grouted deck joints. | | | | | | | | | | | | |

Figure 14: Typical deterioration of grouted deck joint.

| 1 | Monitor condition of grouted deck joints. | | | | |

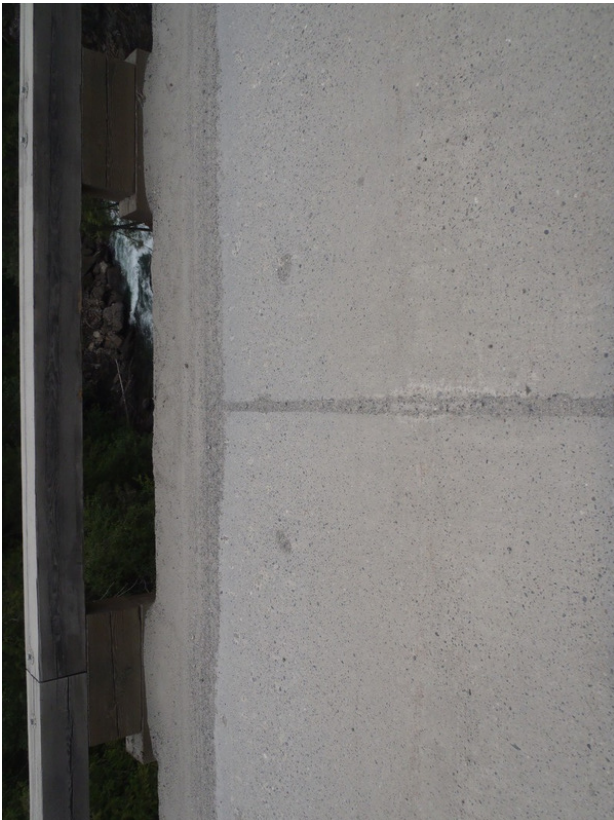
Figure 13: Typical condition of grouted deck joint.

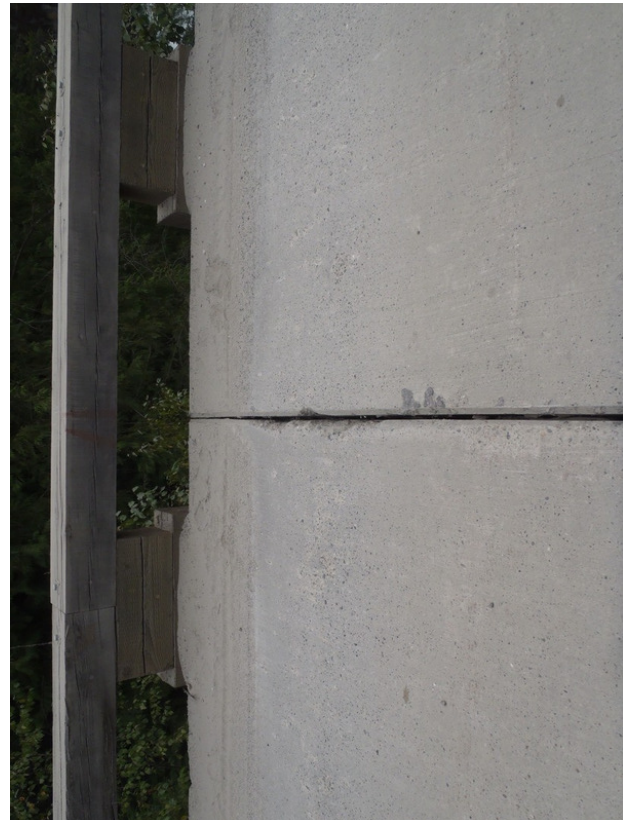
Figure 15: Typical condition of expansion joint.

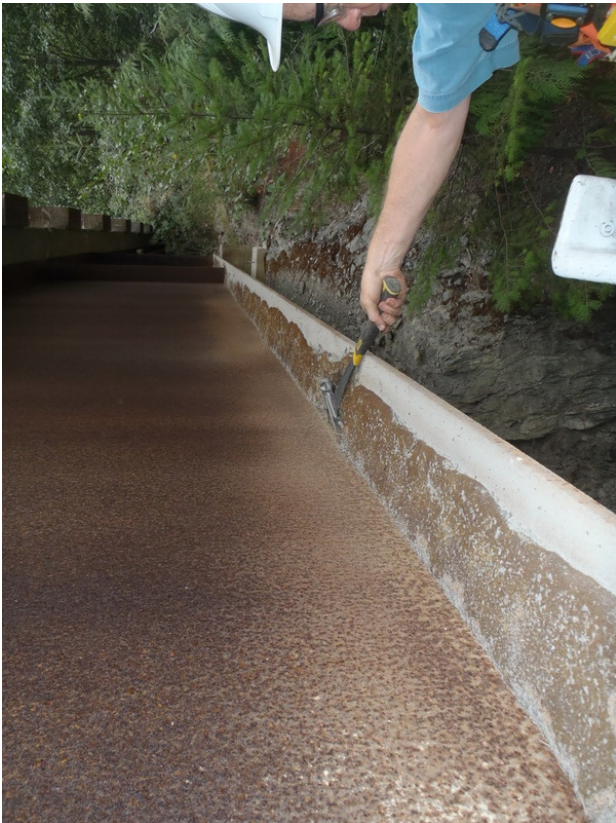
| Bridge No. | CK-2196 | Road Name | Nahatlatch FSR | Inspection Date | 2014-08-12 |
|---|---|---|---|---|---|
| Girders | Fair | Minor corrosion and debris accumulation along bottom flange. | | | |

Figure 17: Typical debris accumulation along bottom flange - Span 2 downstream shown.

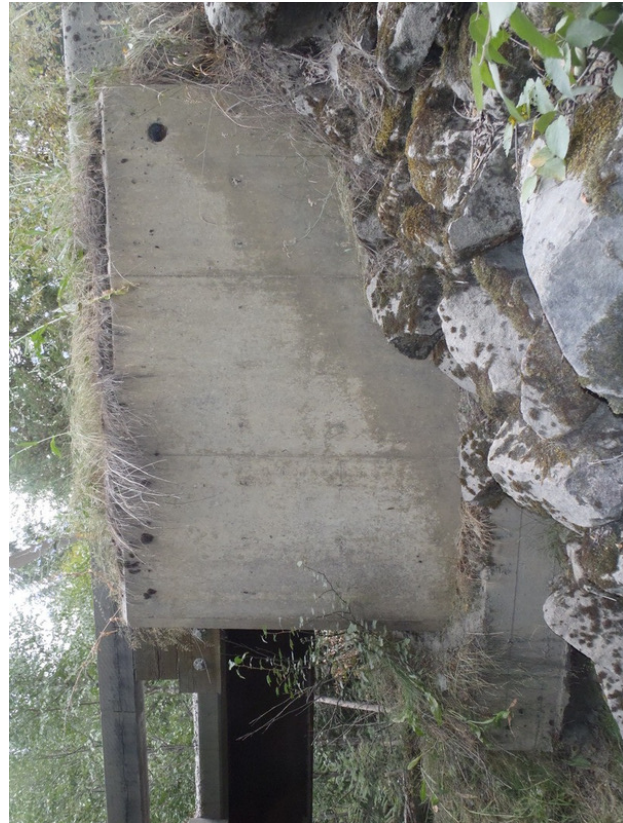
| Bridge No. | CK-2196 | Road Name | Nahatlatch FSR | Inspection Date | 2014-08-12 |
|---|---|---|---|---|---|
| Fill | Fair | Loss of support fill below upstream footing extending 0.5 m under footing. | | | |

Figure 24: Right end upstream wingwall (upper) - note loss of fill below footing.

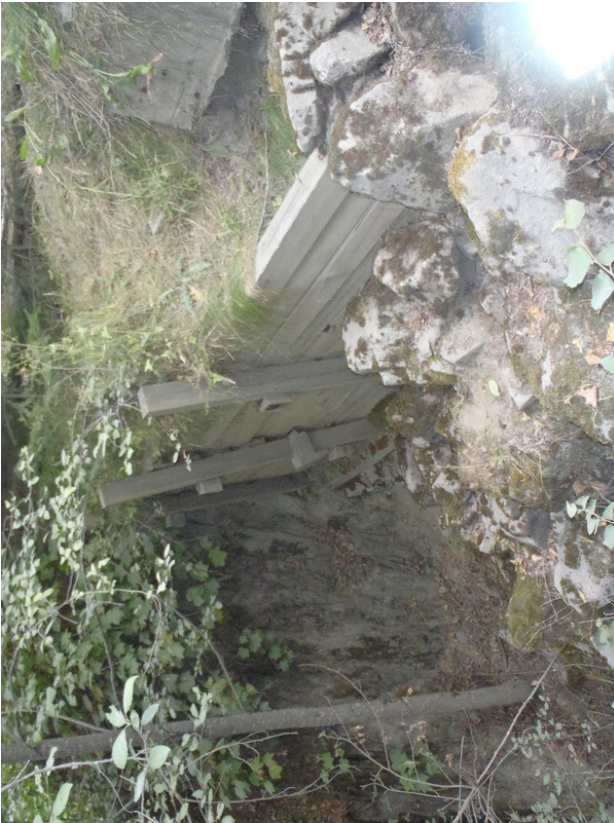
| Bridge No. | CK-2196 | Road Name | Nahatlatch FSR | Inspection Date | 2014-08-12 |
|---|---|---|---|---|---|
| Wingwall | Poor | Lower upstream wingwall (retaining wall) is heavily decayed. 3 of 4 timber tiebacks have failed causing wall to lean outwards (max 10°). See attached sketch for details.<br><br>Upper cast-in-place concrete wingwall in good condition. | | | |

Figure 26: Right end upstream wingwall (lower) - note rotation of wall.

| 3 | Replace lower retaining wall at right end abutment. | High | \$50,000.00 | | |

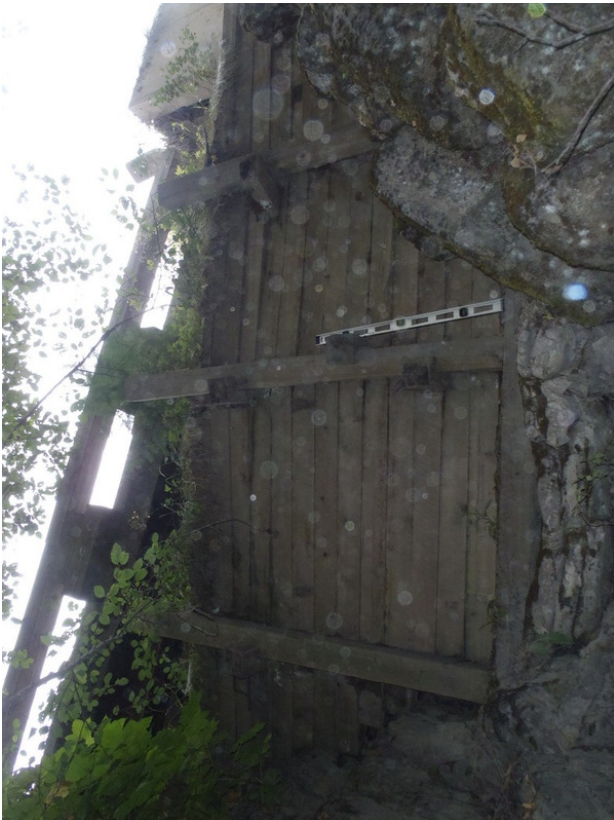
Figure 25: Right end upstream wingwall (lower) - note condition of tiebacks.

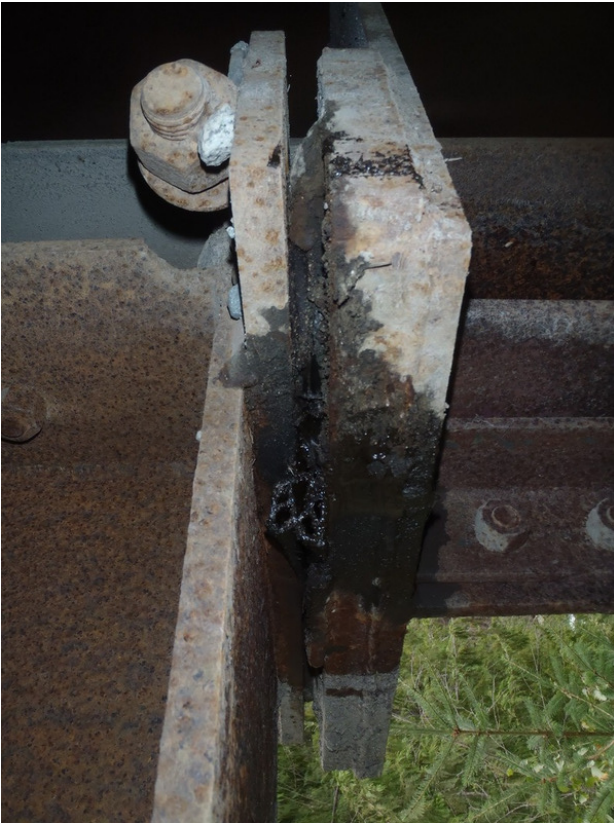
| Bridge No. | CK-2196 | Road Name | Nahatlatch FSR | Inspection Date | 2014-08-12 |
|---|---|---|---|---|---|
| Bearings | Poor | Bearings replaced with stainless steel plates encased with grease.<br><br>Rubber strip seal surrounding bearings have slipped out at all four bearings, allowing the grease to leak out. | | | |

Figure 34: Pier 1 Span 1 bearing - Note bearing squeezed out.

| 1 | Repair bearings at Pier 1. | High | \$5,000.00 | | |

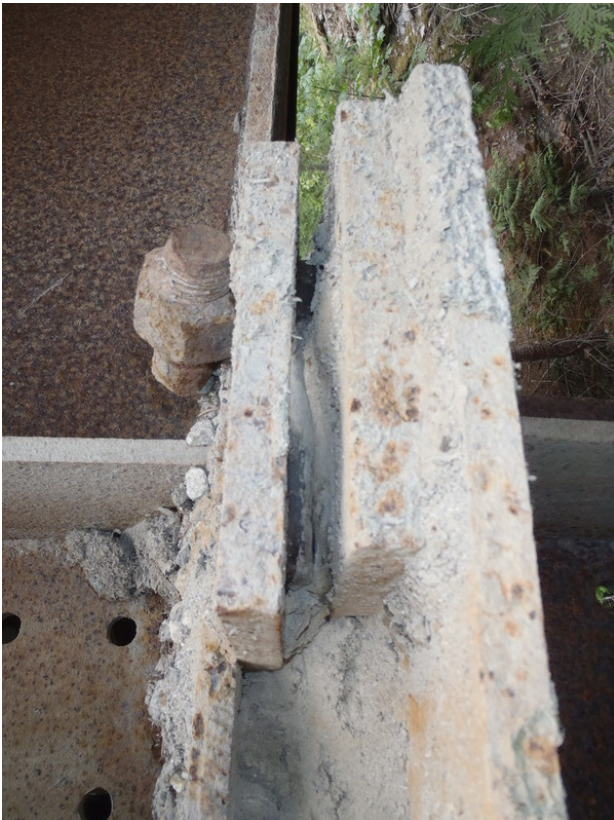
Figure 33: Pier 1 span 1 downstream bearing - Note failed anchor bolt.

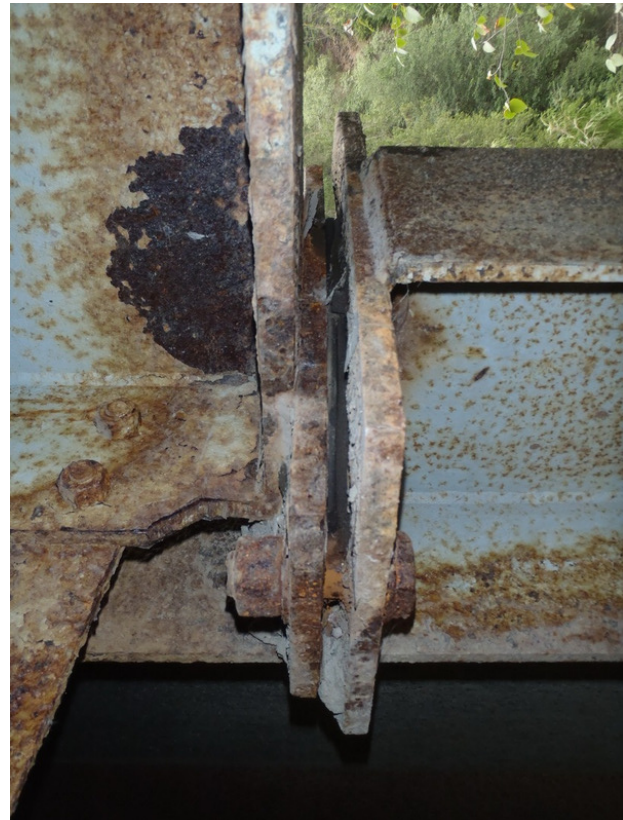
Figure 35: Pier 2 downstream bearing - Note condition of painted steel.

| 2 | Monitor corrosion of steel. | | | | |

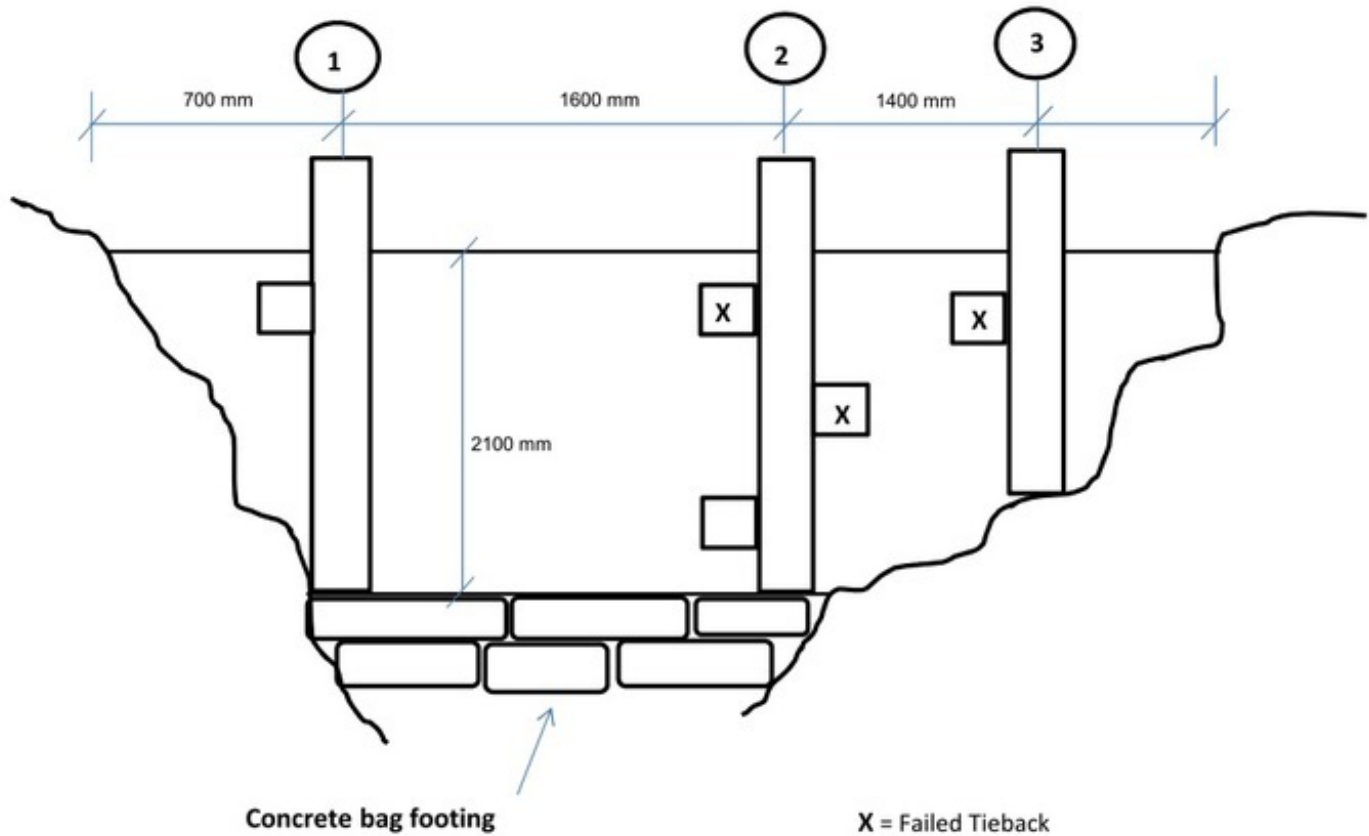
Sketch 1: Right abutment upstream wingwall.

| Post | Measured Angle |
| 1 | 5° |
| 2 | 10° |
| 3 | 7.5° |
