## BRIDGE INSPECTION

**BRIDGE NO./NAME** K445: Pasayten River FSR (48.90 km)

**Inspection Date:** October 2nd, 2012

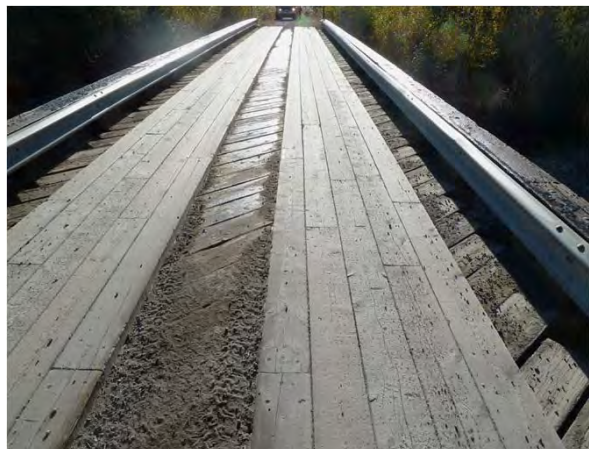
| Running Planks | Fair | Minimal wearing of running planks and deck planks. Minor debris accumulation towards ends of bridge. | | | | | | | | | | |

**Figure 1-6: Typical deck condition.**

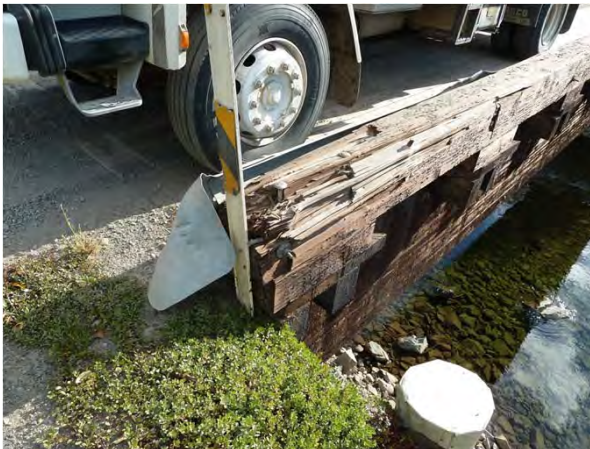
- The deck is generally in fair condition.
- Localized impact damage to W-beam and woods end downstream corner of curb rail.
- Minimal wearing of running planks and deck planks.
- Minor debris accumulation towards ends of bridge.

| Curb Rail/Blocks/Posts | Fair | Localized impact damage to W-beam and woods end downstream corner of curb rail. |

**Figure 1-7: Damaged delineator and curb rail.**

| Items | Description | Priority |
|---|---|---|
| 1. | Replace delineators (4 required) | High |
| 2. | Replace damaged section of curb rail. | High |

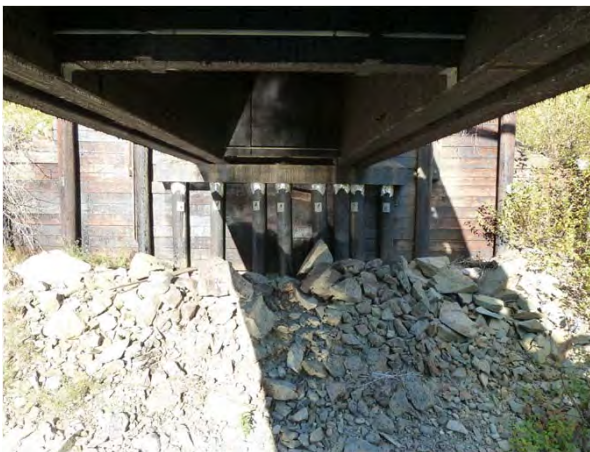
The bridge is generally in good condition, no significant checks noted on the glulam girders. One pile at the camp end abutment has heartwood rot, no sign of crushing and likely does not affect the capacity of the abutment. We recommend monitoring the condition of the pile during future inspections.

**Figure 1-9: Camp end abutment.**

1. Monitor rot in camp end abutment piles.

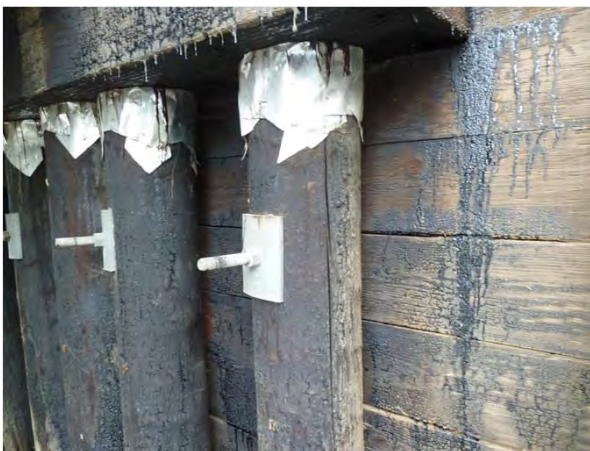
**Figure 1-11: Camp end pile #8.**

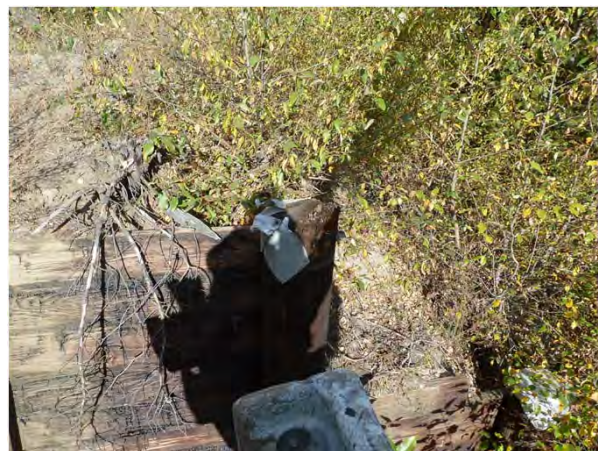
| Wing Wall | Fair | Flashing on the camp end downstream wing wall pile 2 is damaged with end rot on the top of the pile. |

**Figure 1-12: Downstream camp end soldier pile.**

| Items | Description | Priority |
|---|---|---|
| 4. | Replace flashing on top of camp end, downstream wing wall pile 2. | Medium |

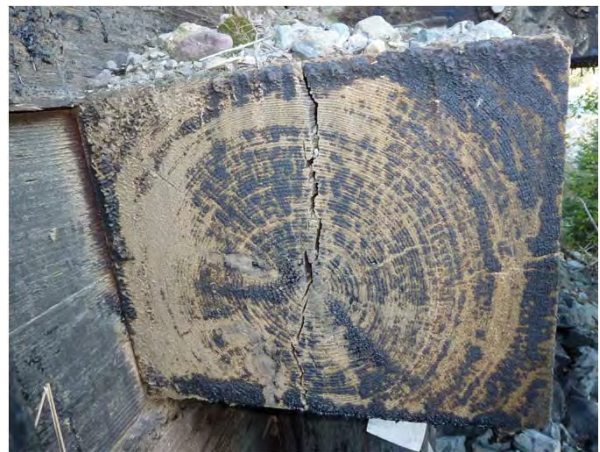
| Caps or Sills | Fair | Vertical check along length of woods end cap beam, no rot noted. |

**Figure 1-16: Check in woods end cap beam.**

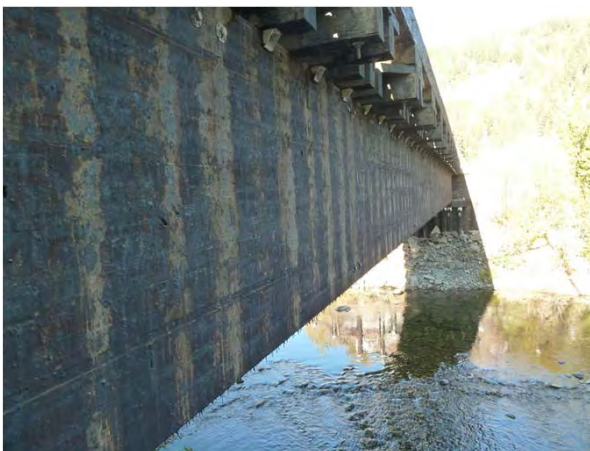
- Creosote leaching out and covering girder faces.
- Minor weathering, few checks noted <20 mm deep.

| Girders | Fair | No significant checks noted. Creosote leaching out and covering face of girders. | | | | | | | | | | |

**Figure 1-17: Downstream face of girder 2.**
