**Re: NON-DESTRUCTIVE TESTING ON BRIDGE K692 - FINN CREEK FSR AT ADAMS RIVER  
BRIDGE**

**NONDESTRUCTIVE TESTING  
OF  
FINN CREEK FSR AT ADAMS RIVER BRIDGE**

## NONDESTRUCTIVE EXAMINATION REPORT

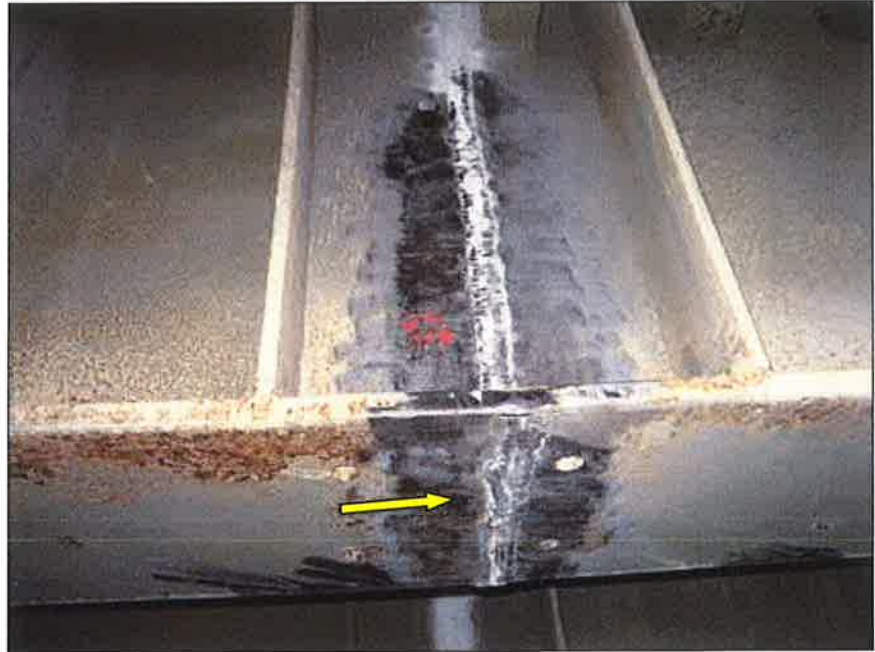
*Photo 1:*

The adjacent stiffener fillet welds on the north side of the girder were inspected using magnetic particle. The fillet welds were all found to have areas of rejectable undercut associated with the welds. The left side stiffener fillet weld was found to have a linear indication indicative of a crack. The indication measured 10mm long and was located at the stiffener to flange connection at the outside toe of the weld. The indication is most likely caused by an improperly filled weld crater (Photo 1, 2, 3 and 4).

*GIRDER 3, SPLICE B*

Note the unevenness of the weld cap on the bottom side of the splice. Repairs to this weld most likely taken place during the original fabrication.

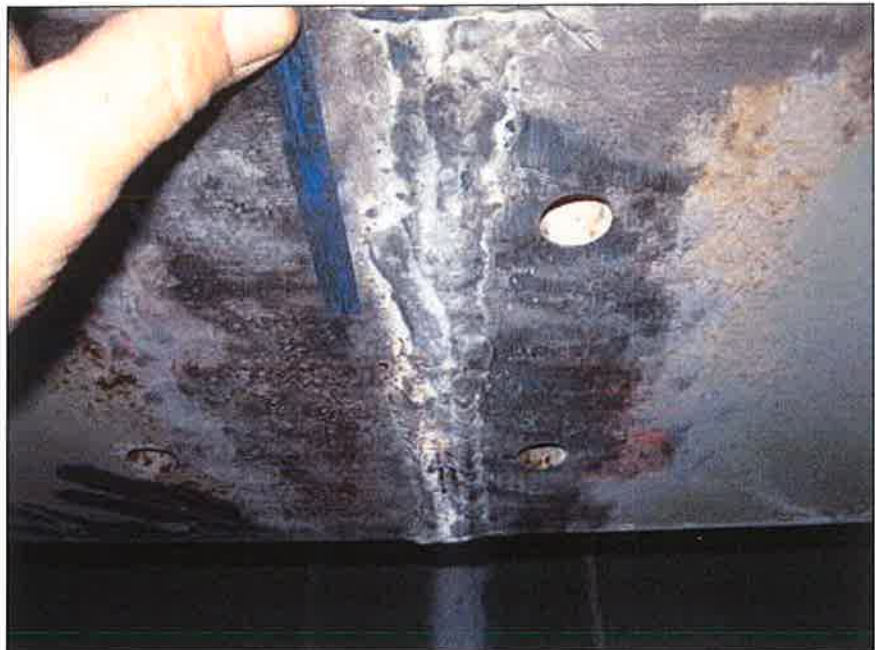
*Photo 2:*

The bottom splice, which measures 29.5cm wide, was inspected using ultrasonic shear wave as well as 50.0cm of the web splice as measured from the bottom splice up. The bottom flange splice was found to be free from any rejectable indications. The web splice was found to have one area that did not meet the requirements set out in the acceptance standard. An area 20mm long and at a depth of 9mm had a rating of 0. The indication is located at 110mm to 130mm from the bottom flange and was -4mm from the centreline of the weld.

*GIRDER 3, SPLICE B*

Closer view of the bottom.

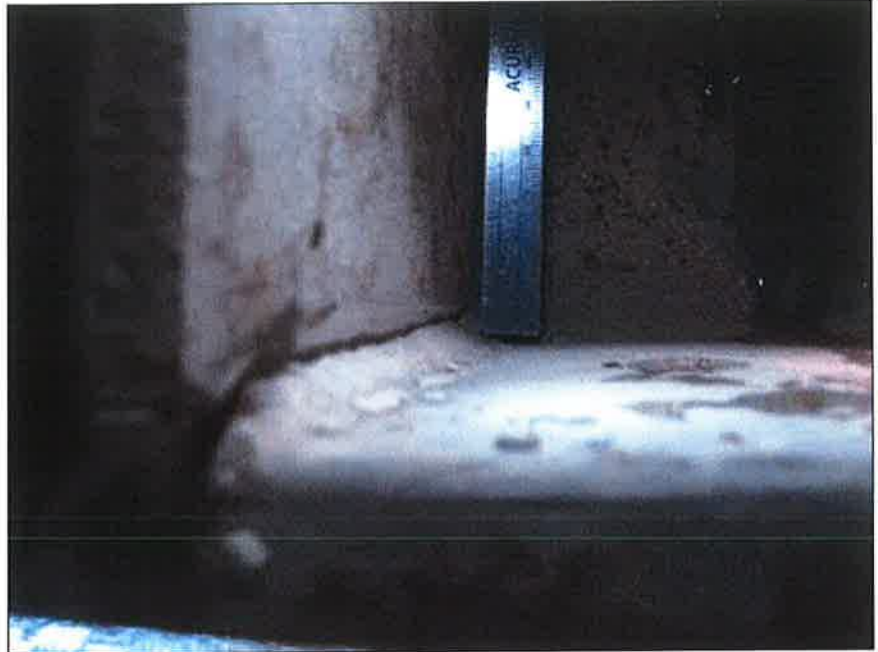
*Photo 3:*

This picture shows the typical undercut discovered while performing magnetic particle of the fillet welds adjacent the weld splices.

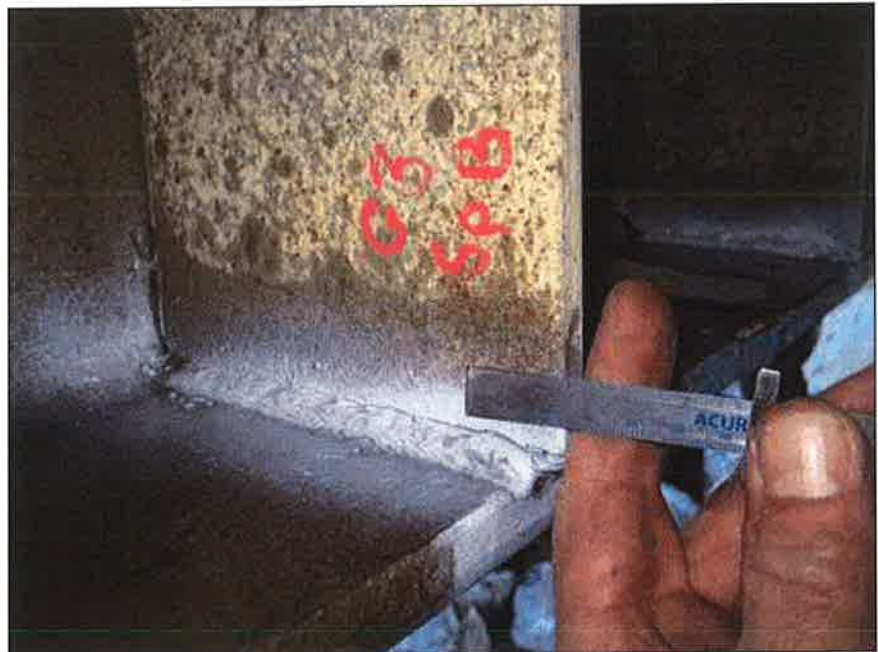
*Photo 4:*

The linear indication discovered while inspecting girder 3, splice B. The indication appears to be in the area of a weld crater suggesting a possible crater crack.

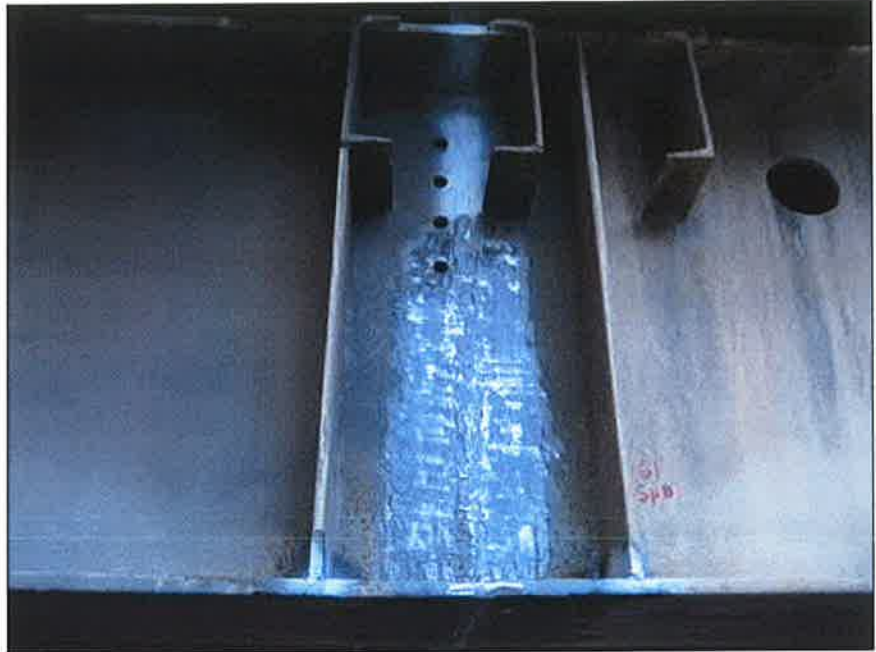
*Photo 5:*

The adjacent stiffener fillet welds on the north side of the girder were inspected using magnetic particle. The fillet welds were all found to have areas of rejectable undercut associated with the welds. The right side stiffener fillet weld was found to have a linear indication indicative of a crack. The indication measured 10mm long and was located at the stiffener to flange connection at the outside toe of the weld (Photo 5, 6 and 7).

*GIRDER 1, SPLICE B*

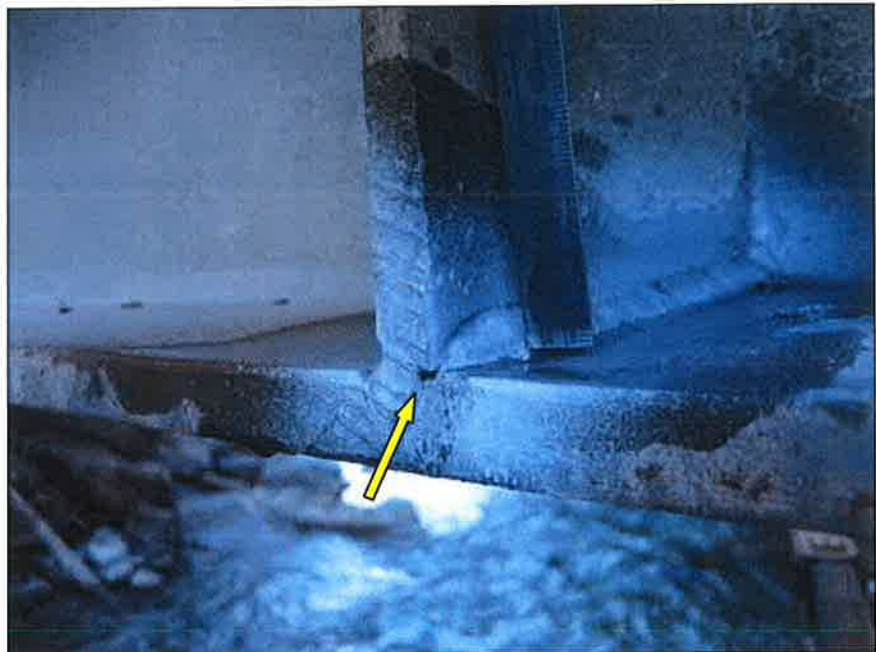
*Photo 6:*

The stiffener adjacent girder 1, splice B. Note the crater at the end of the weld as well as the portion of incomplete penetration.

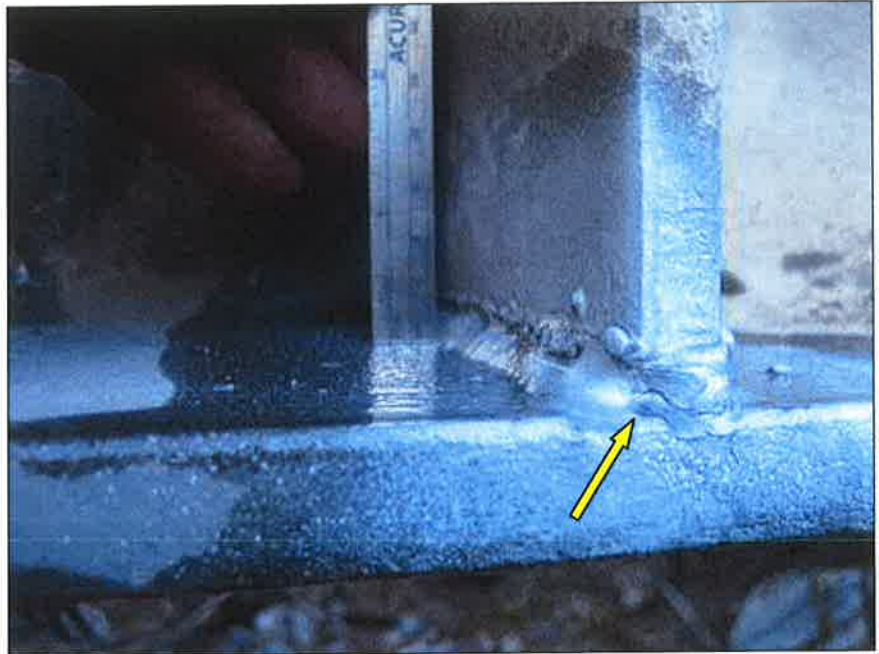
*Photo 7:*

The right side stiffener (looking south) from girder 1, splice B. A small linear indication was discovered during the magnetic particle inspection.

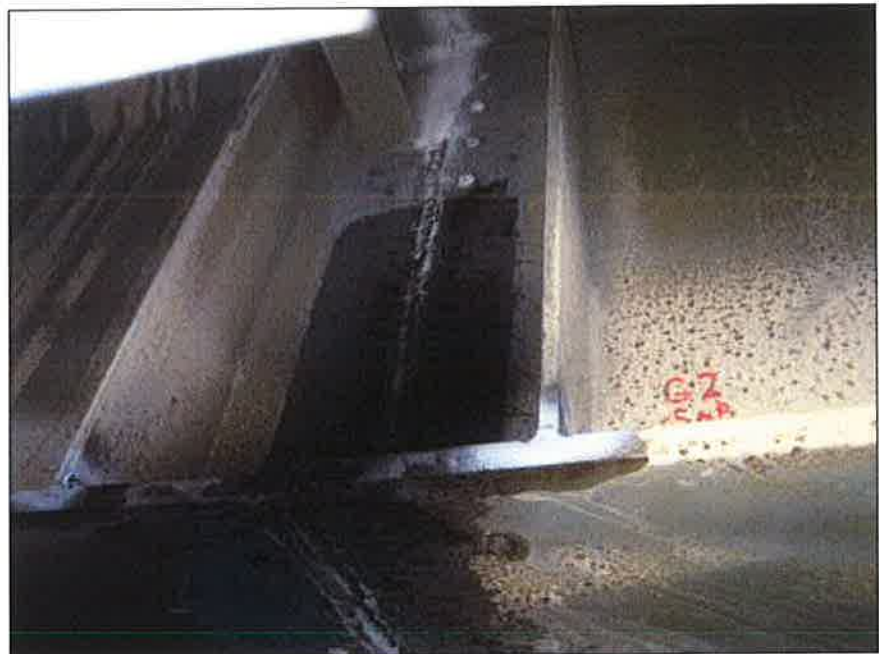
*Photo 8:*

The adjacent stiffener fillet welds on the north side of the girder were inspected using magnetic particle. The fillet welds were all found to have areas of rejectable undercut associated with the welds (Photo 8 and 9).

*GIRDER 2, SPLICE C*

The bottom cap of the bottom flange splice also appears to be reworked.

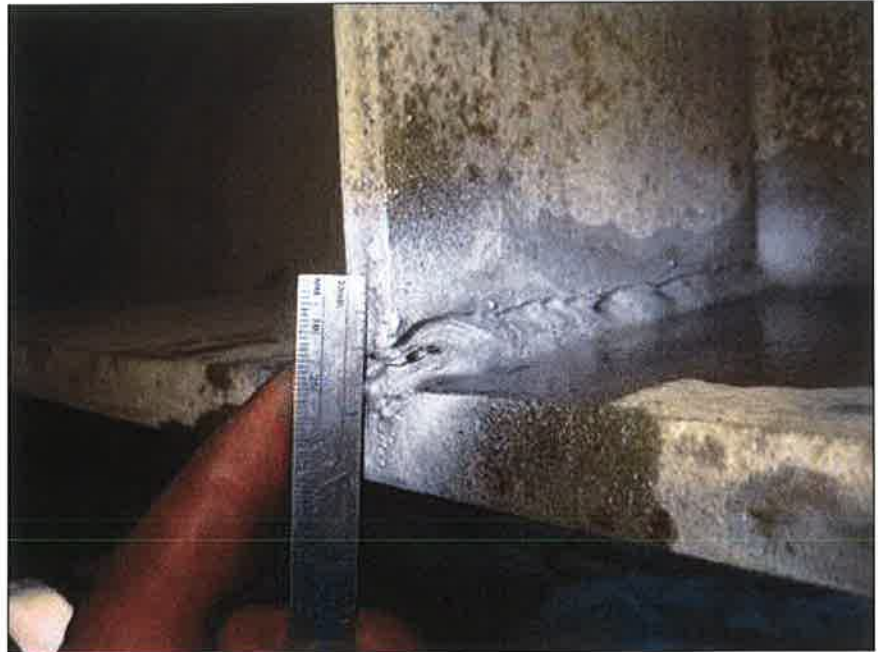
*Photo 9:*

The stiffener at the left side (looking south) of girder 2, splice C. The linear indication down the centre of the weld appears to be in the location where one (1) would find a crater crack. Note the rejectable undercut at the top toe of the fillet.

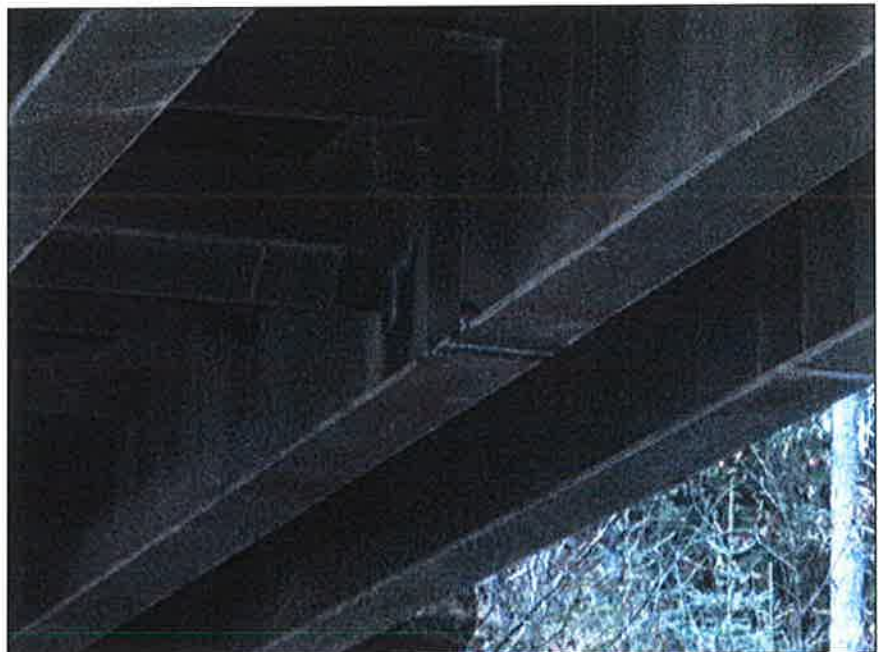
*Photo 10:*

The adjacent stiffener fillet welds on the north side of the girder were inspected using magnetic particle. The fillet welds were all found to have areas of rejectable undercut associated with the welds (Photo 10).

**GIRDER 3, SPLICE C**

No indications were discovered during the ultrasonic inspection. Undercut associated with the stiffeners on both sides of the splice is noted.

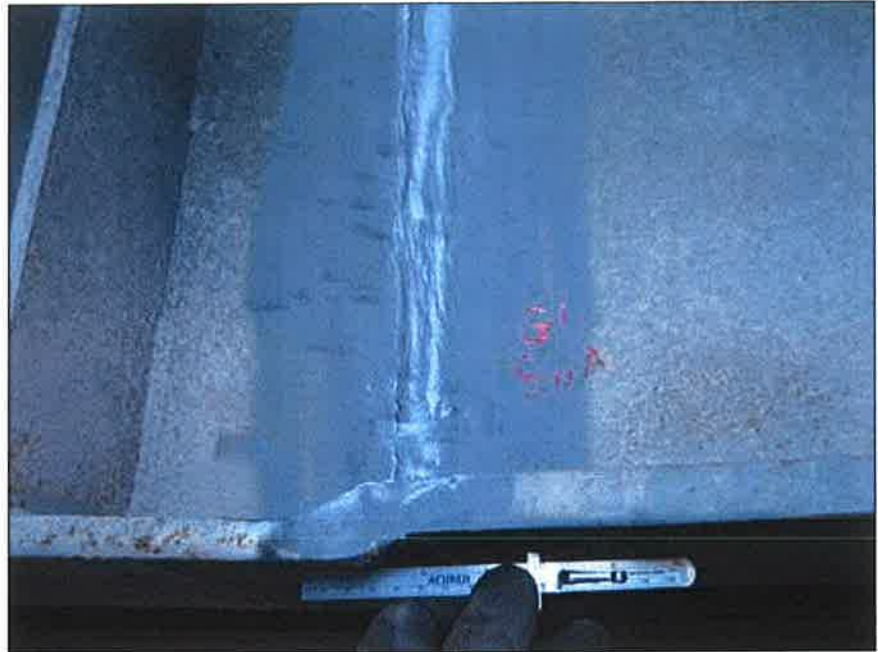
*Photo 11:*

The adjacent stiffener fillet welds on the north side of the girder were inspected using magnetic particle. The fillet welds were all found to have areas of rejectable undercut associated with the welds (Photo 11).

*GIRDER 1, SPLICE A*

Ultrasonic inspection of this splice was found acceptable although severe offset is noted.

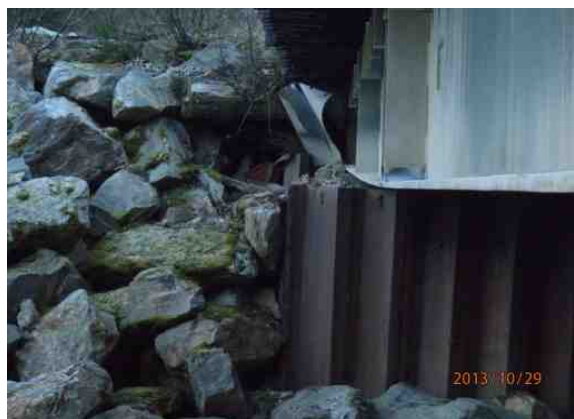
Figure 1-11: Sag in upstream girder.

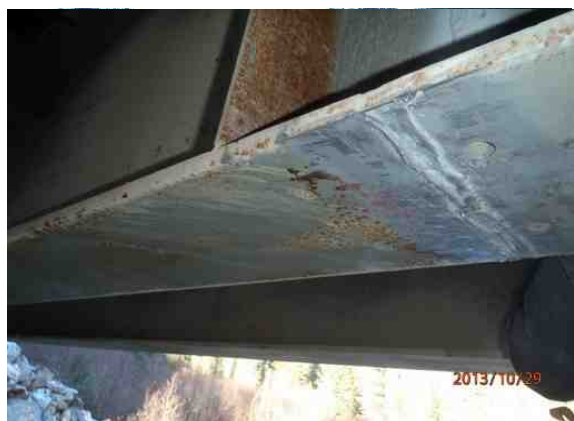
Figure 1-13: Typical previously repaired butt weld.

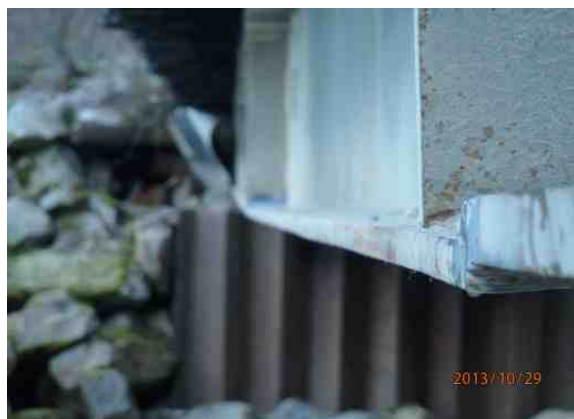
Figure 1-15: Offset weld in upstream girder.

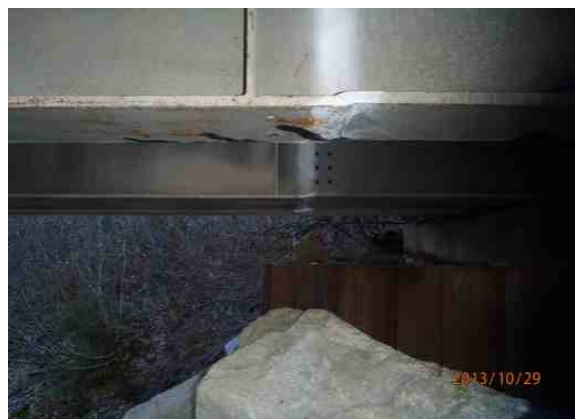
Figure 1-16: Offset butt welds at right abutment.

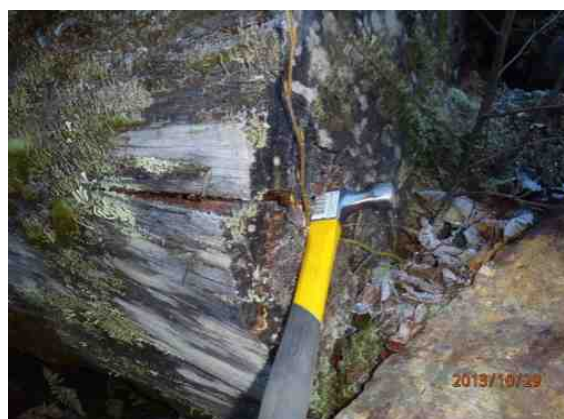
| <b>Associated Engineering</b><br><small>GLOBAL PERSPECTIVE.<br/>LOCAL FOCUS.</small> | | <b>BRIDGE INSPECTION REPORT</b><br><b>STEEL BRIDGE INSPECTION SUMMARY</b> | | | | <b>Ministry of<br/>Forests and Range<br/>Forest Service</b> | |
|---|---|---|---|---|---|---|---|
| | Bulkhead/Wingwalls | | Fair | | Abutment bulkhead consists of cedar logs which are rotten, but still functioning | | |

**Figure 1-22: Right abutment - rotten ballast wall log.**

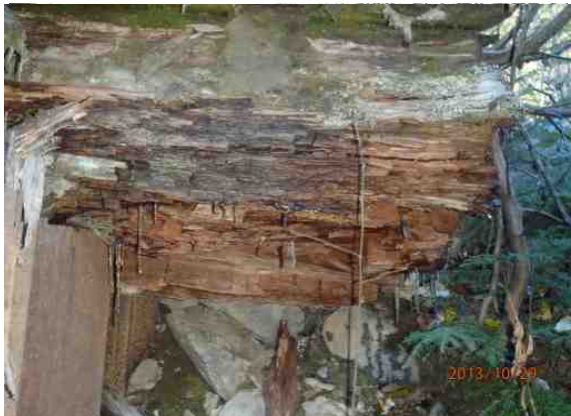
| <b>Associated Engineering</b><br><small>GLOBAL PERSPECTIVE.<br/>LOCAL FOCUS.</small> | | <b>BRIDGE INSPECTION REPORT</b><br><b>STEEL BRIDGE INSPECTION SUMMARY</b> | | | | <b>Ministry of<br/>Forests and Range<br/>Forest Service</b> | |
|---|---|---|---|---|---|---|---|
| | Bulkhead/Wingwalls | | Fair | | Abutment bulkhead consists of cedar logs which are rotten, but still functioning | | |

Figure 1-26: Left abutment- ballast wall - rotten logs.
