**Re: NON-DESTRUCTIVE TESTING ON BRIDGE K692  
FINN CREEK FSR AT ADAMS RIVER BRIDGE**

## NONDESTRUCTIVE EXAMINATION REPORT

PROJECT: Finn Creek FSR at Adams River Bridge K692

Adams River Bridge K692 at the Finn Creek FSR

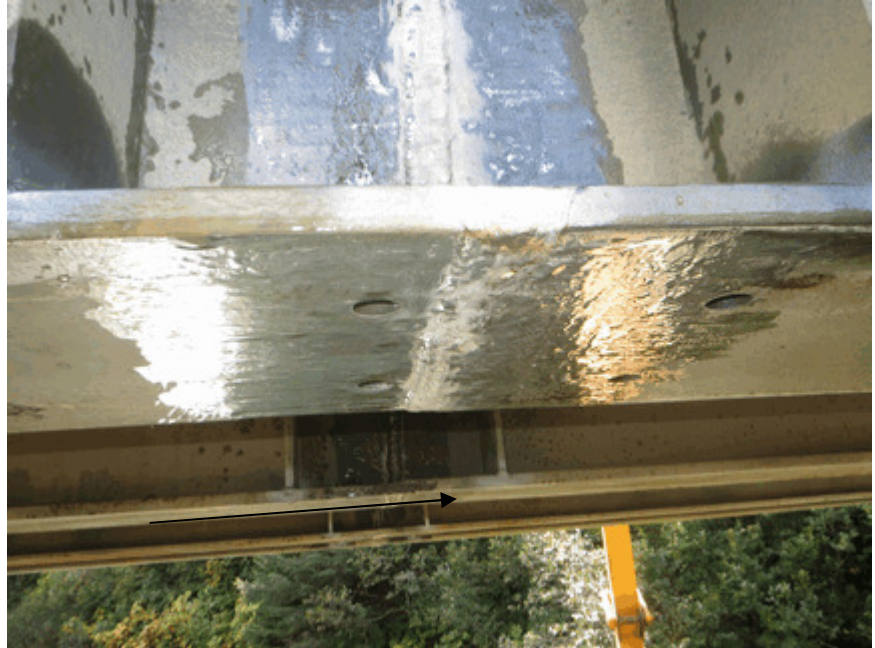
*Photo 1:*

**Girder 1 Splice C: Ultrasonic Shear Wave** The bottom splice, which measures 29.5 cm wide, was inspected using Ultrasonic Shear Wave as well as 50.0 cm of the web splice as measured from the bottom splice up. None of the welds inspected showed any rejectable indications using shear wave.

Girder 1, Splice C. No rejectable indications were discovered while performing ultrasonic shear wave inspection.

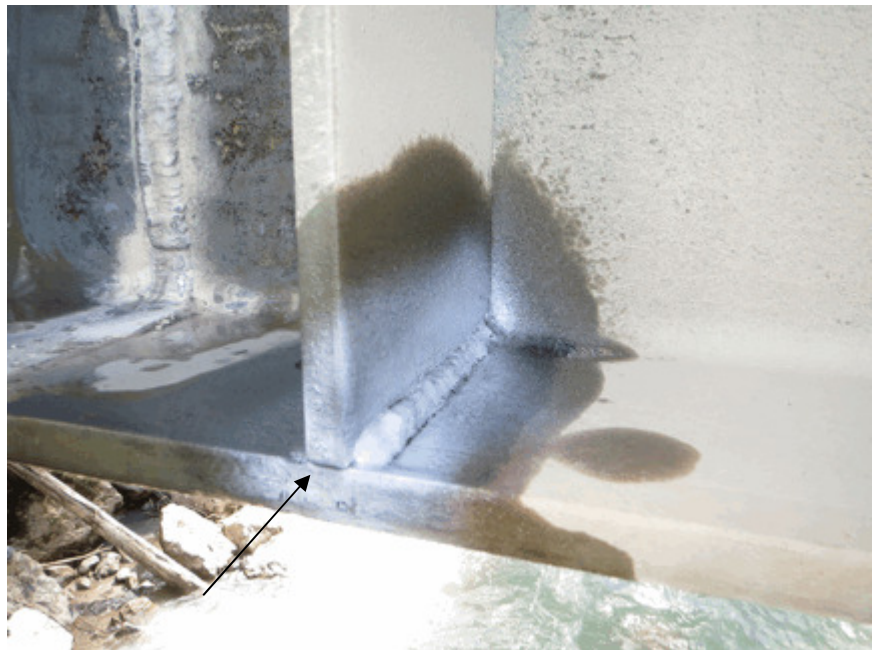
*Photo 2:*

**Girder 1 Splice C: Magnetic Particle.** The adjacent stiffener fillet welds on the North and South sides of the girder were inspected using magnetic particle. The fillet welds were all found to have areas of rejectable undercut associated with the welds. The right side stiffener (looking south) fillet weld was found to have a linear indication in the center of a crater. The fillet weld was not wrapped in this location. The indication measured 10mm long and was located at the stiffener to flange connection at the termination of the fillet weld in a crater. All 2 of the stiffener to flange welds appear to have undercut in excess of the allowable in CSA W59.12.(Photo 1, and 3)

Girder 1, splice C. The right side adjacent stiffener (looking North). The fillet weld was not sealed as the rest of the stiffeners.

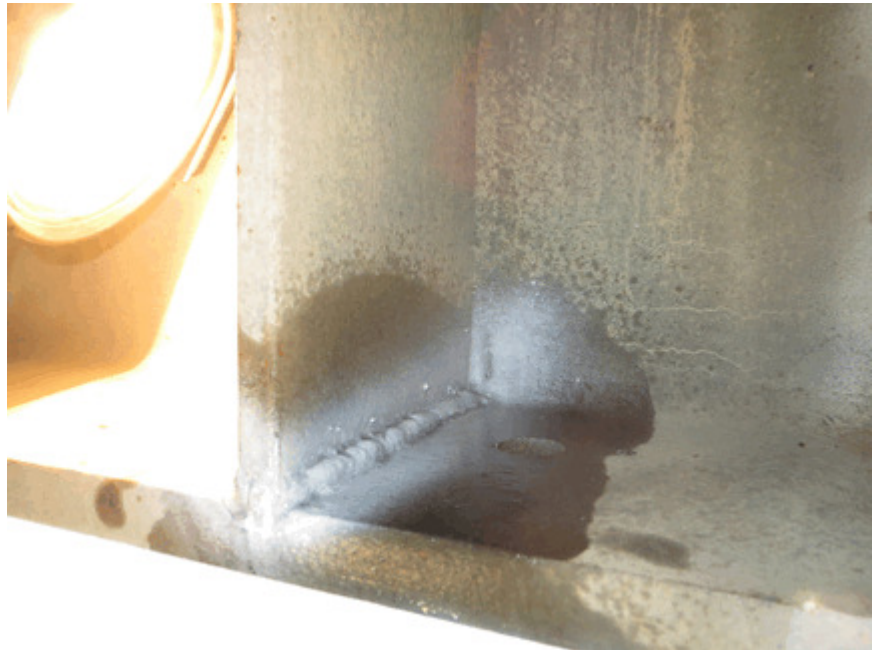
*Photo 3:*

This picture shows the left stiffener fillet weld (looking south) at Girder 1 Splice C. The weld size was as small as 4mm. Undercut was discovered while performing magnetic particle of the fillet welds adjacent the weld splices.

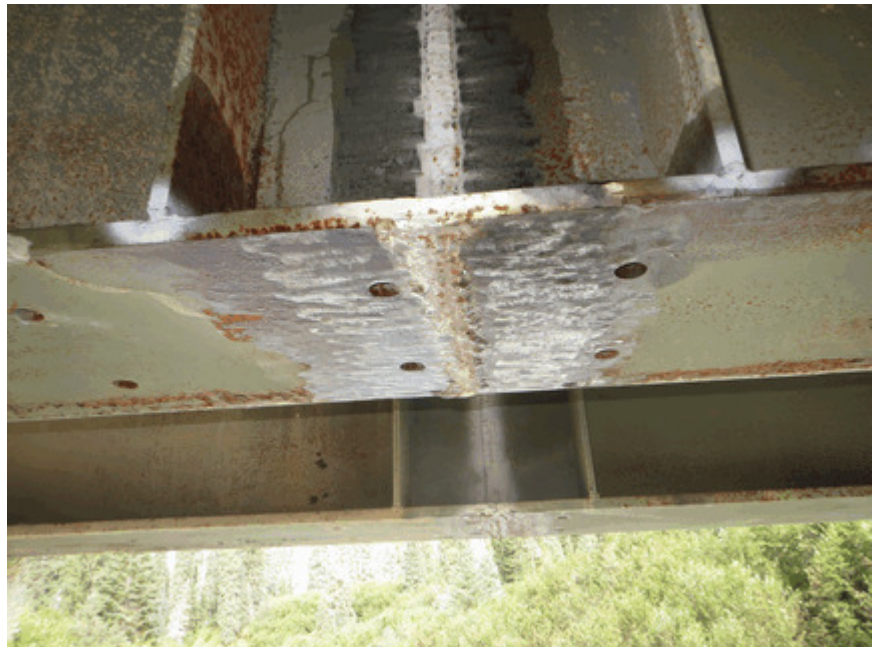
*Photo 4:*

**Girder 2 Splice B: Ultrasonic Shear Wave.** The bottom splice, which measures 29.5 cm wide, was inspected using Ultrasonic Shear Wave as well as 50.0 cm of the web splice as measured from the bottom splice up. The web splice was found to be free from any rejectable indications. The flange splice was found to have one area that did not meet the requirements set out in the acceptance standard. An area 10mm long and at a depth of 17mm had a rating of 0. The indication is located at 150mm from the bottom flange edge and was at the center line of the weld.

**Girder 2 Splice B: Magnetic Particle.** The adjacent stiffener fillet welds on the North and South sides of the girder were inspected using magnetic particle. The fillet welds were all found to have areas of rejectable undercut associated with the welds. The right side stiffener fillet weld was found to have a linear indication

indicative of a crack. The indication measured 10mm long and was located at the stiffener to flange connection at the outside toe of the weld. The indication is most likely caused by an improperly filled weld crater. (Photo 4, 5, and 6)

Girder 2, splice B.

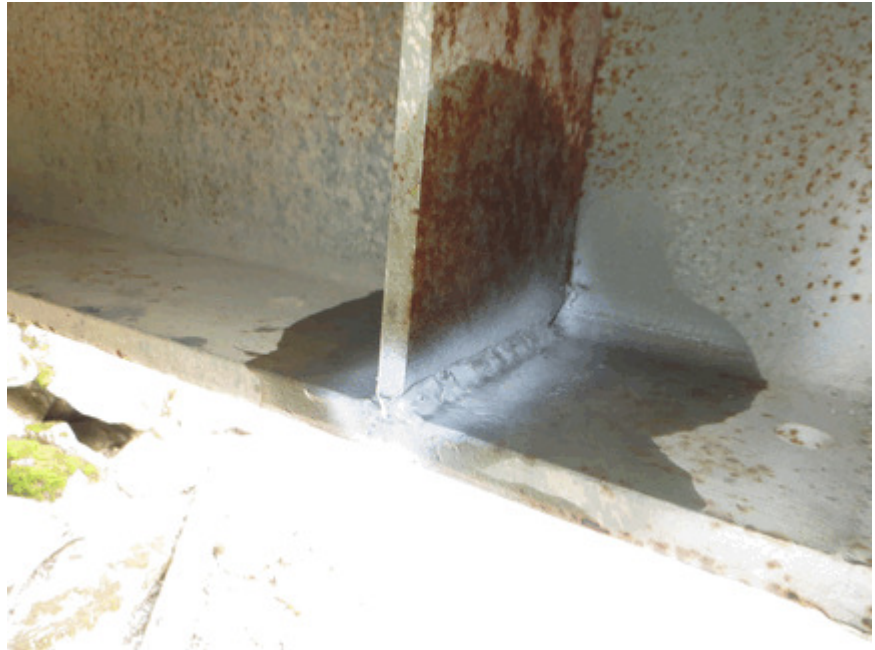
*Photo 5:*

Girder 2, splice B. This picture is of the left stiffener (looking North) and shows the typical fillet weld in this area. Individual lengths of rejectable undercut were noted as well as crater cracks.

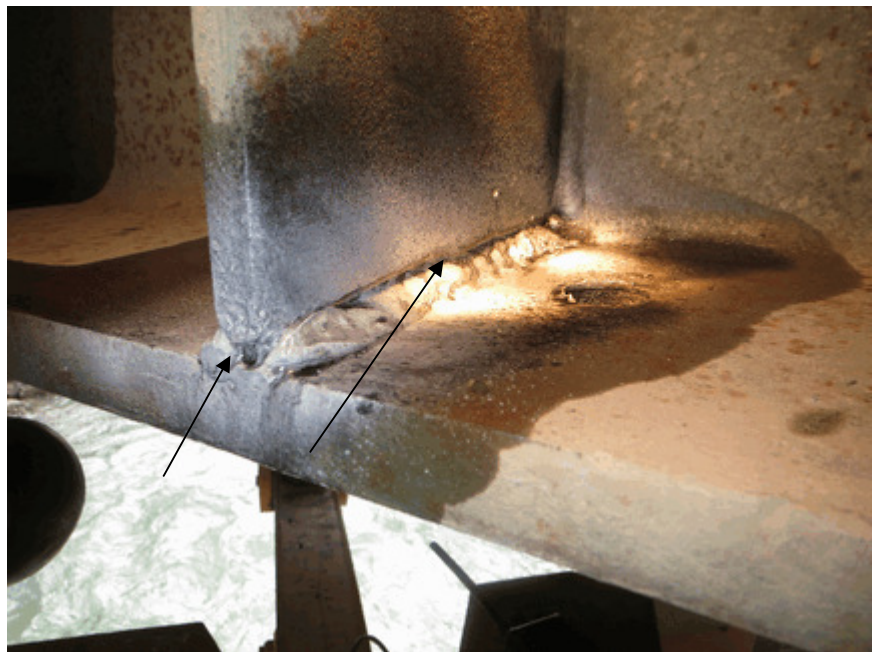
*Photo 6:*

The left side stiffener (looking south), at the Girder 2 Splice B location. Note the excessive undercut at the top leg of the fillet weld as well as the improperly wrapped end.

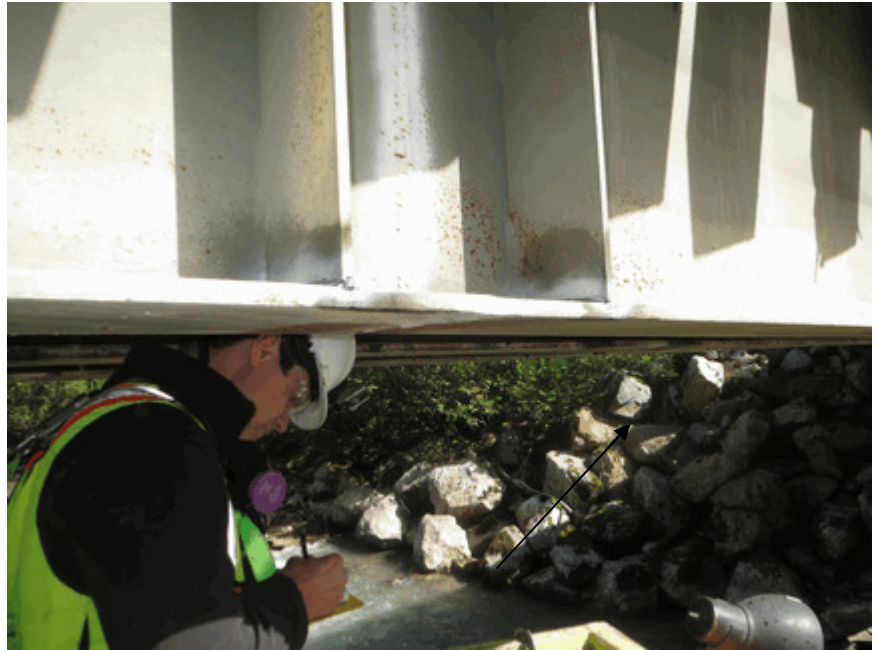
*Photo 7:*

**Girder 4 Splice B: Ultrasonic Shear Wave.** The bottom splice, which measures 29.5 cm wide, was inspected using Ultrasonic Shear Wave as well as 50.0 cm of the web splice as measured from the bottom splice up. No indications were discovered in the web splice. The bottom splice was found to contain a rejectable indication from 23cm to 29.5cm as measured from the North edge of the splice. The indication was found at 15mm deep from the bottom surface and had a rating of 0. The location of the welding defect was verified by the magnetic particle inspection.

**Girder 4 Splice B: Magnetic Particle.** The adjacent stiffener fillet welds on the North and South sides of the girder were inspected using magnetic particle. The fillet welds were all found to contain areas of undercut in excess of the allowable stated in CSA W59.12. No areas of cracking were discovered during this inspection. (Photo 7, 8 and 9)

Girder 4, Splice B.

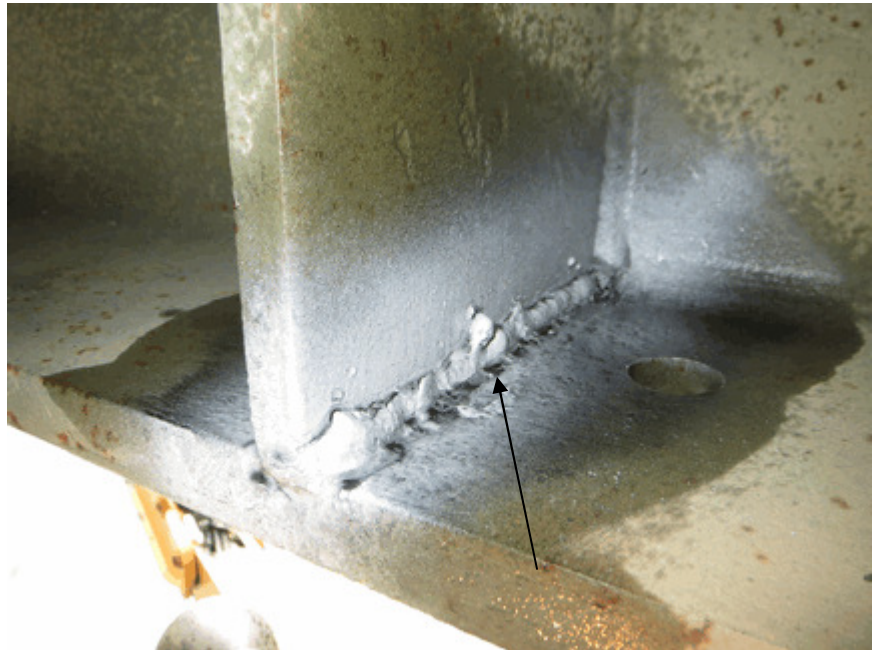
*Photo 8:*

Girder 4, Splice B. This fillet weld is located on the left side stiffener (looking south). The weld was found to contain rejectable undercut as well as a size ranging from 4mm to 10mm. Note the excess weld and poor appearance of the weld.

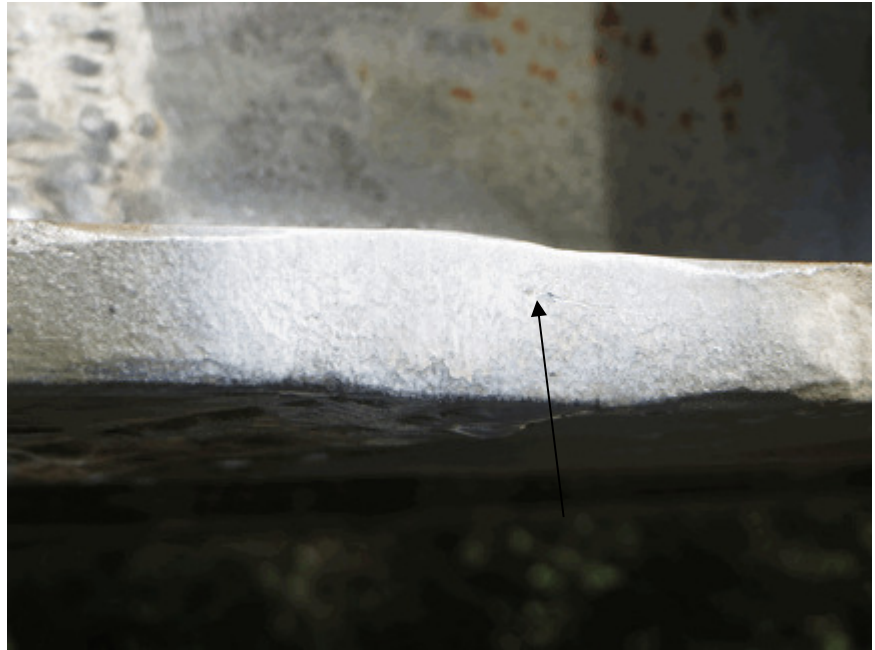
*Photo 9:*

Girder 4, Splice B. During the ultrasonic inspection of the bottom flange weld, a rejectable indication ran along the length of the splice and was noted at the edge of the material. Magnetic particle inspection verified the location of the indication.

The anomalies and possible cracks in the welds may result in fracture of a girder and an associated loss of capacity. Given the numerous anomalies identified by Acuren's 2013 and 2014 inspections, we recommend that the Ministry mitigate the risks associated with the fracture of a girder by replacing the bridge, if they intend to use it for industrial purposes. The Ministry could also mitigate this risk by strengthening the steel girders. In this case, upon confirming the adequacy of the existing steel girder capacity, the girders could be strengthened by installing bolted splices at the butt weld locations. This would provide an alternative load path should the welds fail.

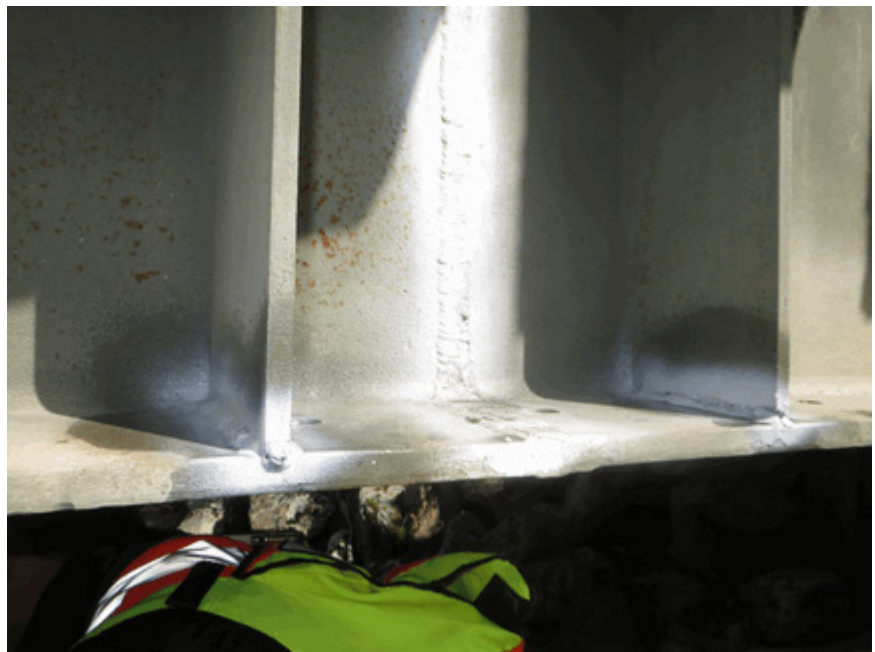
*Photo 10:*

**Girder 4 Splice C: Magnetic Particle.** The adjacent stiffener fillet welds on the North and South sides of the girder were inspected using magnetic particle. The fillet welds were all found to have areas of rejectable undercut and porosity associated with the welds. No areas of cracking were observed. (Photo 10, 11 and 12)

Girder 4, Splice C.

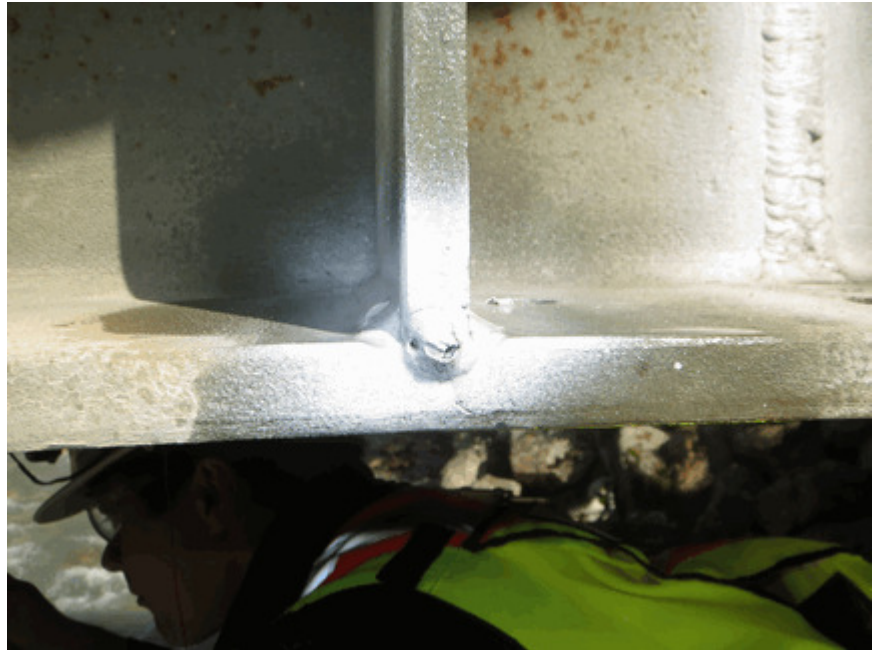
*Photo 11:*

Girder 4, Splice C. The fillet weld was wrapped at the end but is substandard containing porosity and undercut.

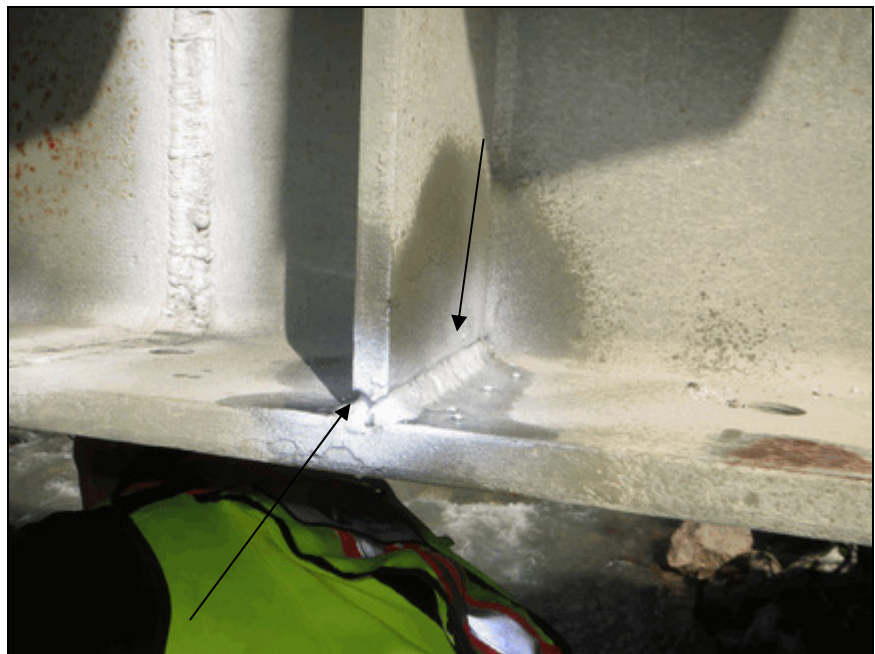
*Photo 12:*

Girder 4, Splice C. This is the right side stiffener (looking north). Note the undercut at the edge of the stiffener and along the fillet weld length.

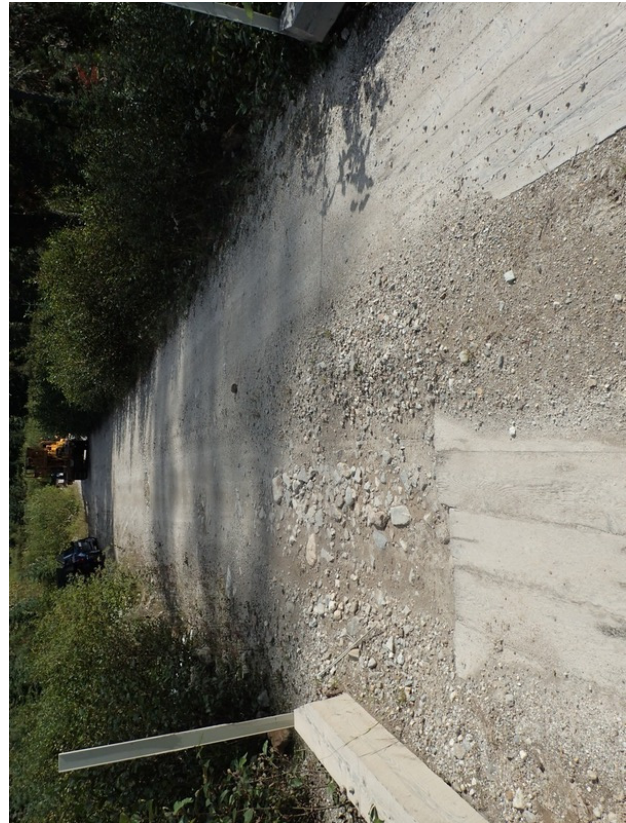
| Approach Road | Fair | | Vegetation overgrowth adjacent to approaches. Potholes and settlement of road at bridge deck. | | | | | | | | | | | | |

Figure 8: Left approach - note potholes at end of deck.

| 4 | Regrade approaches when road is in use. | Low | \$250.00 | | |

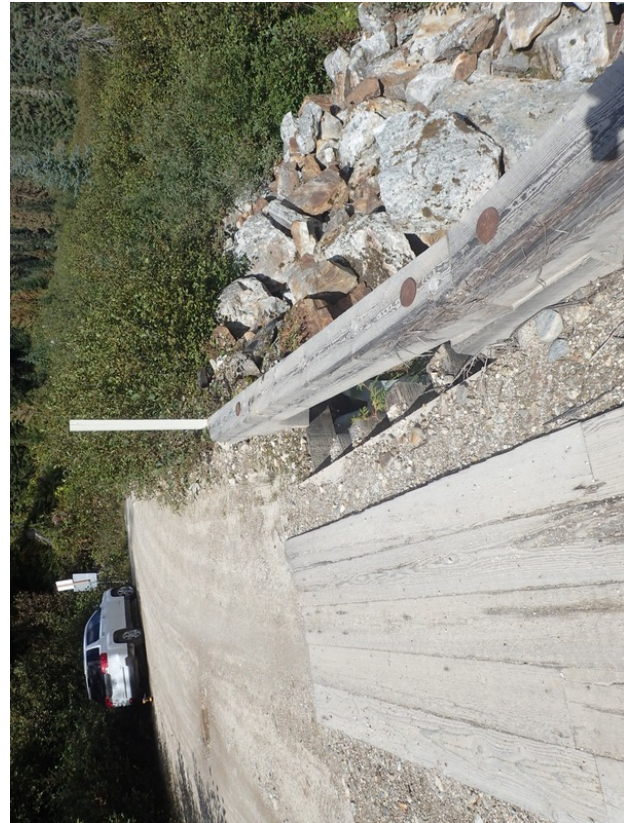
| Running Surface | Fair | | 4-65mm x 250mm running planks on each wheel track, gravel on sub-deck between planks & on deck edge.<br><br>Right end upstream flare: large gap, rail flared but deck does not extend to rail (see figure 12). | | | | | | | | | | | | |

Figure 12: Right approach - note gap between decking and rail.

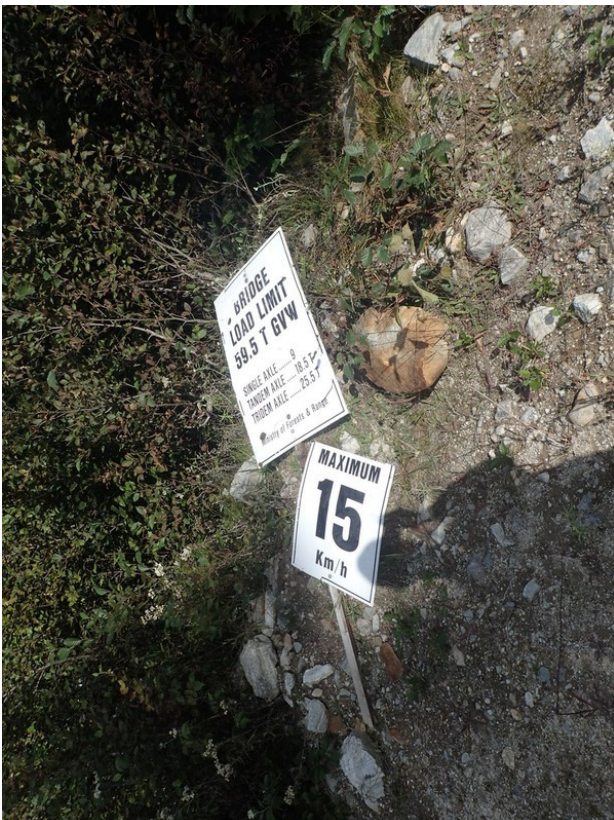
| Signage | Fair | | No bridge ahead signs. 15 km/hr, speed restriction & load posting on right approach only (left approach sign in bush). | | | | | | | | | | | | |

Figure 9: Load posting and speed limit signs - left approach.

| 1 | Reinstall left approach load posting & speed restriction. | High | \$100.00 | | |

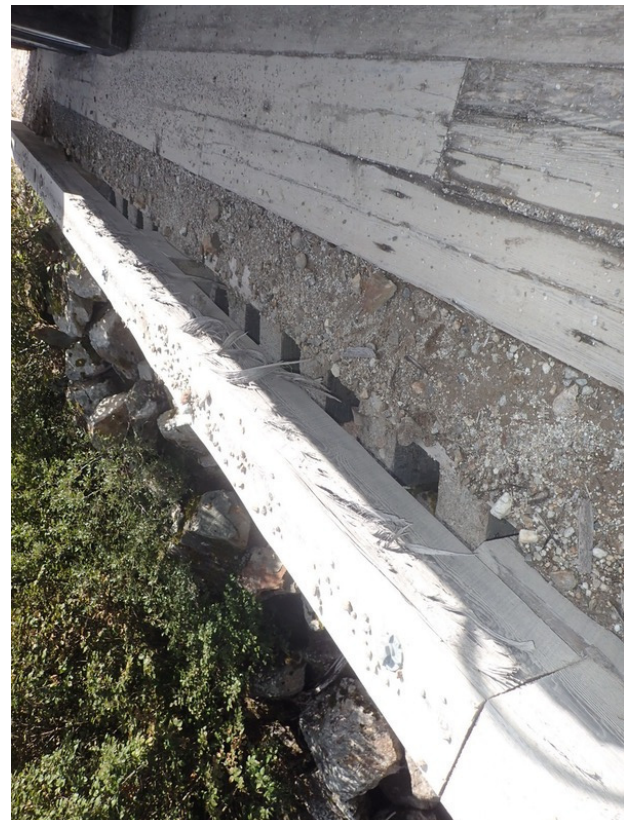
| Curb Rails and Risers | Fair | | No decay, minor rub damage. | | | | | | | | | | | | |

Figure 11: Minor rub damage to rail.

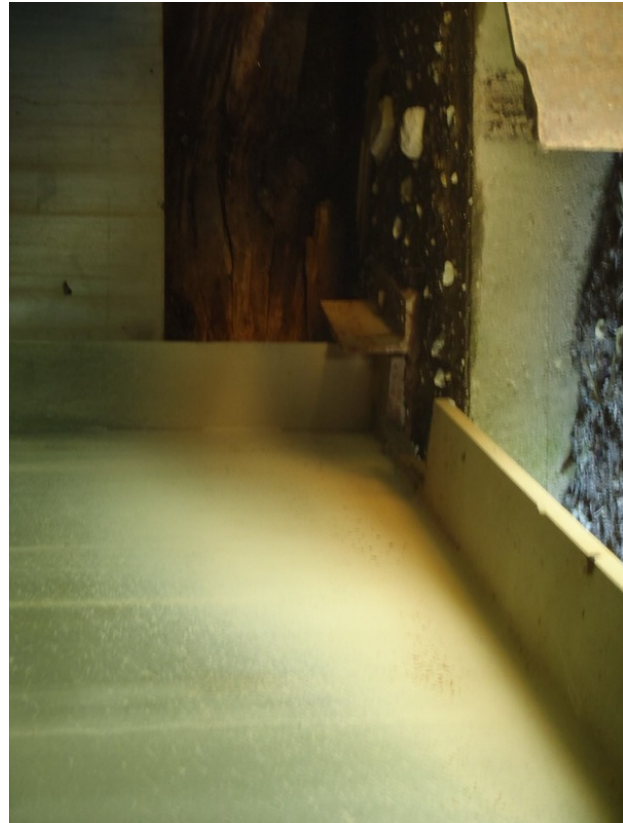
Figure 16: Section removed from girder 1 at left abutment.

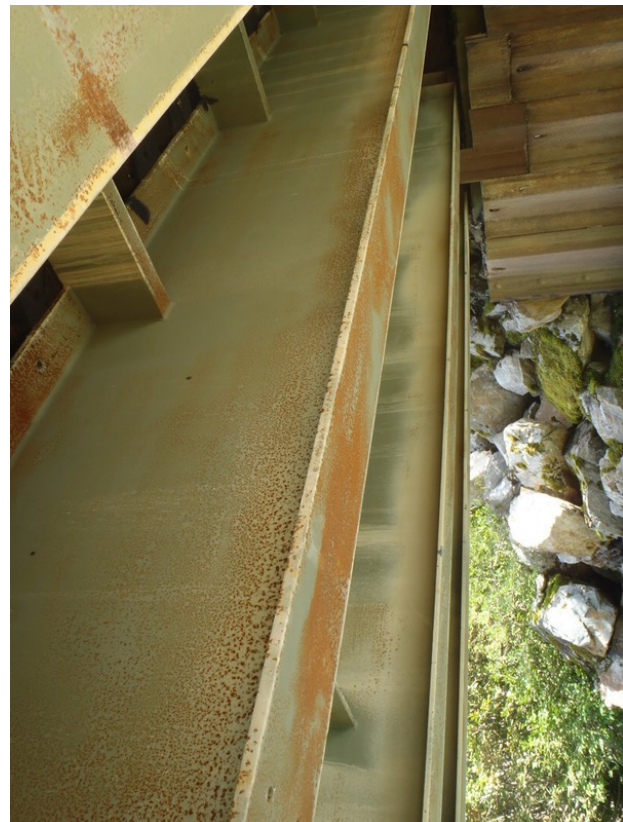
Figure 15: Interior girder condition, girder 3 shown - coating failure with light corrosion.

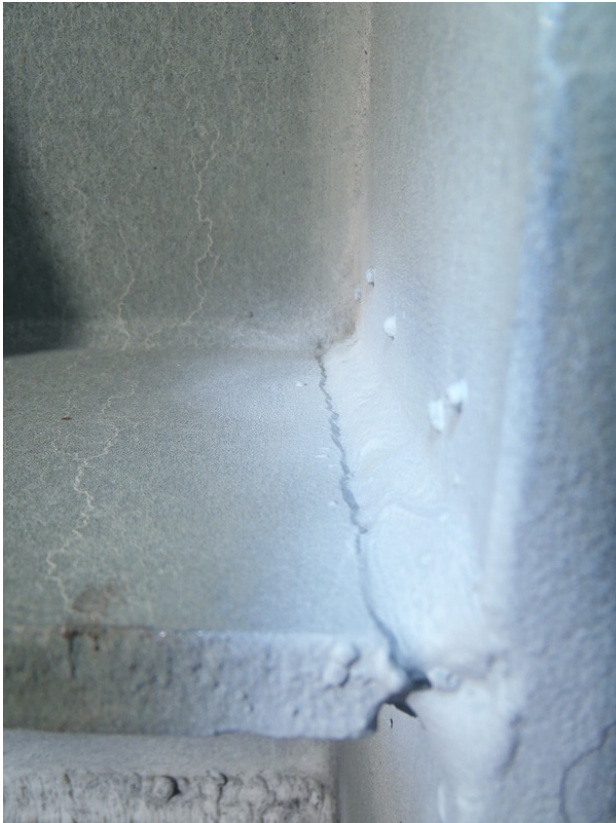
Figure 18: Typical undercutting on stiffener weld - girder 4 location C downstream stiffener shown.

| 1 | Monitor welds in the girders. | | | | |

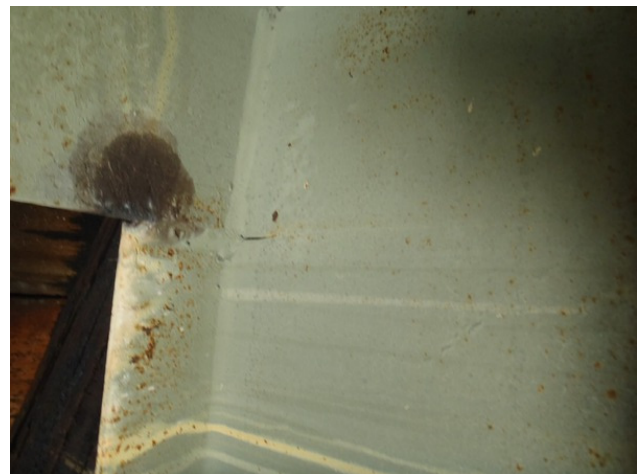
| Diaphragms | Fair | Torch cuts noted in C channel diaphragms at two locations in bay 2 adjacent to the right abutment. | | | |

Figure 19: Torch cut in bay 2 diaphragm adjacent to right abutment.

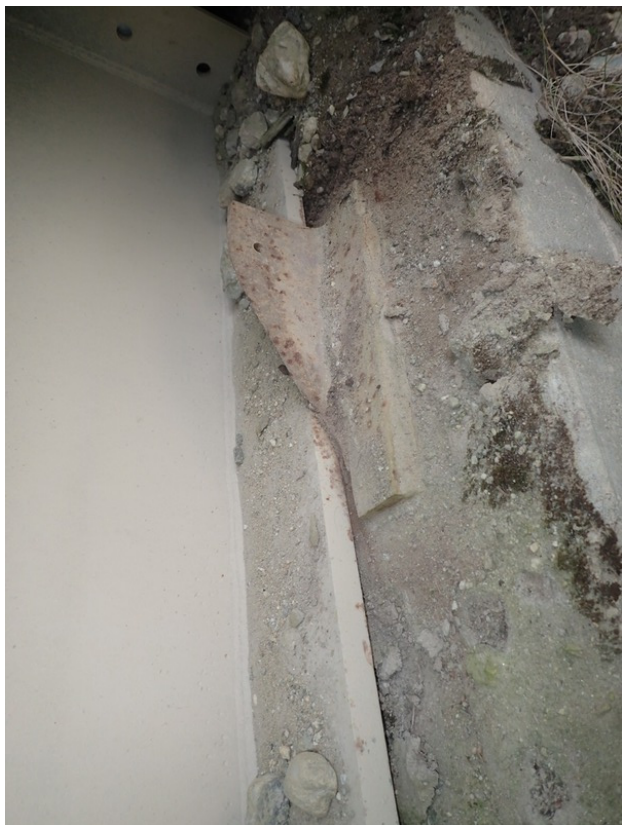
| Bearings | Fair | Neoprene bearing walked out under girder 4. Other bearings not visible. The girders are in bearing against the downstream restraints, suggesting the structure may have previously moved, see figure 22. | | | |

Figure 22: Right abutment girder 1 bearing upstream face - note bearing against restraint.

| 3 | Monitor bearings. | | | | |

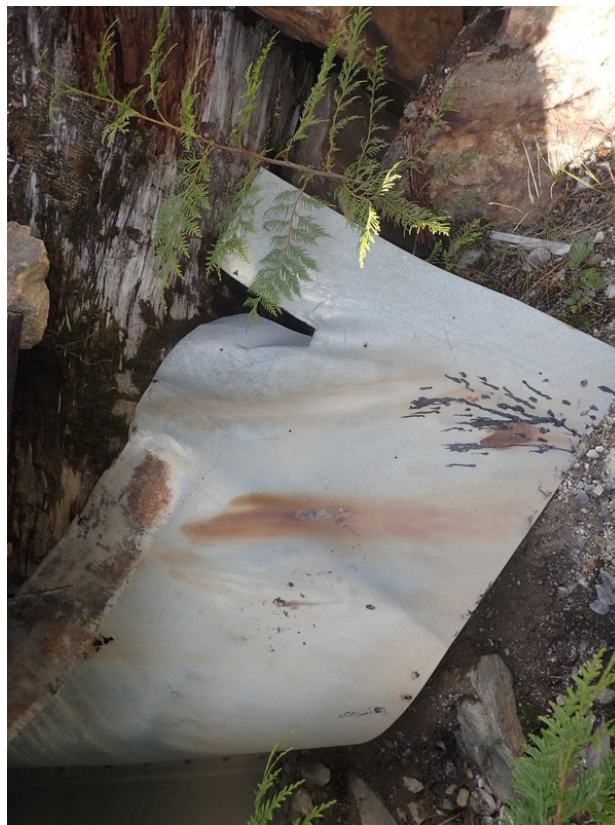
| Ballast Wall | Fair | Sheet pile breast wall.<br><br>Ballast wall consists of cedar logs. Downstream log rotten & disintegrating (see figure 25), fill containment not compromised.<br><br>Flashing between ballast wall logs & girders damaged at both the upstream & downstream ends. | | | |

Figure 24: Right abutment upstream face - typical condition of flashing.

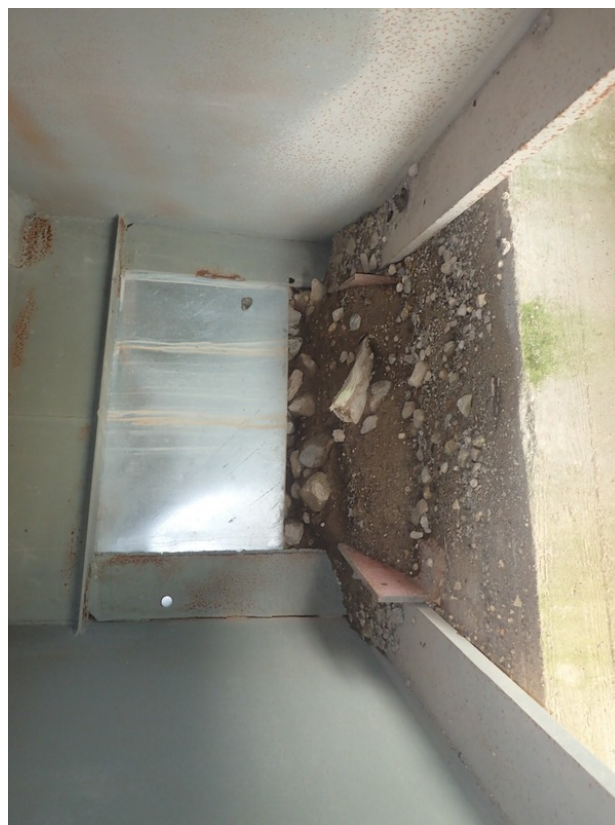
| Caps or Sills | Good | Concrete sill supported on gravel fill behind sheet pile wall. Debris collecting on cap - similar to previous inspection. | | | |

Figure 23: Right abutment - typical condition of flashing between girders and debris collecting on bearings.

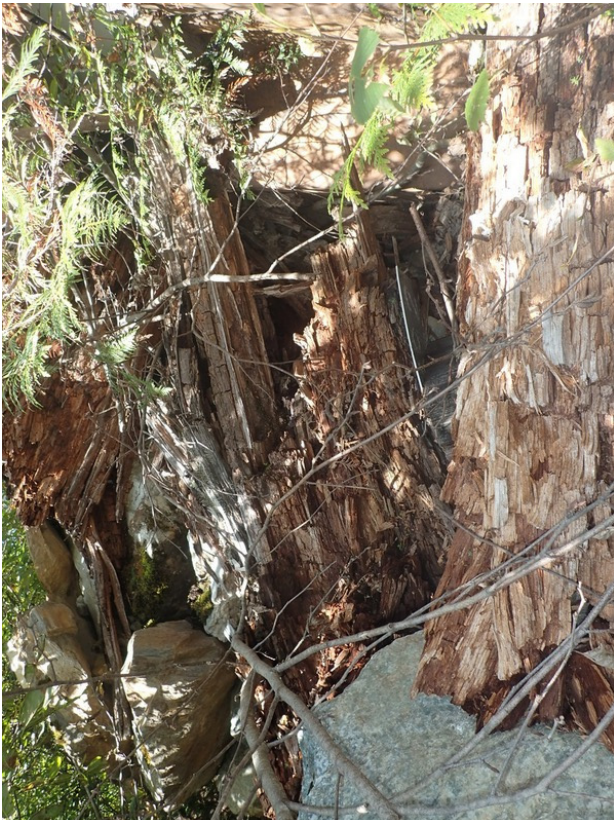
Figure 25: Right abutment downstream face - disintegrating ballast logs.

| 2 | Monitor abutment ballast walls, cedar logs rotten, but still functioning. | | | | |

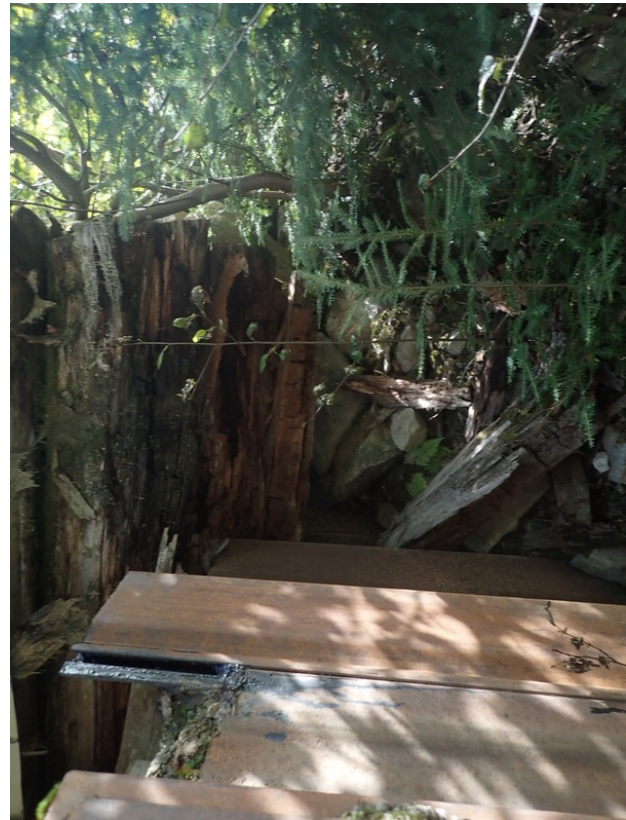
| Ballast Wall | Good | Sheet pile breast wall.<br><br>Ballast wall consists of cedar logs. Downstream log rotten & disintegrating (see figure 27), fill containment not compromised. | | | |

Figure 27: Left abutment downstream face - disintegrating ballast logs.
