## BRIDGE INSPECTION

**BRIDGE NO.** N2-038: Findlay-Lavington  
FSR (12.60 KM)

**Inspection Date:** September 25, 2012

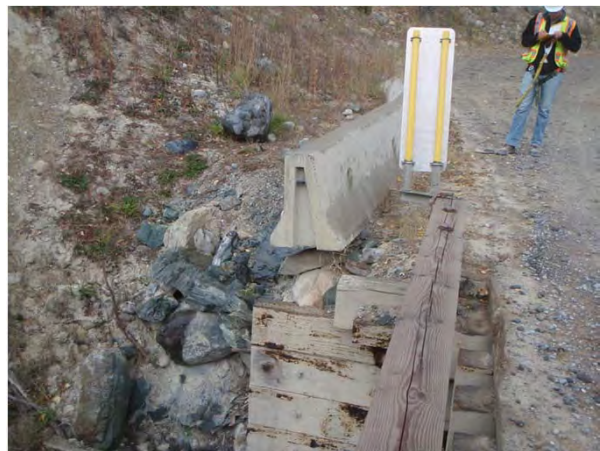
- The approaches are generally in fair condition.
- Tight horizontal curves on both ends of the bridge and vegetation limit visibility.
- Camp end upstream approach barrier pushed by grader
- No approach barrier on camp end downstream and woods end upstream corners.
- Cattle guard on woods end approach.
- All delineators and bridge ahead signs present.

| Fender Condition | Fair | The camp end upstream fender has been pushed to the edge of the approach fill.<br>No barriers present on woods end upstream and camp end downstream corners. |

**Figure 1-6: Camp end upstream concrete barrier.**

The bridge is generally in fair condition. We recommend the approach barriers on the camp end upstream side be repositioned.

| Items | Description | Priority |
|---|---|---|
| 1. | Reposition barriers on camp end upstream side. | Medium |

| | 1 | Recommended | Medium | \$750.00 | Reposition camp end upstream concrete barrier. | | | | | | |

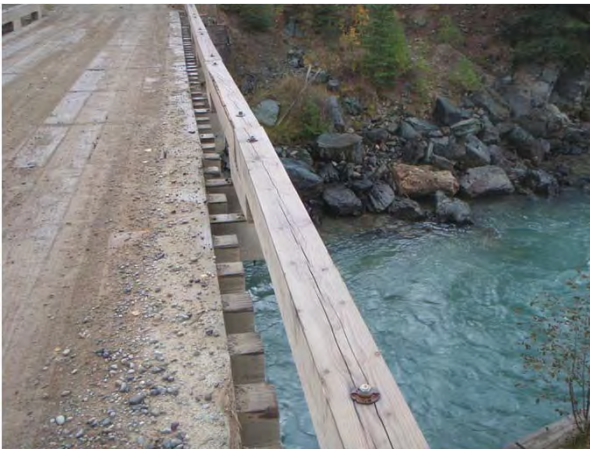
- The deck is generally in fair condition.
- Curb rail is loose on camp end
- Minimal wear observed on deck planks.

| Curb Rail/Blocks/Posts | Fair | Curb rail is loose at camp end. |

**Figure 1-7: Typical curb rail condition.**

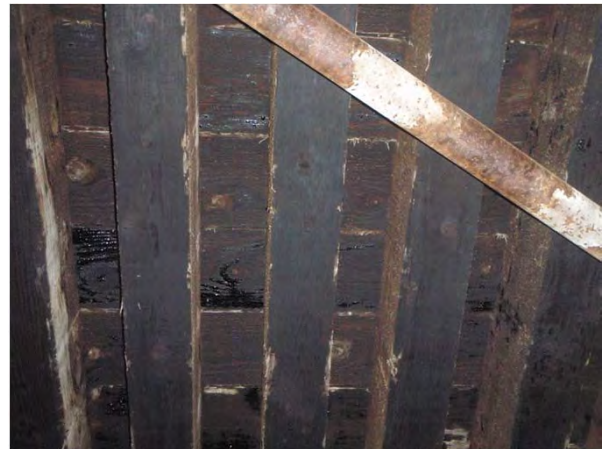
**Figure 1-8: Typical underside of deck.**

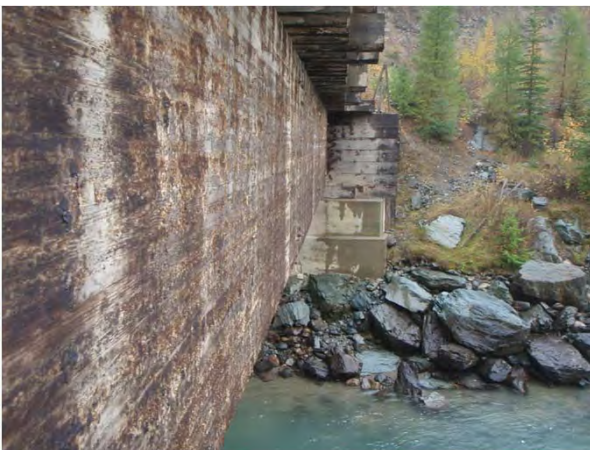
- The girders are generally in fair condition.
- Girder faces are covered with creosote.
- No new checks observed.

| Girders | Fair<br>Creosote leaching out and covering girder faces. No new checks since previous inspection; See additional notes for details. | | | | | | | | | | |

**Figure 1-9: Upstream face of girder 1.**

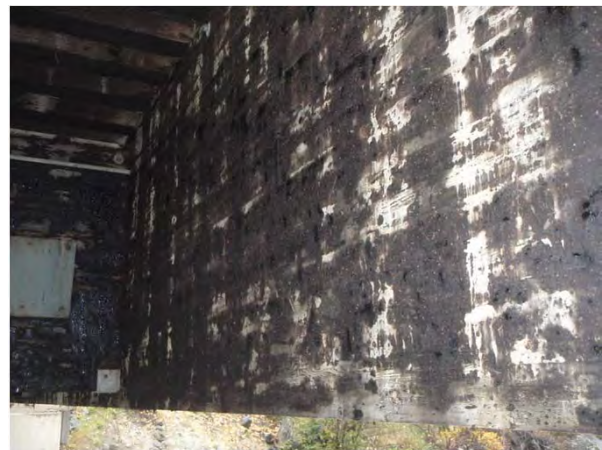
**Figure 1-10: Typical interior face of girders.**

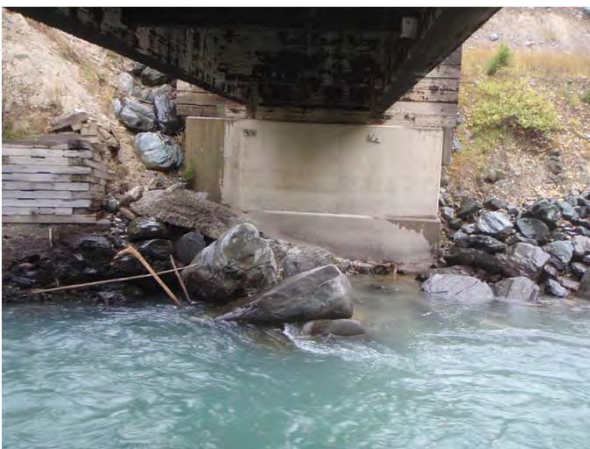
**Figure 1-11: Camp end abutment.**

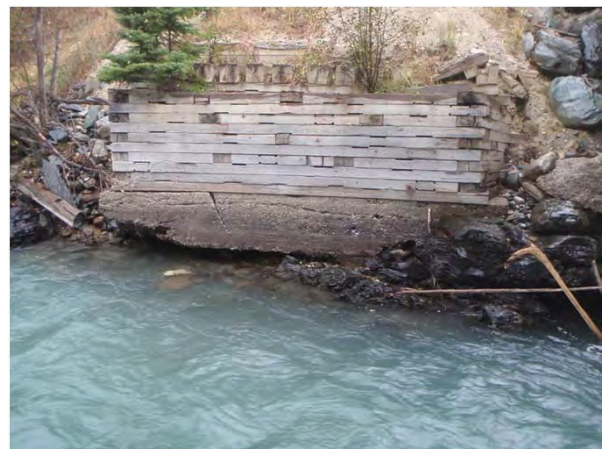
**Figure 1-12: Old bridge abutment upstream of camp end abutment.**

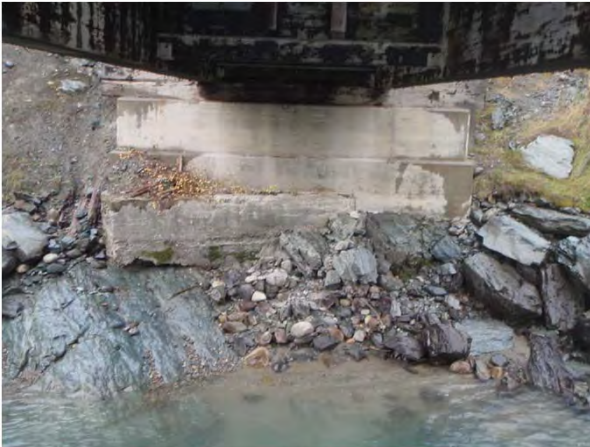
**Figure 1-13: Woods end abutment.**

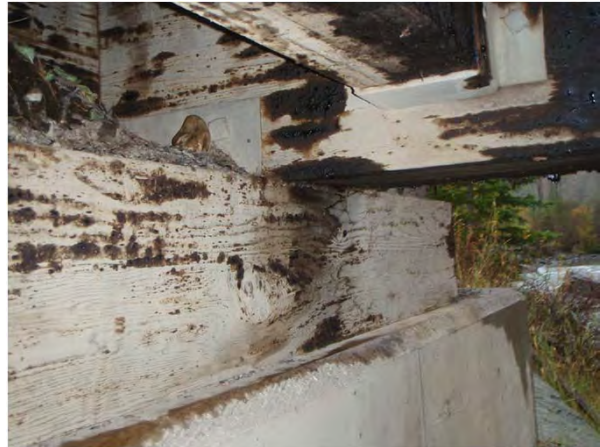
**Figure 1-14: Woods end cap beam.**

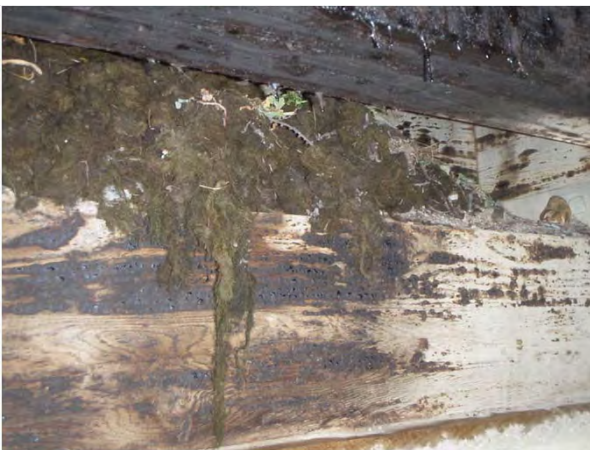
**Figure 1-15: Debris accumulation on woods end cap beam.**

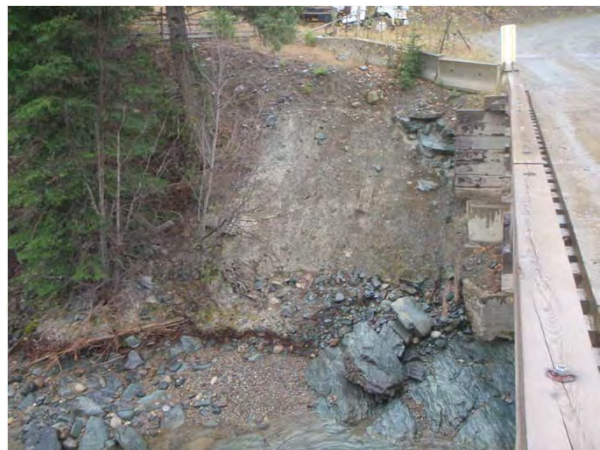
- The abutments are generally in fair condition.
- Inadequate riprap protection on woods end downstream bank resulting in erosion.

| Riprap | Fair | Inadequate riprap on downstream woods end, bank erosion present. |

| | Comment: | Inadequate rip rap downstream woods end, observed erosion at toe of slope. | | | | | | | | | |

**Figure 1-16: Downstream woods end embankment, note erosion at toe of embankment.**

1. Monitor both abutments for scour and erosion.

| | 1 | Monitor both embankments for scour and erosion. | | | | | | | | | |

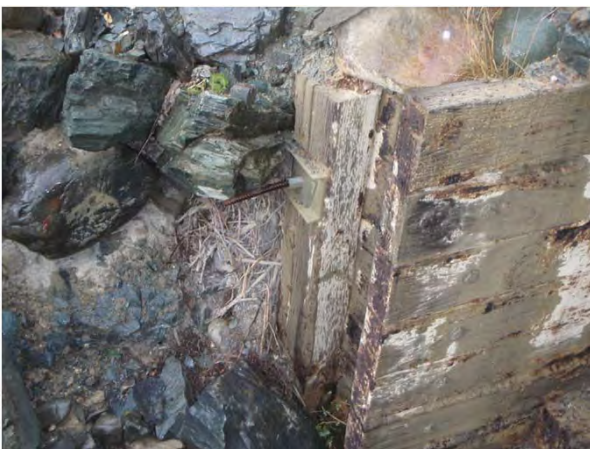
**Figure 1-17: Typical wing wall.**
