## BRIDGE INSPECTION

**BRIDGE NO./NAME** N4-059: Shelter Bay FSR (26.7 KM)

**Inspection Date:** September 21<sup>st</sup> 2012

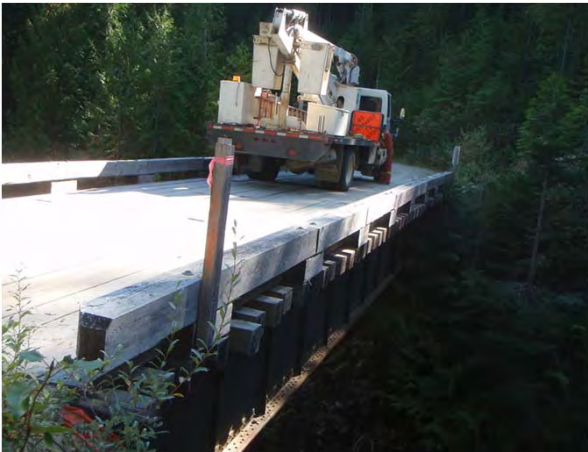
**Figure 1-1: Upstream elevation.**

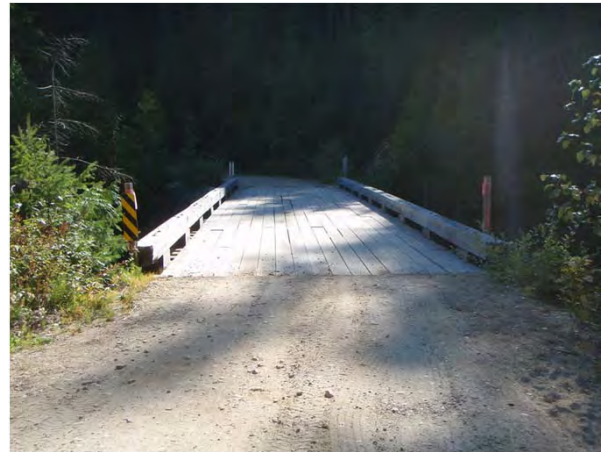
| Alignment | Fair | Tight horizontal curve on woods end approach. |

**Figure 1-2: Looking towards woods end.**

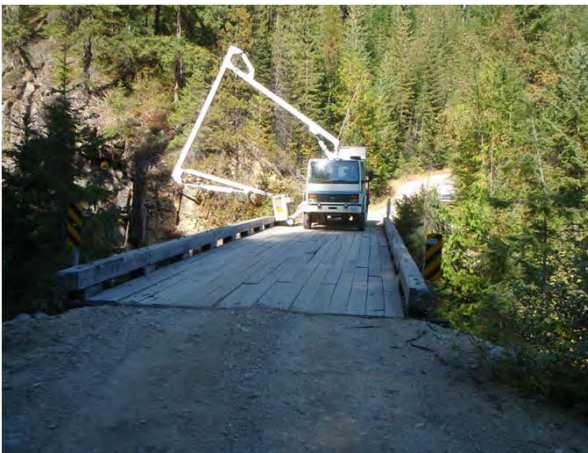
**Figure 1-3: Looking towards camp end.**

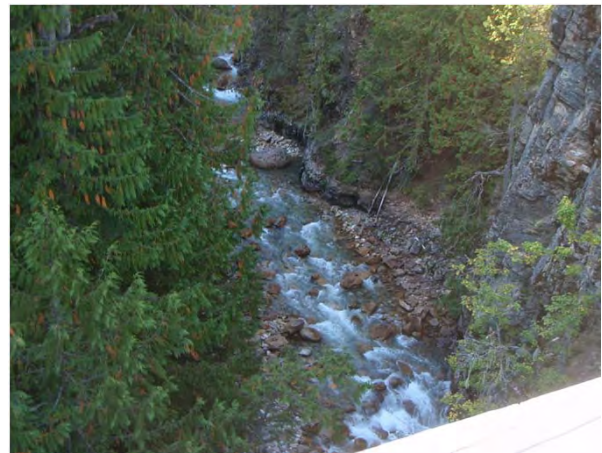
**Figure 1-4: Looking upstream.**

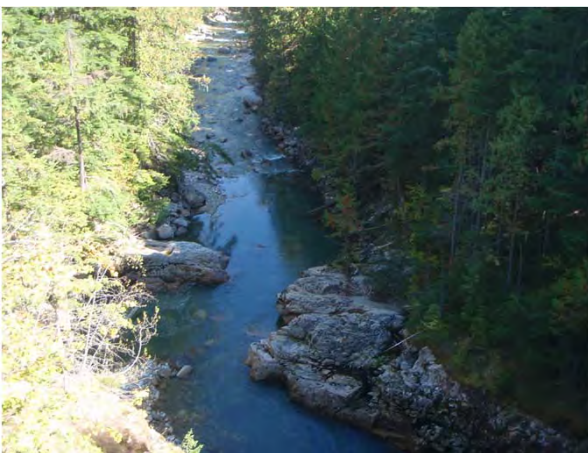
**Figure 1-5: Looking downstream.**

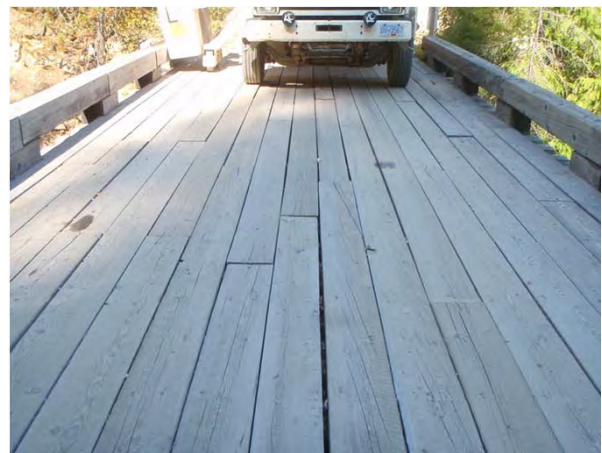
| Running Planks | Good | 10 mm gaps were observed between the deck planks. |

**Figure 1-6: Typical running plank condition.**

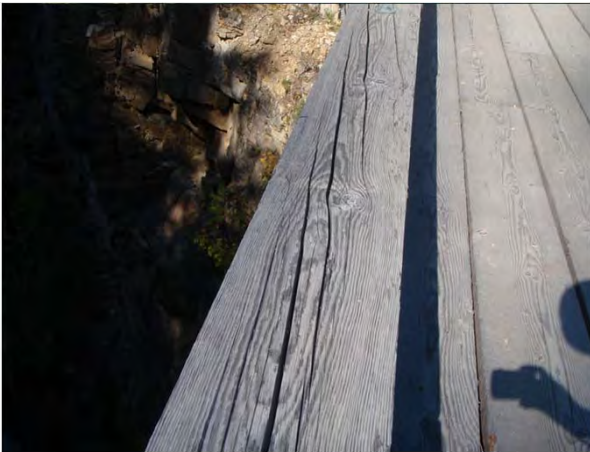
| Curb Rail/Blocks/Posts | Poor | Curb rails are loose and were found to have 50 mm of heart rot, the risers are rotten. |

**Figure 1-7: Typical wide checks in curb rails.**

| | 1 | Recommended | High | \$5,000.00 | Replace timber curb rails and risers |

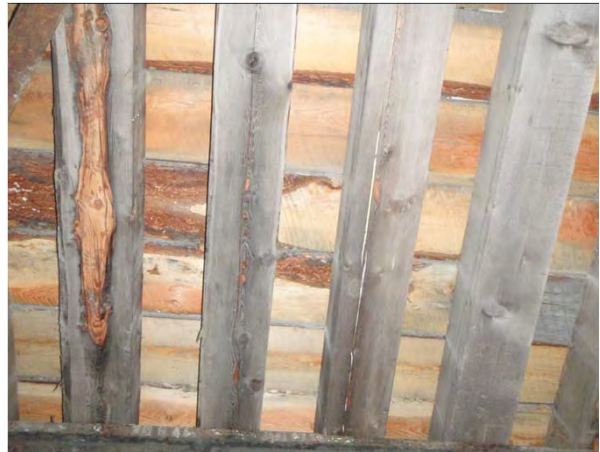
| Overall Deck Condition | Fair | The deck planks have been replaced since the previous inspection and several deck ties were replaced at the same time. |

**Figure 1-8: Underside of deck planks and deck ties.**

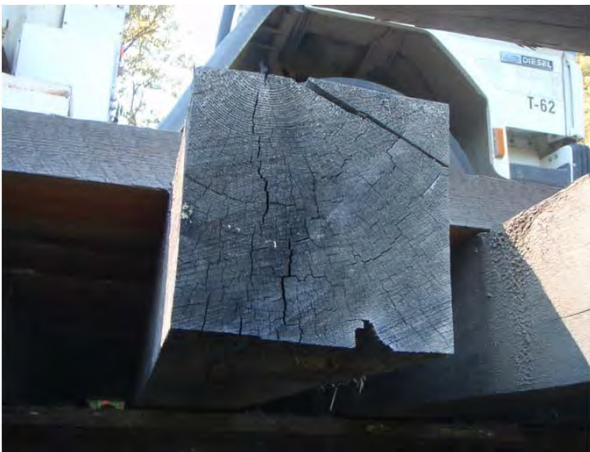
| Ties | Fair | A number of ties have end checks and shakes. |

**Figure 1-9: Typical condition of ends of deck ties.**

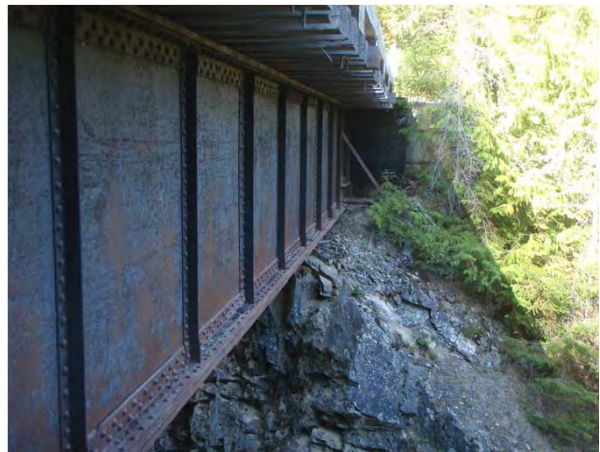
**Figure 1-10: Downstream face looking towards camp end.**

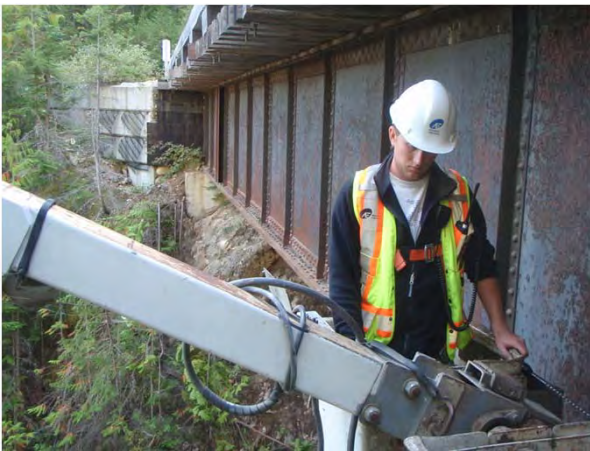
**Figure 1-11: Downstream face looking towards woods end.**

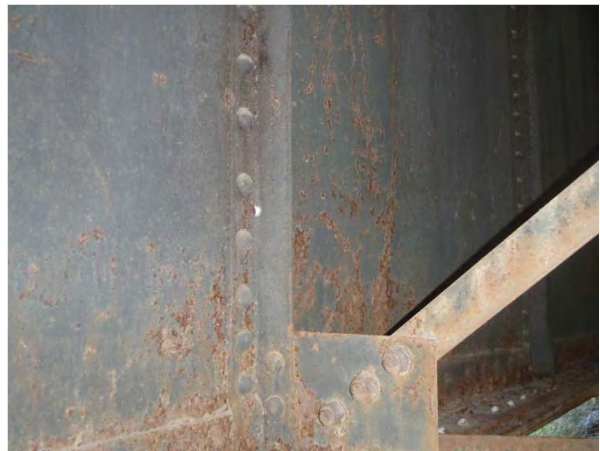
| Girders | Fair | The coating on the bottom flange and lower portion of the web has failed, remainder of the coating exhibiting signs of undercutting (corrosion below the coating). Loose rust formation on underside of bottom flange, no noticeable section loss, pitting of coating on remainder of girder. |

**Figure 1-12: Typical condition of steel girders (note minor paint flaking).**

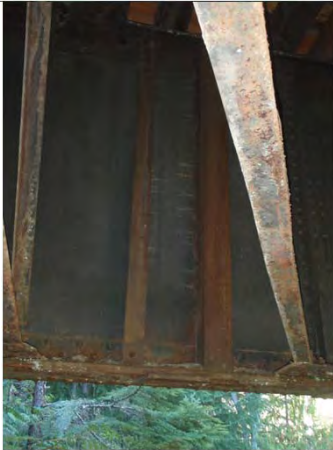
**Figure 1-13: Additional stiffeners welded on interior face of girders.**

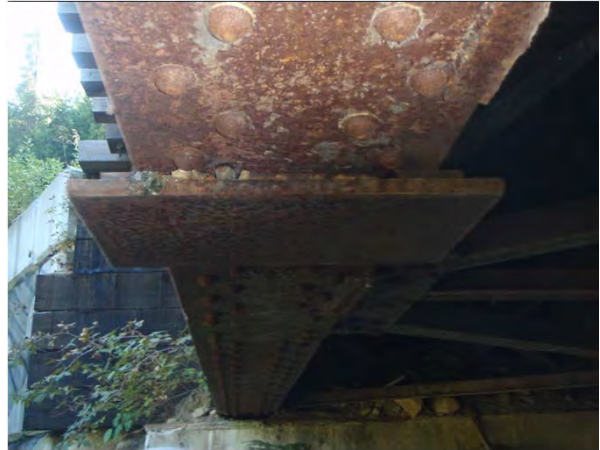
**Figure 1-14: Plate welded to bottom flange of girders on woods end.**

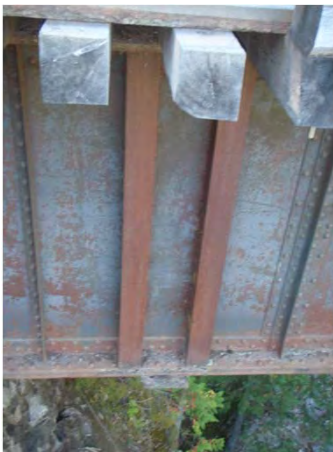
**Figure 1-15: Stiffeners welded on exterior face of girders.**

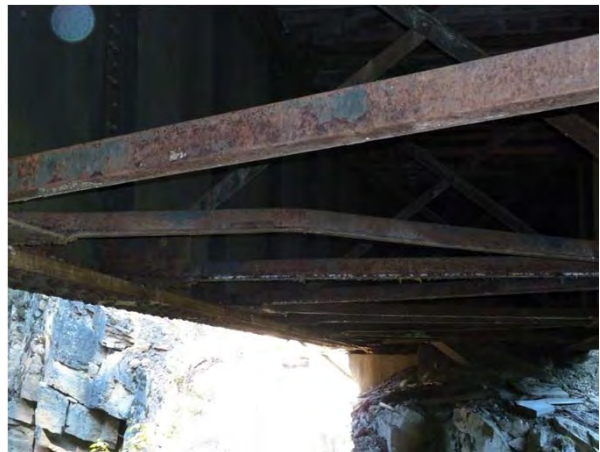
| Bracing | Fair | Several bracing members are bent. |

**Figure 1-16: Bent plan brace near mid span.**

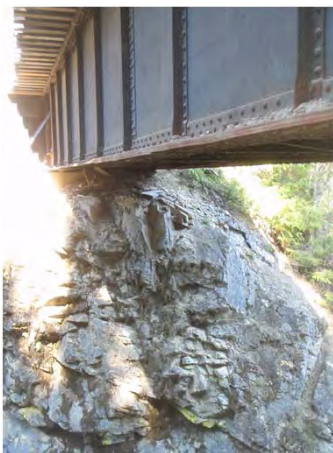
**Figure 1-17: Camp end abutment.**

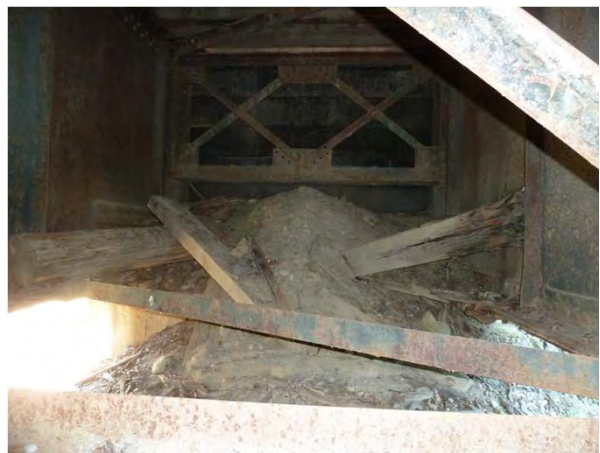
| Concrete Cast in Place | Fair | Debris accumulation limiting access. |

**Figure 1-18: Debris at camp end abutment.**

| | 3 | Recommended | Low | \$150.00 | Clean dirt and debris from bearing areas |

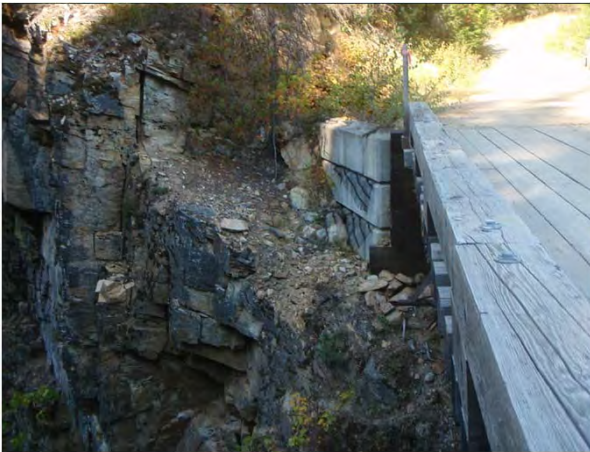
| Wing Wall | Good | No signs of movement. |

**Figure 1-19: Camp end upstream wingwall.**

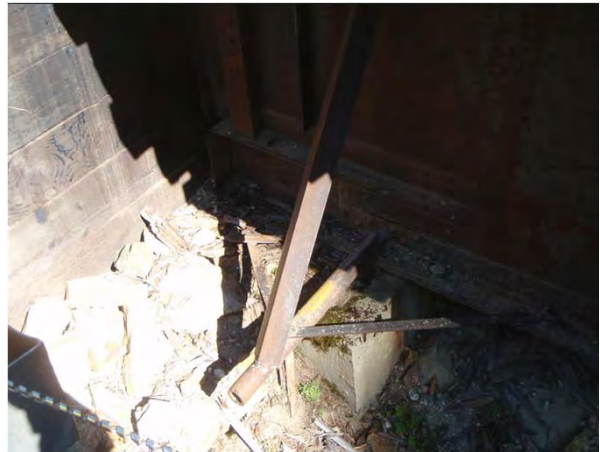
**Figure 1-20: Camp end upstream bearing.**

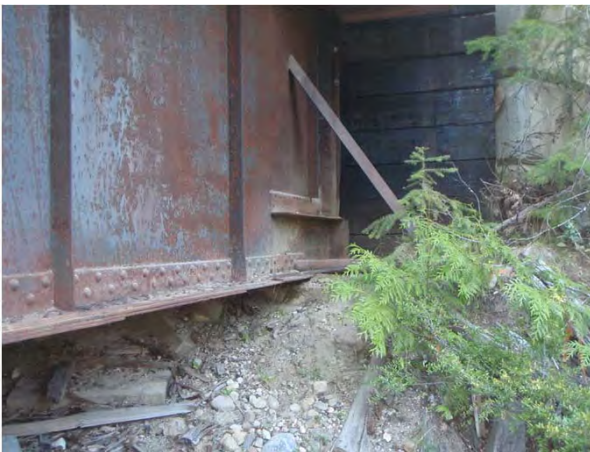
**Figure 1-21: Camp end downstream bearing.**

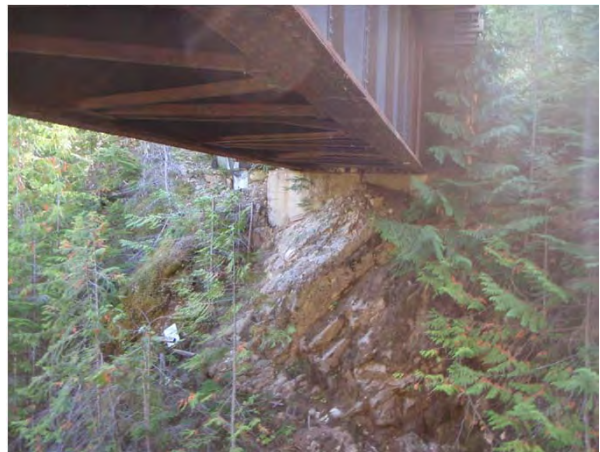
**Figure 1-22: Woods end abutment.**

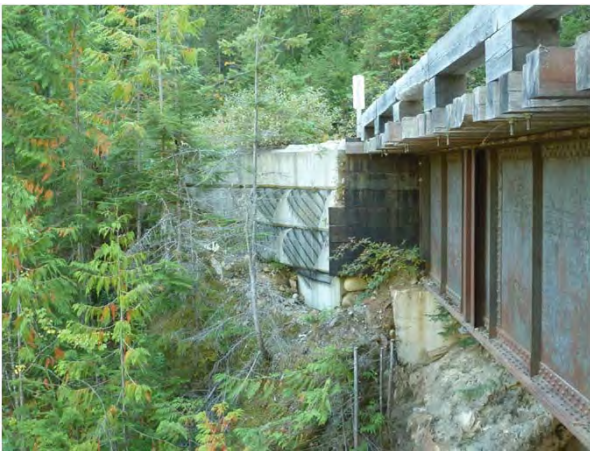
**Figure 1-23: Woods end downstream wingwall.**

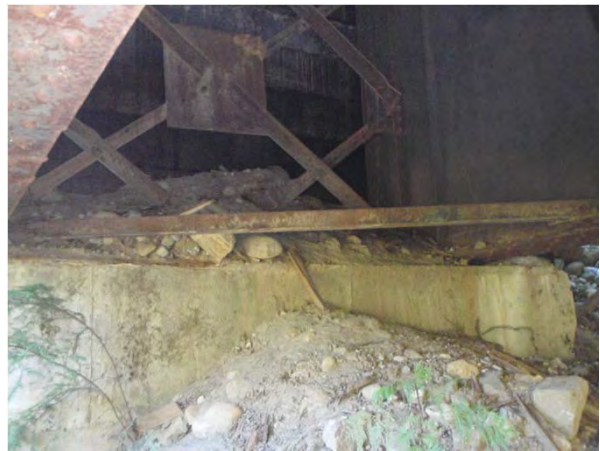
**Figure 1-24: Debris at woods end abutment.**

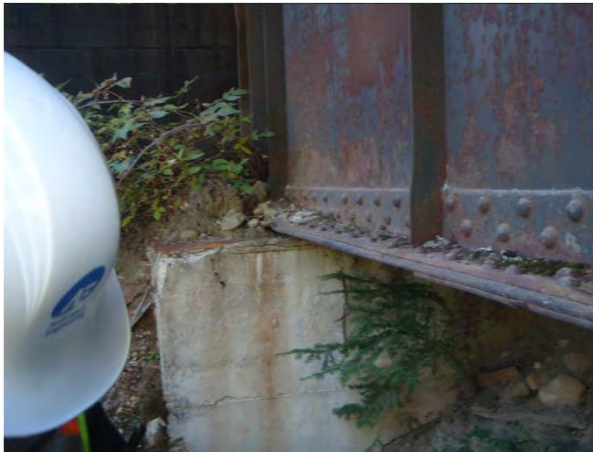
*Figure 1-25: Woods end downstream bearing.*
