# BRIDGE INSPECTION

**BRIDGE NO.** N2-068: Kootenay River  
FSR (32.80 km)

**Inspection Date:** September 23, 2012

## Permanent Bridge Inspection Report

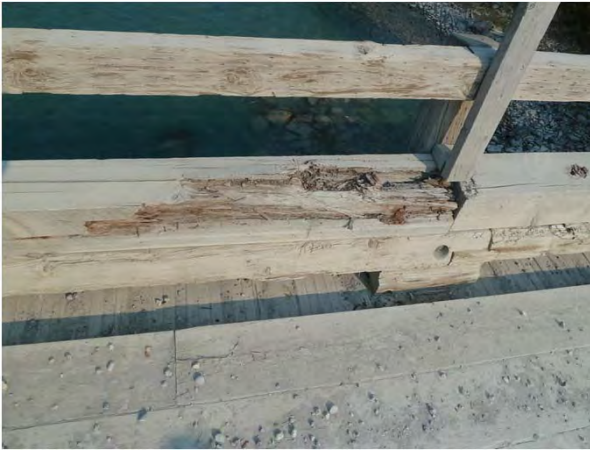
- The deck is generally in fair condition.
- Over 30% of top curb rail is rotten.
- Handrail has missing/ damaged sections and construction is not consistent.

**Figure 1-7: Guardrail rot.**

| Items | Description | Priority |
|---|---|---|
| 1. | Replace top section of curb rails and handrails. | High |

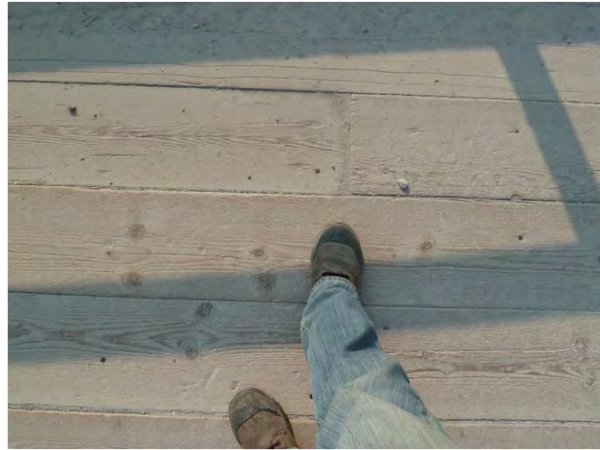
**Figure 1-8: Typical deck condition.**

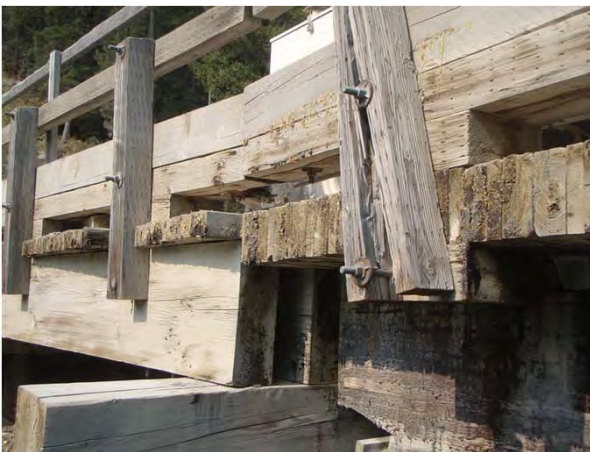
**Figure 1-9: Damaged railing post.**

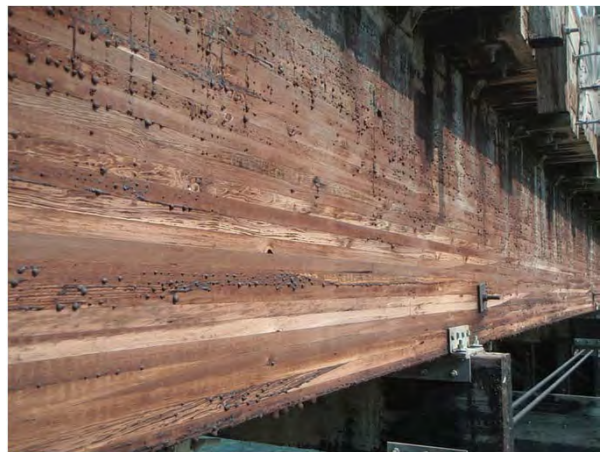
- Fair condition
- Creosote leaching; visible creosote on <25% of the girder faces (south facing)
- No checks observed

**Figure 1-10: Downstream face of girder.**

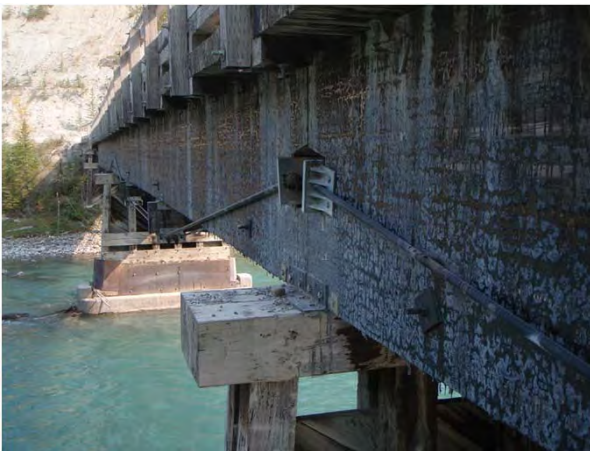
- Fair condition
- Creosote leaching; girder faces 100% covered by creosote
- No checks observed
- Span 5, girder 1 is leaning outwards, likely a result of curb rail impact.

**Figure 1-11: Upstream face of girders.**

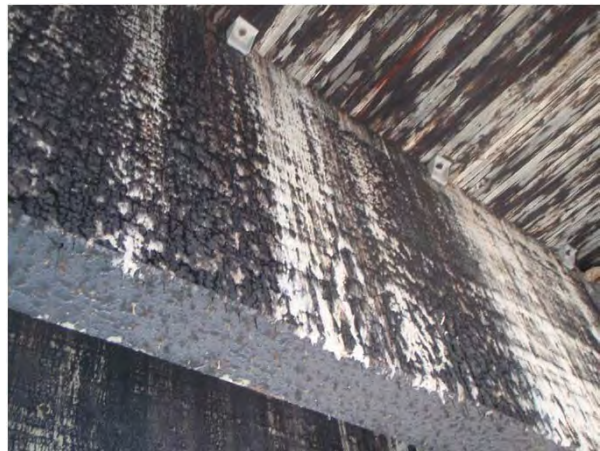
- Fair condition
- Creosote leaching; girder faces 100% covered by creosote
- No checks observed

**Figure 1-12: Typical interior face of girders.**

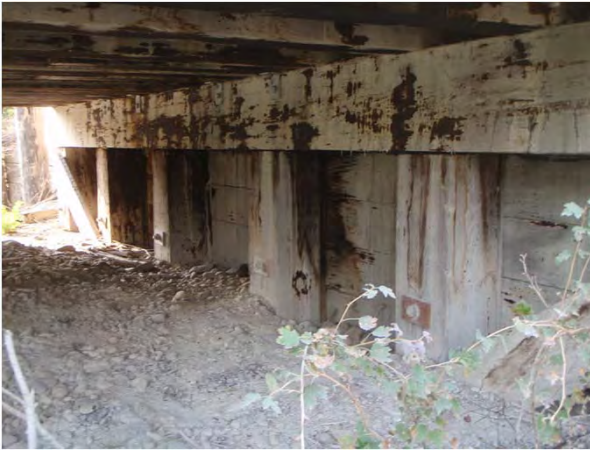
**Figure 1-13: Camp end abutment.**

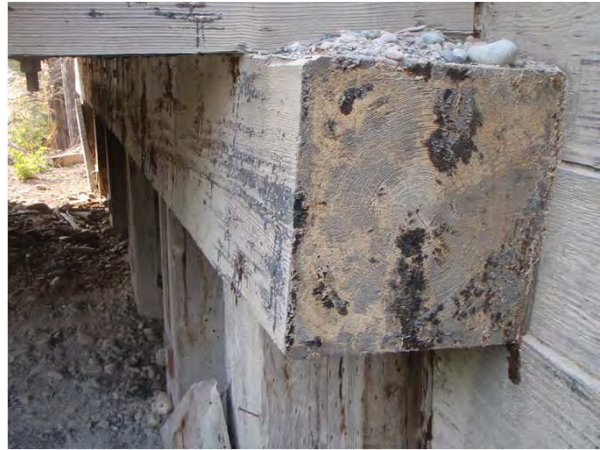
| Caps or Sills | Fair | Cap beams are rotating slightly, not previously noted. |

**Figure 1-14: Camp end cap beam.**

1. Monitor extent of rot in Pier 4 cap beam.
2. Monitor rotation of abutment cap beams.

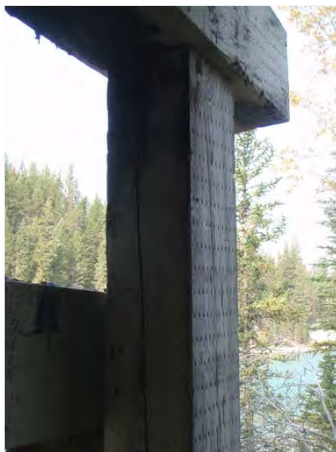
**Figure 1-15: Downstream pier 1 post.**

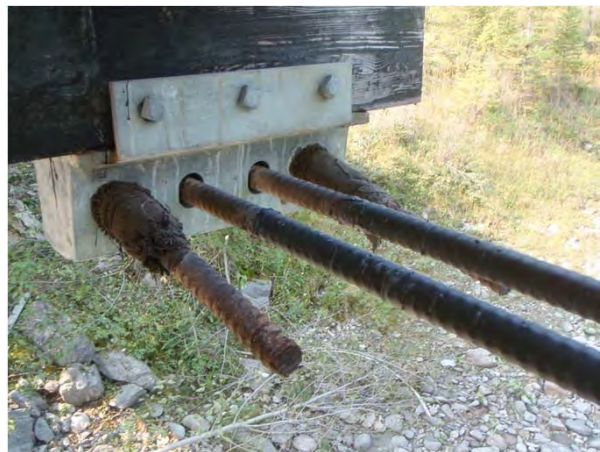
**Figure 1-16: Typical dywidag bars.**

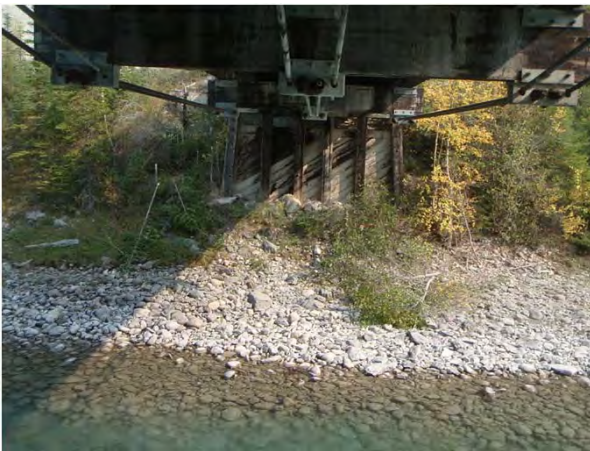
| Caps | Poor | Rot observed above posts 3, 5 & 6 and crushing observed at post 6 |

**Figure 1-17: Pier 1 from camp end.**

| Items | Description | Priority |
|---|---|---|
| 2. | Replace Pier 1 cap beam. | High |

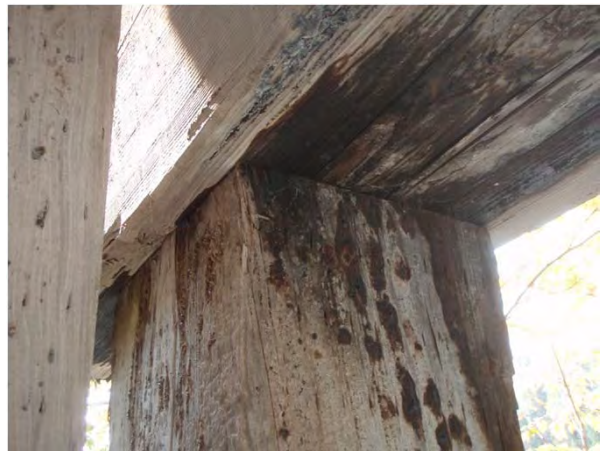
| Overall | Poor | Significant deterioration on cap beam. |

**Figure 1-18: Pier 1 cap crushing at upstream column.**

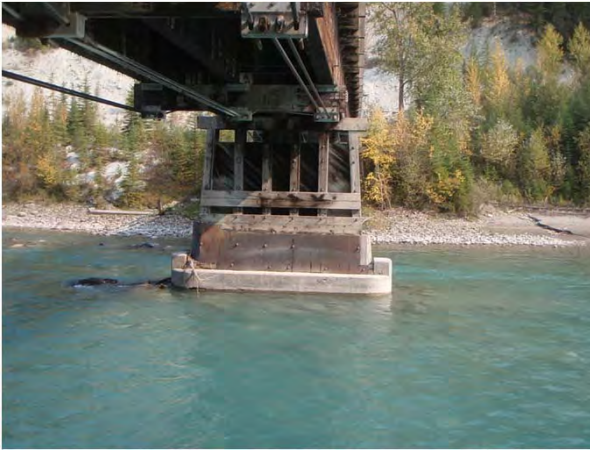
| Overall | Fair | Nosing on both ends of pier are rotten. Debris accumulation upstream. |

**Figure 1-19: Pier 2 from camp end.**

| Items | Description | Priority |
|---|---|---|
| 3. | Replace timber nose on Piers 2 and 3. | Medium |

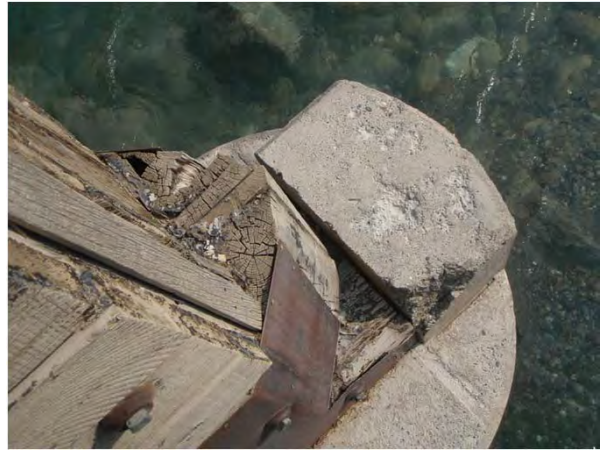
| Overall | Fair | Nosing on both ends of pier are rotten. | | | | | |

**Figure 1-20: Pier 3 nose.**

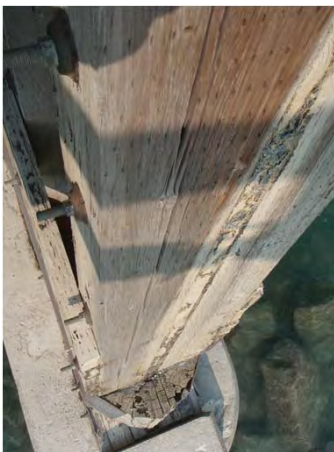
**Figure 1-21: Vertical check on pier 2 downstream pile.**

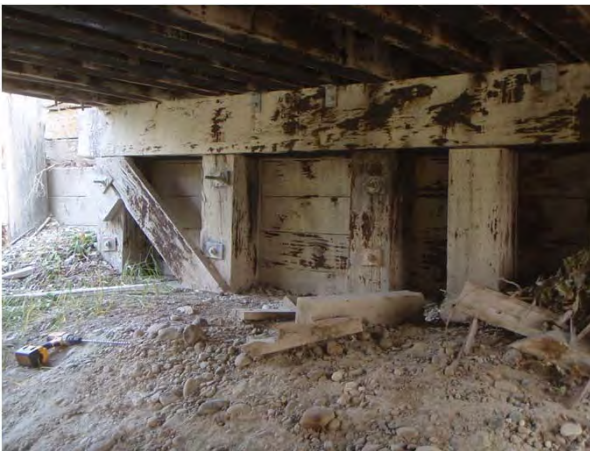
**Figure 1-23: Woods end abutment.**

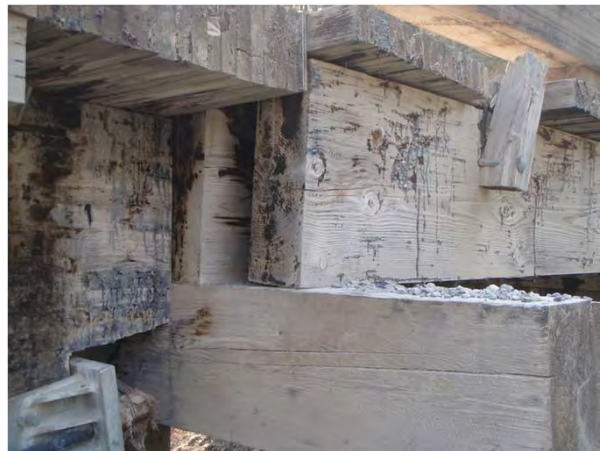
**Figure 1-24: Span 5, girder 1 leaning outwards.**
