## BRIDGE INSPECTION

**BRIDGE NO./NAME**      **N2-103: Kootenay By-Pass (9.50 km)**

**Inspection Date:**      September 23<sup>rd</sup>, 2012

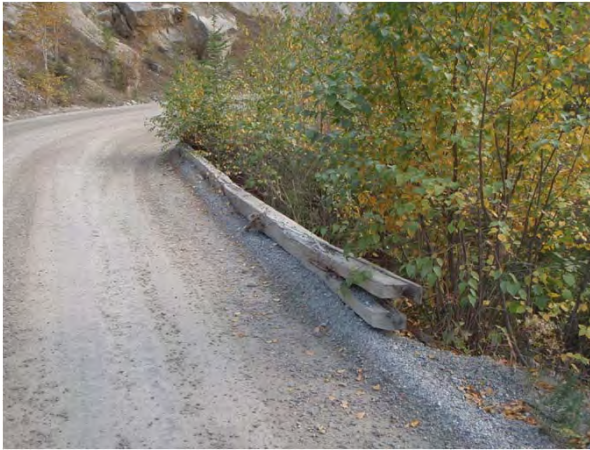
| Brushing Required | Yes | Vegetation on left end approach overgrown. |
| Fender Condition | Poor | The timber fender on the left end approach is heavily rotten and is no longer functional. |

**Figure 1-7: Left end approach, note condition of fender and overgrown vegetation.**

| Items | Description | Priority |
|---|---|---|
| 1. | Replace approach timber fenders. | High |

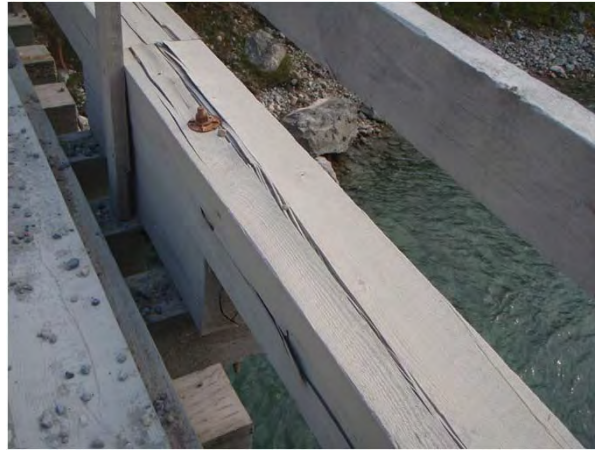
| Curb Rail/Blocks/Posts | Fair | Checks noted along most of the curb rails; curbs were sounded, no rot noted. |

**Figure 1-8: Typical curb rail condition.**

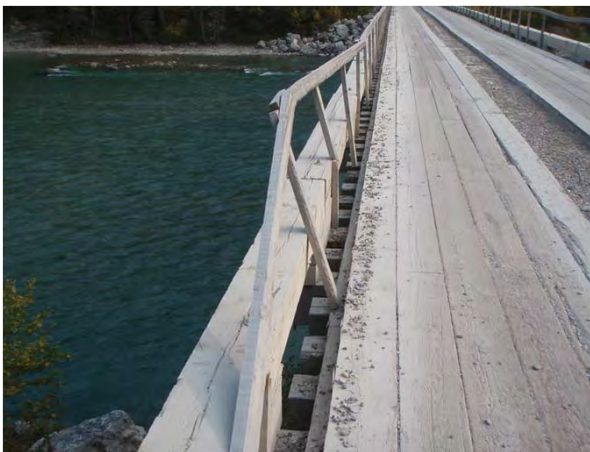
The bridge is generally in fair condition. The steel pedestrian rail installed along the length of the bridge is damaged and loose in a number of places. If the Ministry believes that this rail is necessary, they should make the required repairs otherwise, the rail can be left in place since it does not affect vehicle containment and delineates the deck edge.

| Structure #: | N2-103 | Site #: | N2-103 | Road Name: | KOOTENAY-BY PASS | Inspection Date: | 2012/09/23 |
|---|---|---|---|---|---|---|---|
| Hand Rails/Walkouts | Poor | Sections of damaged, loose or missing hand rail. | | | | | |

**Figure 1-9: Damaged handrail.**

| Items | Description | Priority |
|---|---|---|
| 2. | Replace 40 m of damaged/ missing/ loose hand rails. | Medium |

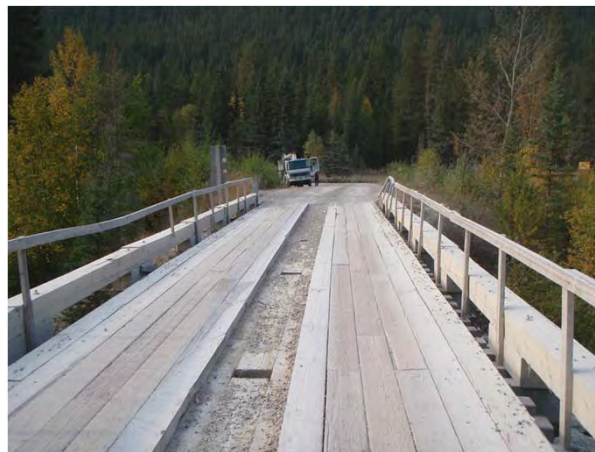
| Structure #: | N2-103 | Site #: | N2-103 | Road Name: | KOOTENAY-BY PASS | Inspection Date: | 2012/09/23 |
|---|---|---|---|---|---|---|---|
| Running Planks | Fair | Minimal wear on running planks. | | | | | |

**Figure 1-10: Wearing surface.**

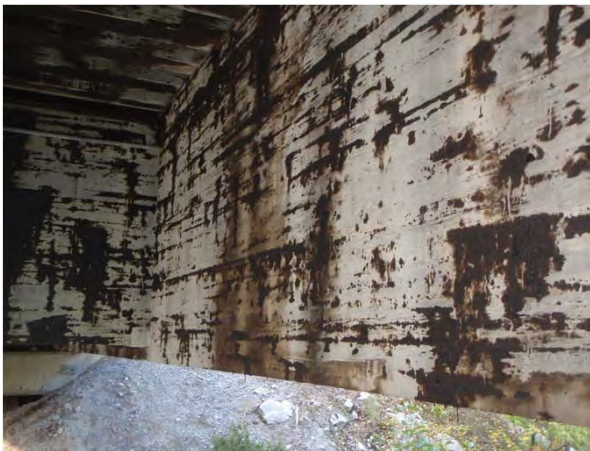
- Minimal creosote leaching out of girder face at laminate joints.
- No weathering.

**Figure 1-11: Typical interior face of girders.**

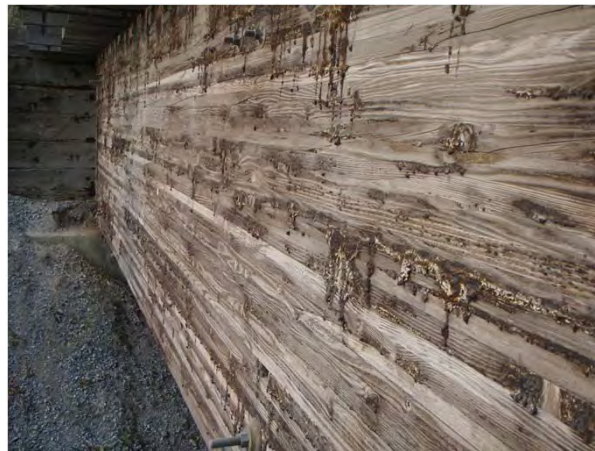
- Creosote leaching out, 75% of girder face exposed.
- Moderate weathering, numerous checks noted; similar to previous inspections.

| Tag Type | Check Start | Check End | Length (mm) | Max. Depth (mm) | Max. Width (mm) | Location (mm) | Condition |
|---|---|---|---|---|---|---|---|
| Existing | Camp end abut. | AE 25 | 4000 | 40 | - | 1000 mm from top of girder | Has not propagated. |
| New | Camp end abut. | AE 1272 | 14,500 | 70 | - | 450 mm from top of girder | Check propagated 2500 mm from AE 937. |
| Existing | - | AE 685 | - | 60 | - | 1000 mm from top of girder | Possible extension of AE 25. Cored below check, no rot noted. |
| Existing | Camp end abut. | AE 937 | 9000 | 70 | - | 450 mm from | Has not propagated. |

**Figure 1-12: Downstream face of span 4 - girder 2.**

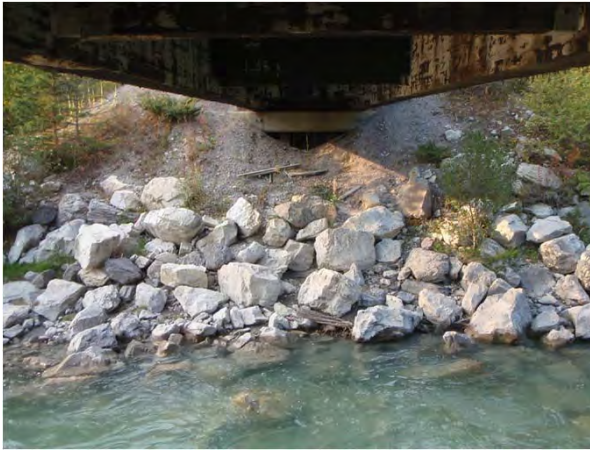
**Figure 1-13: Right end abutment.**

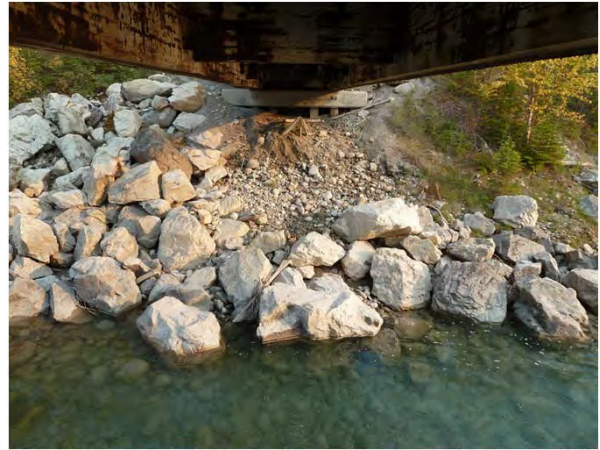
| Caps or Sills | Fair | Minor hairline cracking noted on the left end concrete cap above the tiebacks and between the middle piles. |

**Figure 1-14: Left end abutment.**

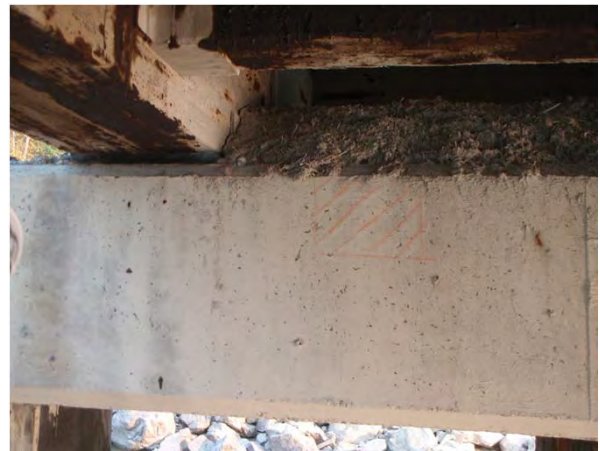
| Caps | Good | One small section of delamination (0.5 ft2) on the right end of the cap, not previously noted. |

**Figure 1-18: Pier 1 cap delamination.**

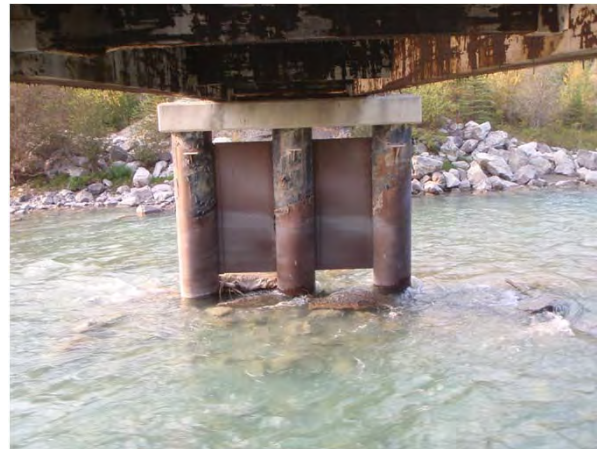
| Caps | Good | Debris is accumulating on top of concrete cap. |

**Figure 1-20: Pier 3 from left end.**
