## BRIDGE INSPECTION

**BRIDGE NO./NAME** N4-005: Akolkolex – Crawford FSR (19.0 km)

**Inspection Date:** September 22<sup>nd</sup>, 2012

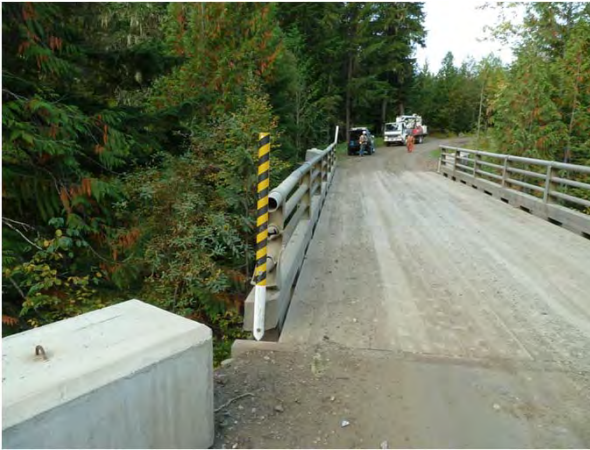
- The approaches are generally in good condition.
- Horizontal curve on both approaches limits visibility.
- Delineator missing on one corner, two other delineators point in the wrong direction.
- New concrete lock block barriers placed on all four corners.

| Delineator Missing Left | 1 | One sign missing, one points in the wrong direction. |

**Figure 1-7: Incorrect delineator, woods end downstream corner.**

| Items | Description | Priority |
|---|---|---|
| 1. | Install missing delineator and correctly align remaining delineators. | High |

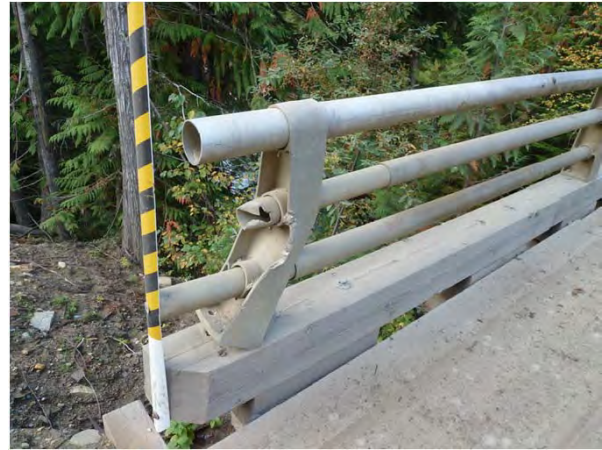
| Hand Rails/Walkouts | Poor | Steel parapets attached to the top of the timber curb rails, likely intended to function as pedestrian railings. Numerous sections of impact damage noted on the steel parapets. Steel parapets are poorly installed (directly on top of timber curb rail); missing rail splices noted. |

**Figure 1-8: Damaged end, post woods end downstream corner.**

| Items | Description | Priority |
|---|---|---|
| 2. | Repair steel parapets (pedestrian containment) as required. | Medium |

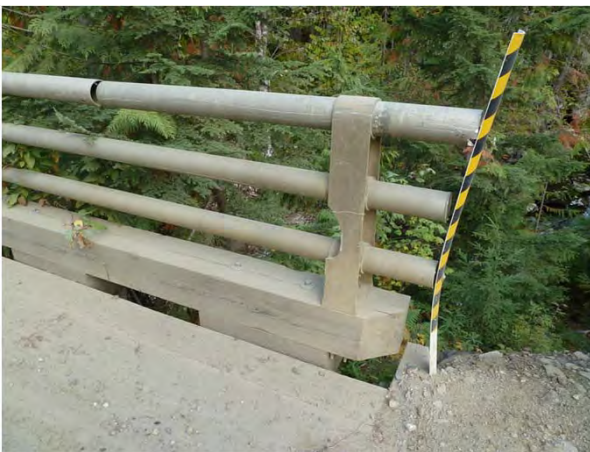
**Figure 1-9: Damaged post, woods end upstream corner.**

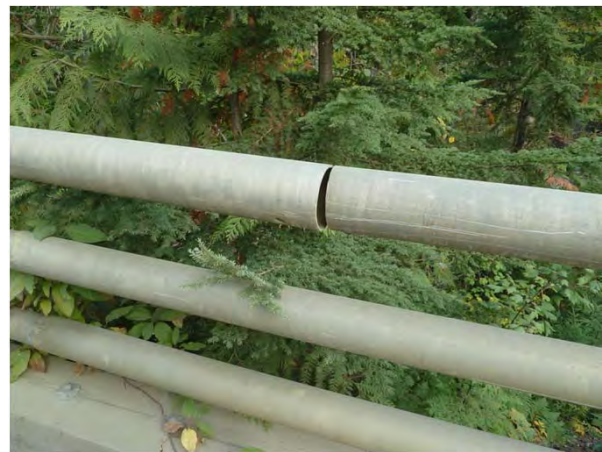
**Figure 1-10: Missing railing splice near woods end upstream side.**

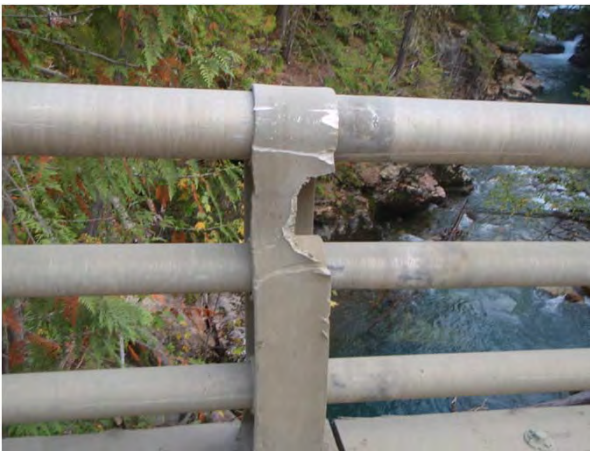
**Figure 1-11: Damaged post near camp end upstream corner.**

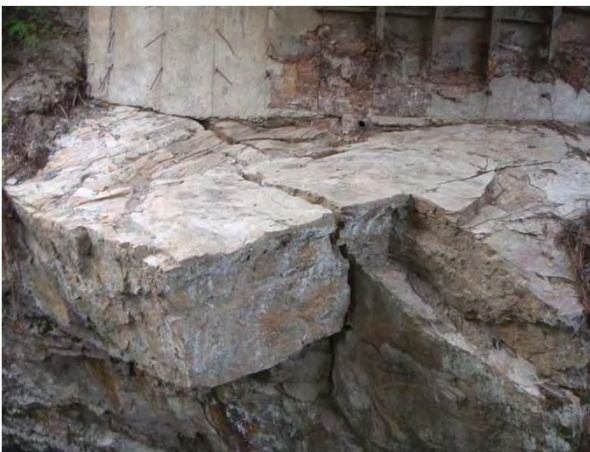
| Fill | Fair | Large fracture noted on bed rock in front of abutment, failure would affect the abutment stability. |

**Figure 1-15: Fractured rock below camp end abutment.**

1. Monitor bed rock stability at right end abutment.
2. Monitor condition of timber sills for further deterioration.

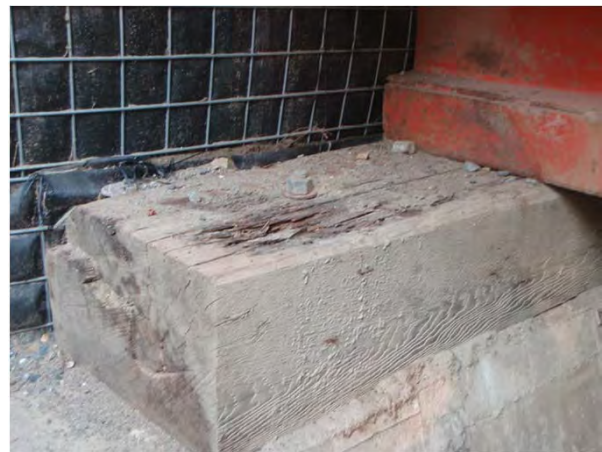
| Caps or Sills | Fair | Minor surface rot on the left end abutment timber sill under girders 1 and 4, and on the right end abutment timber sills under girder 4, no crushing noted. Debris accumulating on top of right end abutment timber sill. |

**Figure 1-16: Camp end downstream timber sill (note pocket of rot).**

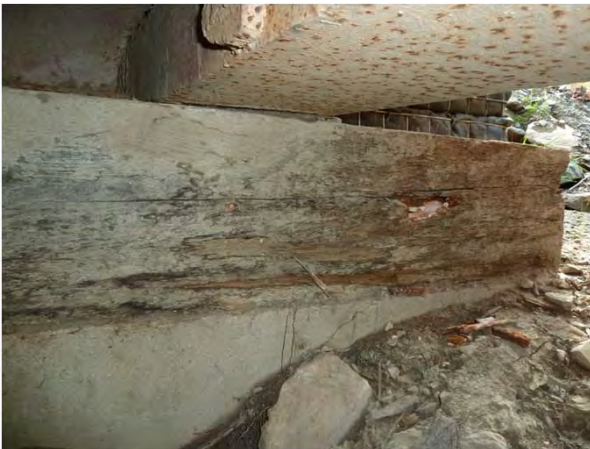
**Figure 1-19: Woods end upstream bearing (note sap rot on exposed portion of timber).**

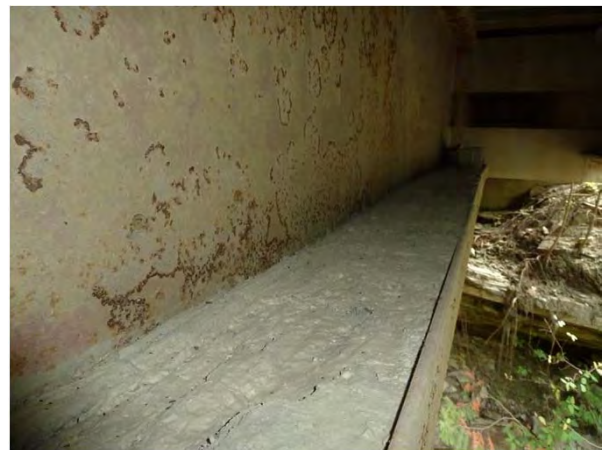
| Girders | Fair | Bottom flanges are covered in debris. Coating failing, minor corrosion observed. |

**Figure 1-22: Debris accumulation on bottom flange.**

| Items | Description | Priority |
|---|---|---|
| 4. | Remove debris from bottom flange of girders | Low |
