## BRIDGE INSPECTION REPORT

### GLULAM BRIDGE INSPECTION SUMMARY

Ministry of  
Forests and Range  
Forest Service

| | R3-074 | Bulkley River | | D. Chen/ M. Hanson | 1-Oct-13 | |

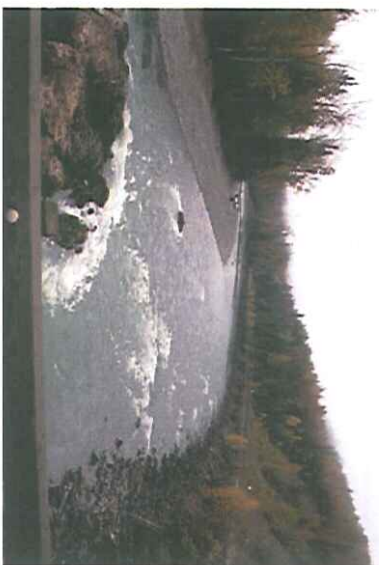
Figure 1-1: Looking upstream.

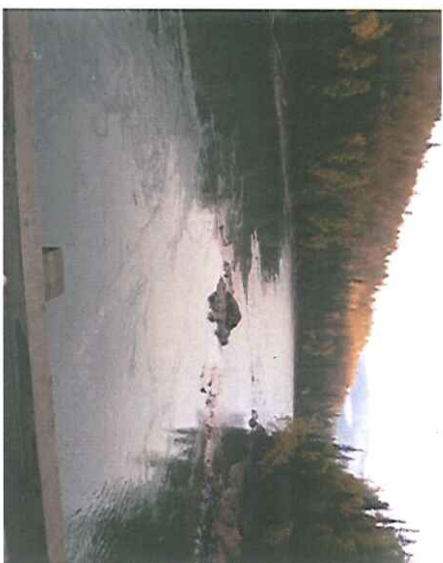
Figure 1-2: Looking downstream.

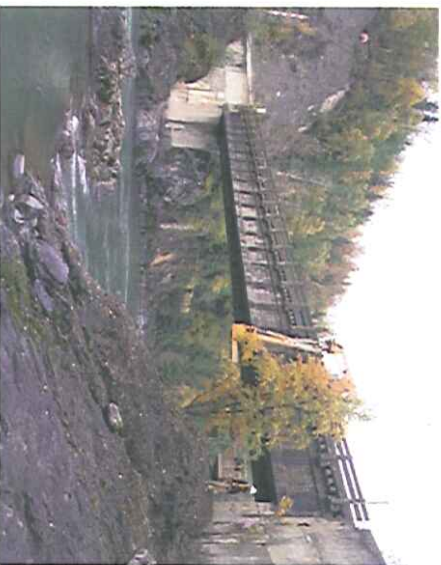
Figure 1-3: Upstream elevation.

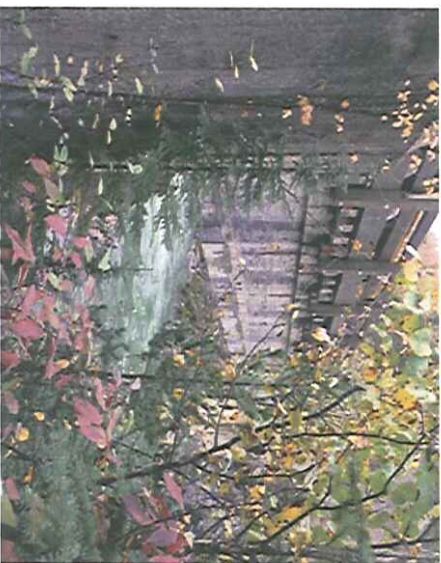
Figure 1-4: Downstream elevation.

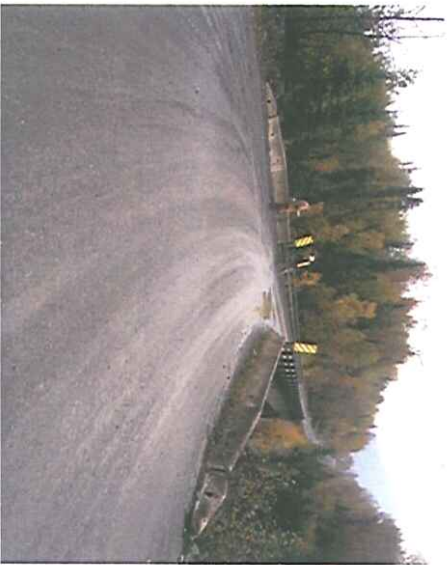
Figure 1-5: Left end approach.

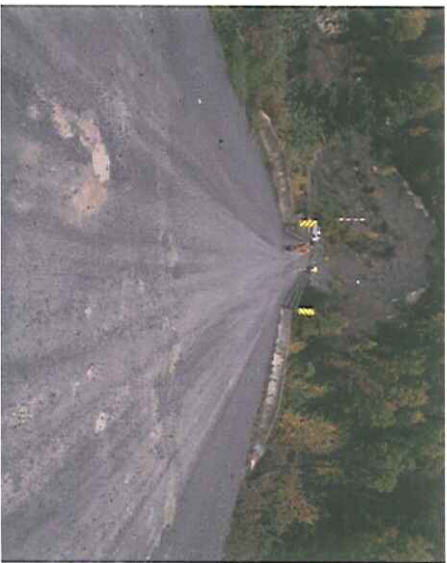
Figure 1-6: Right end approach.

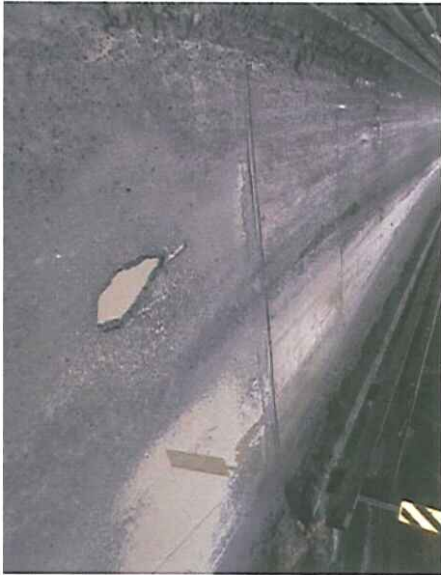
| BRIDGE ELEMENT | CONDITION | REMARKS |
|---|---|---|
| Approach Road | Fair | Minor potholes and rutting adjacent to abutment joint noted at both approaches; water ponding noted at left end approach. Left end approach joint armoring has failed. |

Figure 1-7: Left end approach joint - note pothole.

| No. | Description | Priority | Cost Estimate |
|---|---|---|---|
| 1 | Repair potholes in approaches (asphalt patch ~ 1 m2) | Medium | \$1,000 |

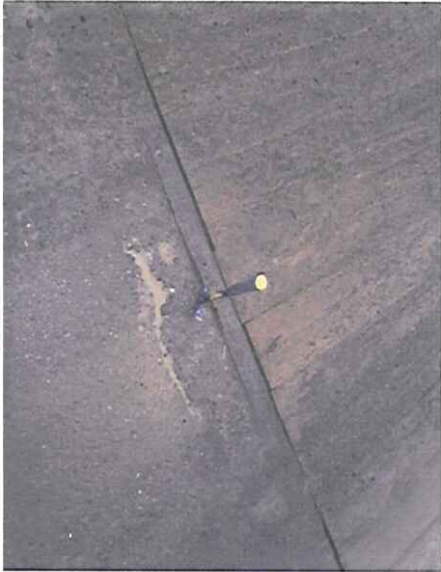
Figure 1-8: Left end approach joint - note failed armoring.

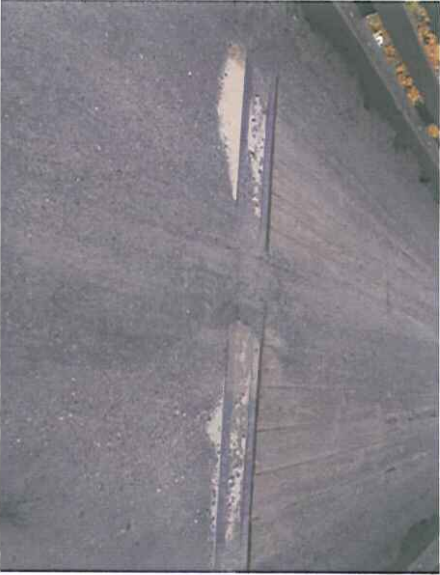
Figure 1-9: Right end approach joint.

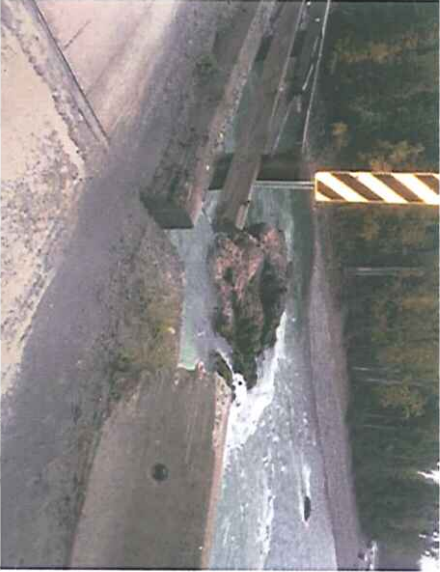
| BRIDGE ELEMENT | CONDITION | REMARKS |
|---|---|---|
| Barriers | Fair | Concrete barriers at left end approach are not aligned with the bridge curbs; upstream barrier has a 1 m gap to curb rail and the end section is not connected. Spalls noted on both left end barriers. Right end approach has concrete barriers on both sides; good condition. |

Figure 1-10: Gap at left end approach upstream barrier - note damaged handrail.

| No. | Description | Priority | Cost Estimate |
|---|---|---|---|
| 4 | Realign approach barriers | Low | \$1,500 |

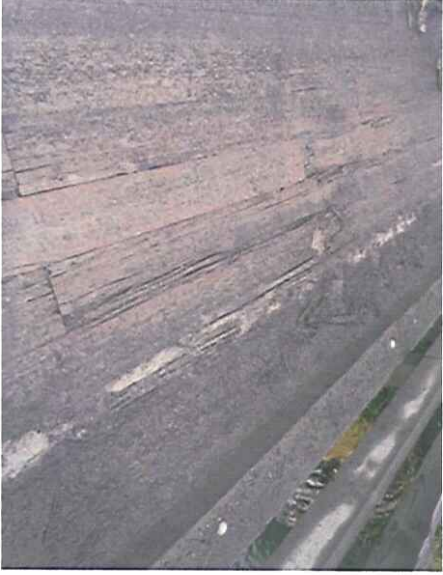
| BRIDGE ELEMENT | CONDITION | REMARKS |
|---|---|---|
| Timber Deck | Poor | Wearing planks are heavily worn and have numerous pockets of rot. Debris accumulation on deck surface. |

Figure 1-11: Typical wearing surface.

| No. | Description | Priority | Cost Estimate |
|---|---|---|---|
| 2 | Replace wearing planks (75mm x 250mm planks covering 4.3m x 46.2 m area) | Medium | \$15,000 |

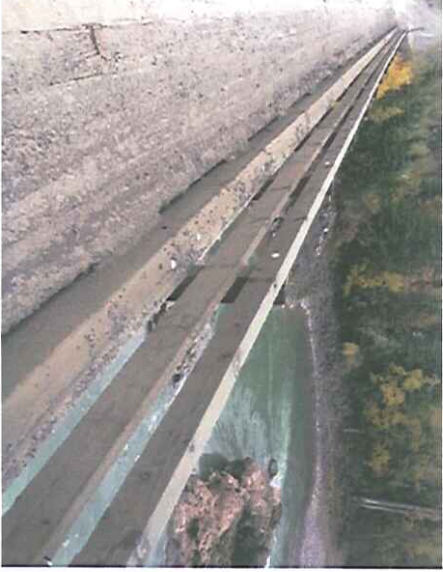
Figure 1-12: Upstream curb and hand rail.

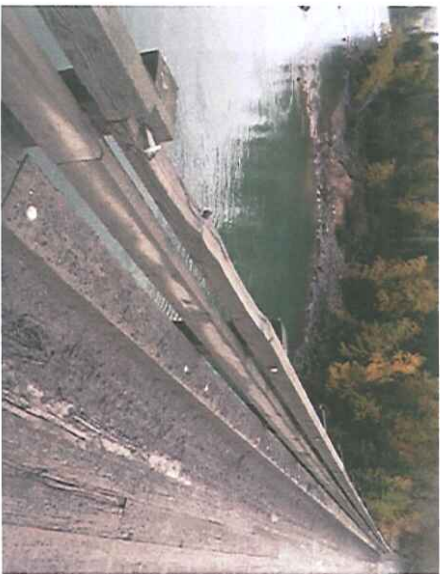
Figure 1-13: Downstream curb and hand rail.

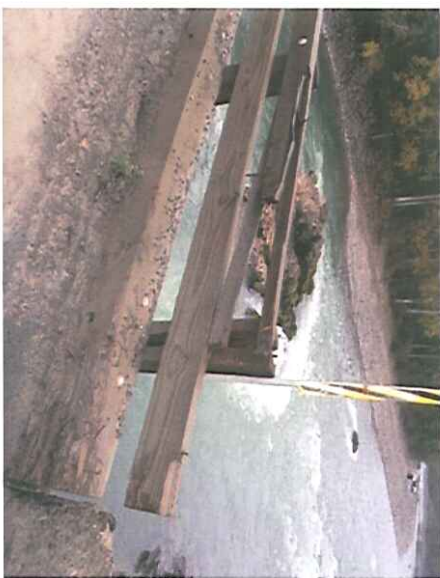
| BRIDGE ELEMENT | CONDITION | REMARKS |
|---|---|---|
| Hand Rails | Fair | Broken post and top plank on upstream handrail at left end of bridge; two top planks are broken on downstream handrail near left end of bridge. |

Figure 1-14: Damaged upstream handrail and post near left end.

| No. | Description | Priority | Cost Estimate |
|---|---|---|---|
| 3 | Replace 3 top handrail sections and 1 handrail post (100mm x 150 mm top planks, 200mm x 150 mm x 1450mm post) | Medium | \$2,000 |

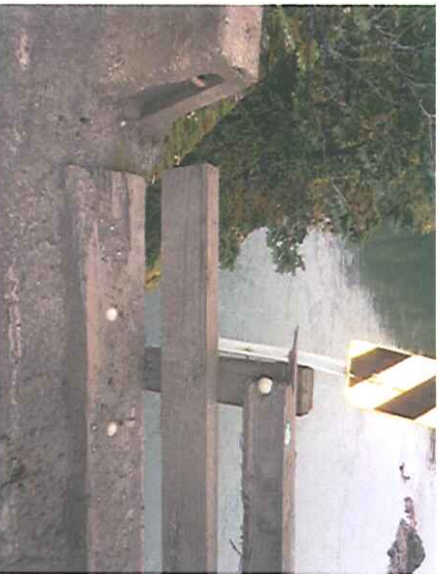
Figure 1-15: Damaged downstream handrail near left end.

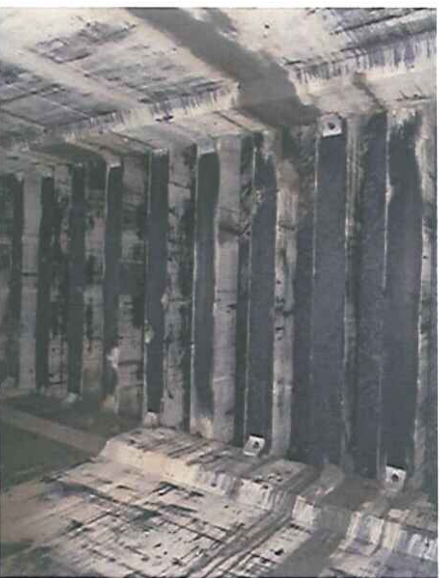
Figure 1-16: Typical underside of deck.

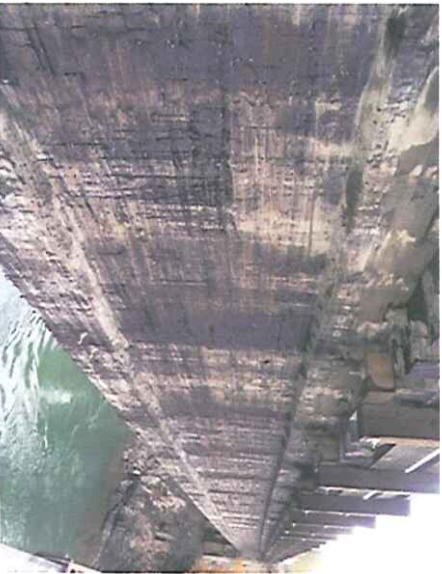
Figure 1-17: Girder 1 upstream face.

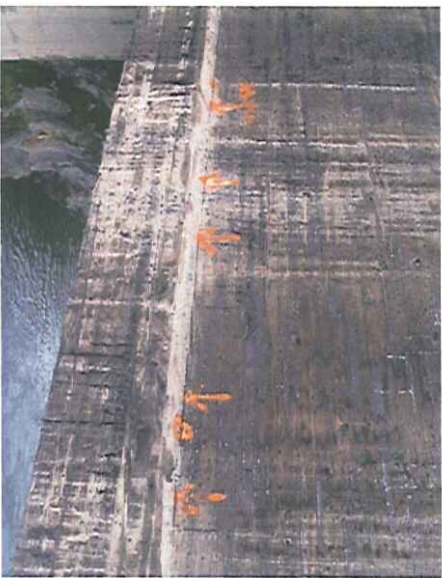
The bridge is generally in fair condition. Water and debris is continuing to penetrate girder 1 through check AE954 to AE1332 and check AE2261 to AE2260; however, no decay has been identified. The condition has not changed since the 2011 inspection. While we observed deterioration of the concrete abutment, there is no signs of instability.

Figure 1-18: Girder 1 u/s face - check along bottom flange near left abutment. See notes.

| No. | Description |
|---|---|
| 2 | Monitor condition of Girder 1 upstream face at checks along the bottom flange at the web joint where water and debris are accumulating. |

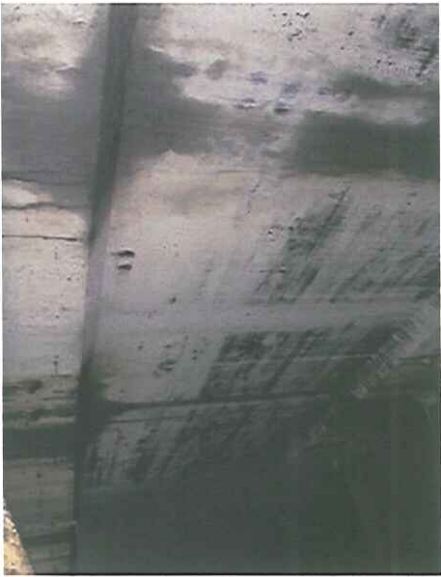
Figure 1-19: Girder 2 downstream face.

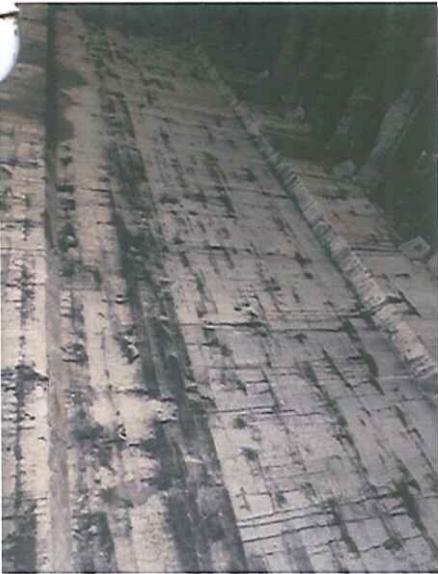
Figure 1-20: Girder 3 upstream face.

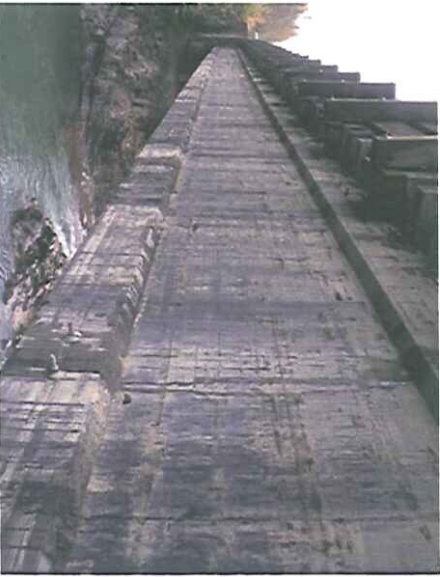
Figure 1-21: Girder 4 downstream face.

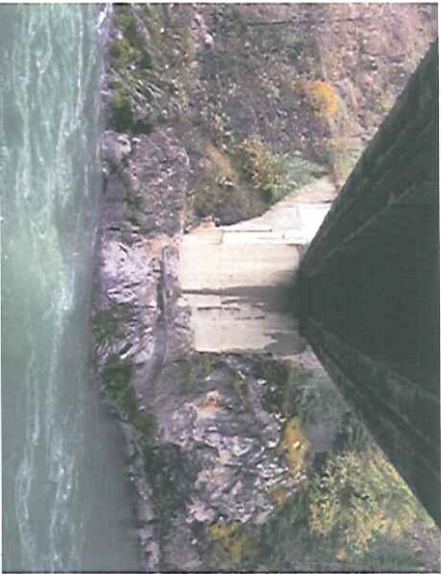
Figure 1-22: Left end abutment.

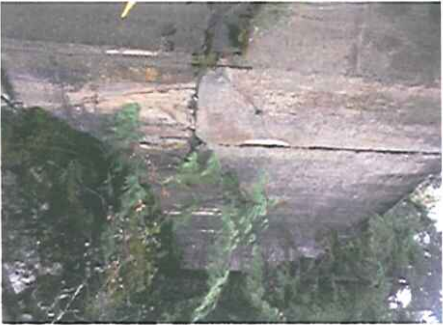
Figure 1-23: Left end abutment downstream wingwall.

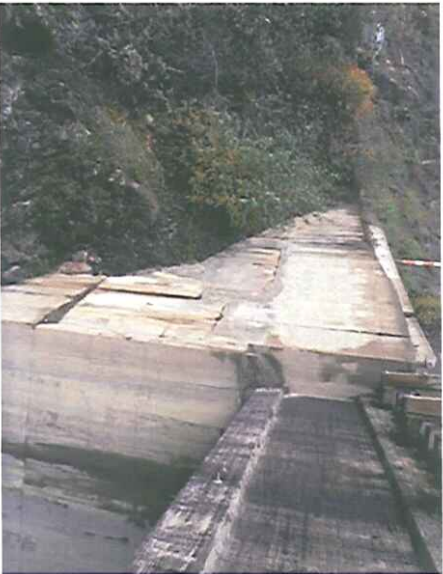
Figure 1-24: Left end abutment upstream wingwall - note concrete deterioration & water ingress.

| No. | Description |
|---|---|
| 1 | Monitor concrete deterioration on right end abutment and both wingwalls. |

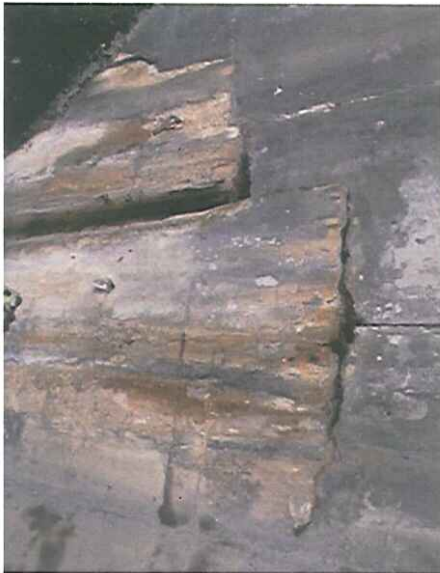
Figure 1-25: Left end abutment upstream wingwall.

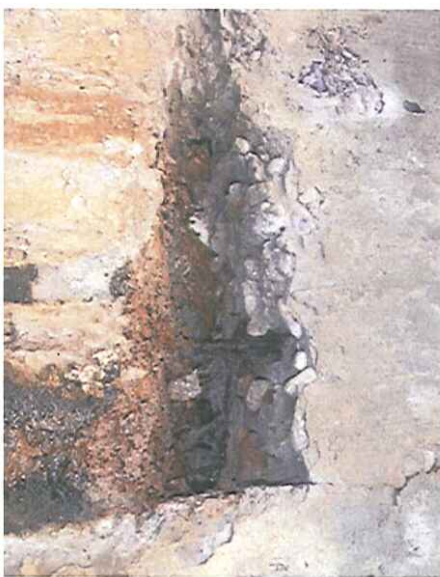
Figure 1-26: Spall with exposed rebar at left end abutment upstream wingwall.

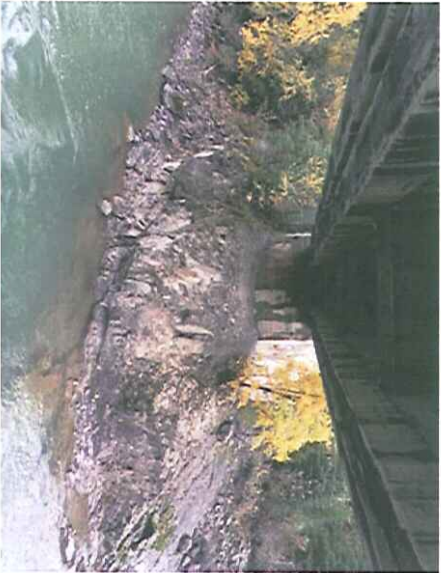
Figure 1-27: Right end abutment.

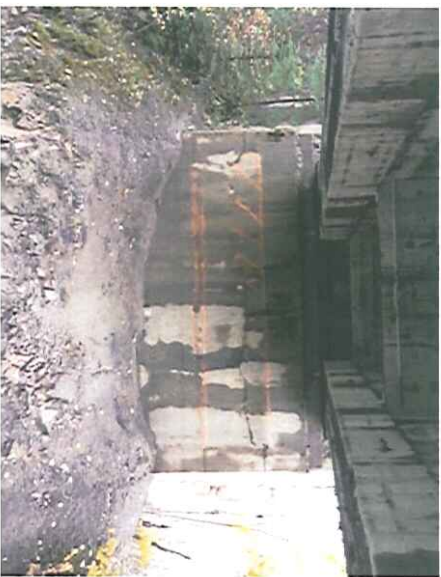
Figure 1-28: Front face of right end abutment. note delamination.

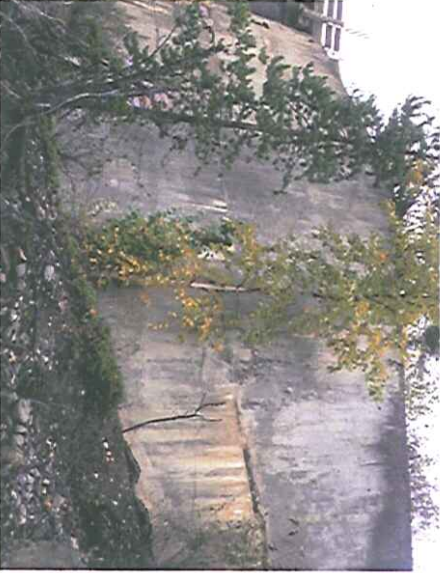
Figure 1-29: Right end abutment upstream wingwall - note concrete deterioration.
