## BRIDGE INSPECTION REPORT

### GLULAM BRIDGE INSPECTION SUMMARY

| Nadina | | Morice-Tahisa FSR | 9947.02 | 24.00 | Northing |
| | RS-032 | Nadina River | | D. Chen | 30-Sep-08 |

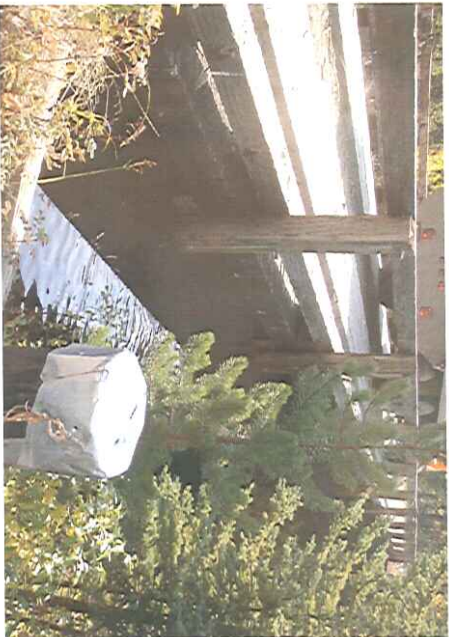
Figure 1-1: Upstream elevation.

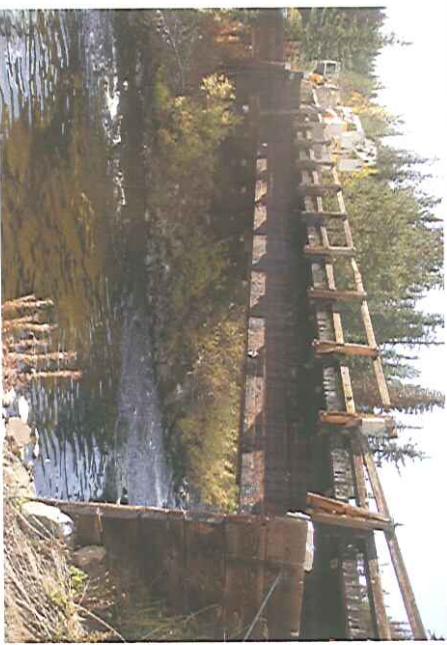
Figure 1-2: Downstream elevation.

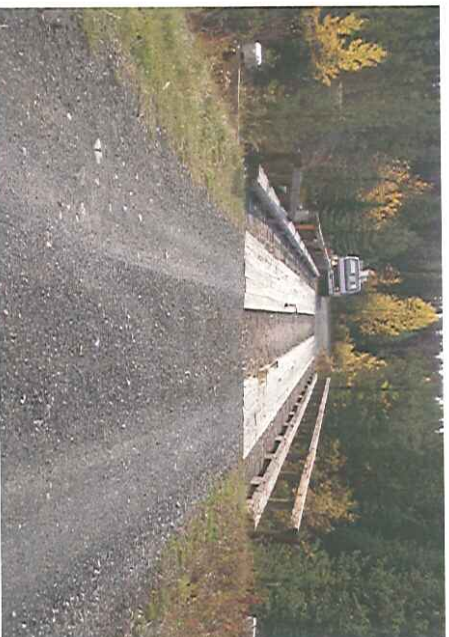
| BRIDGE ELEMENT | | CONDITION | | REMARKS | |
|---|--|---|--|---|--|
| Alignment | | Fair | | Horizontal curve at camp end approach. | |

Figure 1-3: Camp end approach.

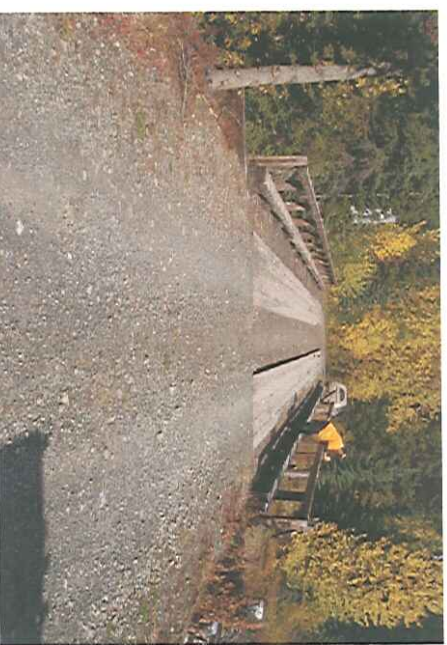
| BRIDGE ELEMENT | | CONDITION | | REMARKS | |
|---|--|---|--|---|--|
| Approach Road | | Fair | | Potholes at woods end approach. | |

Figure 1-4: Woods end approach.

| No. | Description | Priority | Cost Estimate |
|---|---|---|---|
| 5 | Regrade approaches. | Low | |

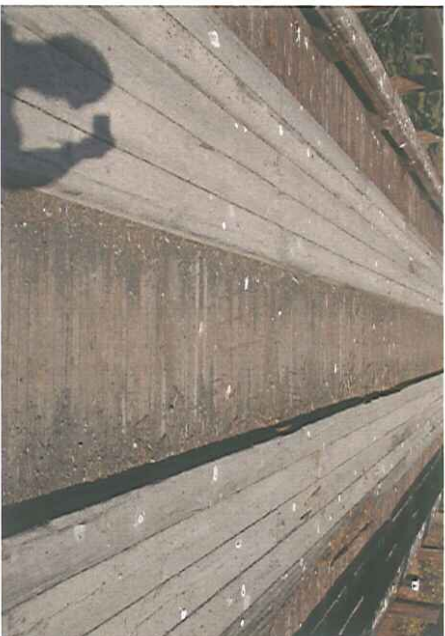
| BRIDGE ELEMENT | | CONDITION | | REMARKS | |
|---|--|---|--|---|--|
| Timber Deck | | Fair | | 5 - 200x100 untreated wearing planks along each wheel line; pockets of rot noted in 4 planks. 1 plank at camp end is rotten. Drilled, moist near underside. Woods debris and gravel accumulation on deck. | |

Figure 1-7: General deck condition.

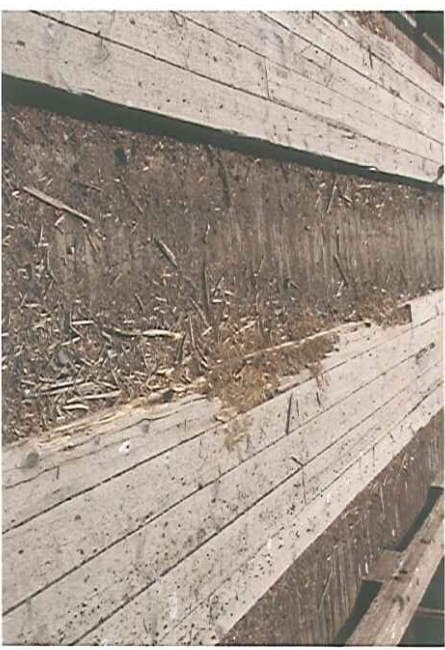
Figure 1-8: Rotten wearing deck plank.

| No. | Description | Priority | Cost Estimate |
|---|---|---|---|
| 3 | Replace 1 rotten wearing plank. | High | |

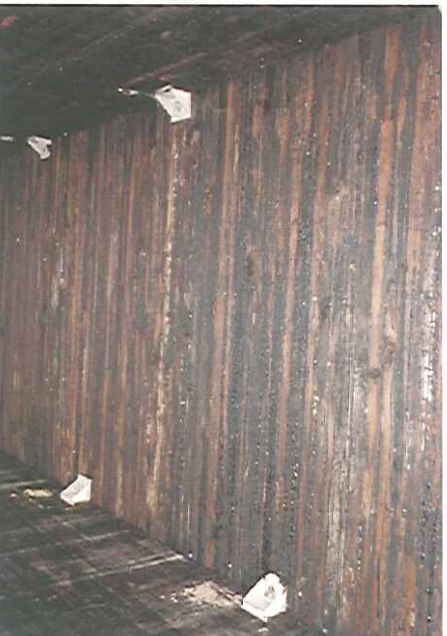
| BRIDGE ELEMENT | | CONDITION | | REMARKS | |
|---|--|---|--|---|--|
| Ties & Subdeck | | Fair | | 180mm thick creosote treated transversely laminated structural deck. Drilled at 3 locations, moist, initial stages of rot noted. | |

Figure 1-9: Typical condition underside of the transversely laminated structural deck.

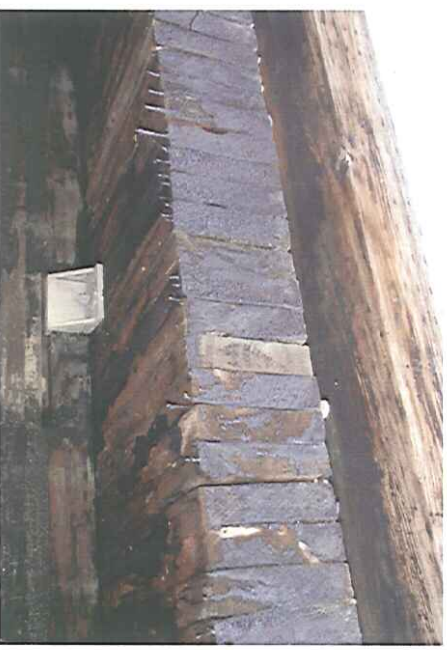
Figure 1-10: Typical edge condition of the transversely laminated structural deck.

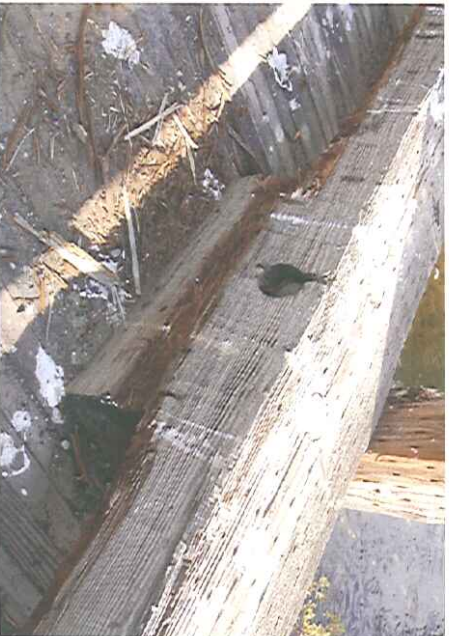
| BRIDGE ELEMENT | | CONDITION | | REMARKS | |
|---|--|---|--|---|--|
| Curbs & Blocks | | Fair | | Typical checking and rub damage along both curb rails. Curb rails do not conform to the current MoF standards. | |

Figure 1-11: Typical rub damage on curb rail, rot initiated.

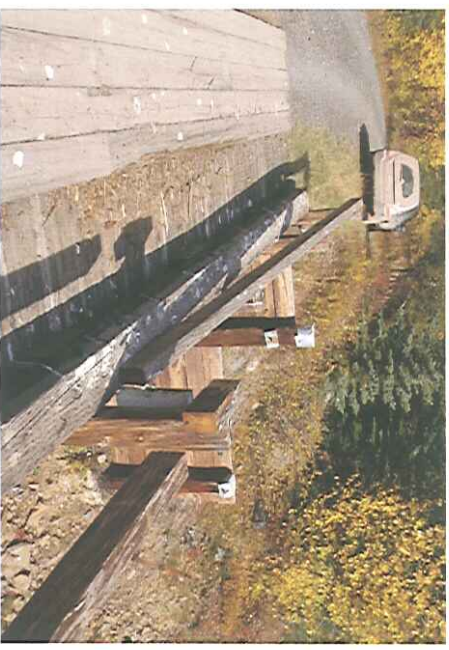
| BRIDGE ELEMENT | | CONDITION | | REMARKS | |
|---|--|---|--|---|--|
| Hand Rails | | Poor | | Minor damage noted on downstream hand rails. 1 rail near woods end broken. | |

Figure 1-12: Broken rail at camp end downstream corner.

| No. | Description | Priority | Cost Estimate |
|---|---|---|---|
| 4 | Repair broken downstream camp end hand rail. | High | |

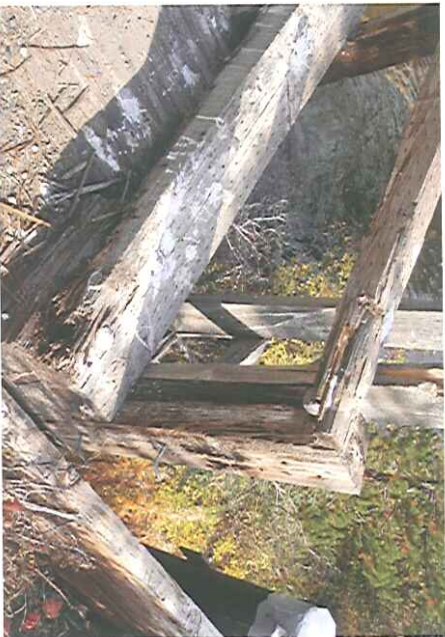
Figure 1-13: Damaged rail at woods end downstream corner.

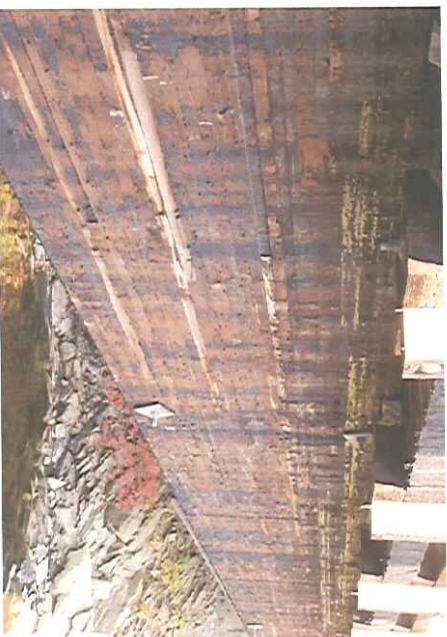
Figure 1-15: Downstream exterior girder.

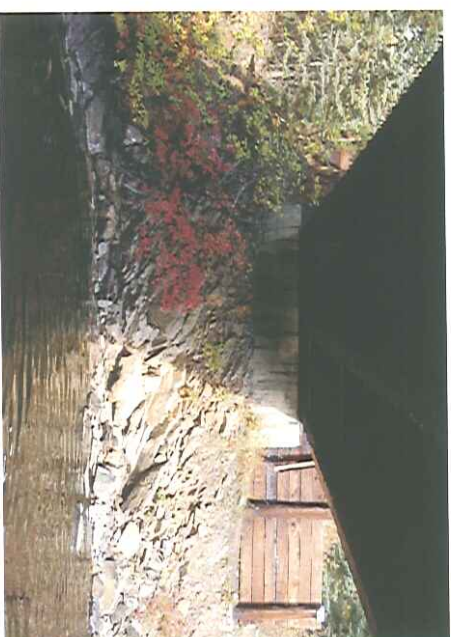
Figure 1-17: Camp end abutment.

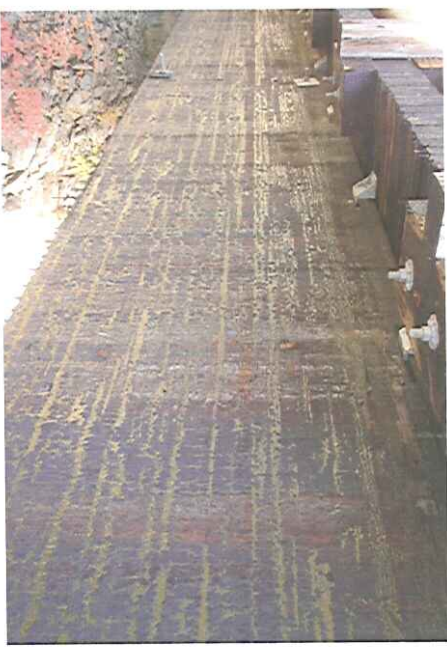
Figure 1-14: Upstream exterior girder.

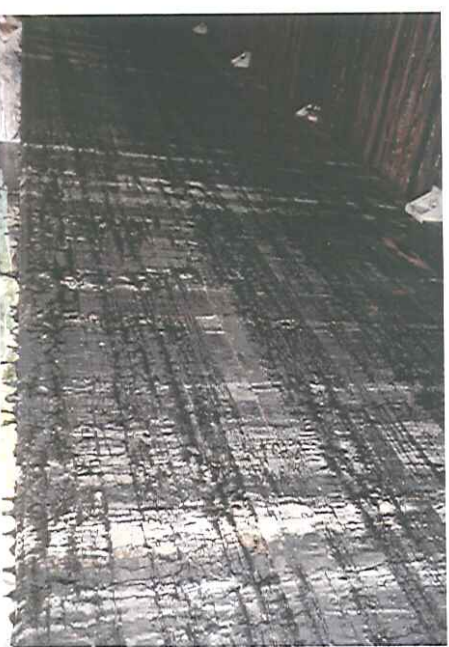
Figure 1-16: Typical unweathered face of girder.

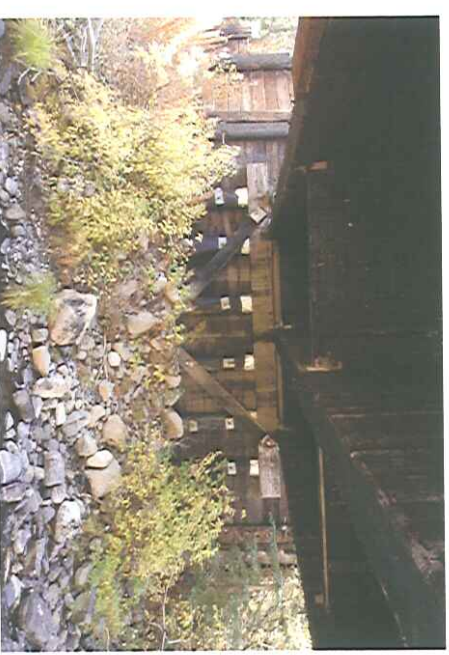
Figure 1-18: Woods end abutment.

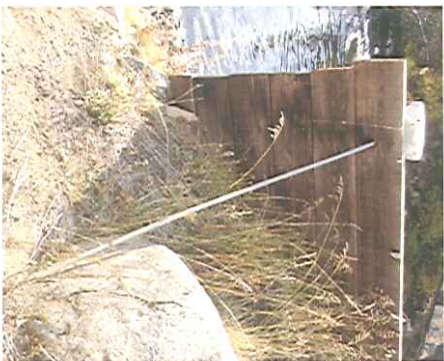
| | Fill | Fair | Ballast wall edge pile tieback exposed at approach embankments. | | | |
| | Fill | Fair | Wingwall edge pile tieback exposed at approach embankments. | | | |

Figure 1-19: Typical exposed pile tieback at abutments.

Monitor undermining of woods end ballast wall. Monitor condition of exposed wingwall edge pile tieback at both approach embankments. Monitor condition of exposed concrete base of camp end ballast wall downstream edge pile. Consider installing guide rails at approaches. Consider upgrading curb rails to conform with the current MoF standards.

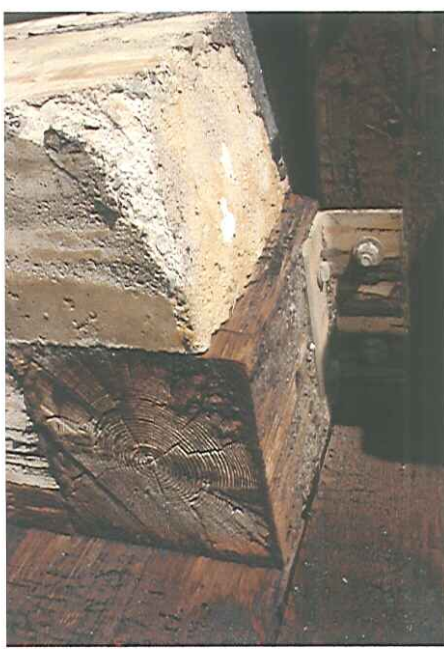
| ABUTMENT CAMP END | Sill | Good | Creosote treated timber sill, minor end split noted on the downstream edge. | | | |

Figure 1-20: Camp end abutment timber sill.

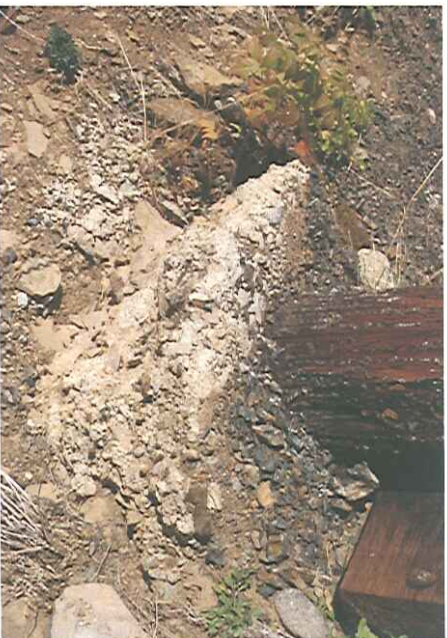
| | Piles / Posts | Good | 3 creosote treated soldier piles (1 u/s, 2 d/s). Piles are sound, drilled 1. Concrete base of downstream edge pile exposed, condition has not changed since last inspection. | | | |

Figure 1-21: Exposed concrete base, camp end abutment downstream ballast wall pile.

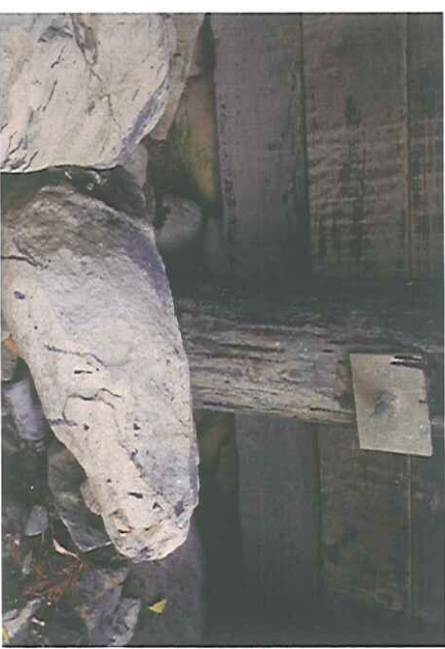
| | Bulkhead/Wingwalls | Fair | Creosote treated timber ballast wall and wingwalls. Minor undermining of ballast wall. | | | |

Figure 1-22: Minor undermining of the woods end abutment ballast wall.
