## BRIDGE INSPECTION

**BRIDGE NO./NAME** SI - 3041: Mt. Brenton FSR (2.00 KM)

**Inspection Date:** October 31<sup>st</sup> 2012

| Structure # | Crossing Name | Forest Service Road | User km | CBR km | | | |

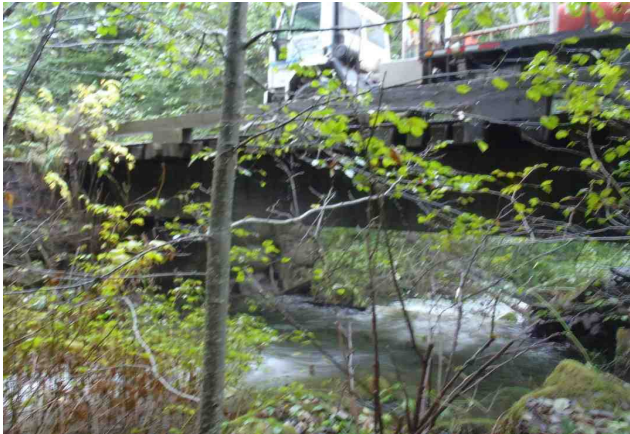
Figure 1-1: Upstream elevation.

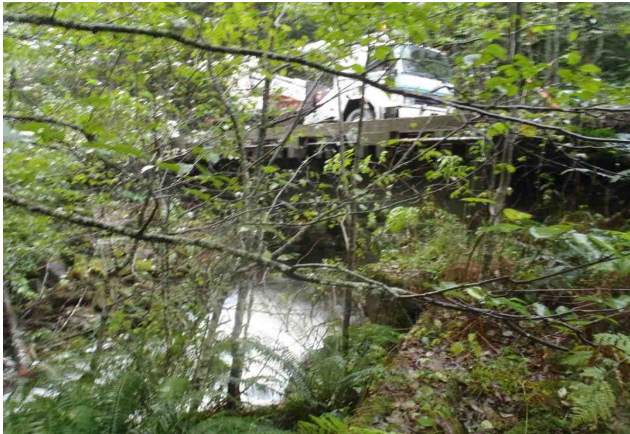
Figure 1-2: Downstream elevation.

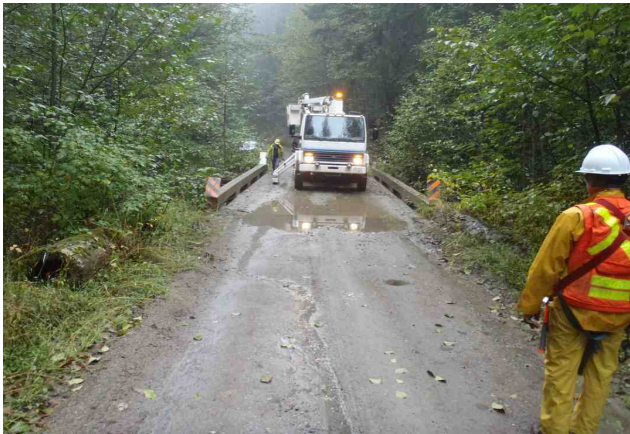
Figure 1-3: Looking towards camp end.

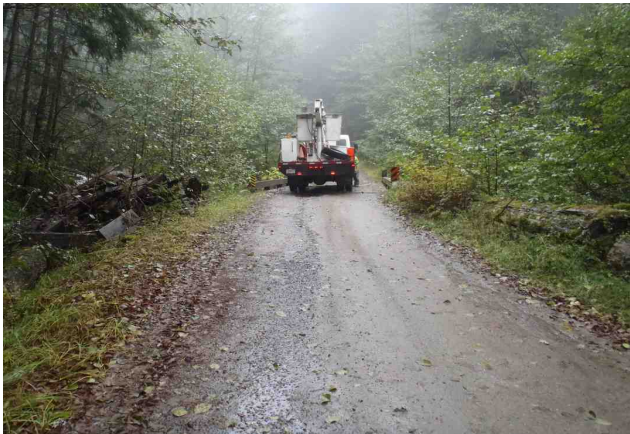
Figure 1-4: Looking towards woods end.

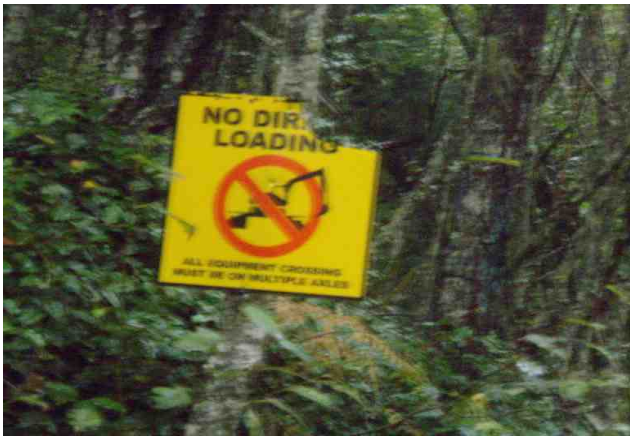
Figure 1-5: Camp end approach sign.

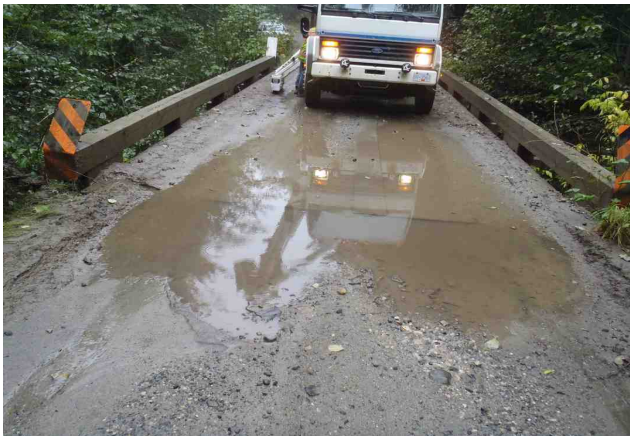
During the inspection, we noted significant water pooling on the wearing planks near woods end (approximately 1/3 of span length). Water accumulation would likely speed up the rate of decay in timber deck components and result in reduced service life of the bridge deck. Therefore, we recommend the Ministry to consider re-grading the approach roadway to allow better drainage of bridge deck.

| Road Surface | Fair | Approach road surface is lower than deck surface, water pooling and potholes were noted adjacent to deck. |

Figure 1-6: Woods end approach joint, water pooling.

| Items | Description | Priority |
|---|---|---|
| 2. | Re-grade approach roadways. | Low |

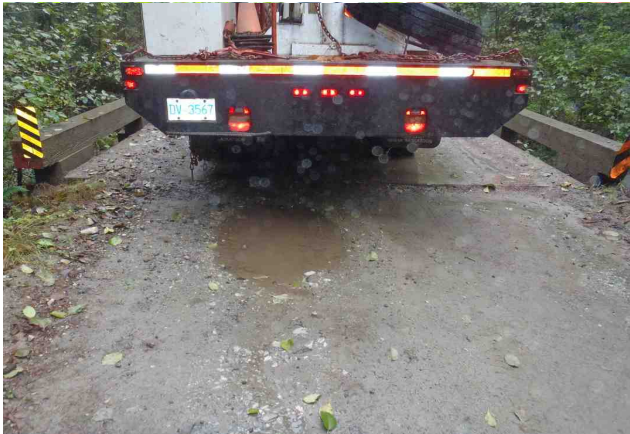
Figure 1-7: Camp end approach joint.

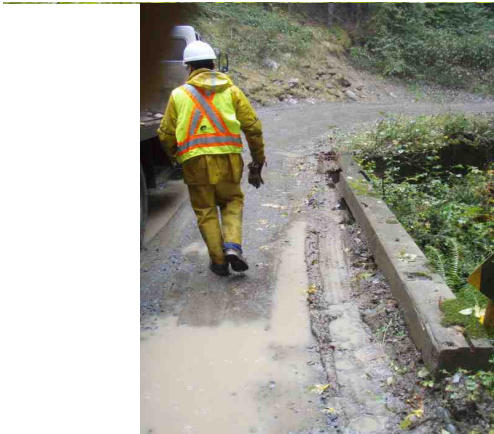
- Minor debris accumulation on wearing planks. Water pooling was noted on the wearing planks near woods end (approximately 1/3 of span length).
- Ties are generally in good condition, no rot was found.
- Curbs are generally in good condition, no rot was found.

Figure 1-8: Typical deck and curb rail condition.

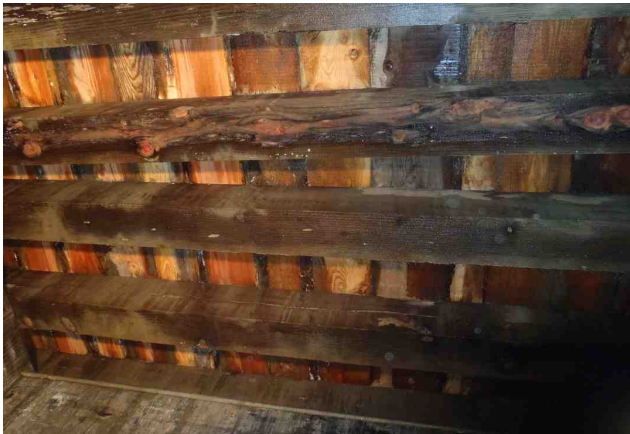
Figure 1-9: Typical deck soffit condition.

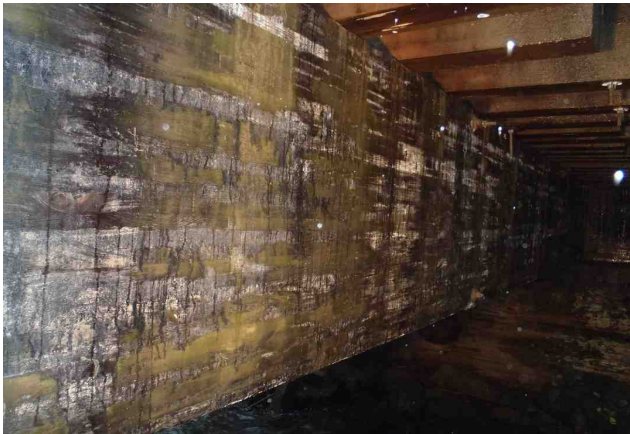
- Creosote leaching; visible creosote on > 75 % of the girder face.
- Minor checking, no significant check noted.

Figure 1-10: Upstream girder exterior face.

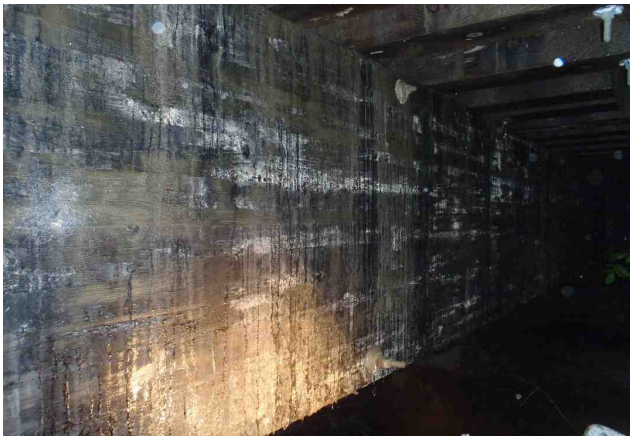
- Creosote leaching; visible creosote on > 75 % of the girder face.
- Minor checking, no significant check noted.

Figure 1-11: Downstream girder exterior face.

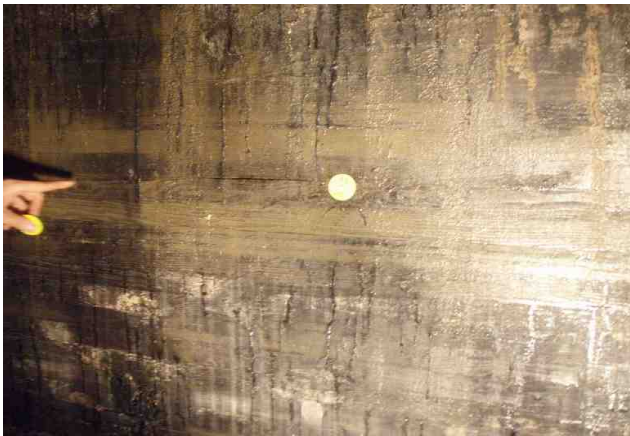
| Tag Type | Check Start | Check End | Length (mm) | Max. Depth (mm) | Max. Width (mm) | Location (mm) | Condition |
|---|---|---|---|---|---|---|---|
| New | AE2331 | AE2339 | 1200 | 90 | | 530 from top | |
| New | AE2332 | Camp End Abut. | 1100 | 60 | | 410 from top | |

Figure 1-12: New check tagged on downstream girder exterior face.

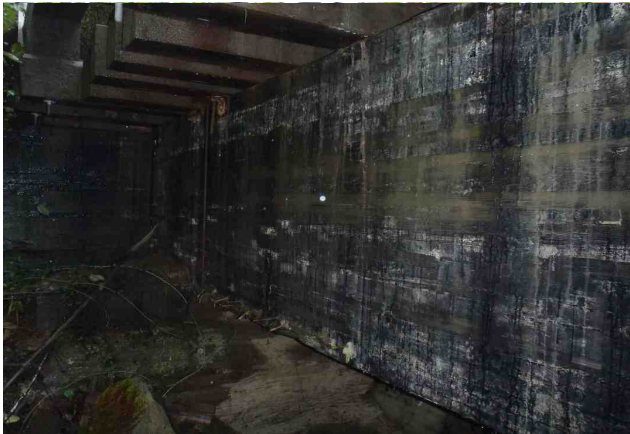
- Glulam girders appear to be recycled from an older bridge.
- Downstream girder has a steel tie bracket installed at approximately 1000 mm from the camp end abutment.
- A number of epoxy injection tubes were located at approximately 75 mm from the bottom of the downstream girder (on both faces), extending 2500 mm from the camp end abutment.

Figure 1-13: Epoxy injection tubes on the exterior face of downstream girder near camp end.

1. Monitor condition of the glulam girders.

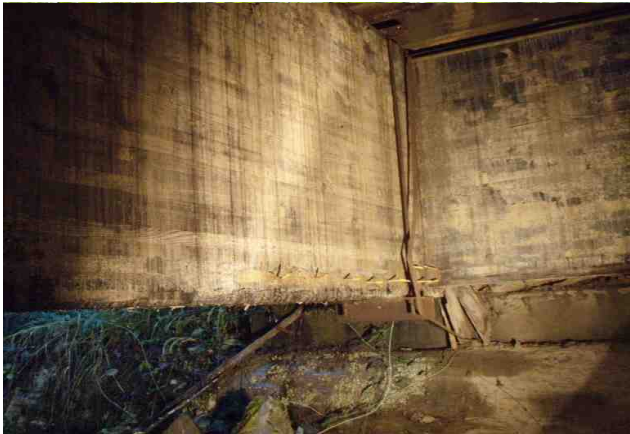
Figure 1-14: Epoxy injection tubes on the interior face of downstream girder near camp end.

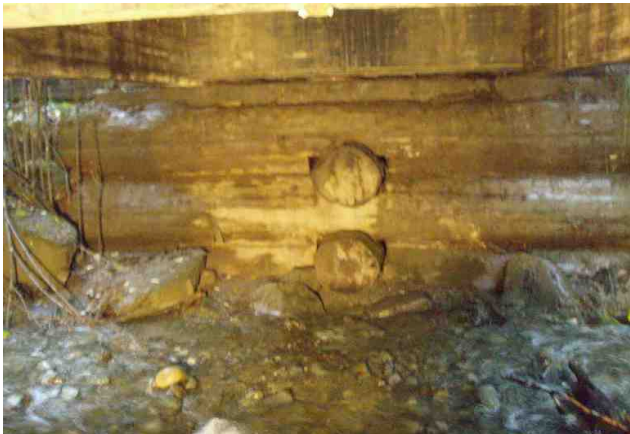
- Generally in good condition.
- No signs of decay noted on the creosote treated timber sill.
- No significant deterioration on crib logs.

Figure 1-15: Woods end log crib.

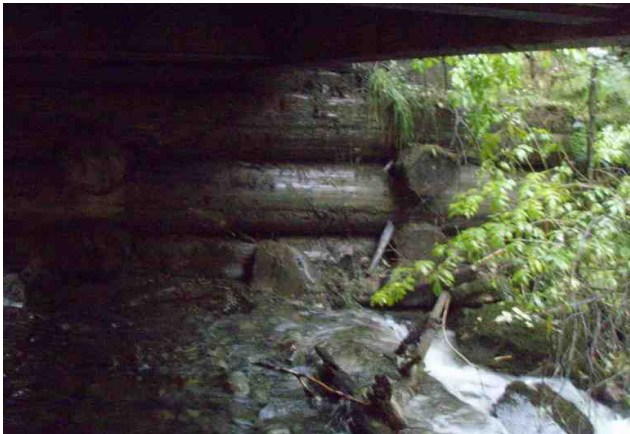
Figure 1-16: Woods end log crib downstream end.

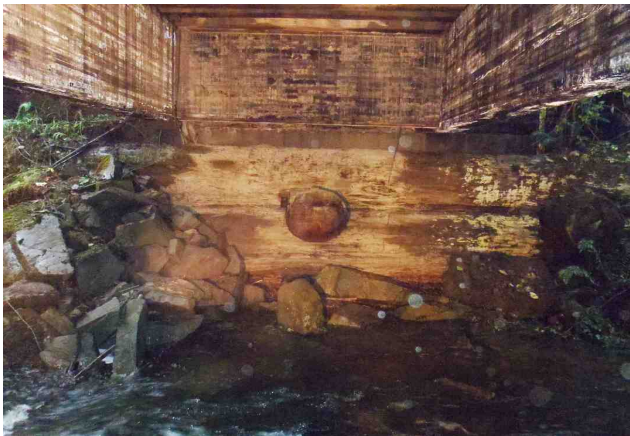
Figure 1-17: Camp end log crib.
