| Structure # | Crossing Name | Forest Service Road | User km | CBR km | | |
|---|---|---|---|---|--|--|
| SI-5635 | Kennedy River | Sproat Lake FSR | 0.5 | 0.5 | | |

| <div>Associated<br/>Engineering</div> | | <div>GLOBAL PERSPECTIVE.<br/>LOCAL FOCUS.</div> | | <div>BRIDGE INSPECTION REPORT</div> <div>BRIDGE INSPECTION PHOTOS</div> | | <div>BRITISH COLUMBIA</div> <div>Ministry of<br/>Forests, Lands and<br/>Natural Resource Operations</div> | |

October 3, 2011

**Re: CONDITION INSPECTION AND LOAD RATING OF THE KENNEDY RIVER BRIDGE**

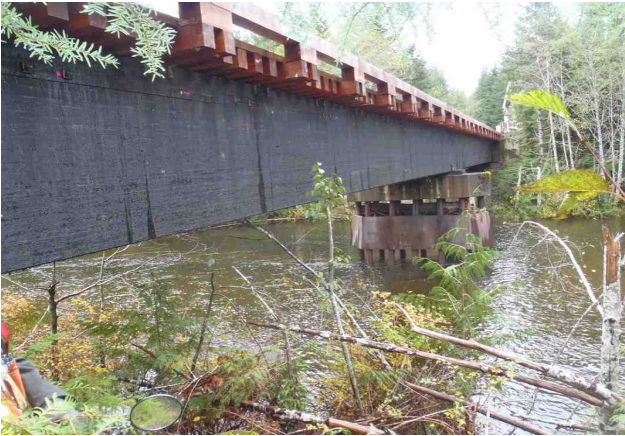
**Figure 1-1: Upstream elevation.**

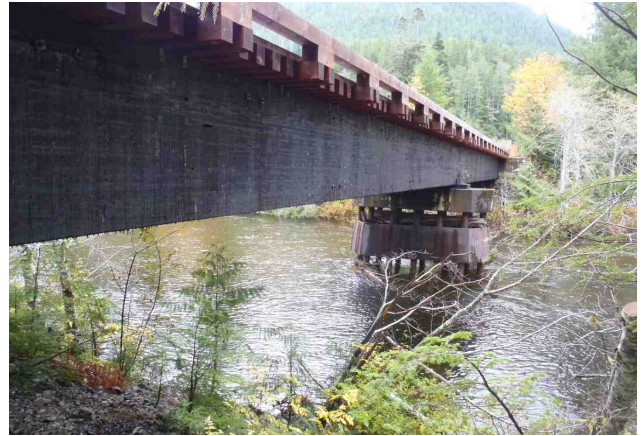
**Figure 1-2: Downstream elevation.**

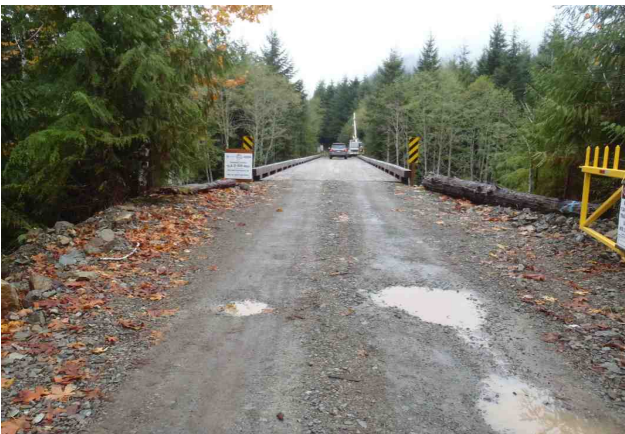
**Figure 1-3: Looking towards woods end.**

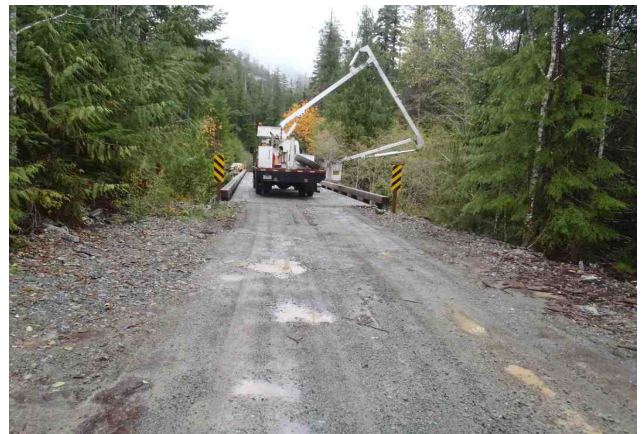
**Figure 1-4: Looking towards camp end.**

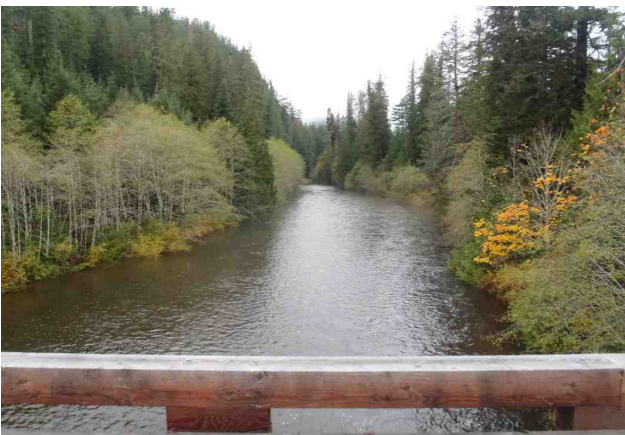
**Figure 1-5: Looking upstream.**

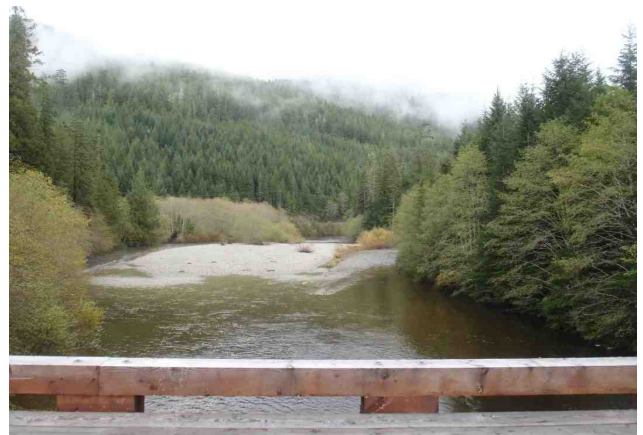
**Figure 1-6: Looking downstream.**

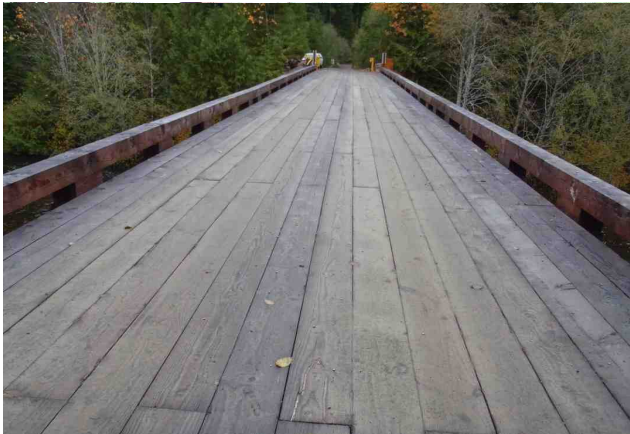
Figure 1-7: General deck condition.

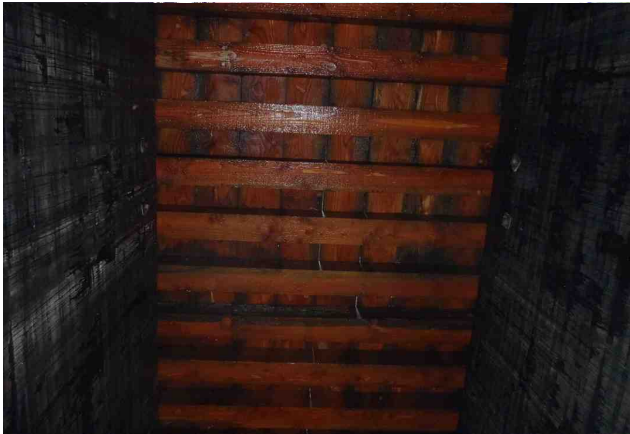
Figure 1-8: Typical deck soffit condition.

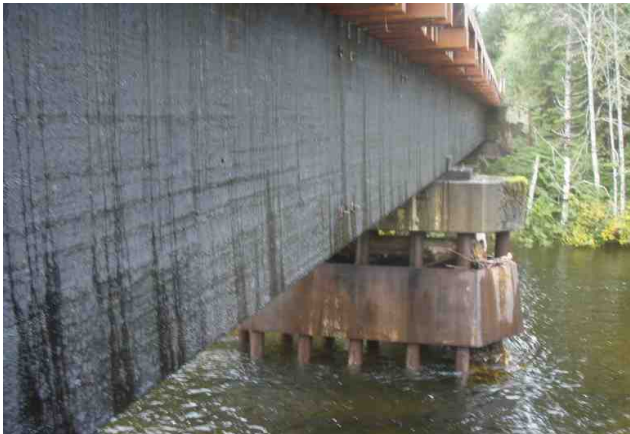
Figure 1-9: Span 1 girder 1 upstream face.

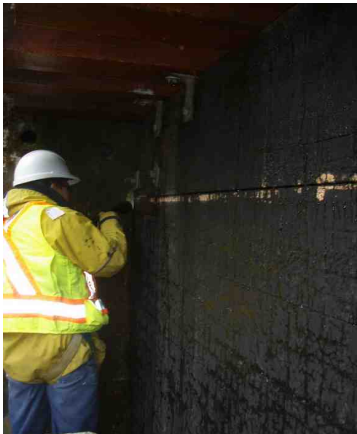
Figure 1-10: Span 1 girder 1 upstream face; end check at camp end.

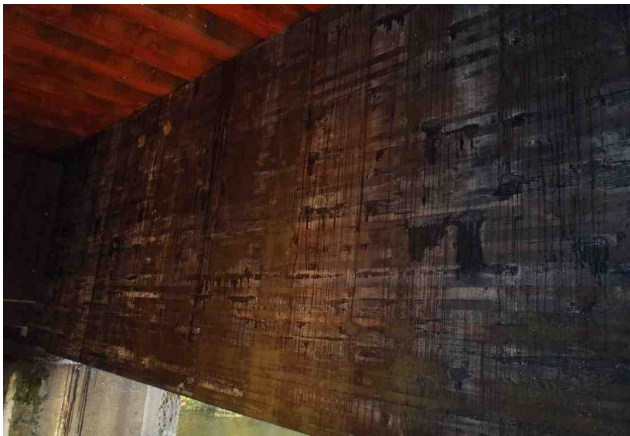
Figure 1-11: Span 1 girder 2 downstream face.

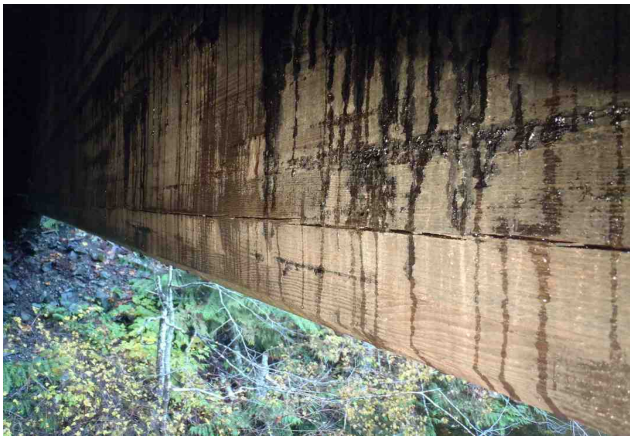
Figure 1-12: Span 1 girder 3 upstream face; check near bottom of girder.

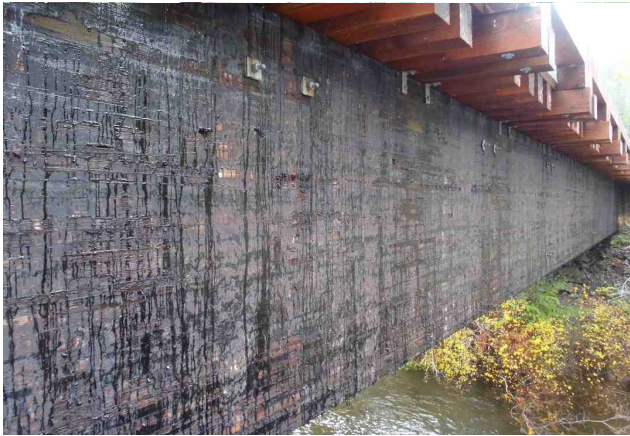
Figure 1-13: Span 1 girder 4 downstream face.

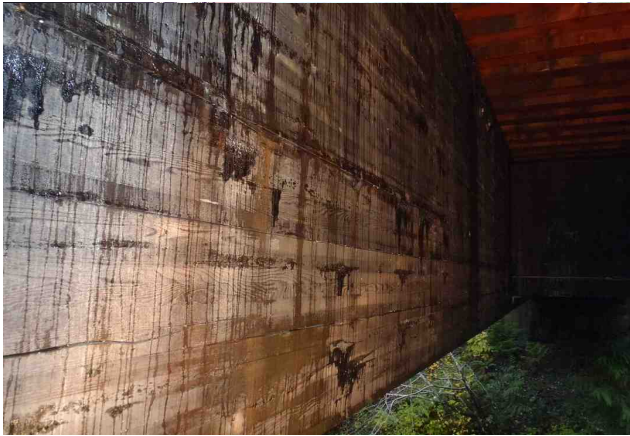
Figure 1-14: Span 2 girder 3 upstream face near pier. (AE2329, AE2341, AE2328)

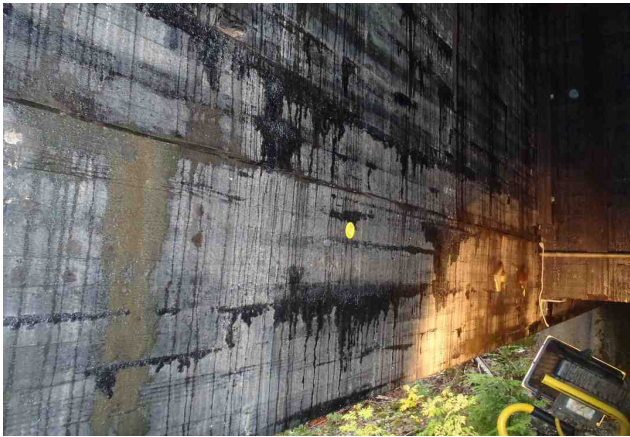
Figure 1-15: Span 2 girder 3 upstream face near mid-span. (AE2301-AE2302)

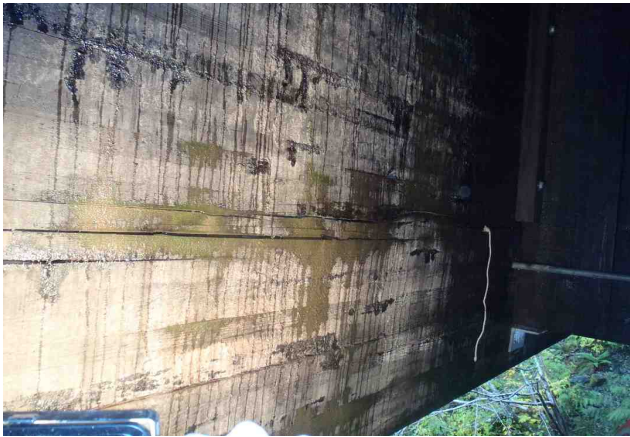
Figure 1-16: Span 2 girder 3 upstream face near woods end.

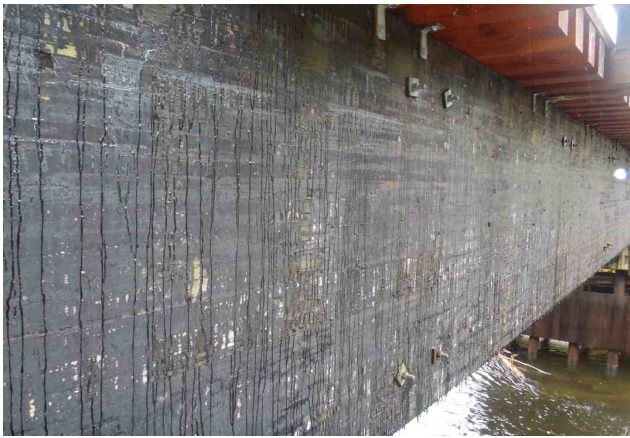
Figure 1-17: Span 2 girder 4 downstream face.

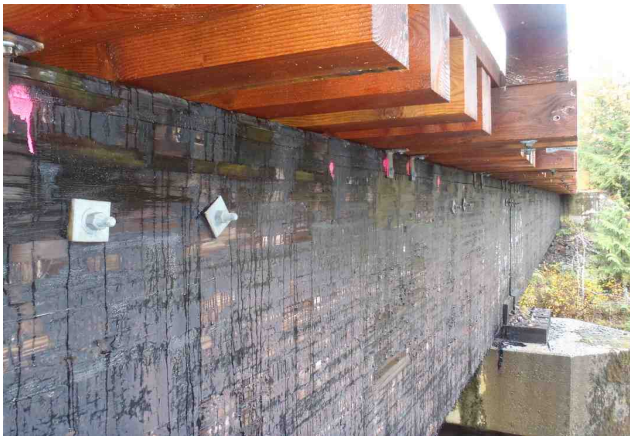
Figure 1-18: Span 2 girder 4 downstream face; longitudinal checks along the top of girder.

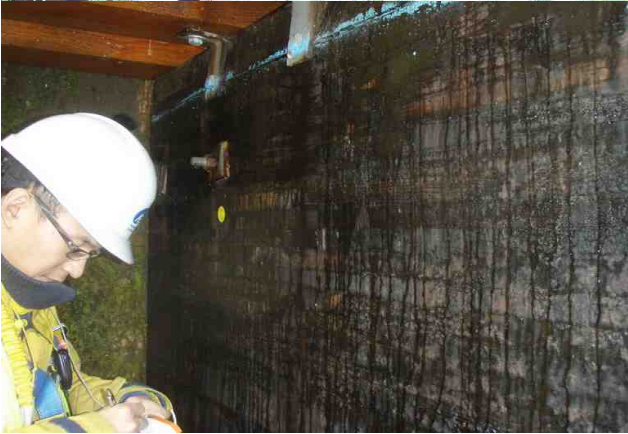
Figure 1-19: Span 2 girder 4 downstream face; end check at woods end.

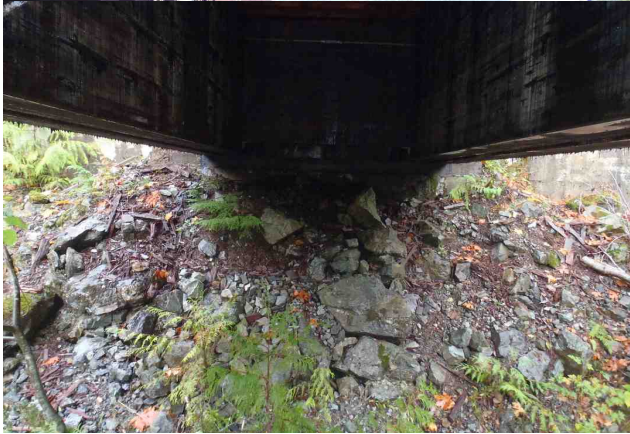
Figure 1-20: Camp end abutment.

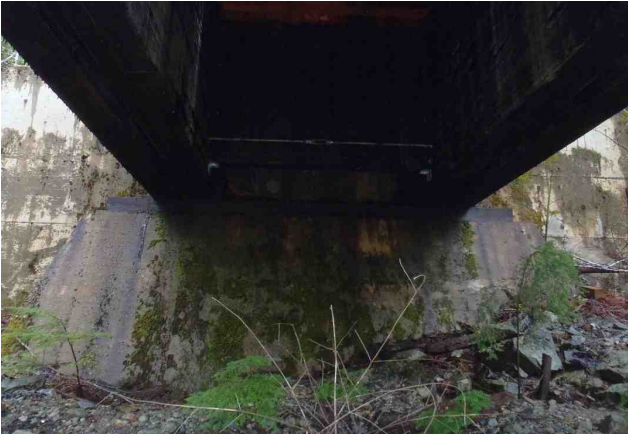
Figure 1-21: Woods end abutment.

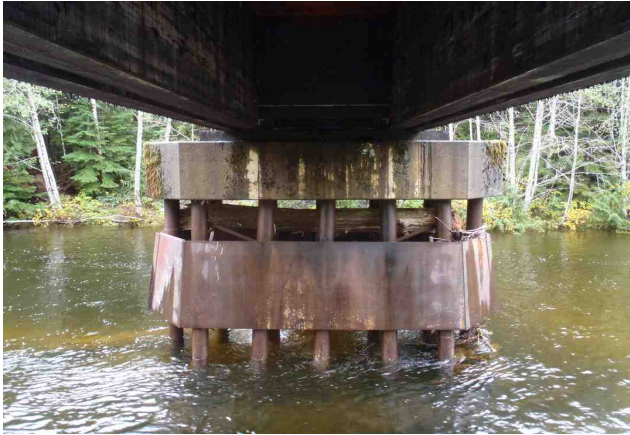
Figure 1-22: Pier camp end face.

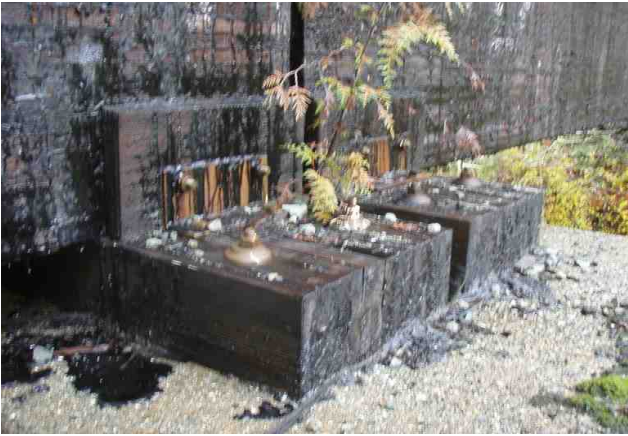
Figure 1-23: Timber sills on pier.

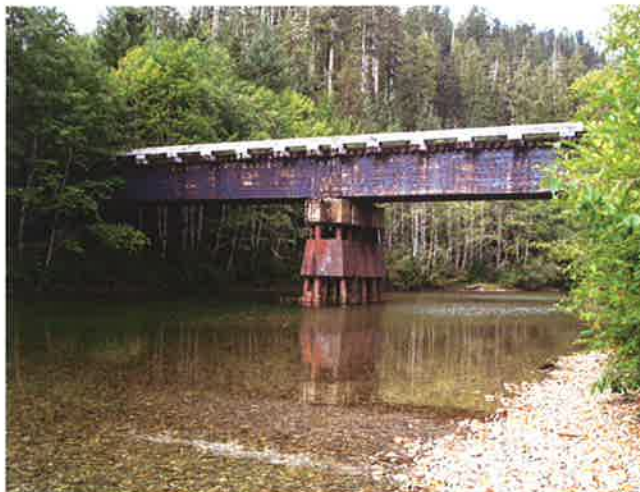
**Photo 1 - Downstream Elevation**

At the time of the inspection, access to the bridge was only available to the areas adjacent to the abutments (see **photo 1**).

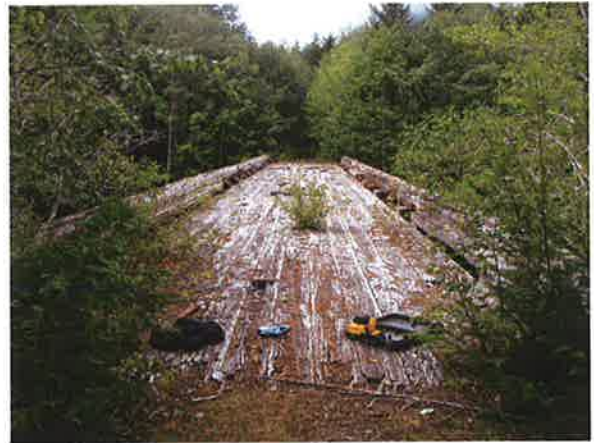
Photo 2 - Typical Condition of Bridge Deck

The bridge comprises two 27.4 m simple spans and a 14 ft timber deck. The Glulam girders are grouped in two pairs at 10-ft centres. The bridge deck, curbs and cross-ties are in very poor condition (see **photo 2**).

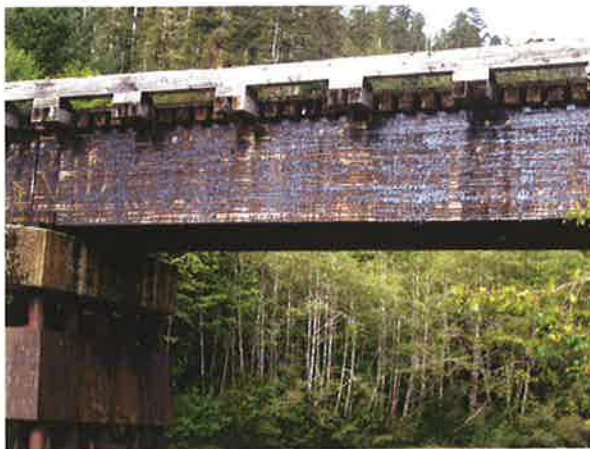
Photo 3 - Typical Condition of  
Exterior Girder

The exterior faces of the upstream and downstream girders were weathered with the creosote leaching out (see **photo 3**). There is limited weathering and checking on the interior faces. We observed cracks and checks of various sizes near the abutments. We also observed a significant crack on the upstream exterior girder near the camp end abutment about 400 mm from the girder top (see **photo 4**). This crack measures 5 mm wide, 170 mm deep and approximately 8 m long. We cored the girder just below the crack and detected no rot.

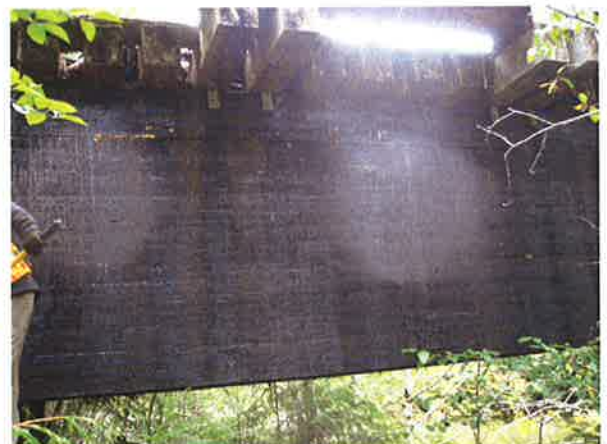
Photo 4 - Girder Crack near  
the Camp End Abutment

To account for the crack, we did not include the top 400 mm of the girder (i.e., only assumed a 1700 mm deep girder). For the other girders, the whole section was considered effective (i.e., 2100 mm deep). Assuming all four girders share the live loads based on their stiffness, the 1700 mm deep girder carries 25% of the live load and the 2100 mm deep girder carries 46% of the live load.
