## BRIDGE INSPECTION

**SI - 5635: Kennedy River  
Bridge on Sproat Lake FSR  
(0.50 KM)**

**Inspection Date:** November 1<sup>st</sup> 2012

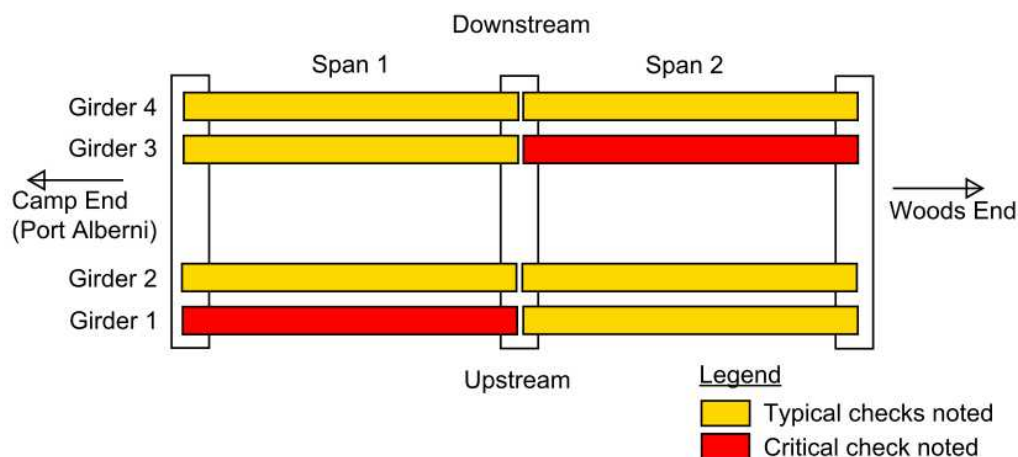
## Key Plan for Girders with Critical Check

## Checks on Girders:

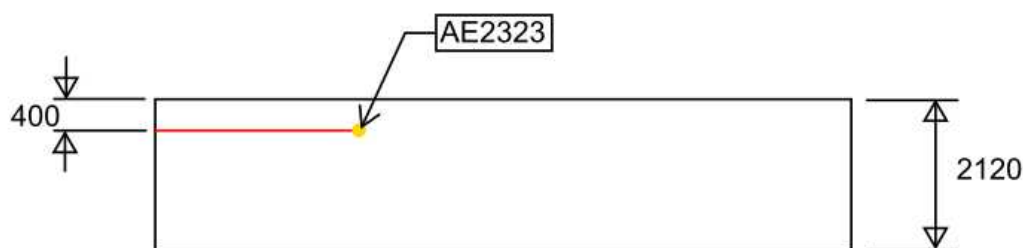
**Span 1 – Critical Check on Girder 1 Upstream Face**

- Creosote leaching; girder face 100% covered by creosote.
- Numerous isolated checks at the deck tie clip and diaphragm bolt locations near the top of the girder; average 2000 mm long, 10 mm wide, and 140 mm deep in places. The checks were not tagged since they do not affect the capacity of the girder.
- A significant check was identified, extended from tag AE70 (camp end) to tag AE2323; eventually links to tag AE71.

Span 1 – Girder 1 upstream face:

| Tag Type | Check Start | Check End | Length (mm) | Max. Depth (mm) | Max. Width (mm) | Location (mm) | Condition |
|---|---|---|---|---|---|---|---|
| Existing | AE70 | AE71 | 7200 | 170 | 5 | 400 from top | Extends from AE70 to new tag AE2323; eventually links to AE71. Drilled 2 locations, no rot |
| New | AE2324 | AE2305 | 4400 | 150 | | 320 from top | |
| New | AE2306 | Pier | 1800 | 90 | | 710 from top | |
| New | AE2346 | AE2307 | 5200 | 165 | | 630 from top | AE2307 is approx. 1600 mm from pier |

- Monitor checks on the glulam girders.

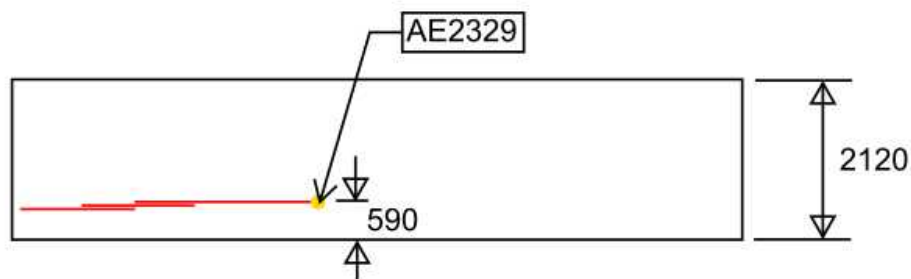
**Span 2 – Critical Check on Girder 3 Upstream Face**

The glulam girders are in fair to poor condition. We found several large checks in Span 2, Girder 3 upstream face that were not previously identified. Based on our observations, we do not anticipate further reduction of the current bridge load rating due to the newly identified checks. However, the large checks in Span 2, Girder 3 upstream face are unusual due to their locations as we normally would not expect such significant checking on the interior face of an interior girder (which is partially protected from weathering). We recommend the Ministry monitor these checks for propagation. Should these checks show signs of propagation in the future inspections, we recommend the Ministry complete a load rating of Span 2 to verify whether the girder has sufficient capacity to support the current 64 tonne posted load limit.

- Creosote leaching; visible creosote on > 75 % of the girder face.
- Numerous checks were observed along the girder length, average 25 mm deep.
- A number of significant checks were identified on the Span 2 Girder 3 upstream face near the pier (Checks tagged AE2329, AE2341, and AE2328). All significant checks are located on the lower 1/3 of the girder depth.

Span 2 – Girder 3 upstream face:

| Tag Type | Check Start | Check End | Length (mm) | Max. Depth (mm) | Max. Width (mm) | Location (mm) | Condition |
|---|---|---|---|---|---|---|---|
| Existing | AE2310 | AE1733 | 5600 | 120 | | 1400 from top | AE1735 retagged to AE2310 |

| New | AE2345 | AE2348 | 3600 | 50 | | 280 from bott. | Drilled, no rot |
| New | AE2349 | AE2347 | 4800 | 100 | | 520 from bott. | Drilled, no rot |
| New | AE2301 | AE2302 | 4000 | 95 | | 480 from bott. | |
| New | AE2329 | Pier | 11300 | 140 | | 520-590 from bott. | Check terminates approx. 50-100 mm before girder end. Drilled 2 locations, no rot, water accumulation noted |
| New | AE2341 | Pier | 9700 | 130 | | 300 from bott. | Check terminates approx. 50-100 mm before girder end |
| New | AE2328 | Pier | 5500 | 105 | | 720 from bott. | Check terminates approx. 50-100 mm before girder end |

- During the inspection, we utilized the resistograph to drill the Span 2 Girder 3 at the mid-span and at approximately 3 m from the pier. We drilled upward (vertically) from the bottom of the girder; the result at both locations does not show any signs of rot.
