# BRIDGE INSPECTION

**BRIDGE NO./NAME**                      **K384: 201 FSR (58.50 KM)**

**Inspection Date:**                      September 29<sup>th</sup>, 2012

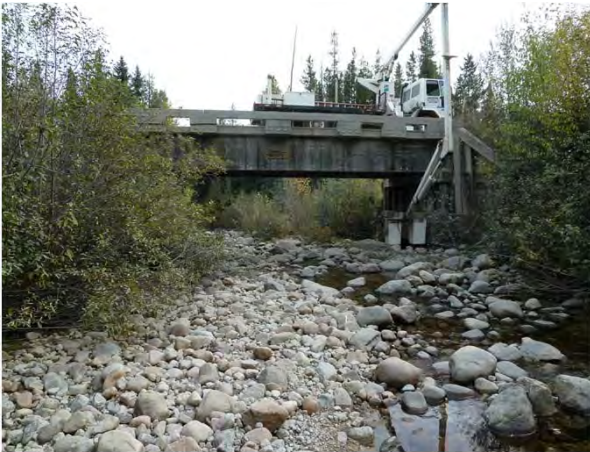
**Figure 1-1: Downstream elevation.**

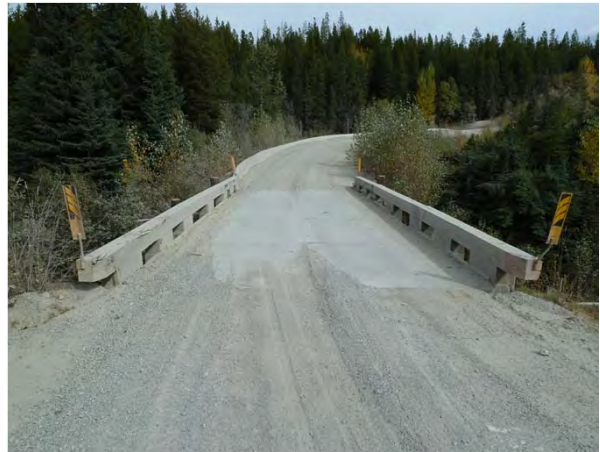
**Figure 1-2: Looking towards woods end.**

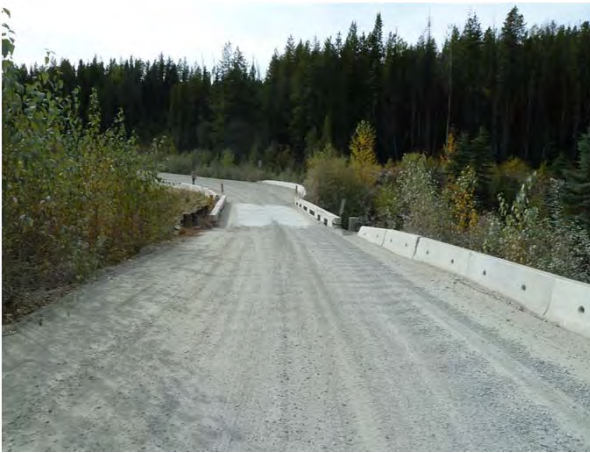
**Figure 1-3: Looking towards camp end.**

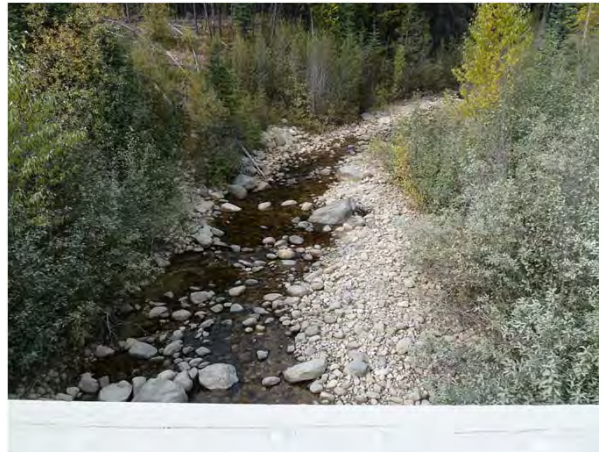
**Figure 1-4: Looking upstream.**

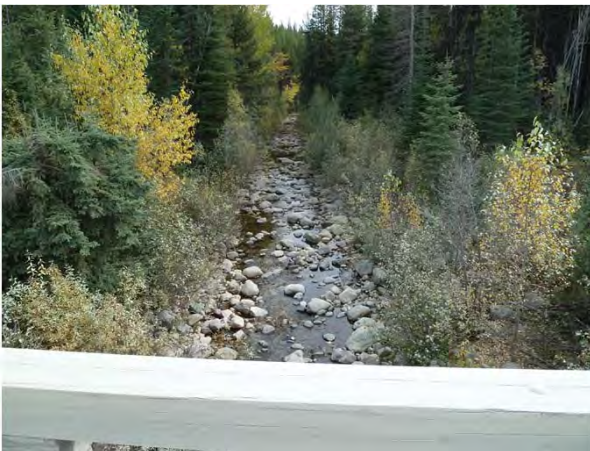
**Figure 1-5: Looking downstream.**

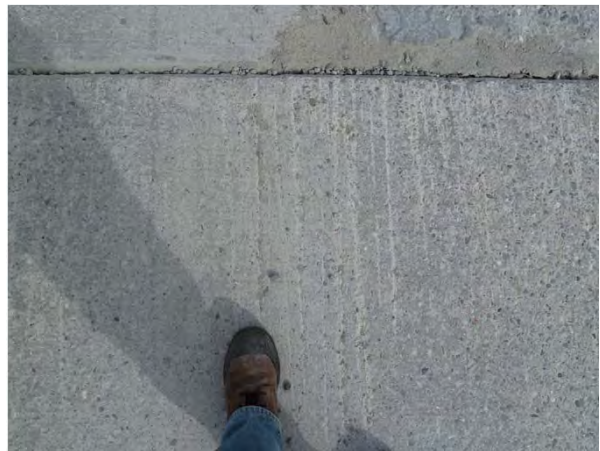
**Figure 1-6: Typical deck condition.**

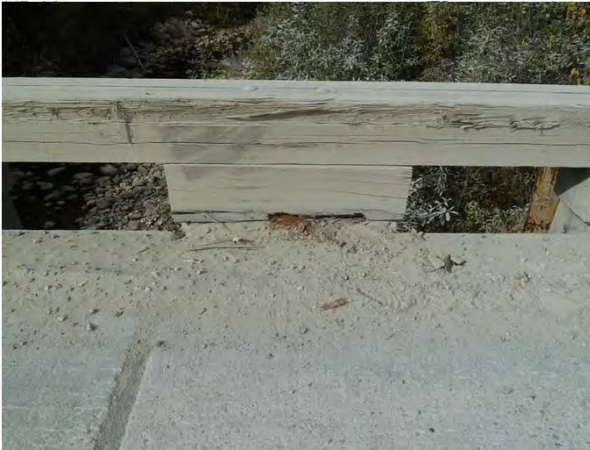
| Curb Rail/Blocks/Posts | Fair | Checking along length of curb rail. Two blocks have rot on the bottom edge. |

**Figure 1-7: Typical guardrail condition.**

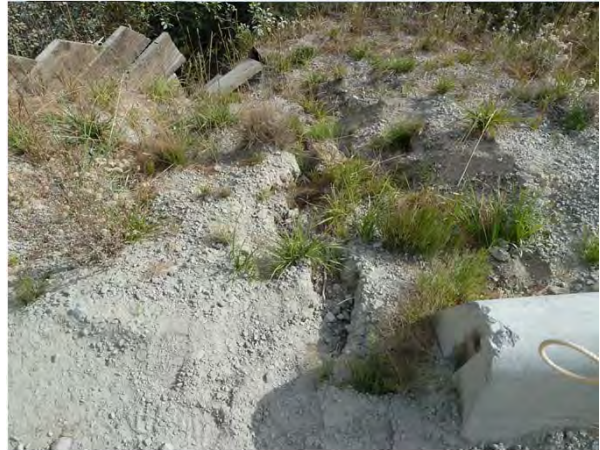
| Road Surface | Good | Small erosion channel on the downstream side of approach embankment. |

**Figure 1-8: Erosion channel, downstream side of camp end approach embankment.**

| # | Description |
|---|---|
| 1 | Monitor erosion of camp end embankment. |

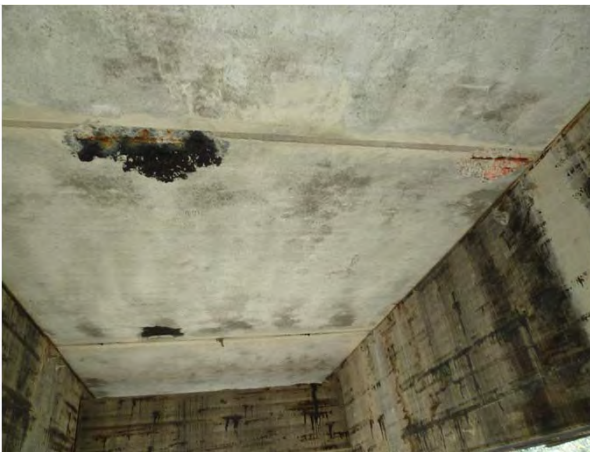
| Deck Joints | Fair | Concrete panels are butted together, resulting in spalling at the joints due to movement between panels. |

**Figure 1-9: Typical underside of deck condition, note spalling at joint.**

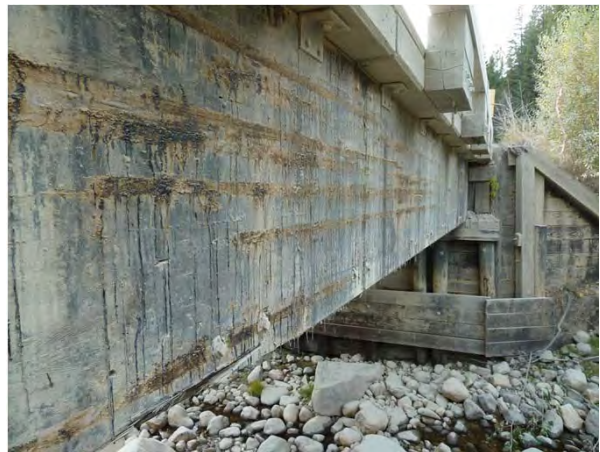
- Minimal creosote leaching at laminate joints; girder faces 100% covered by creosote.
- No checking
- Minor damage to bottom of girder 1.

**Figure 1-10: Typical upstream face of girder 1.**

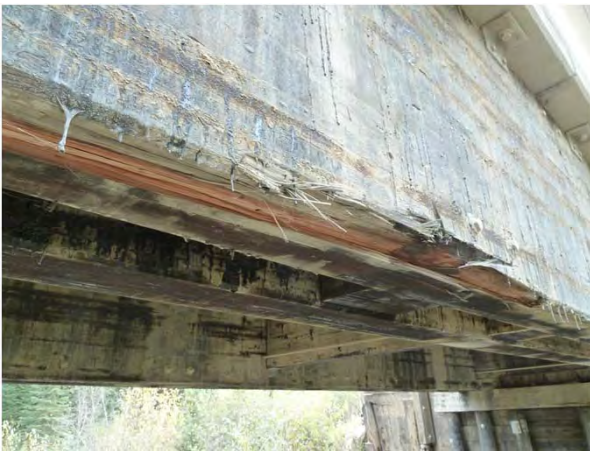
**Figure 1-11: Damaged girder 1.**

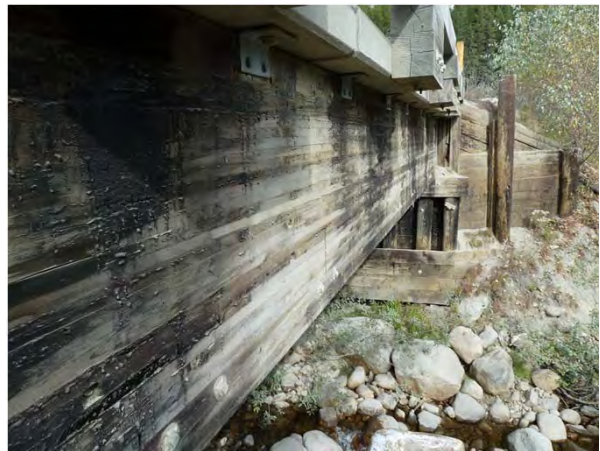
- Creosote leaching; visible creosote on 25-50% of the girder face.
- Minor checking – full length checks noted, typically 30 – 50 mm deep, similar to previous inspections.

**Figure 1-12: Typical downstream face of girder 4.**

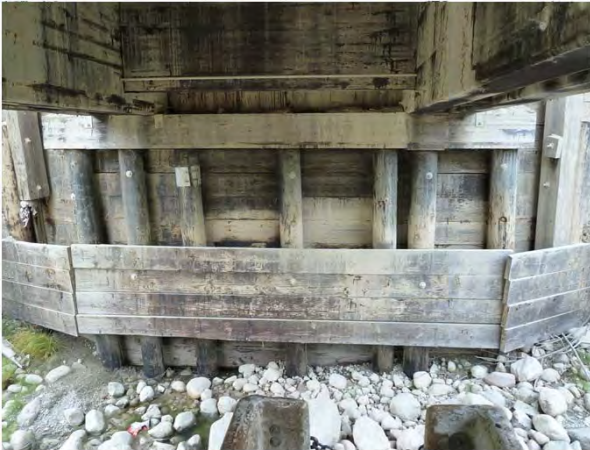
- The camp end abutment is generally in fair condition.
- Two ballast wall planks have pushed outwards resulting in nominal material loss, still remains functional.
- Cap beam has a slight rotation as noted in the previous inspection.
- All abutment piles sounded, no rot noted.
- Tops of wing wall piles are missing flashing.
- Downstream wing wall Pile 2 has ~ 150 mm of heartwood rot and is rotating. The wing wall plank directly above the pile is also rotten. Condition is similar to previous inspections.
- The downstream wing wall top cross beam is missing and several planks are being pushed outwards, but still remain functional.
- Debris is accumulating cap beam.

**Figure 1-13: Camp end abutment.**

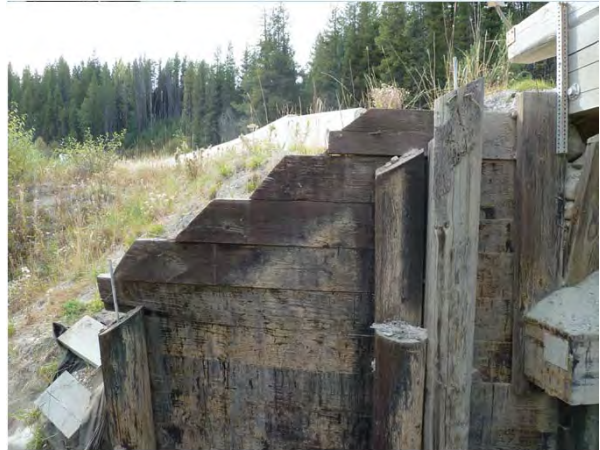
| Wing Wall | Poor | Tops of wing wall piles are missing flashing. Camp end downstream wing wall Pile 2 has ~ 150 mm of heartwood rot and is rotating. The wing wall plank directly above the pile is also rotten. Condition is similar to previous inspections. The camp end downstream wing wall top cross beam is missing and several planks are being pushed outwards, but still remain functional. |

**Figure 1-14: Downstream camp end wing wall, note missing top cap beam.**

| Items | Description | Priority |
|---|---|---|
| 1. | Replace missing top cross beam and install flashing on pile tops. | Medium |

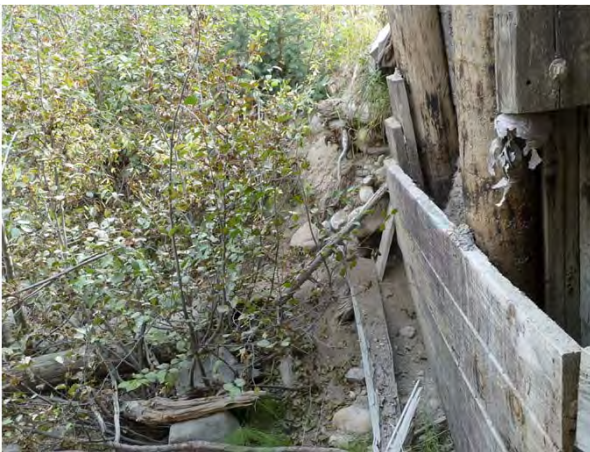
The bridge is generally in fair condition. The downstream camp end wing wall should be monitored for movement as it appears to be continuing to rotate.

**Figure 1-15: Downstream camp end wingwall rotating outwards.**

| # | Description |
|---|---|
| 2 | Monitor movement of camp end downstream wing wall. |

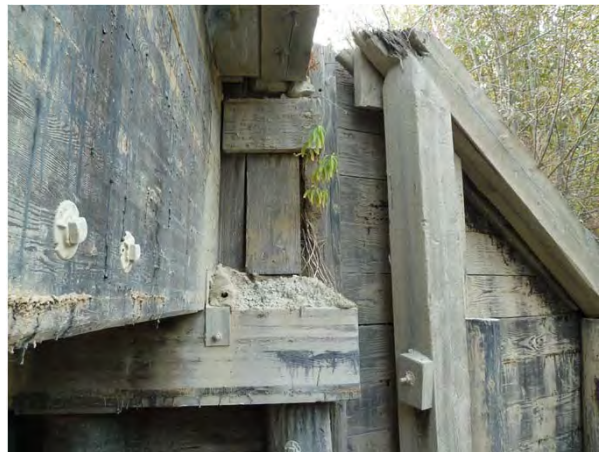
**Figure 1-16: Upstream camp end wing wall and abutment.**

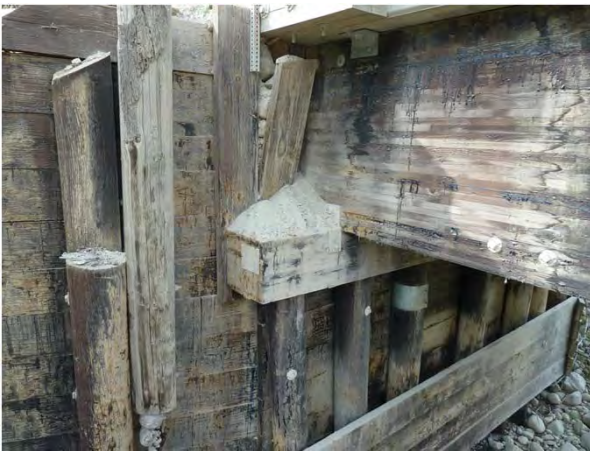
| Ballast Wall | Fair | Two ballast wall planks on camp end have pushed outwards resulting in nominal material loss, still remains functional. |

**Figure 1-17: Camp end abutment downstream, note damaged ballast wall plank.**

| Items | Description | Priority |
|---|---|---|
| 2. | Repair camp end ballast wall planks. | Medium |

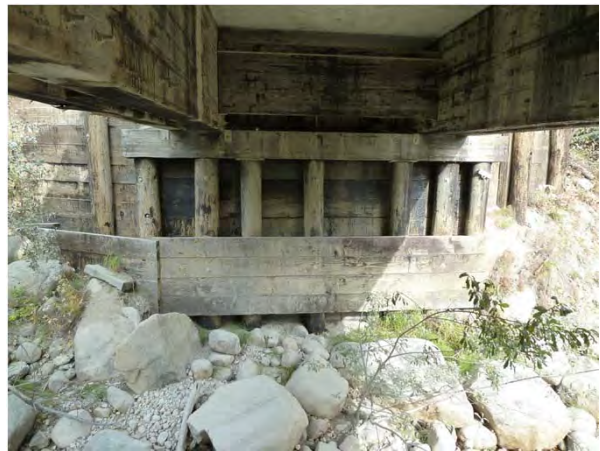
- The woods end abutment is generally in fair condition.
- Cap beam has a slight rotation as noted in the previous inspection.
- All piles sounded, no rot noted.
- Vertical crack, 1 m in length on pile 1.
- Tops of wing wall piles are missing flashing.
- Debris is accumulating on cap beam.

**Figure 1-18: Woods end abutment.**

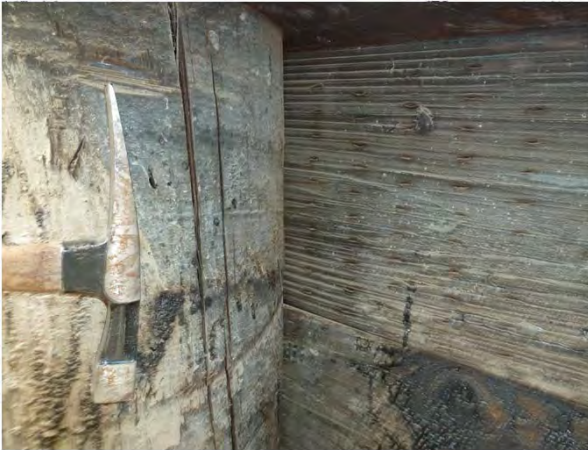
| Piles or Posts | Fair | All abutment piles sounded, no rot. Vertical crack, 1 m in length on woods end abutment pile 1. |

**Figure 1-19: Split in pile 1 woods end.**
