| Bridge No. | K424 | Road Name | Placer Mountain FSR | | | | | | | | | | Inspection Date | 2014-08-11 | | |
| 54 m | Similkameen River | | | | | | | | | | M. Hanson / D. Harrison | | | | | |
| Comments | Two span steel girder bridge with precast concrete deck panels. | | | | | | | | | | | | | | | |

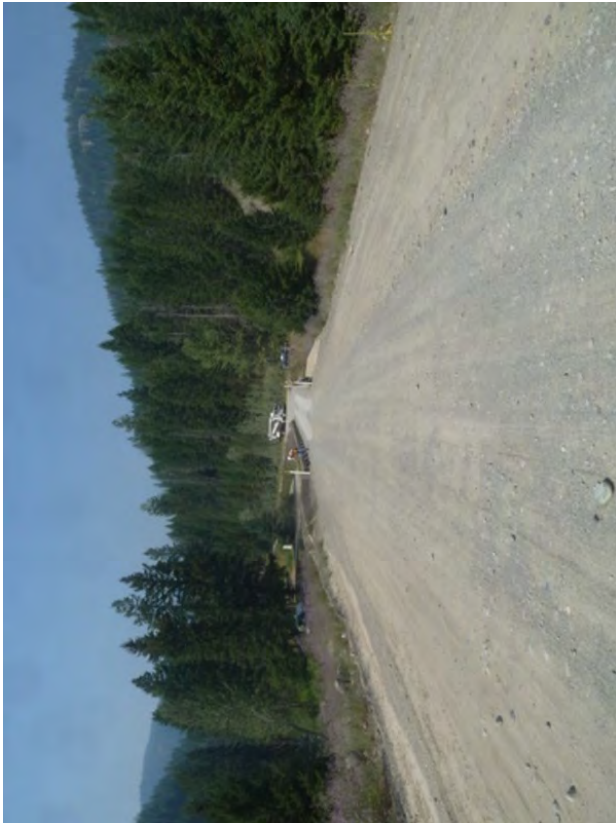
Figure 6: Right approach.

| Alignment | Fair | | | Horizontal curve at right approach. | | | | | | | | | | | | |

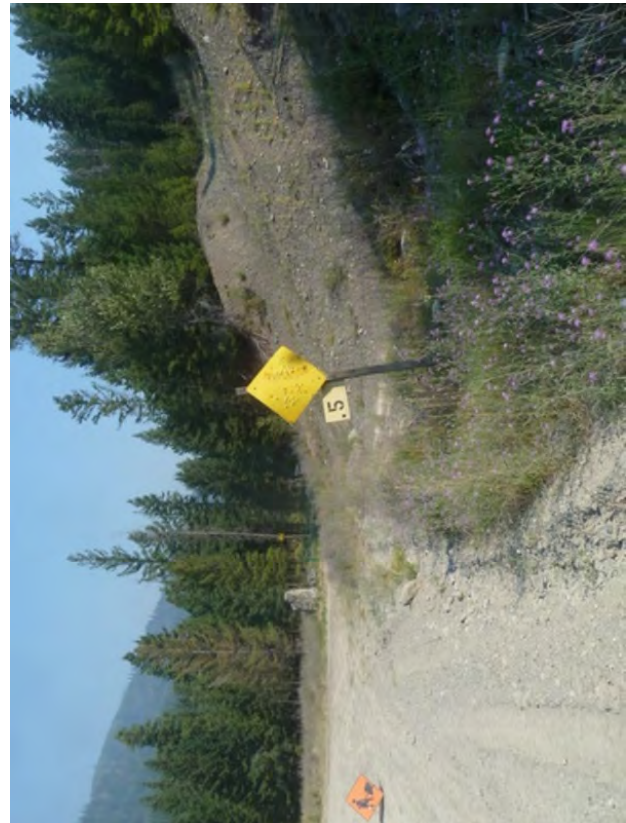
| Signage | Poor | | | Bridge ahead sign at right end approach is heavily weathered and faded. | | | | | | | | | | | | |

Figure 7: Bridge ahead sign at right approach.

| 2 | Replace bridge ahead sign at right approach. | High | \$500.00 | | |

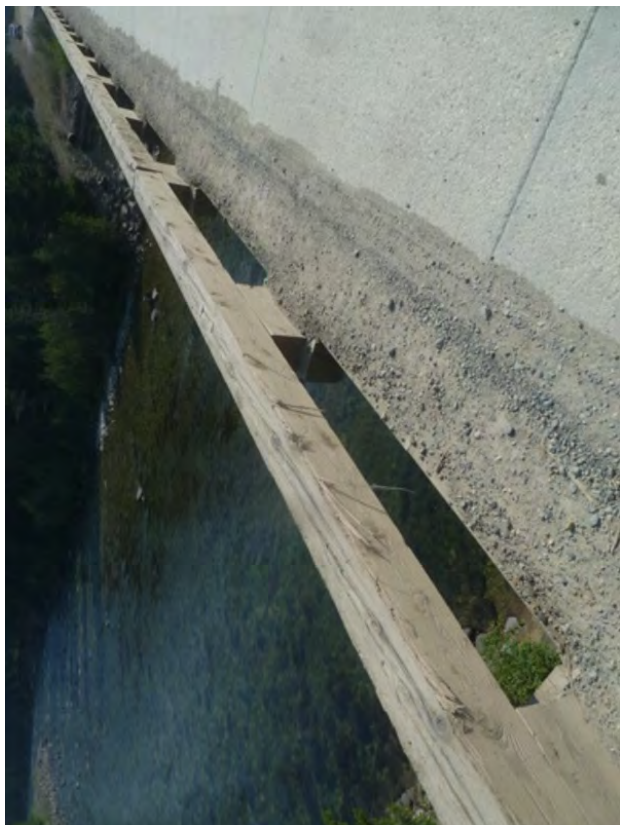
| Curb Rails and Risers | Poor | | | <p>Insect damage and severe checking noted throughout curbs and risers. Curbs and risers cored and sounded, decay noted in several locations.</p> <p>Minor impact damage at left end downstream curb.</p> <p>Failed riser at right end downstream curb.</p> | | | | | | | | | | | | |

Figure 10: Typical condition of downstream curb.

| 1 | Replace all curb rails and risers | High | \$15,000.00 | | |

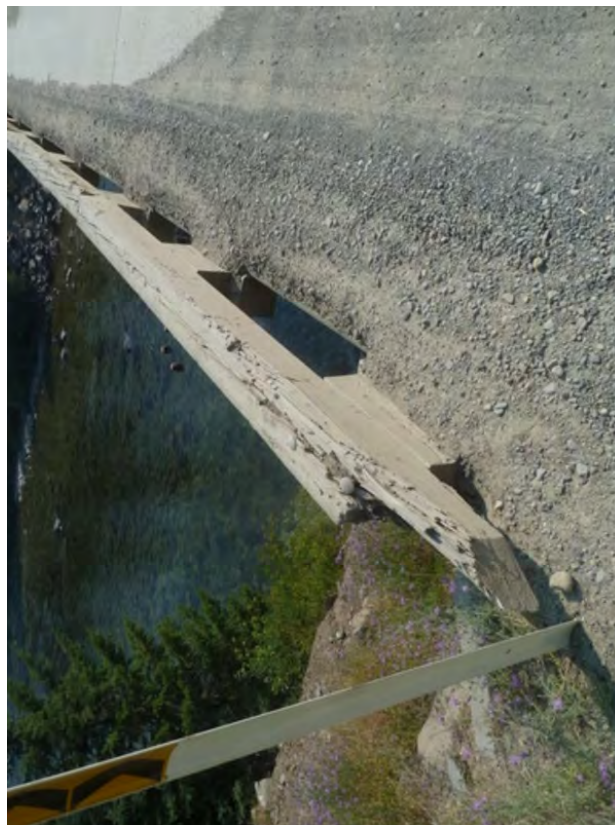
Figure 12: Damaged curb at left end downstream corner.

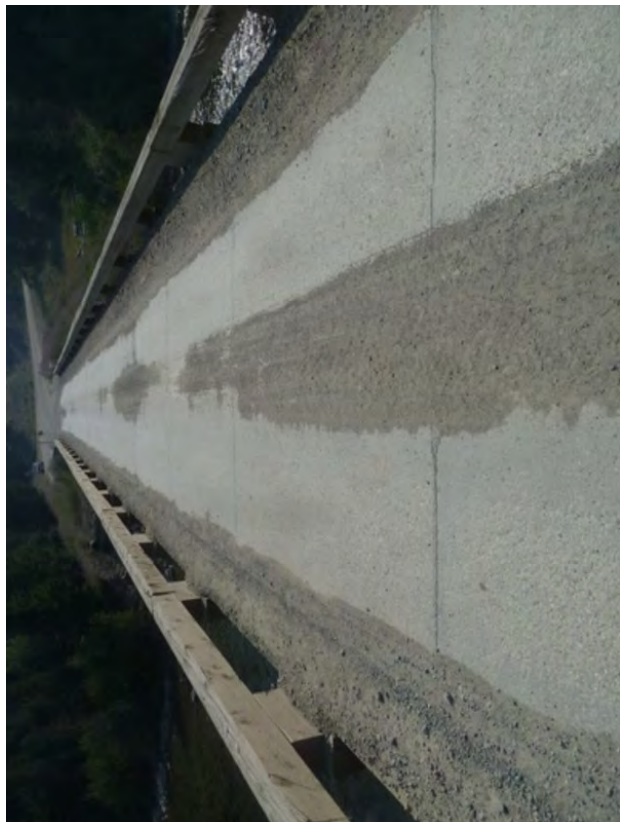
| Running Surface | Fair | | | <p>Moderate wear along concrete deck surface, likely a result of hauling activity (ie truck chains or snow plow). Debris accumulation along deck edge.</p> <p>Underside of deck is in good condition. Minor spall previously noted at left end downstream corner does not appear to have changed since 2011 inspection.</p> | | | | | | | | | | | | |

Figure 9: General deck condition - Note debris accumulation along deck edge and centre of deck - possible cause of noticeable wear.

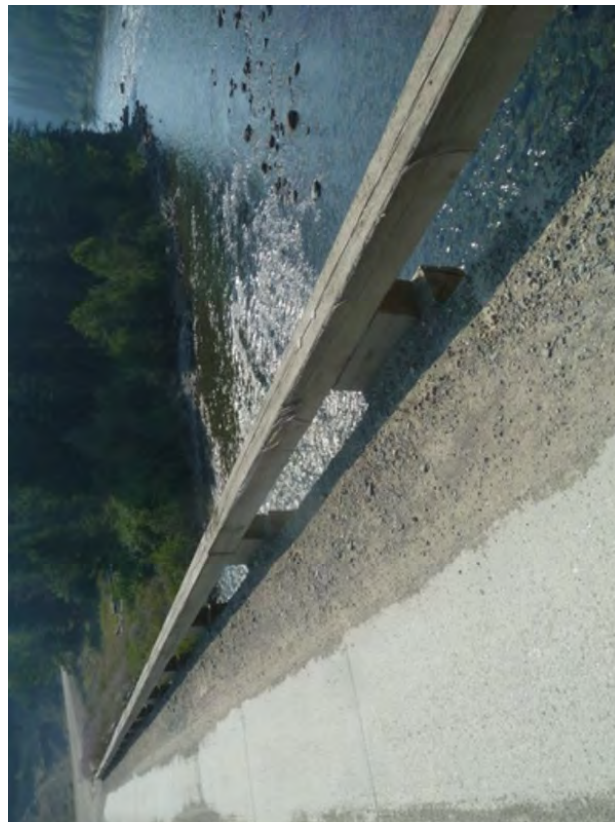
Figure 11: Typical condition of upstream curb.

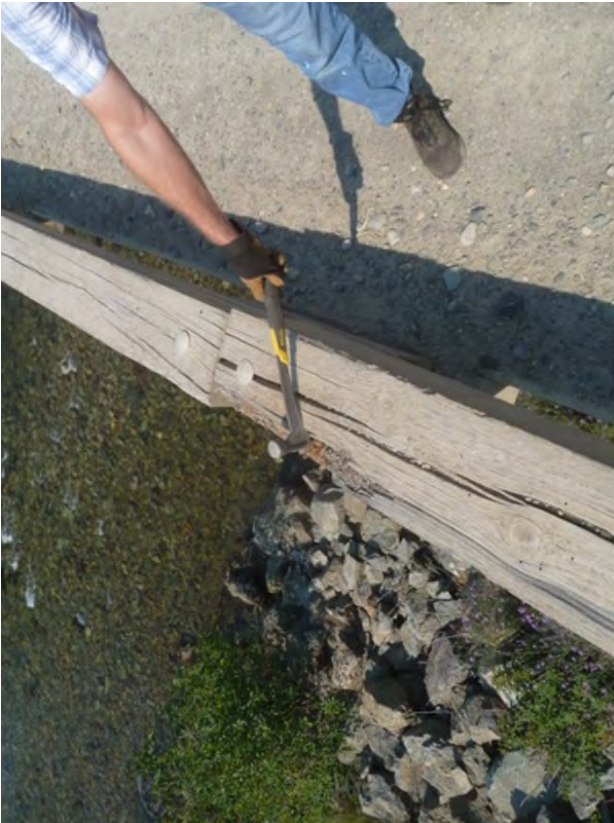
Figure 14: Rot in upstream curb near right end.

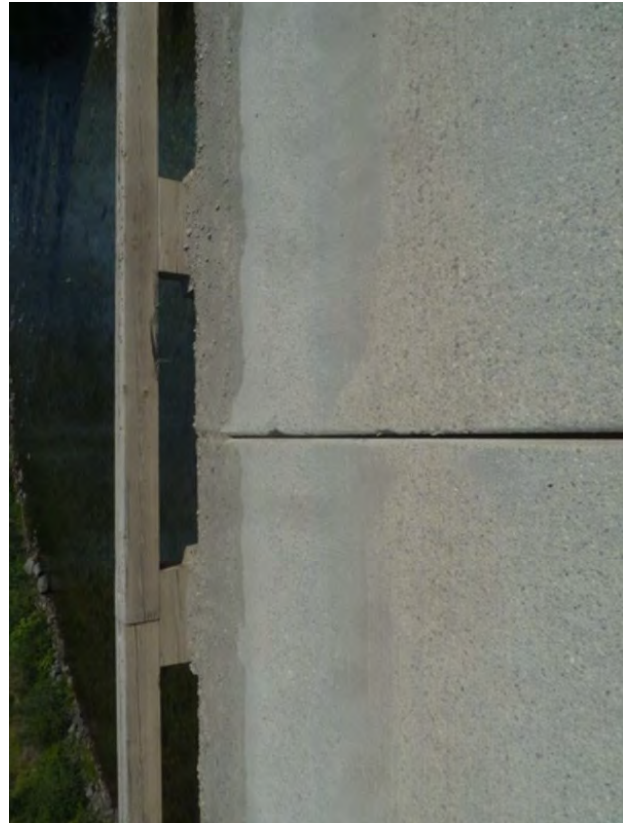
| Deck Joints | Poor | | | <p>Pier 1 compression seal has failed.</p> <p>All grouted deck panel joints are in good condition.</p> | | | | | | | | | | | | |

| Caps | Fair | Debris accumulation on top of cap due to failed compression seal. | | | |

Figure 16: Pier 1 deck joint - Note missing compression seal.

| 3 | Replace deck joint compression seal at Pier 1. | Medium | \$5,000.00 | | |

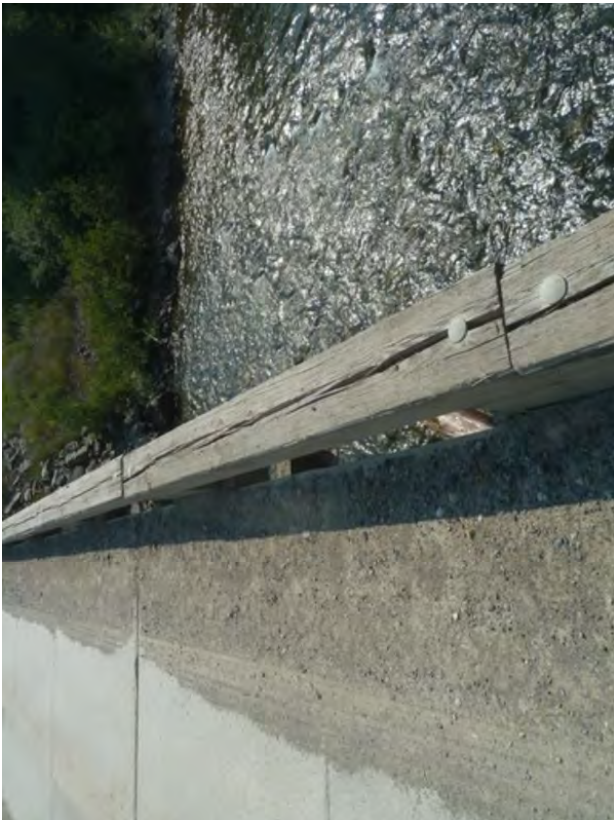
Figure 13: Wide checking in upstream curb.

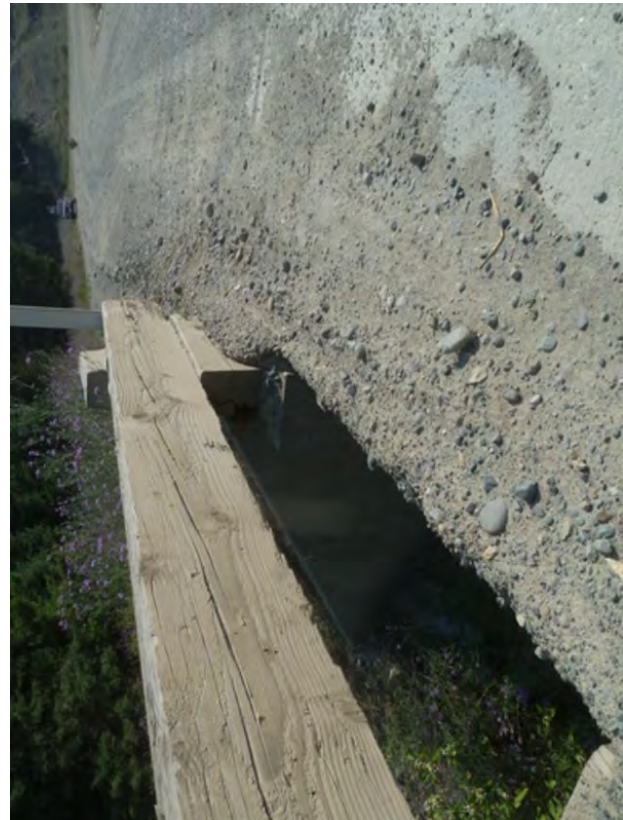
Figure 15: Failed curb riser at right end downstream.

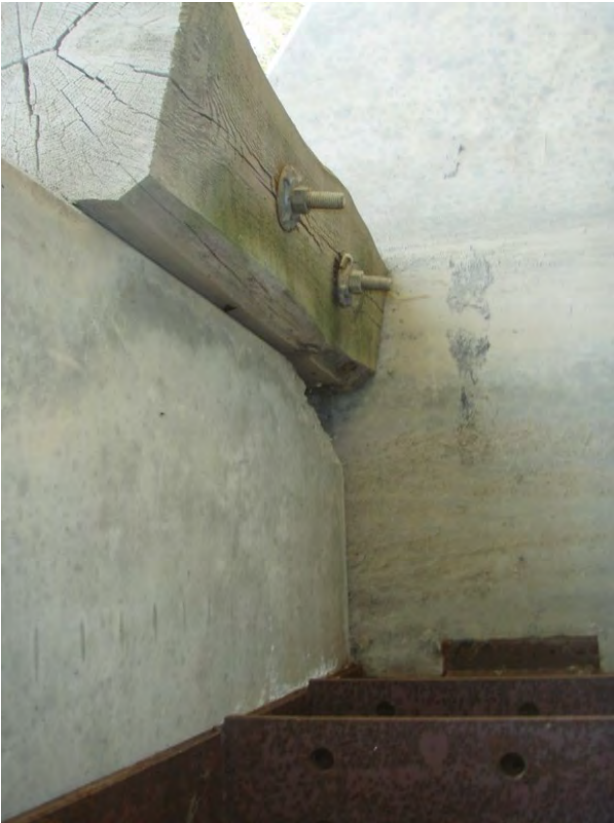
Figure 22: Deck panel at left end downstream - Note spalled concrete.

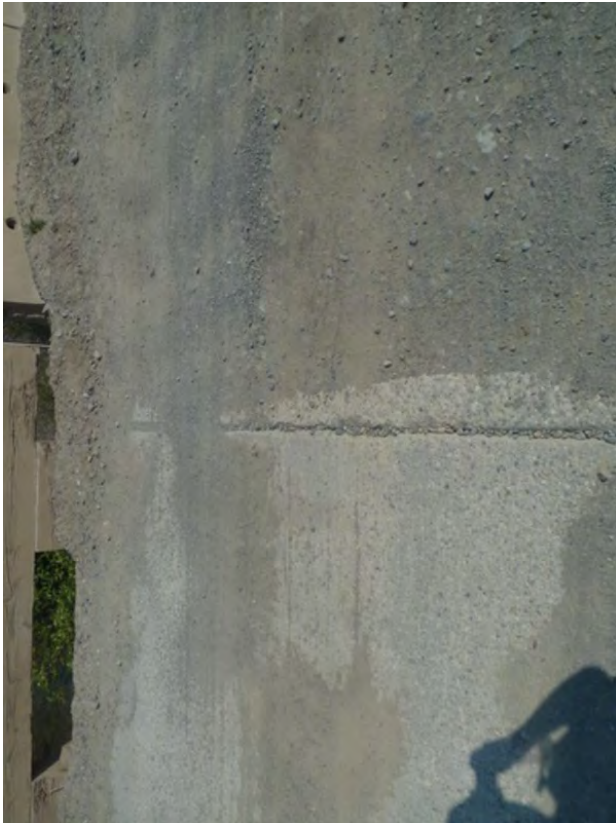
| Ballast Wall | Fair | Minor spalling along top of ballast wall from vehicle traffic. | | | |

Figure 26: Top of right end ballast wall - Note wear along top edge of ballast wall.

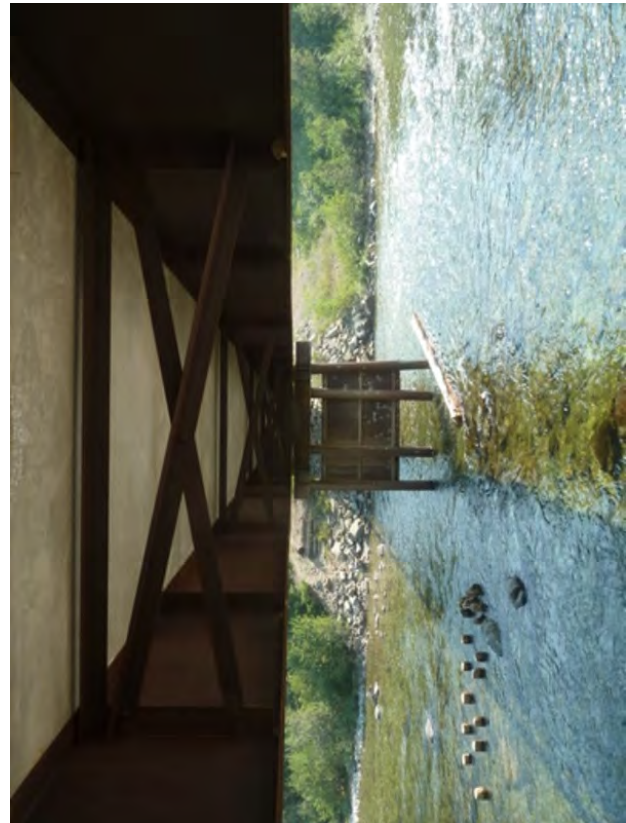
| Piles/Posts | Good | Single log jam at base of upstream pile. | | | |
| Wall | Fair | Steel plate diaphragm does not extend to the mudline, providing a trap for floating debris. | | | |

Figure 27: Pier 1, left face - Note debris at base of pier.

| 4 | Consider extending steel plate pier diaphragm to mudline during low flows. | Medium | \$20,000.00 | | |

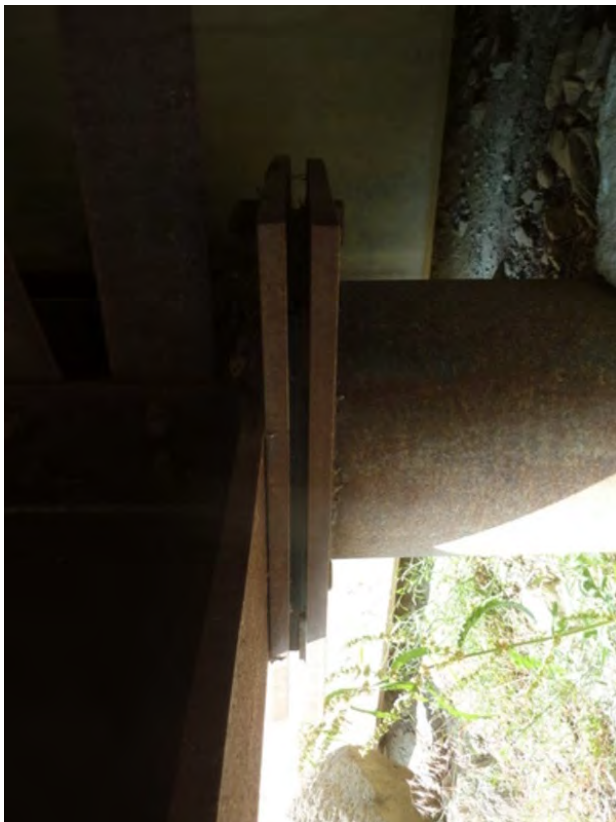
Figure 29: Typical abutment bearing, left end upstream shown.

| Bearings | Good | Rodent nesting debris around both bearings. | | | |

| 5 | Remove rodent nests from abutments. | Low | \$500.00 | | |
