| Bridge No./Name: | N2-068: Kootenay River FSR / Kootenay River (32.80 km) |
| Inspection Date: | August 1, 2015 |

**BRIDGE INSPECTION SUMMARY & RECOMMENDATIONS:**

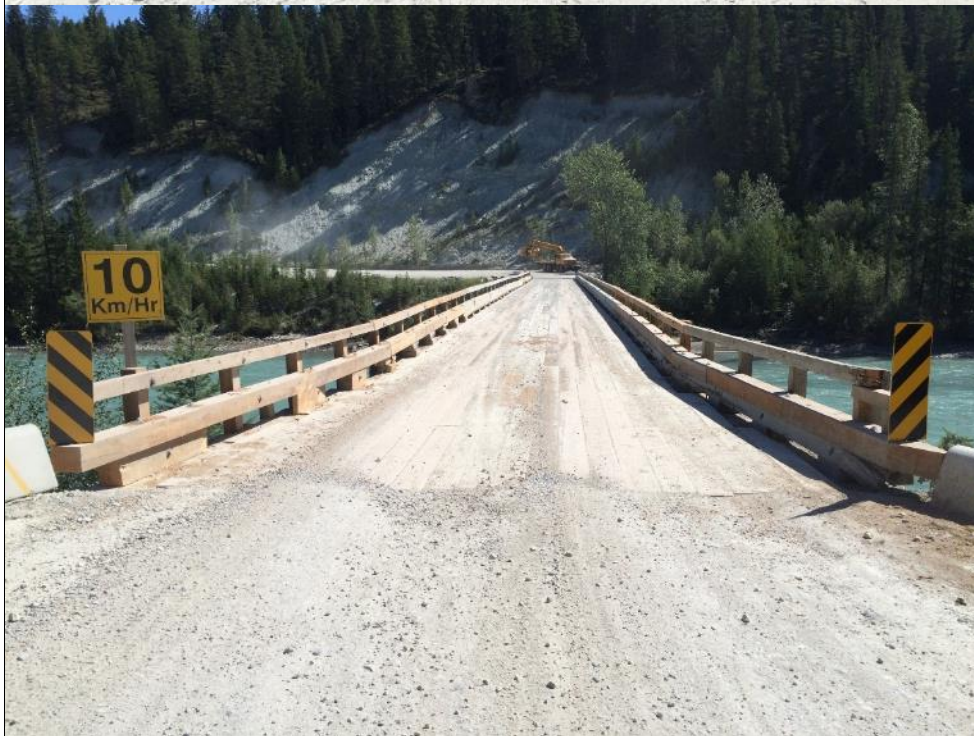
Photo #4  
Abutment 2 (camp) approach

- Both approaches have only one precast concrete barrier per side.
- Abutment 2 (camp) approach has some minor rutting within wheel paths.

-Note isolated minor rutting of approach through wheel paths.

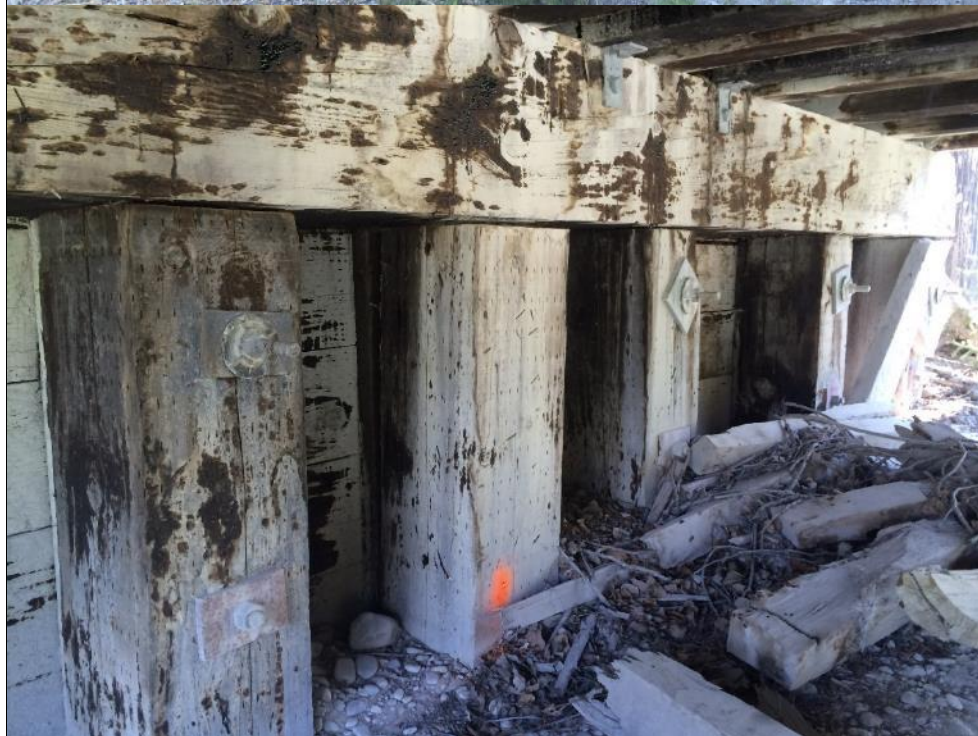
Photo #6  
Abutment 1

- Pile 4 was found to contain rot.
- Pile cap is rotated outwards, more extensively at the U.S side.
- Some sluffing of approach fill noted around wingwalls.

-Orange point denotes area of  
rot found in Pile 4.

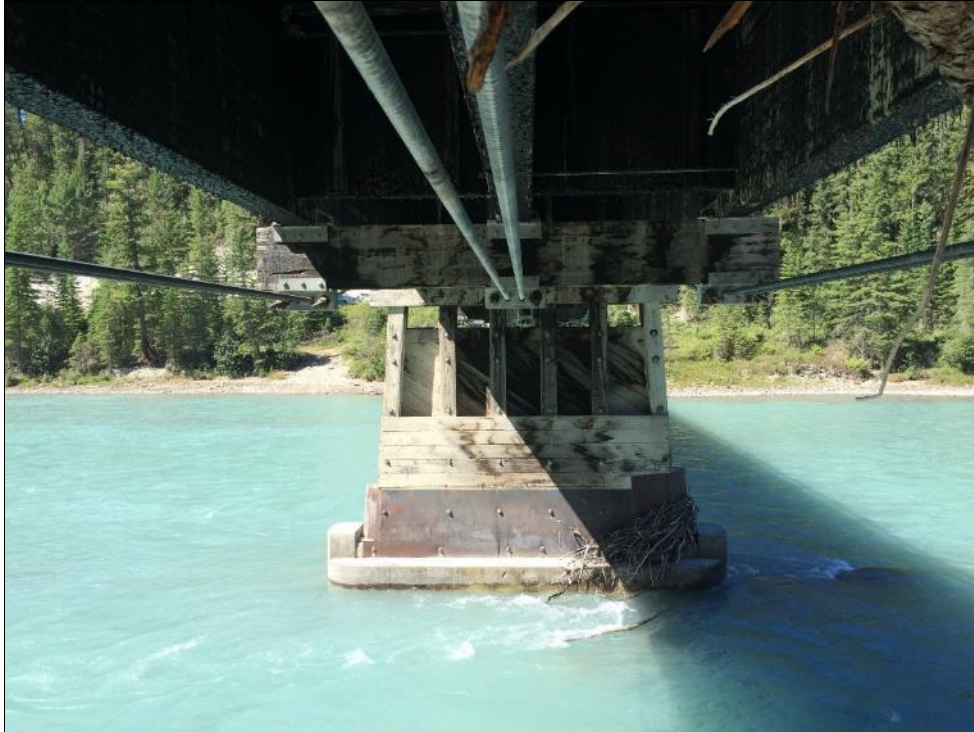
Photo #11  
Pier 2 - looking to Abutment 2

-Note minor accumulation of drift debris on U.S end of pier.

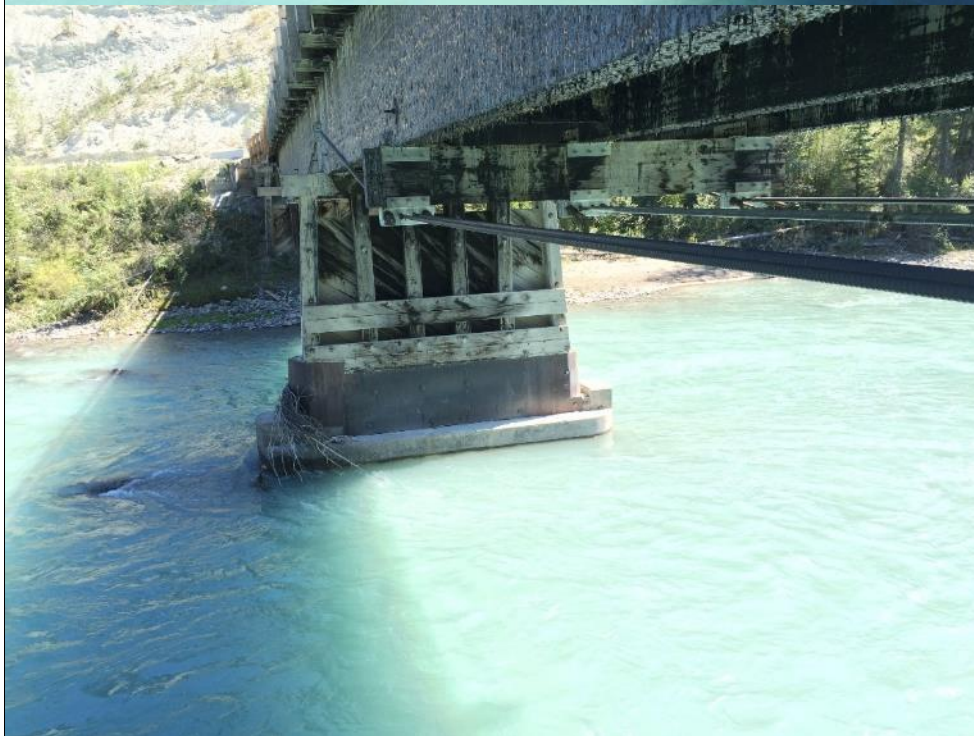
Photo #12  
Pier 2 – looking to Abutment 1

-Note isolated sheathing planks are missing.

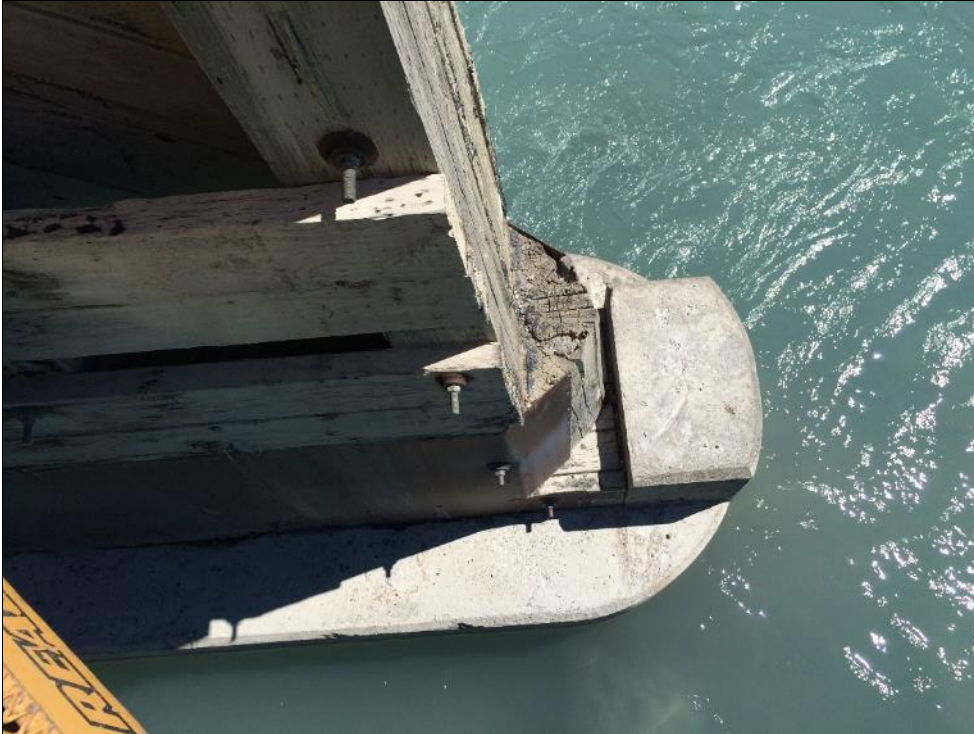
Photo #13  
Pier 2 – D.S end

- Bottom timber pier shaft sills are rotten with bulging of the thin steel plate sheathing noted.
- Significant accumulation of silt and debris noted between pier shafts and sheathing.
- Minor accumulation of drift debris was noted at U.S end of pier.

-Extensive rot noted in lower portion of timber pier shaft, behind sheathing.

| ITEM | DESCRIPTION | PRIORITY |
|---|---|---|
| 2 | Further assess and plan for pier replacement / preservation. Consider a Level 2 timber coring assessment. | High |

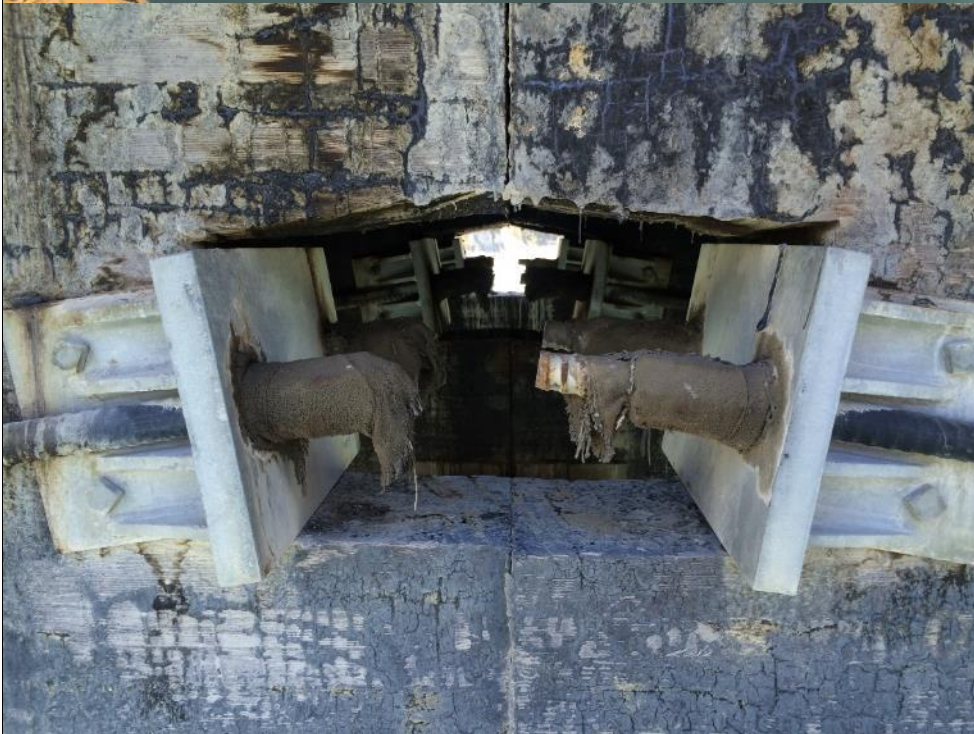
Photo #14  
Anchorages of bolstering over  
Pier 2

-Typical condition.

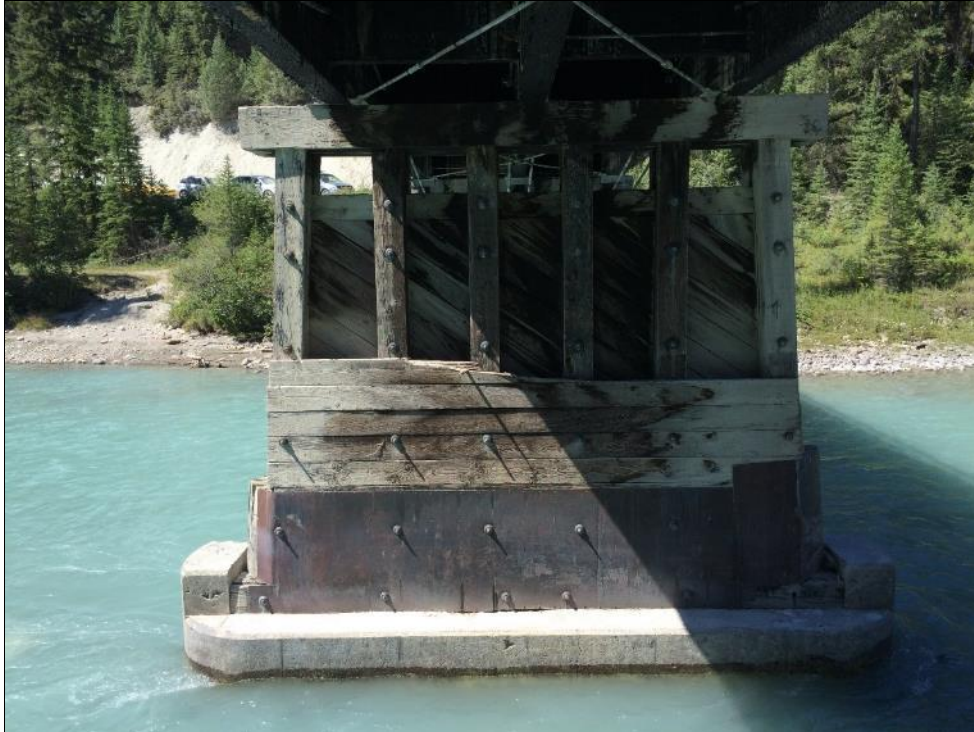
Photo #15  
Pier 3 – looking to Abutment 2

-Note isolated damaged timber sheathing.

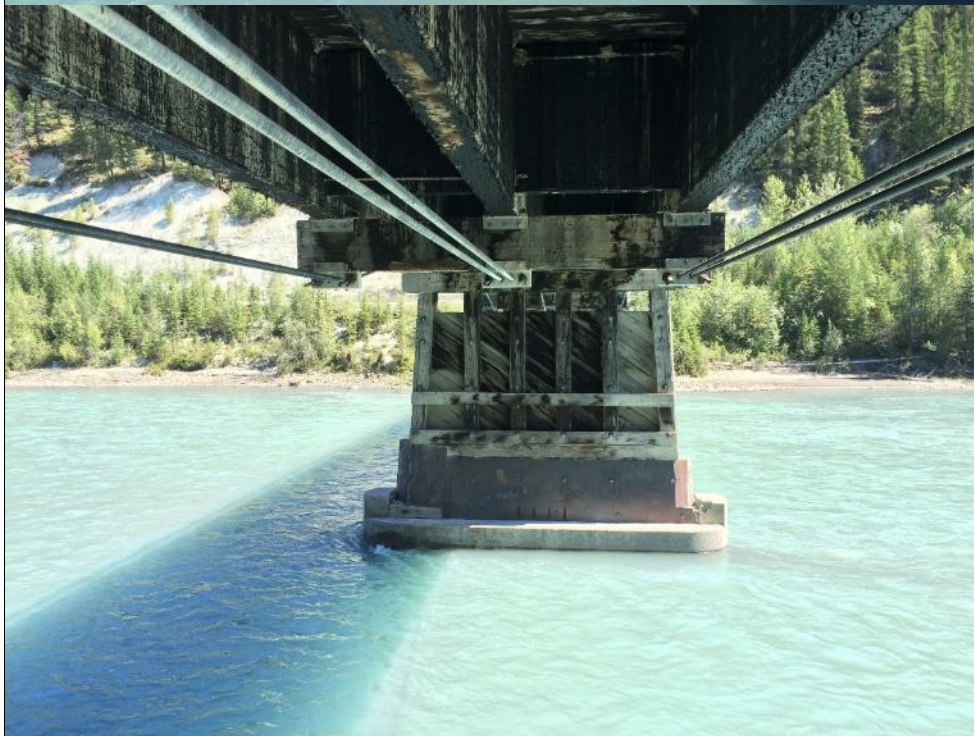
Photo #16  
Pier 3 – looking to Abutment 1

-Note areas of sheathing planks missing.

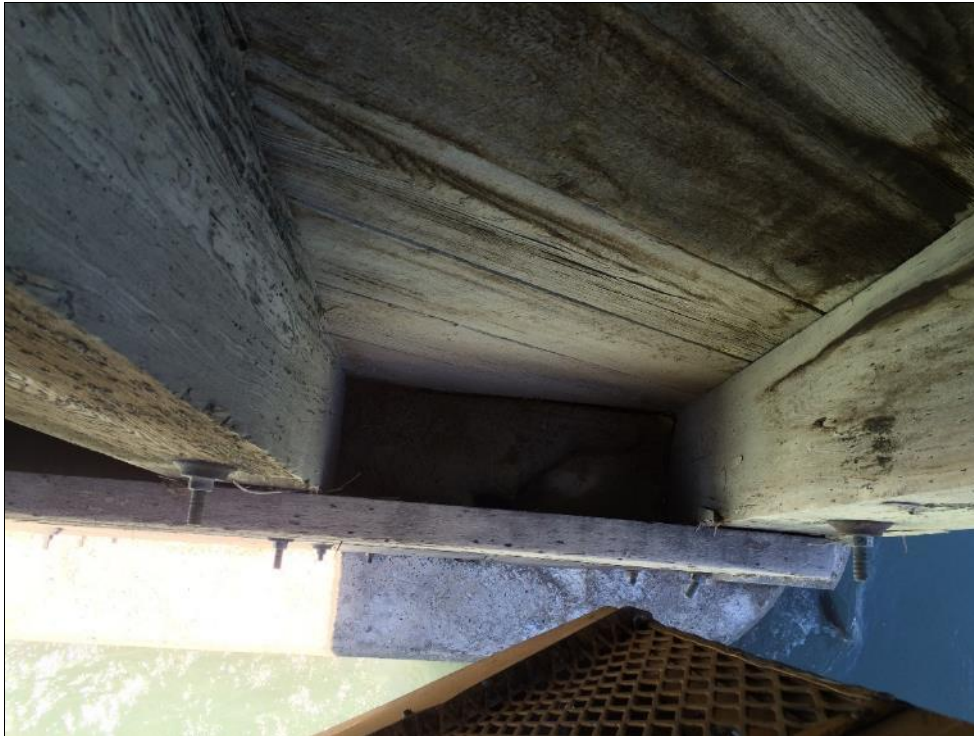
Photo #17  
Pier 3 - looking downwards  
between shafts and behind  
sheathing

- The lower portion of the timber pier shafts were not visible for inspection due to the thin steel plate sheathing, however the presence of rot is highly suspected, given proximity to water level, the significant accumulation of trapped, saturated silt and debris noted between pier shafts and sheathing, and what appears to be slight bulging of the steel sheathing.

-Sheathing is trapping silt and  
moisture.

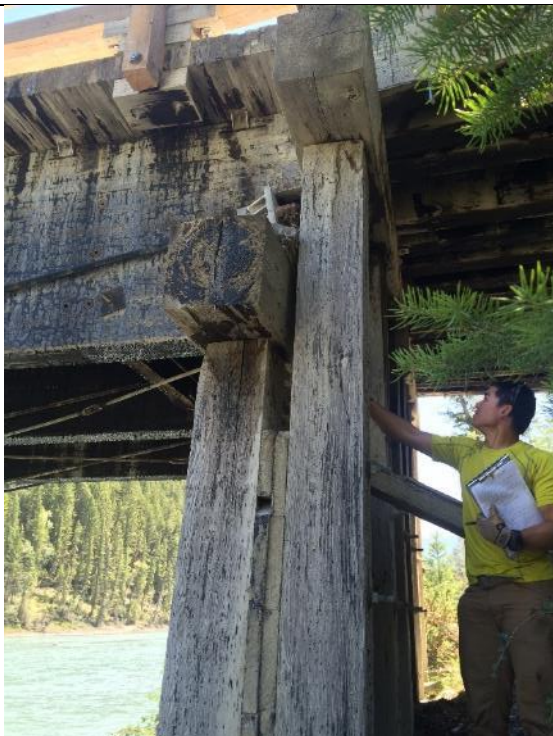
| | <p>Photo #21<br/>Pier 4 – Looking D.S</p> <p>-Note significant check in end of left cap.<br/>-Timber sounded with a hammer throughout with no indication of rot noted.</p> |

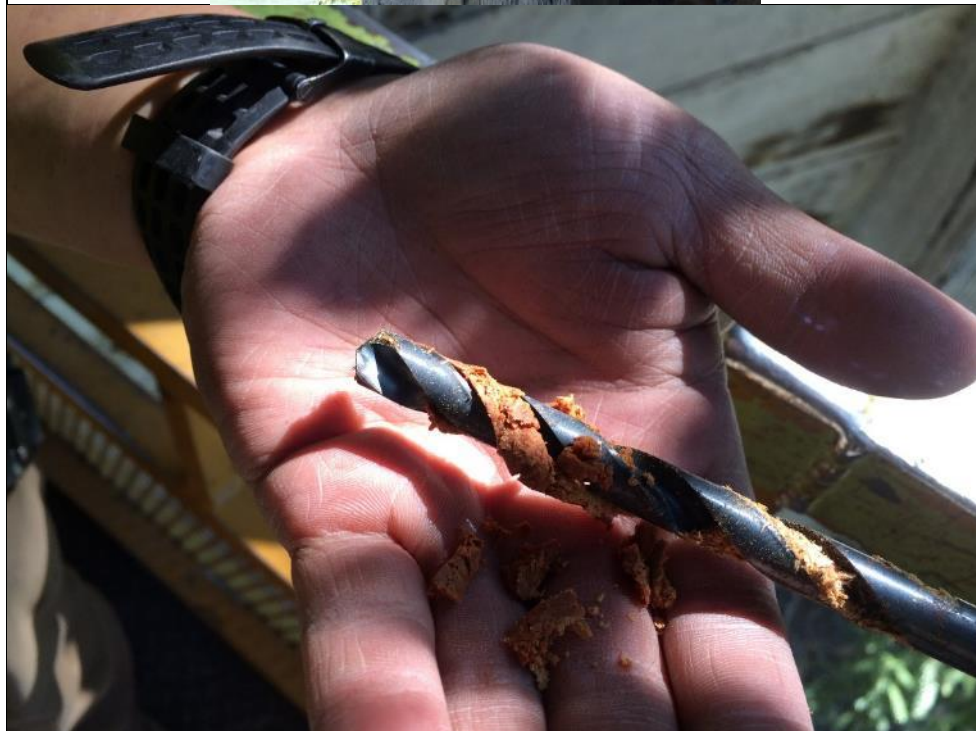
- Pier 4, D.S pier cap (Abutment 1 side) was cored with no indications of rot, where orange paint indicator was previously applied (see photo log).

| | <p>Photo #22<br/>Pier 4 – shaving from core taken</p> <p>-Shavings did not indicate presence of rot.</p> |

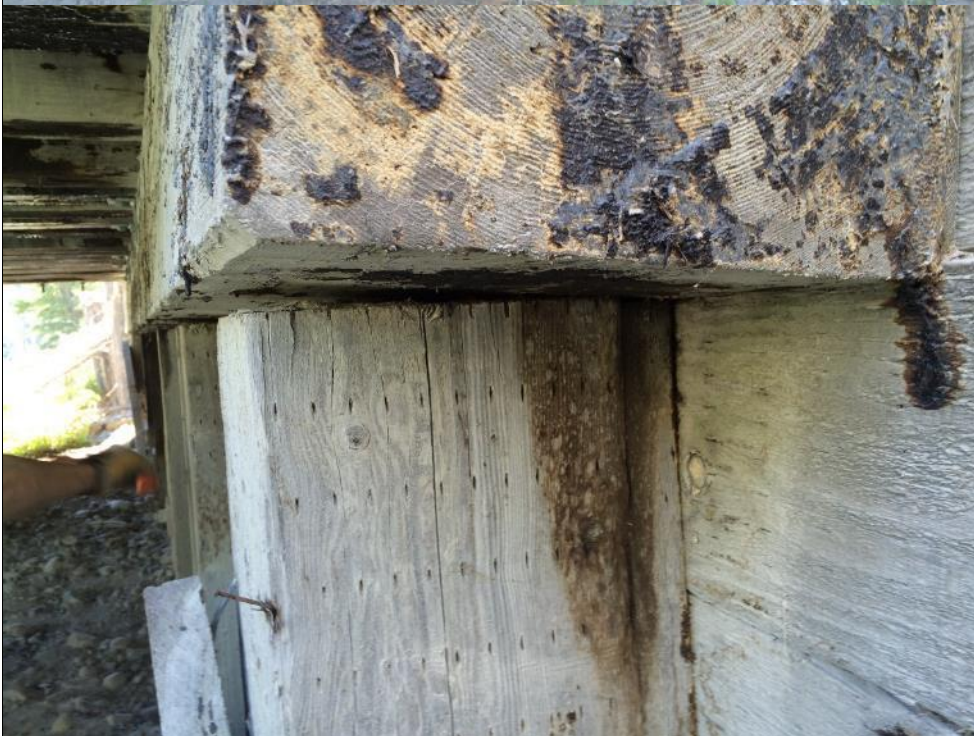
Photo #24  
Abutment 2 - piles and pile cap

- A2 cap is rotated outwards approx. 5°.
- Wingwall planks are not bearing on wingwall piles in regular locations.
- Timber elements sounded throughout and appear to be in fair condition.

-Pile cap appears to be rotating outwards.

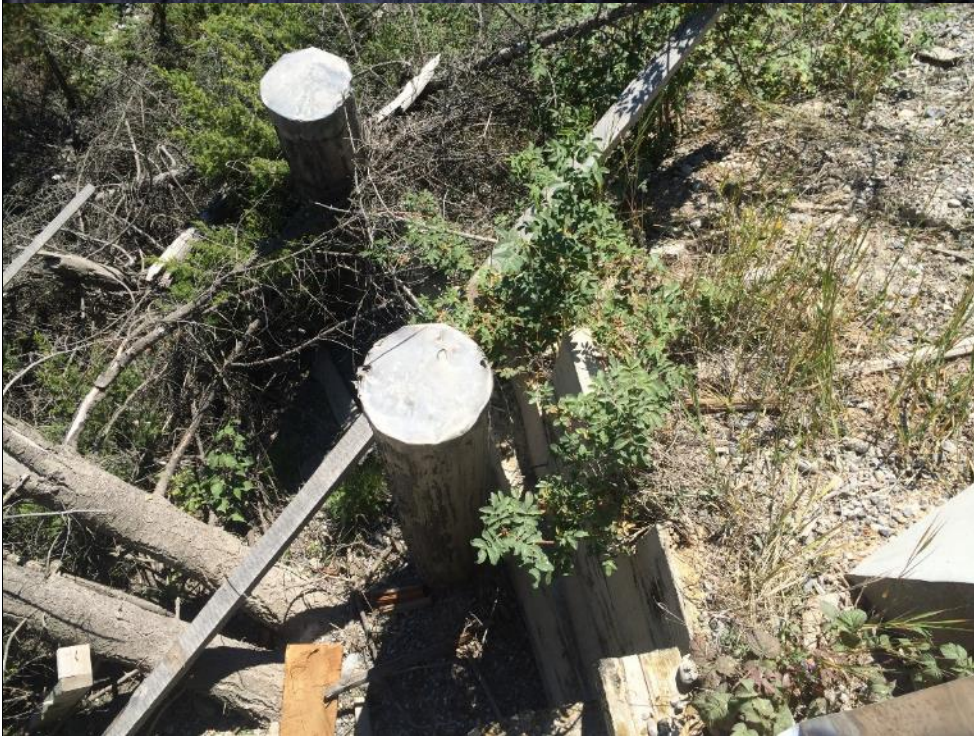
Photo #26  
Abutment 2 - D.S wingwall

-Top wingwall planks are not restrained by first pile.

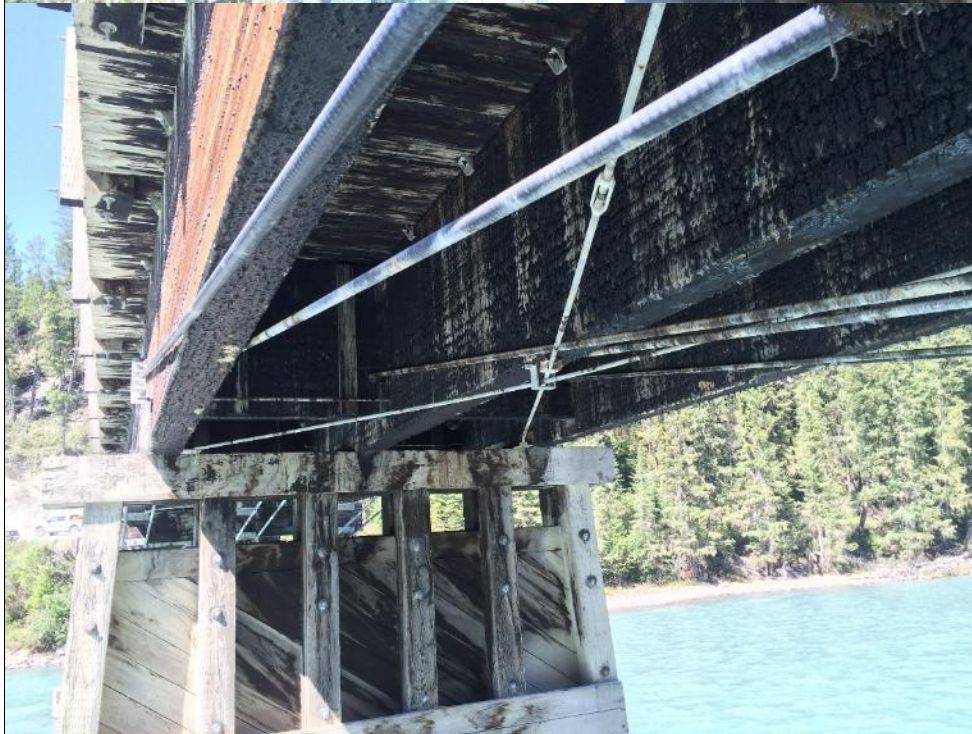
Photo #28  
Underside of Span 2 looking to  
Abutment 2

- Creosote coverage of approx 75 - 100% remaining on U.S interior face.
- Creosote coverage of approx 20% remaining on D.S exterior face, with significant weathering, but no significant checks or splits noted.

-Good creosote coverage on interior faces, however poor creosote coverage of Girder 3, exterior face.

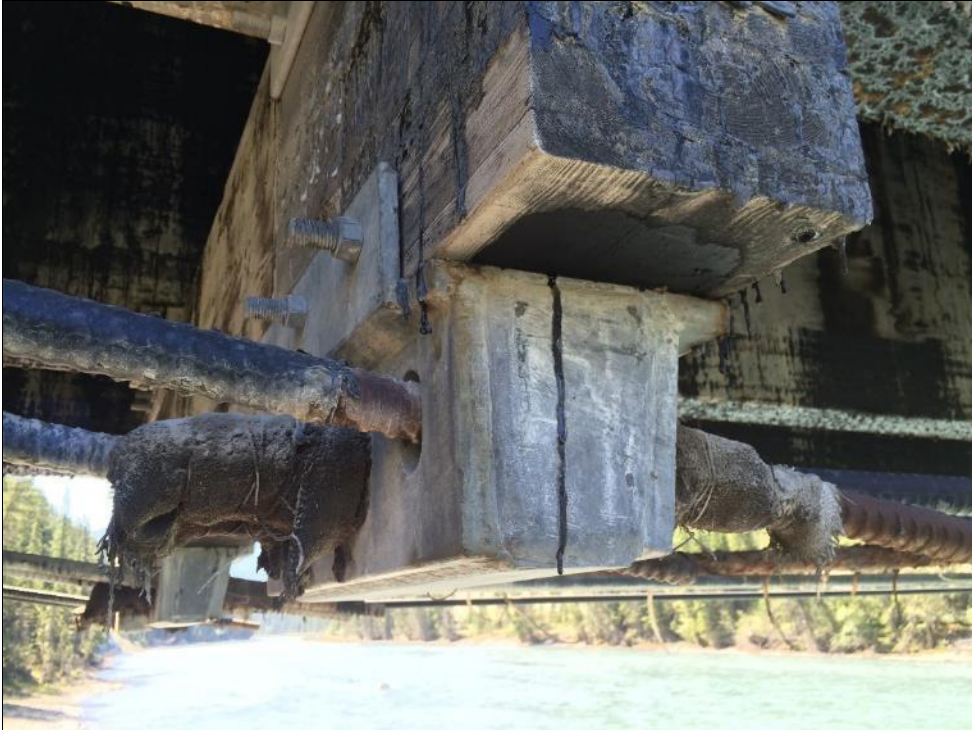
Photo #29  
Span 2 bolstering bracket

-Steel bracket and timber strut appears to be in good condition (typical).

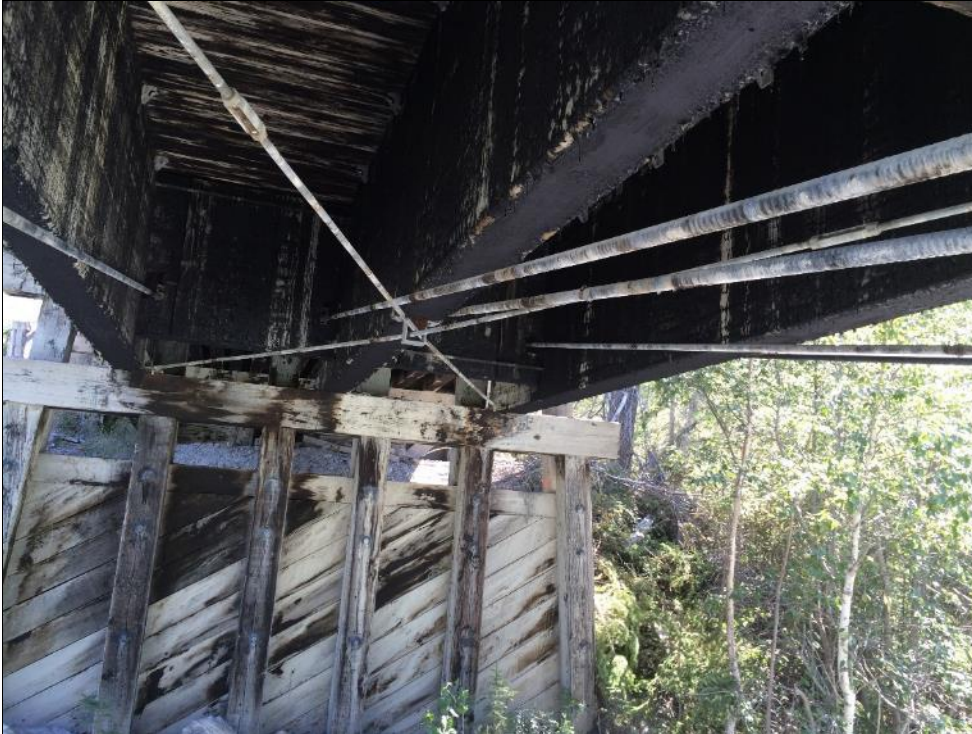
Photo #31  
Bolstering rods

-Bolstering rods appear to be in good condition with little damage to coatings except around anchorage ends.

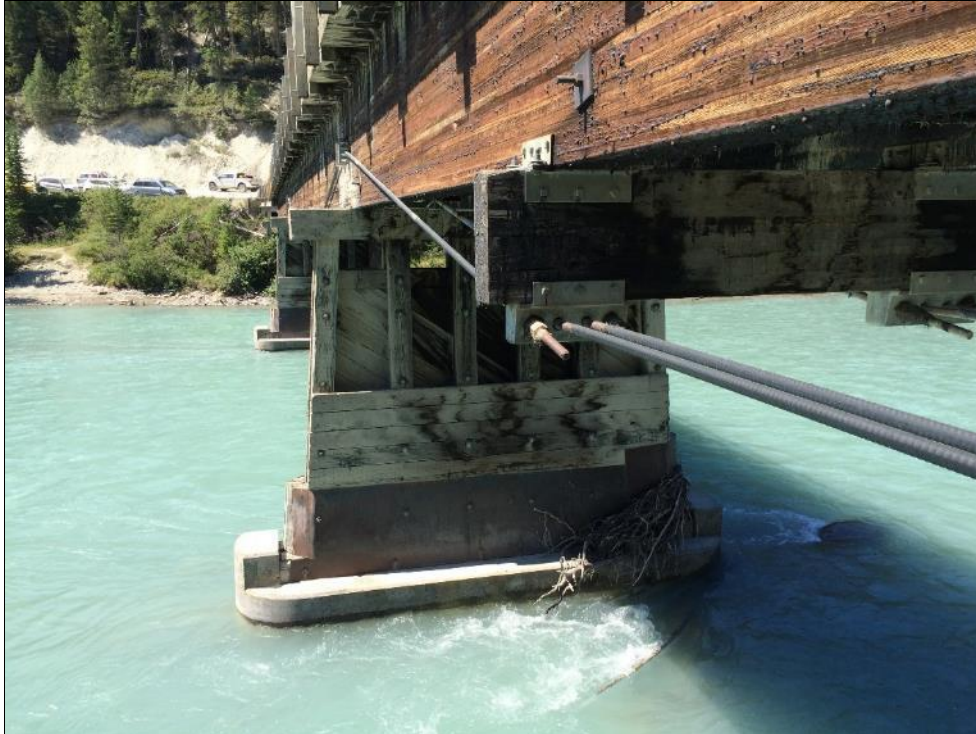
Photo #33  
Span 2, Girder 1, bolstering  
bracket 2, looking to Abutment 2

-Poor creosote coverage on  
exterior of Girder 3.

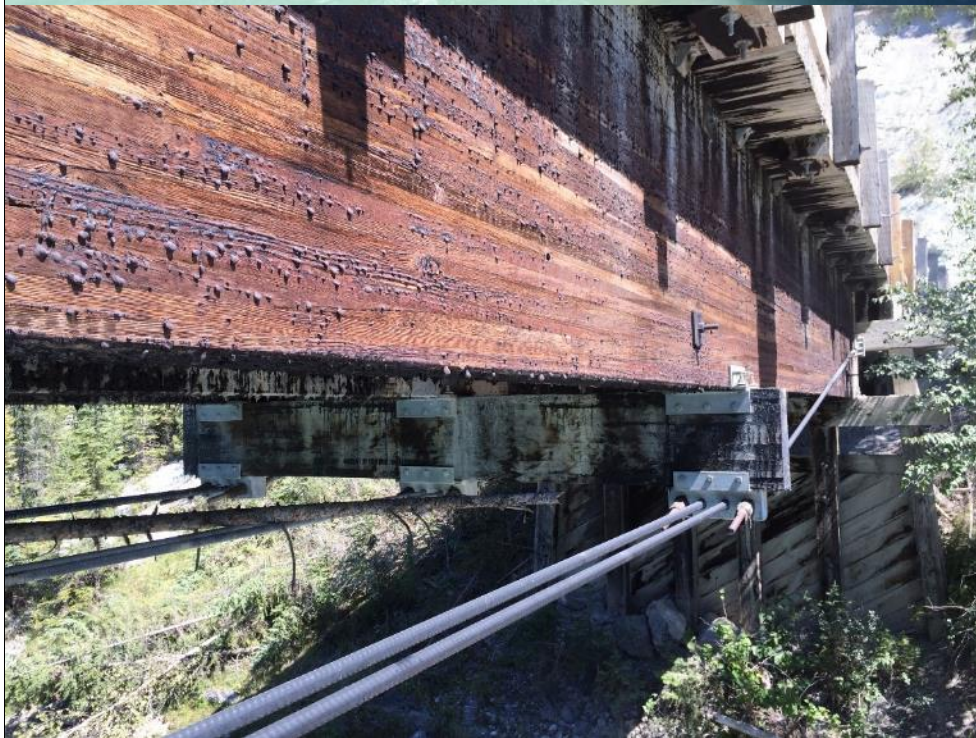
Photo #34  
Span 2, Girder 3, bolstering  
bracket 1, looking to Abutment 1

-Note log resting on bolstering  
rods between bracket 1 and 2,  
likely indicative of previous high  
water.

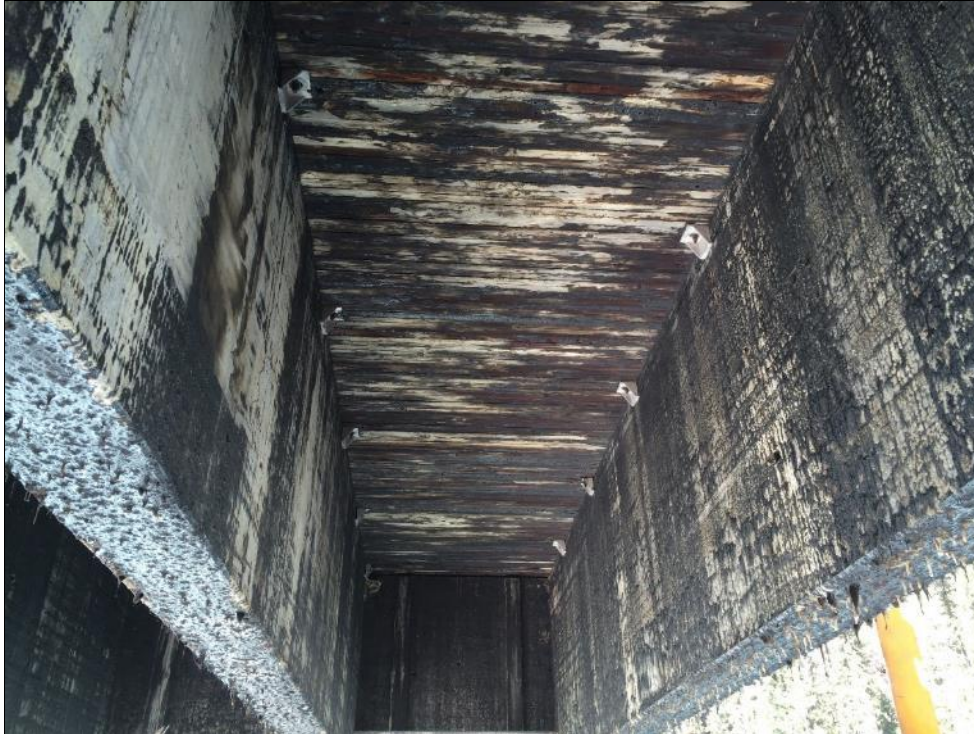
Photo #35  
Interior faces of Girder 2 & 3

Typical condition, with extensive creosote coverage remaining.

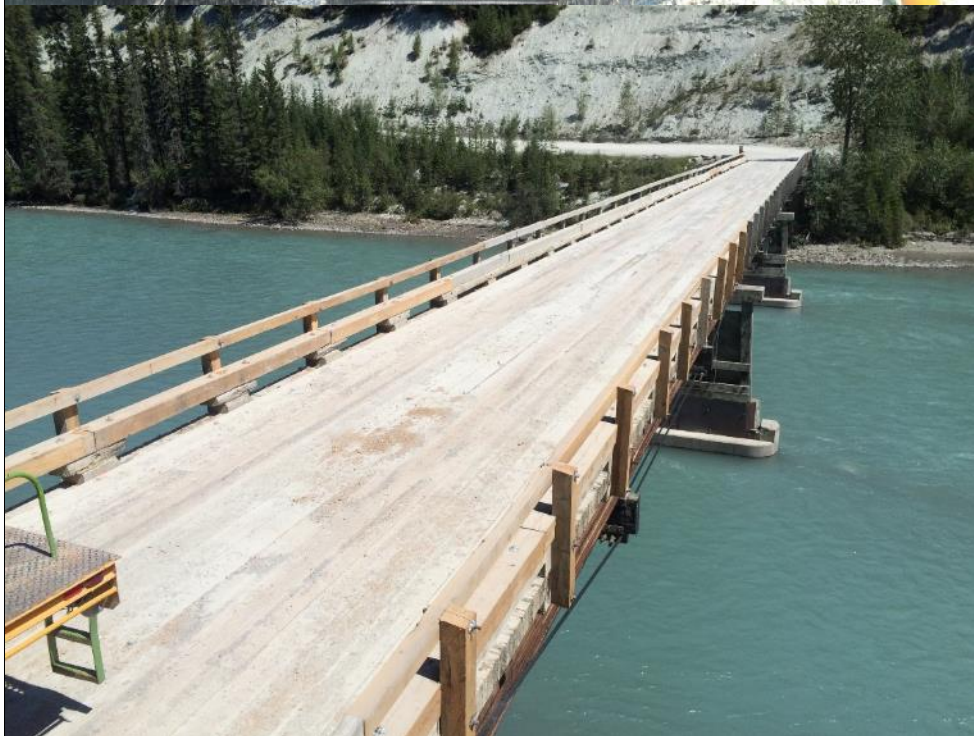
Photo #36  
Top of deck, looking to  
Abutment 1

- Approx 25% of curb / handrail has recently been replaced, however isolated sections of original curb rail was found to contain rot.
- Subdeck was found to be saturated, but no indications of rot were noted.
- Minor accumulation of granular debris on deck.

-Note that portions of the handrail has recently been replaced.
