## BRIDGE DATA:

| Bridge No./Name: | N2-130: White Swan FSR / White River (32.4km) |
| Inspection Date: | July 31, 2015 |

Steven Stanley, C.E.T.  
LEX3 Engineering Inc.

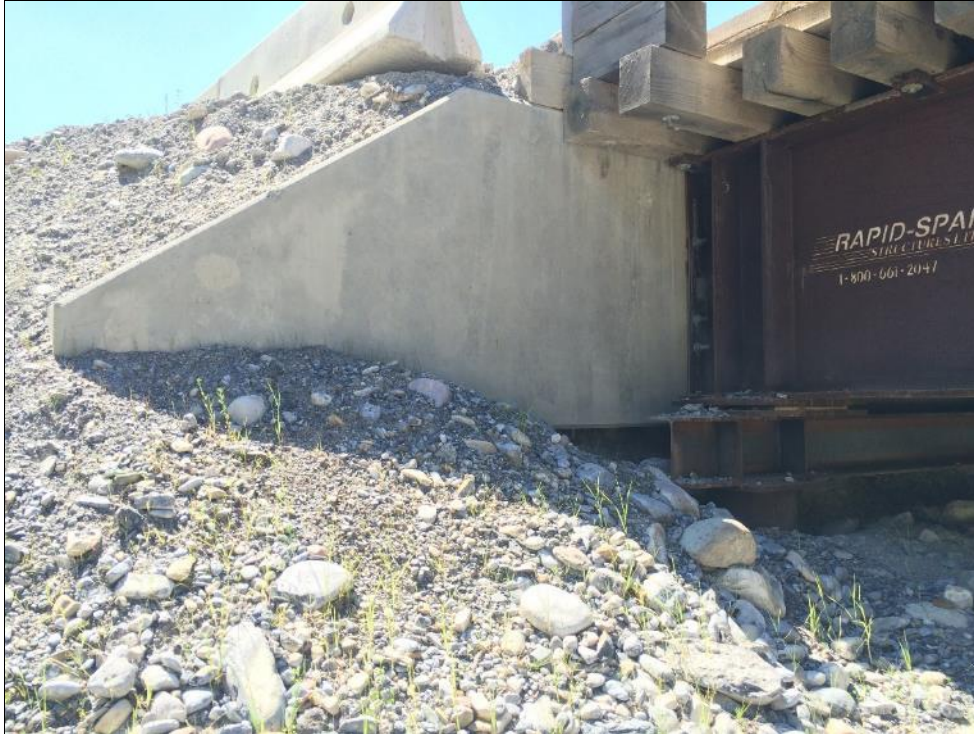
Photo #5  
Abutment 1 U.S side

- Well armored with adequately sized rip rap.
- Some sloughing of approach fill noted from under concrete ballast wall.
- Neoprene bearing pads are present and in good condition.
- Light surficial corrosion of steel caps, bracing and tops of piles.
- Damage / deformation noted on Diaphragm 1 steel angle that appears to have since been reinforced.

-Sloughing of approach fill noted from under concrete ballast wall.

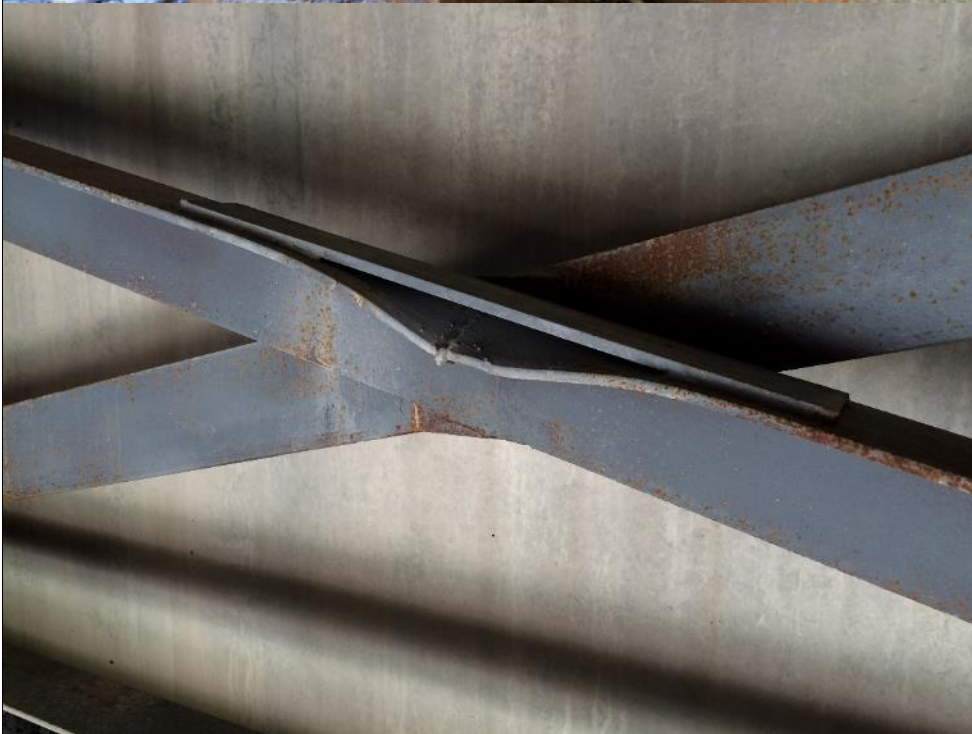
Photo #8  
Abutment 1 steel diaphragm

-Note deformation of steel angle leg that has since been stiffened.

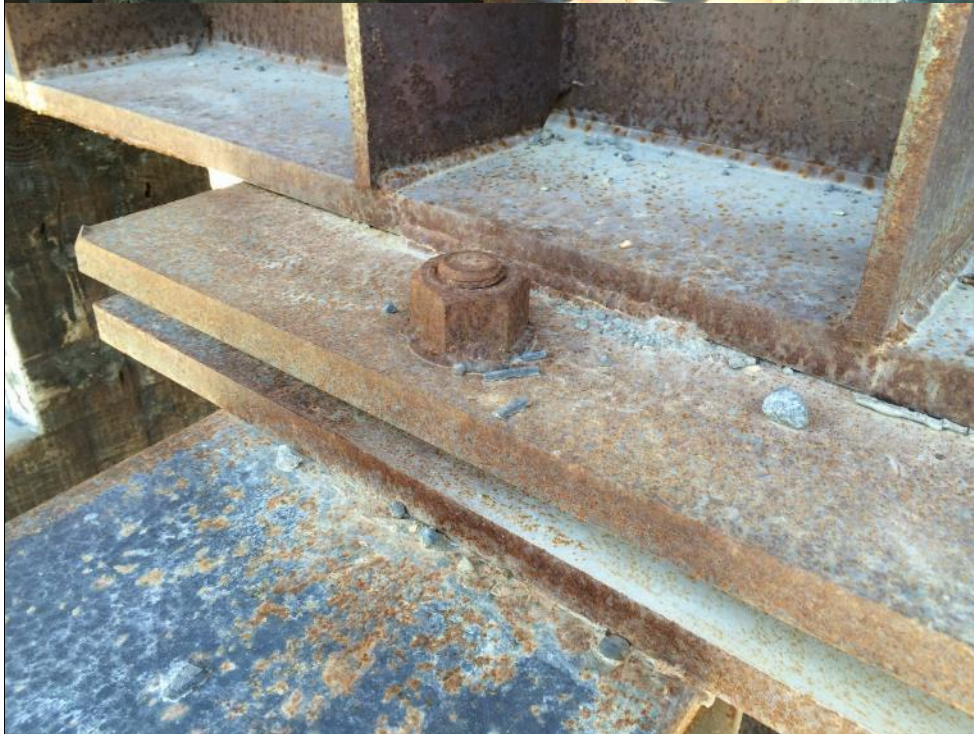
Photo #12  
Pier 1 bearing

-Note fixed bearings over this pier.

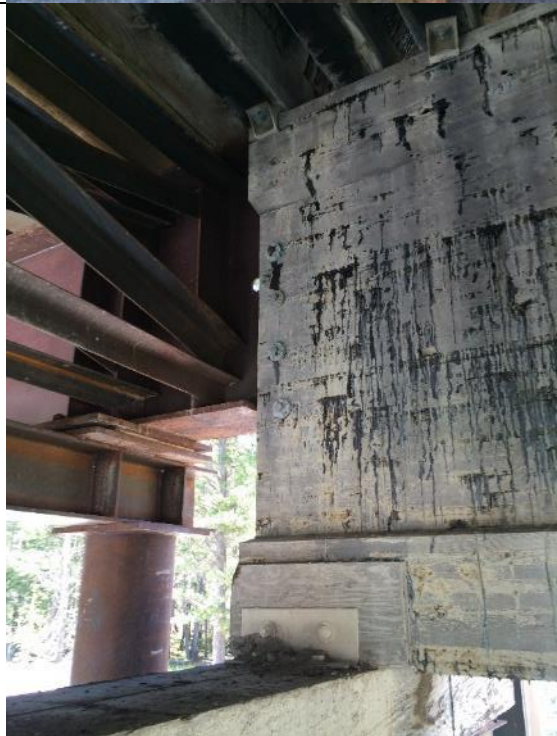
| | | | <p>Photo #14<br/>End of Girder 2 over Pier 1</p> <p>-Note no neoprene bearing pads under glulam girders.</p> |

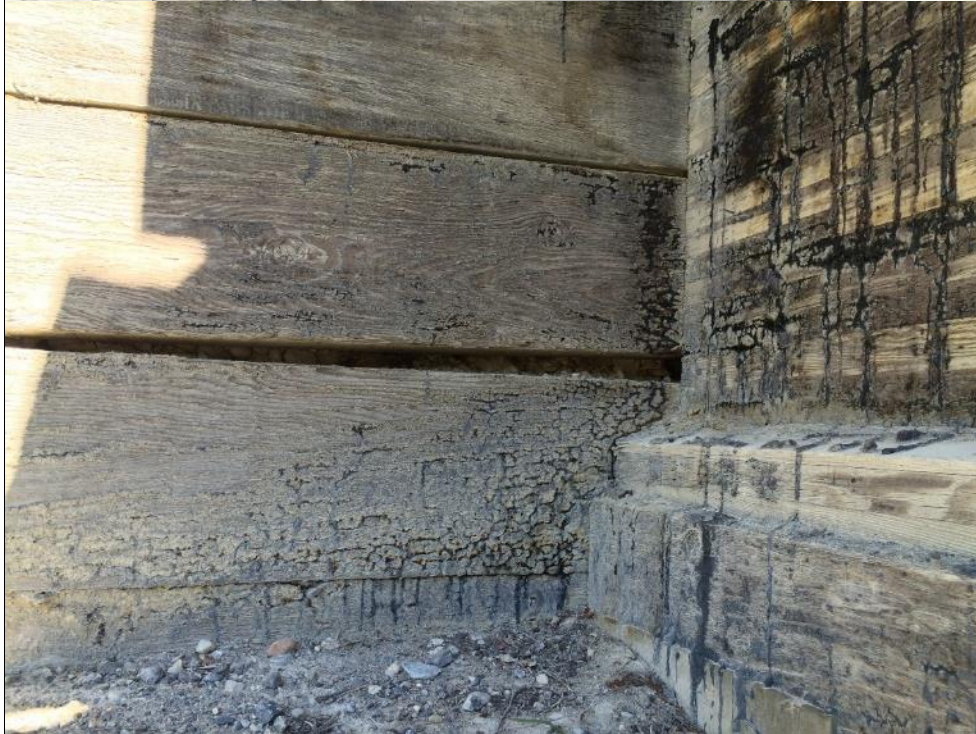
Photo #20  
Abutment 2 D.S. end of Girder 2 /  
ballast wall

-Note gap between timber  
ballast wall planks.

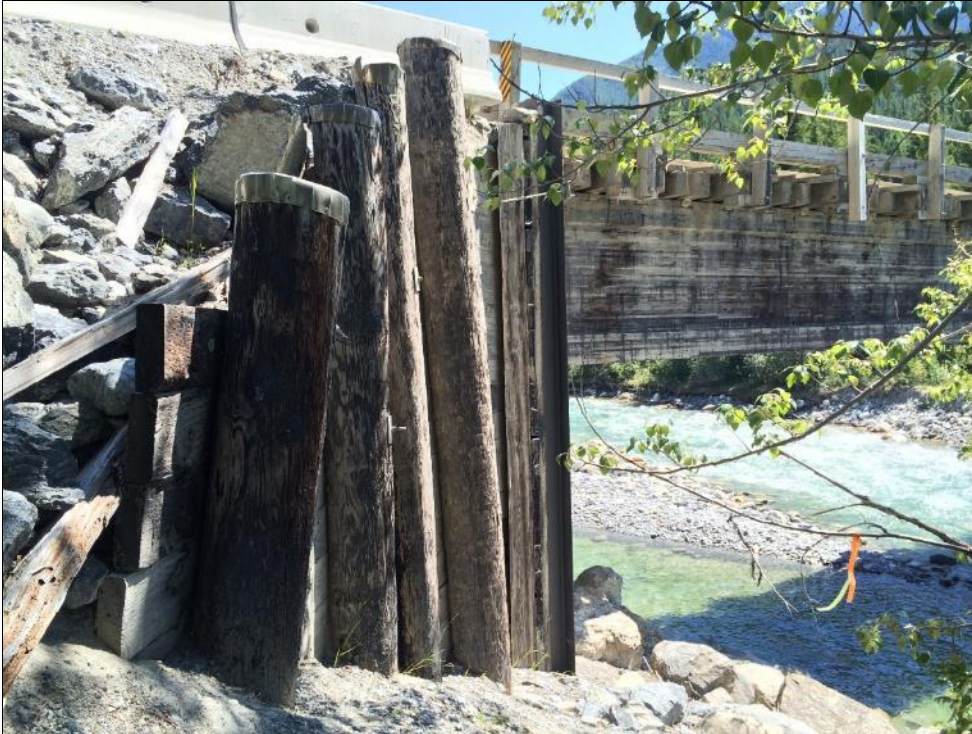
Photo #21  
Abutment 2 D.S wingwall

- Well armored with adequately sized riprap.
- Some sloughing of approach fill noted from under / through ballast wall.
- D.S end of timber pile cap has a full depth split.
- Isolated gaps noted between ballast wall planks.
- 2<sup>nd</sup> D.S wingwall, top of pile capping / flashing is damaged.
- 1<sup>st</sup> D.S wingwall pile is rotating inwards, towards the river approx 8°, remaining D.S wingwall piles are rotating outwards.

-Significant wingwall pile rotation noted.

| ITEM | DESCRIPTION | PRIORITY |
|---|---|---|
| 3 | Consider repairing / replacing Abutment 2 D.S wingwall. | Medium |

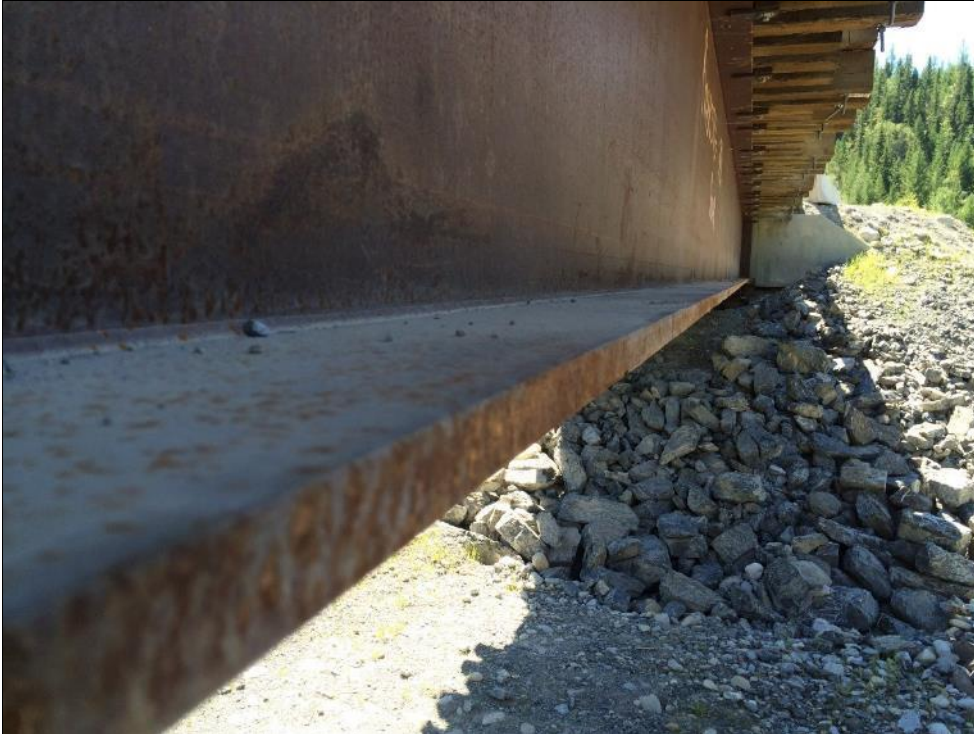
Photo #23  
Span 1, Girder 2 looking to  
Abutment 1

- Girder 1:
  - Minor variations / rippling noted along the bottom flange profile, beginning approx. 3 m from the pier end.

-Minor profile variations  
(rippling) in bottom flanges  
noted.

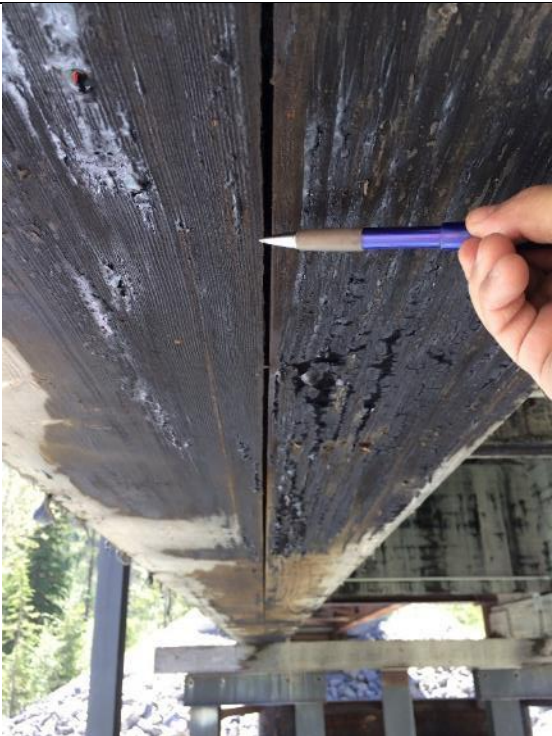
- Girder 1:
  - Creosote coverage of approx. 30 – 40% remaining on interior face.
  - Creosote coverage of approx. 25 – 50% remaining on exterior face.
  - Wide (7mm), shallow (40mm) long (approx. 30m) split in the underside of bottom flange (bottom lamination), beginning at the pier.

| | | <p>Photo #25<br/>Span 2, Girder 1 underside<br/>looking to Abutment 1</p> |

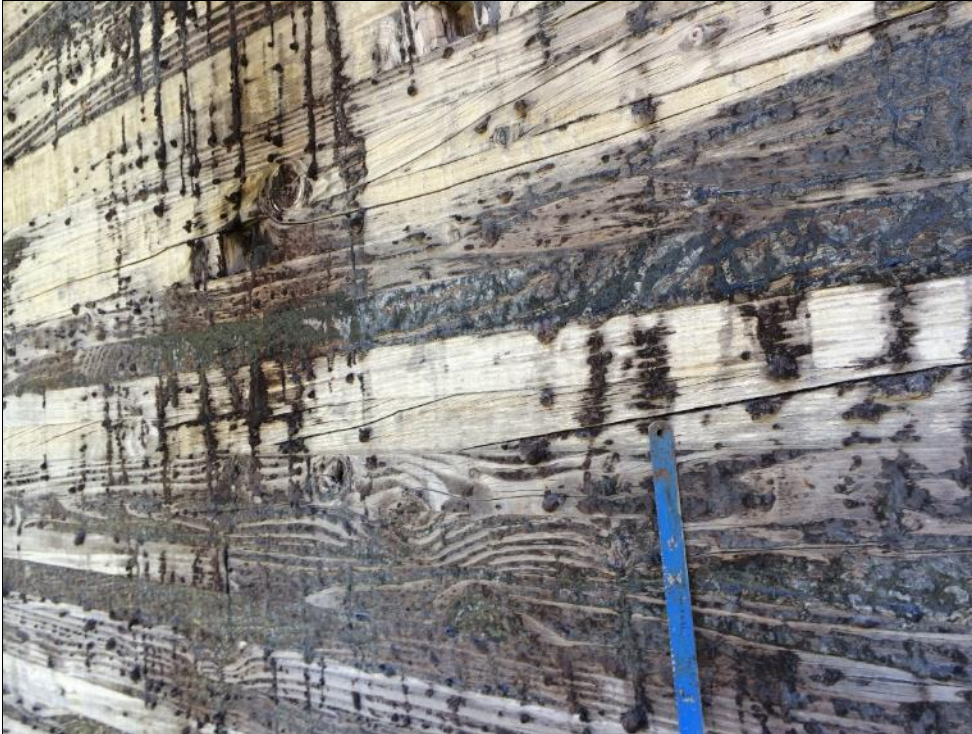
Photo #27  
Span 2, Girder 2

- Girder 2:
  - Creosote coverage of approx. 25% remaining on exterior face.
  - Creosote coverage of approx. 30-40% remaining on interior face.
  - Regular, narrow, shallow, short splits throughout.

-Regular, narrow, shallow, short discontinuous splits throughout girder face.

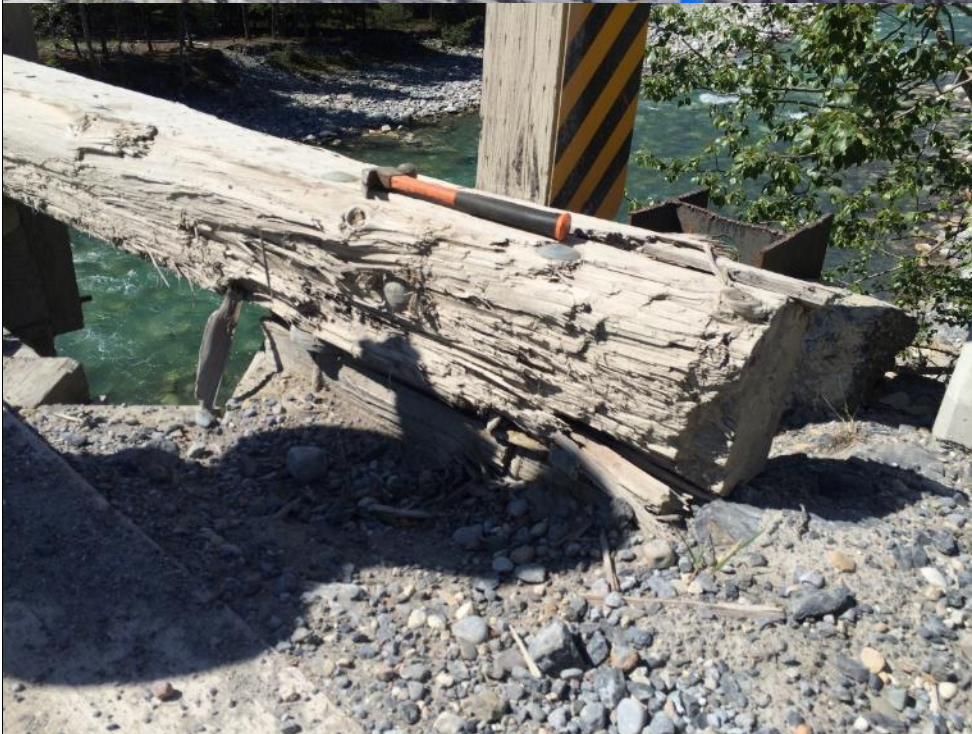
Photo #28  
End of curb rail at Abutment 1

-Note damaged curb rail

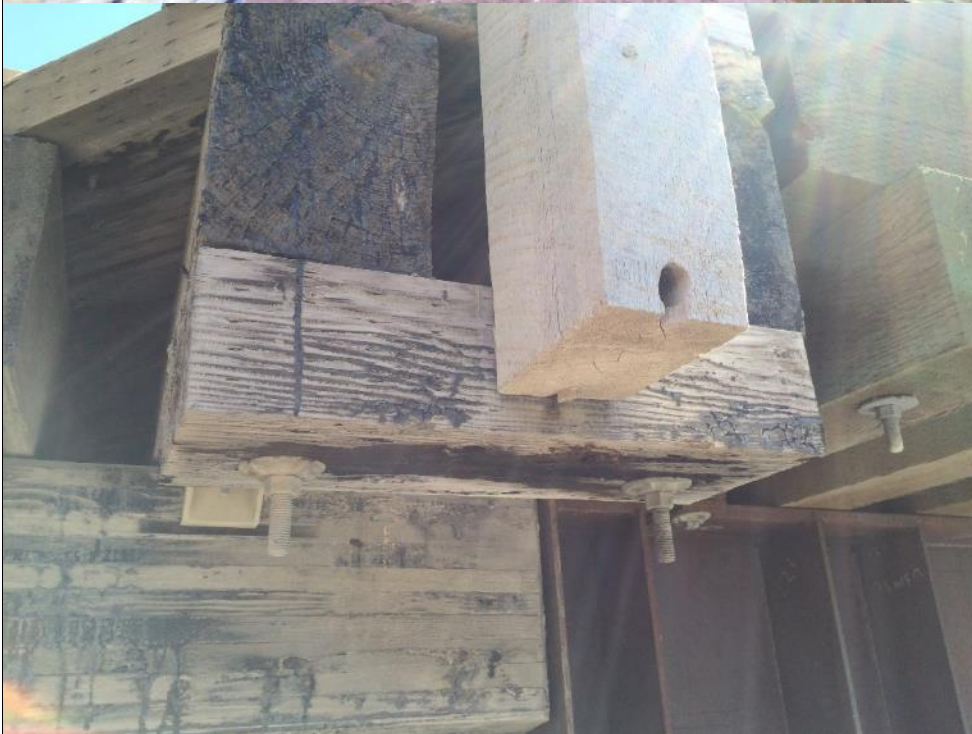
Photo #30  
Span 2 (old) deck structure

-Note diagonal sub-deck
