## BRIDGE INSPECTION

**BRIDGE NO.** N3-044: Sullivan FSR  
(68.20 km)

**Inspection Date:** September 22, 2012

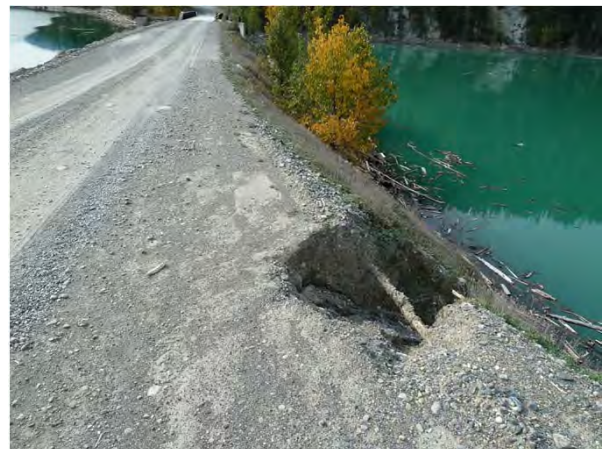
- The approaches are generally in fair condition.
- Bank eroding due to road runoff, 100 m away from camp end abutment.

| Fill | Fair | Fill material being lost from gaps in ballast wall planks. Minor fill erosion at camp end downstream embankment adjacent to wing wall. |

| Road Surface | Fair | Section of road/ bank sloughing on camp end downstream, appx 1 cubic meter. |

**Figure 1-6: Bank erosion on camp end approach.**

| Items | Description | Priority |
|---|---|---|
| 4. | Repair bank erosion on camp end approach. Replace lost fill material and add riprap to stabilize the bank. | Medium |

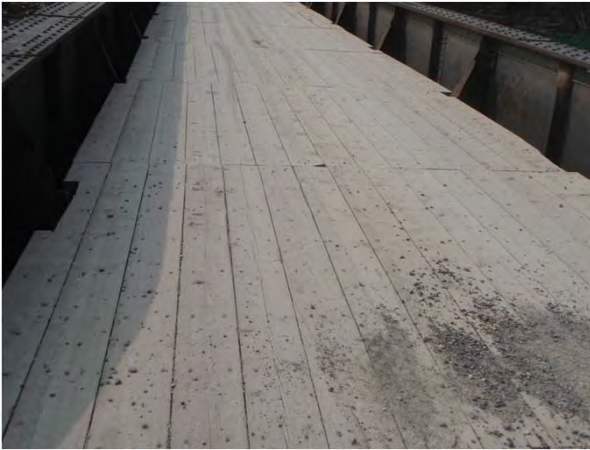
| Running Planks | Good | Wearing planks sit directly on ties. Replaced since 2011 inspection. |

**Figure 1-7: Wearing surface.**

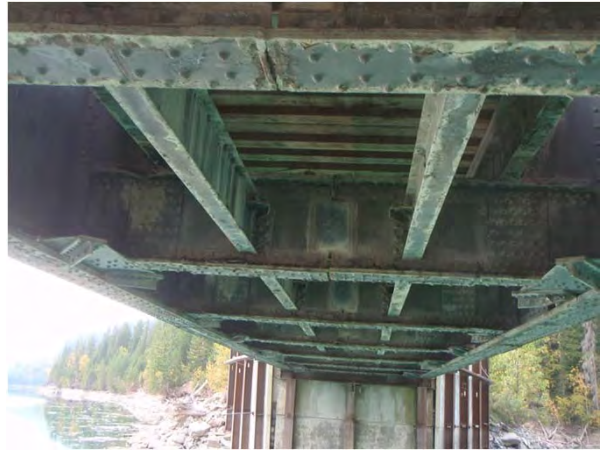
**Figure 1-8: Underside of deck.**

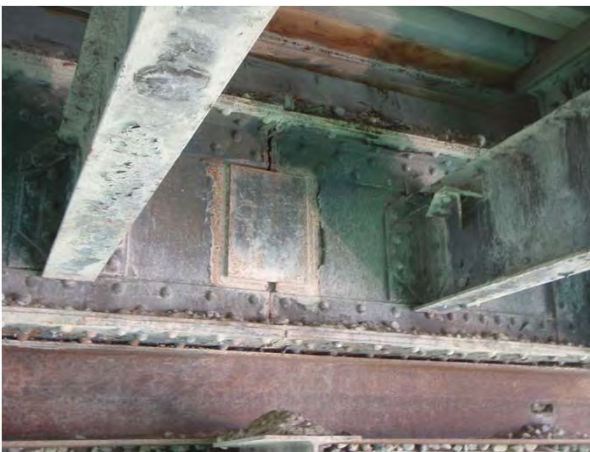
**Figure 1-9: End beam splice connection.**

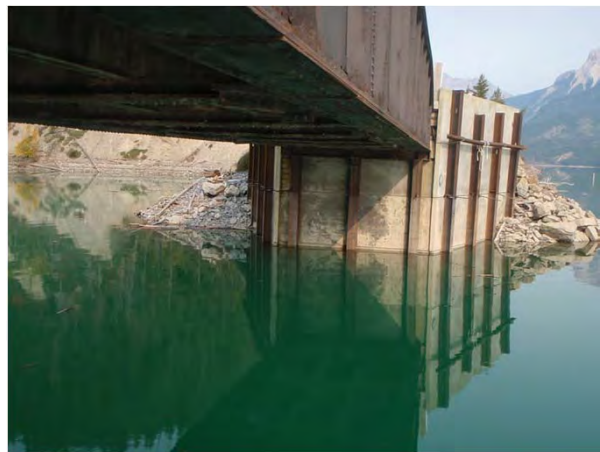
**Figure 1-10: Camp end abutment.**

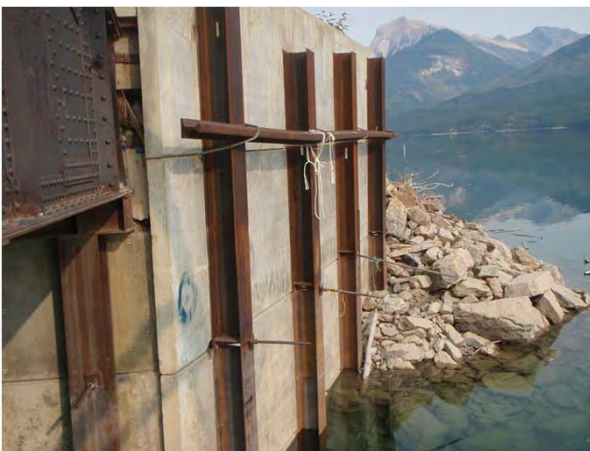
**Figure 1-11: Camp end upstream wing wall.**

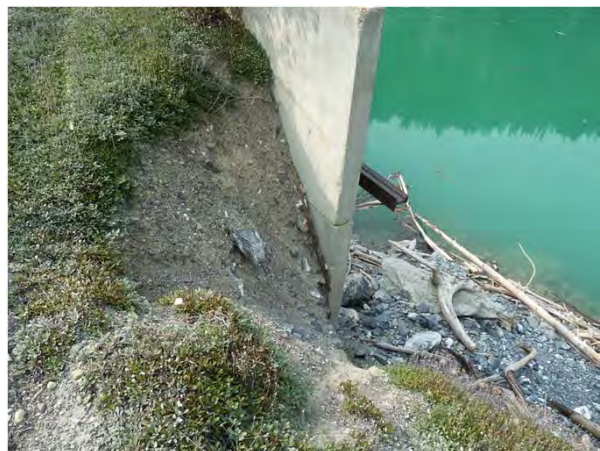
**Figure 1-12: Camp end downstream embankment.**

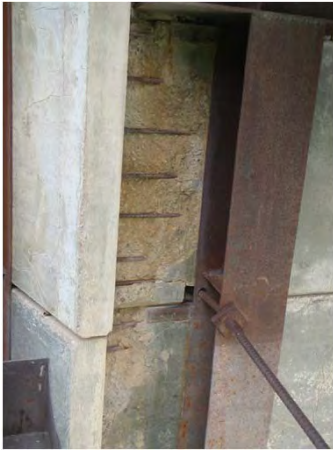
| Ballast Wall | Fair | Camp end breast wall spalling heavily along downstream end with exposed reinforcement; delamination noted near bottom; Ballast walls are still structurally sound. Upper timber ballast wall planks at both abutments are rotten and have fallen apart allowing fill to be pushed out. |

**Figure 1-13: Camp end ballast wall downstream.**

| Items | Description | Priority |
|---|---|---|
| 1. | Repair concrete spalls on the camp end breast wall panel. | Medium |

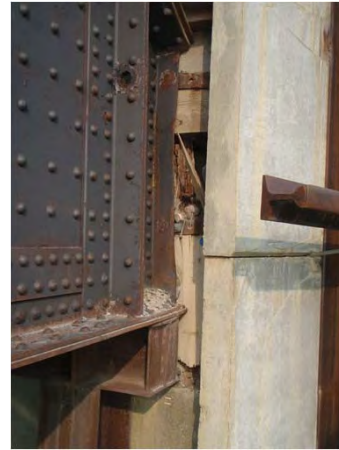
**Figure 1-14: Camp end upstream ballast wall.**

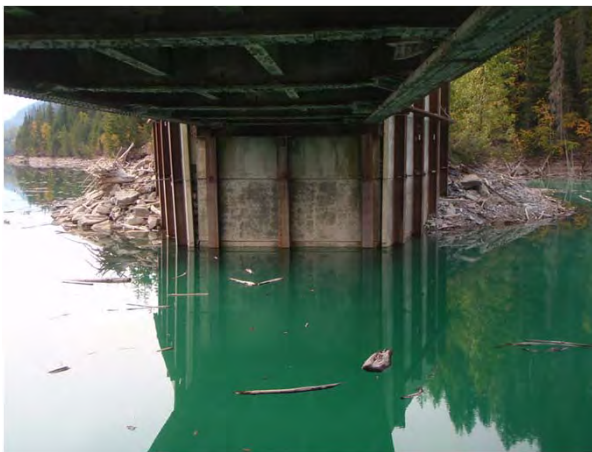
**Figure 1-15: Woods end abutment.**

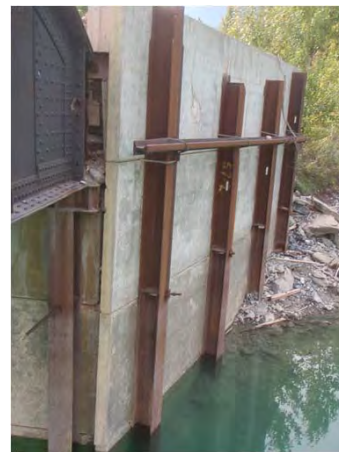
**Figure 1-16: Woods end downstream wing wall.**

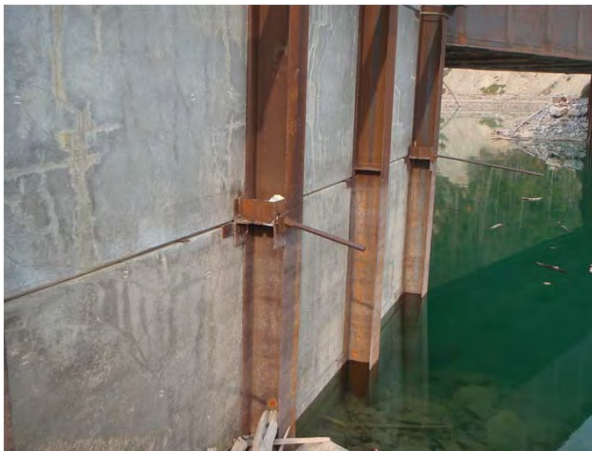
| Wing Wall | Fair | Dywidag rod failed on woods end upstream wall. Rod needs to be tightened on woods end upstream side. Woods end wing walls are leaning outwards creating a 75-100mm gap between the ballast wall. Woods end downstream wing wall piles are not vertical (5 mm over 600 mm). Woods end upstream wing wall piles are not vertical (12 mm over 600 mm.) |

**Figure 1-17: Woods end upstream wing wall, note missing anchor.**

| Items | Description | Priority |
|---|---|---|
| 2. | Repair and tighten woods end wing walls Dywidag rods as required. | Medium |

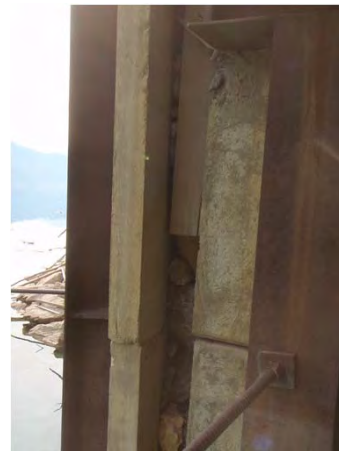
**Figure 1-18: Woods end upstream wing wall gap.**

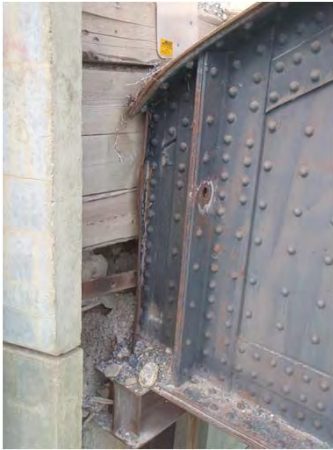
**Figure 1-19: Woods end upstream planks missing.**

| Items | Description | Priority |
|---|---|---|
| 3. | Replace rotten ballast wall planks on upper section of walls. | Medium |
