## BRIDGE INSPECTION

**BRIDGE NO./NAME**            **N4-015: Downie FSR (15.4 KM)**

**Inspection Date:**        September 21<sup>st</sup> 2012

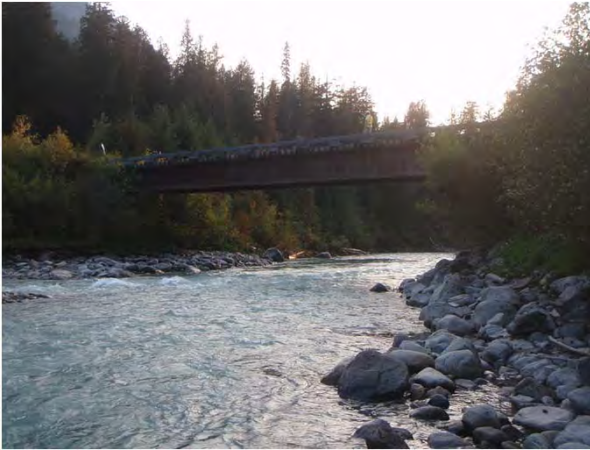
**Figure 1-1: Upstream elevation.**

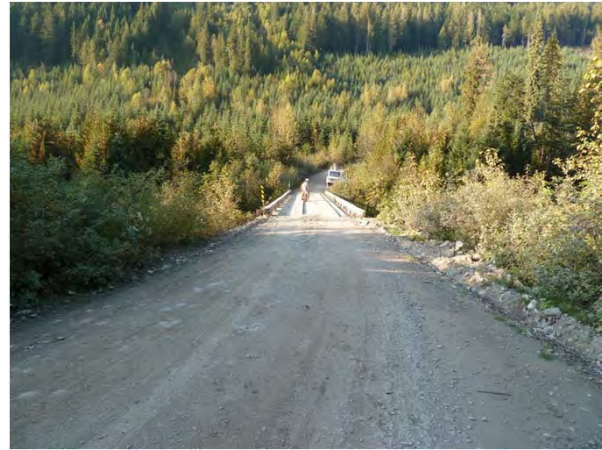
**Figure 1-2: Looking towards woods end.**

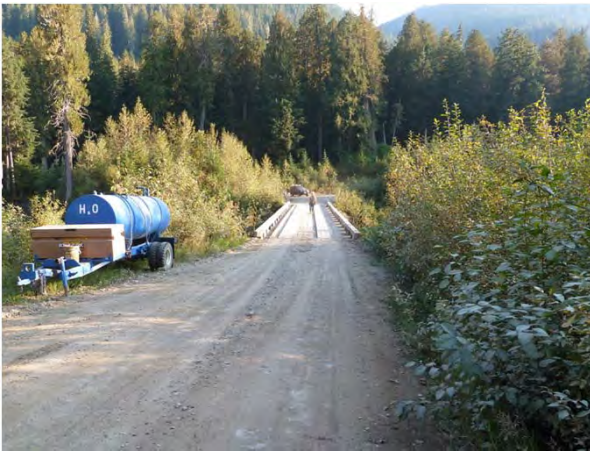
**Figure 1-3: Looking towards camp end.**

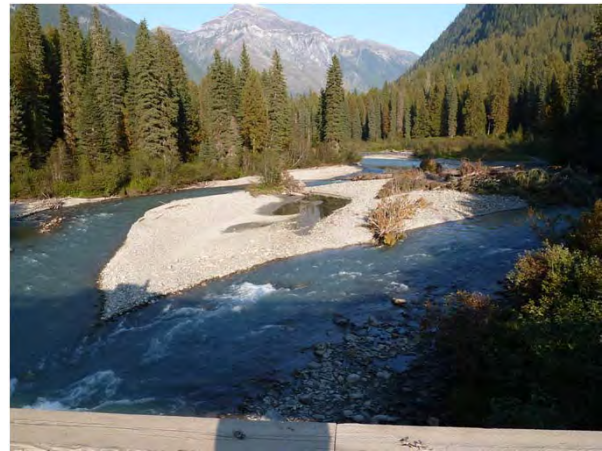
**Figure 1-4: Looking upstream.**

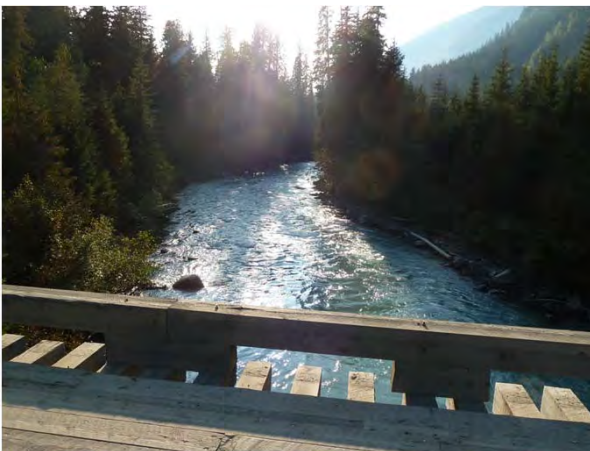
**Figure 1-5: Looking downstream.**

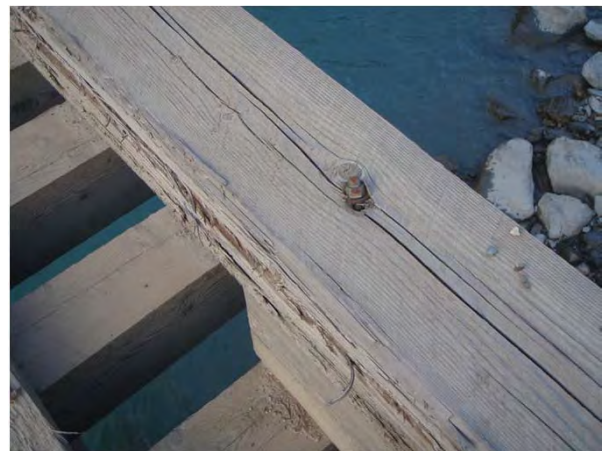
| Hardware | Fair | Impact damage to bolts on upstream curb rail. Incorrect bolts and washers used for the curb rail, malleable washers have not been installed. |

**Figure 1-6: Typical damaged curb rail bolt on upstream rail (note no malleable washer).**

| | 1 | Recommended | High | \$2,500.00 | Replace curb rail hardware and install additional bolts to conform to Ministry standards |

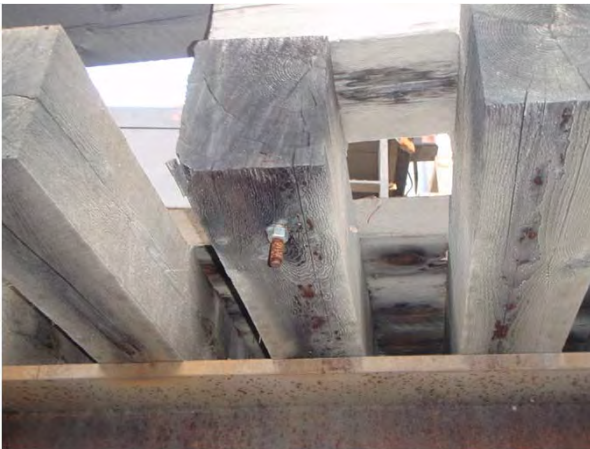
**Figure 1-7: No malleable washer on underside of curb rail connection.**

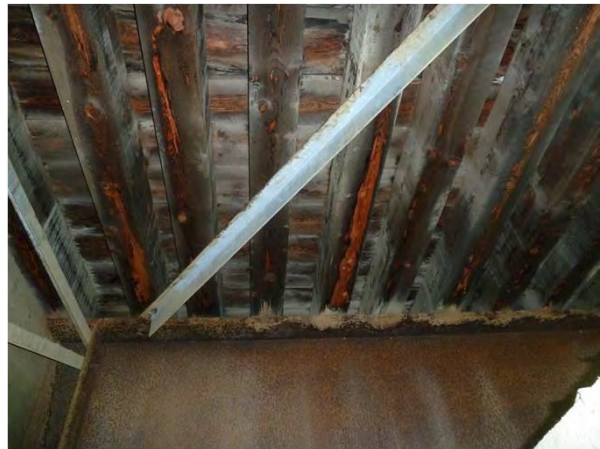
| Sub Deck | Fair | Minor conk growth observed on the underside of the deck. |

**Figure 1-8: Typical condition of underside of deck.**

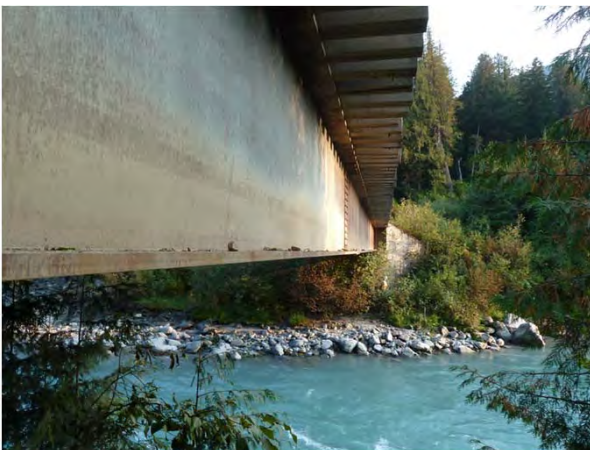
**Figure 1-9: Downstream face looking towards camp end.**

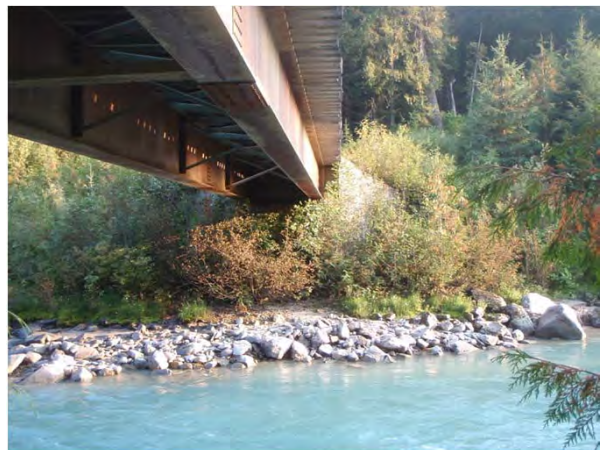
**Figure 1-10: Camp end abutment.**

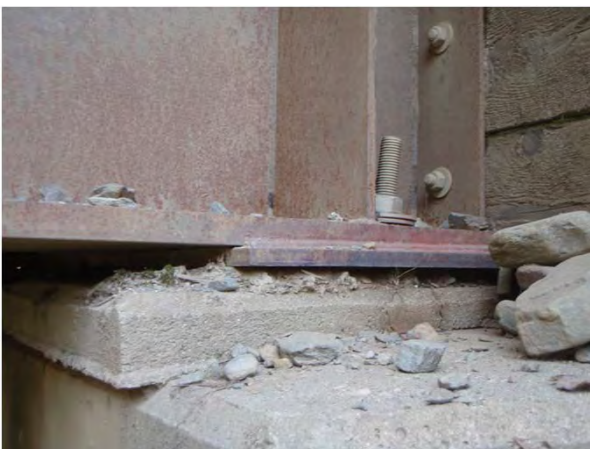
**Figure 1-11: Camp end downstream bearing.**

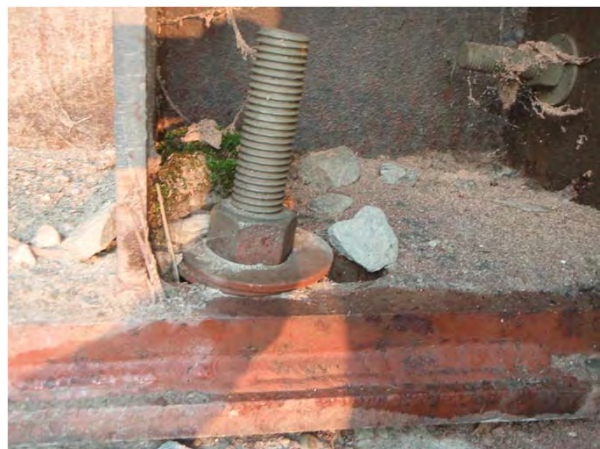
| Hardware | Fair | Anchor bolts are bent away from stream, condition unchanged. |

**Figure 1-12: Slotted plate and bent anchor bolt on camp end downstream corner.**

| | 1 | Continue monitoring the condition of the abutment anchor bolts. |

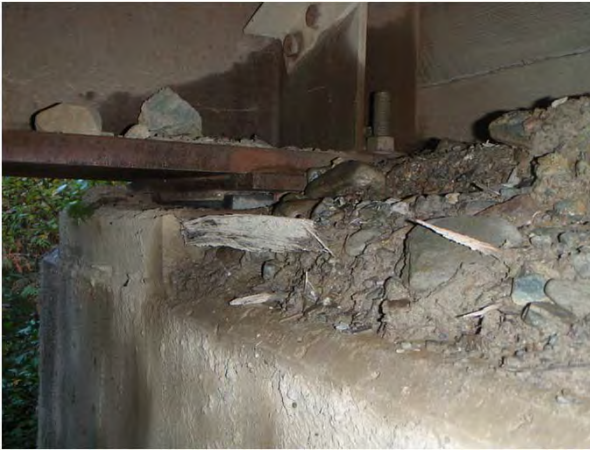
| Bearings | Fair | Debris accumulation on bearings. |

**Figure 1-13: Camp end upstream bearing (note debris accumulation in bearing area.**

| | 3 | Recommended | Low | \$300.00 | Clean debris from bearing areas. |

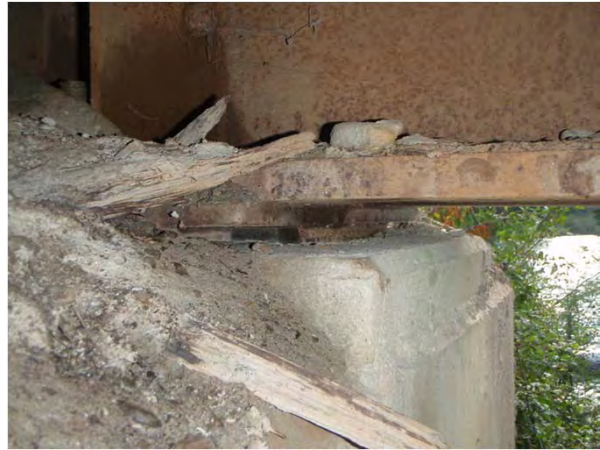
**Figure 1-14: Camp end downstream bearing.**

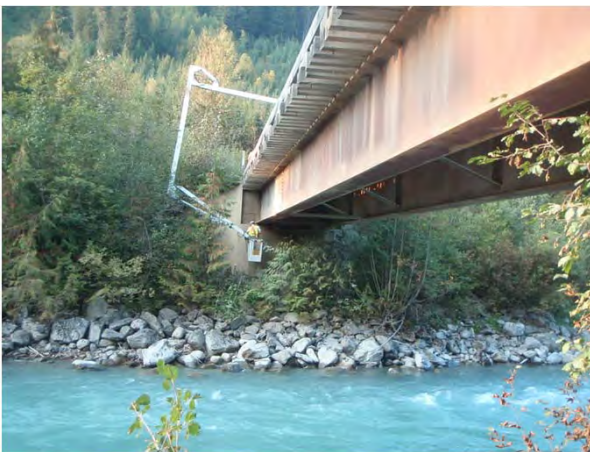
**Figure 1-15: Woods end abutment.**

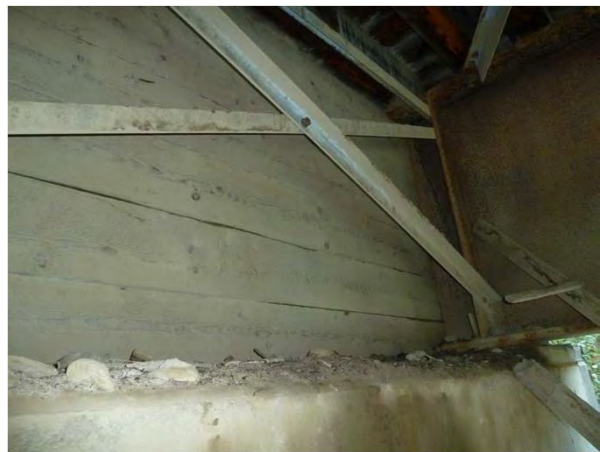
**Figure 1-16: Woods end ballast wall.**

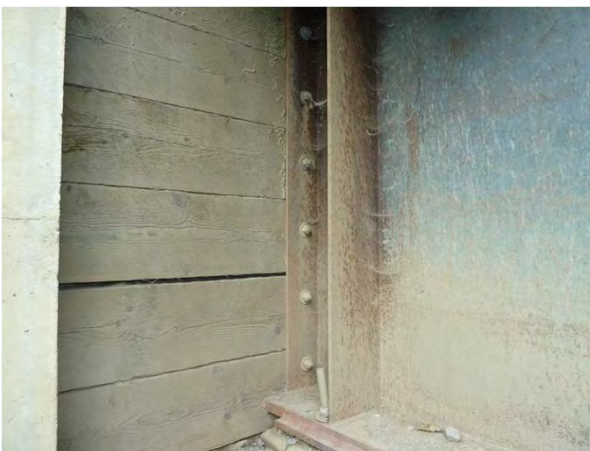
**Figure 1-17: Typical ballast wall to girder connection.**

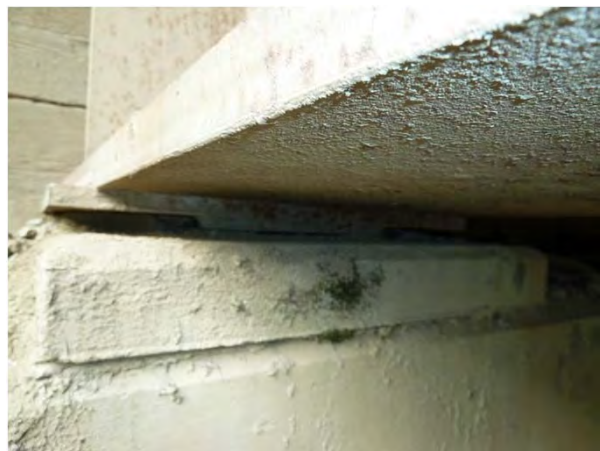
**Figure 1-18: Woods end downstream bearing.**

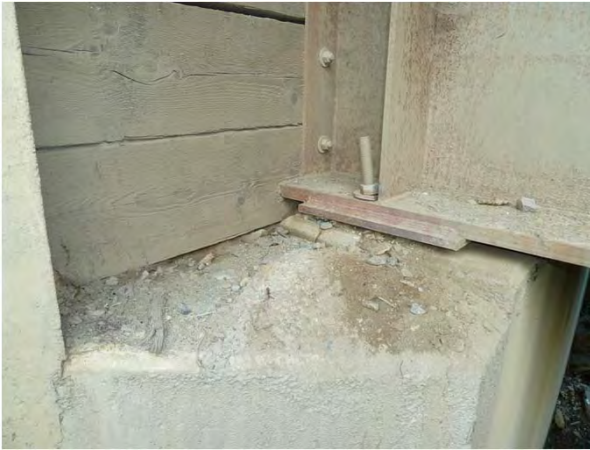
**Figure 1-19: Bent anchor bolt woods end downstream side.**

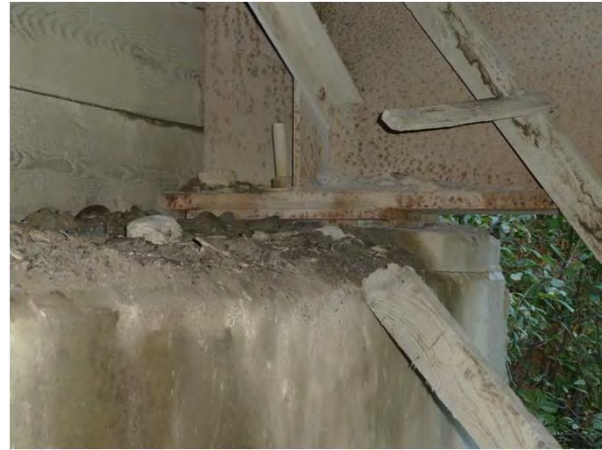
**Figure 1-20: Woods end upstream bearing.**
