## BRIDGE DATA:

| Bridge No./Name: | SC- 8165: Sechelt Wilson FSR/ Hudson Creek (0.5Km) |
| Inspection Date: | June 24, 2015 |

## 2015 Close Proximity Bridge Inspection

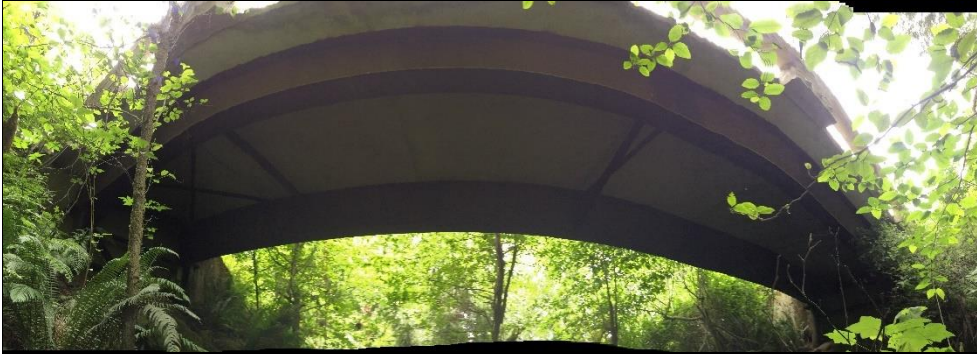
Photo #1  
Downstream elevation /  
underside

-Note panorama photo which  
makes the bridge look curved.

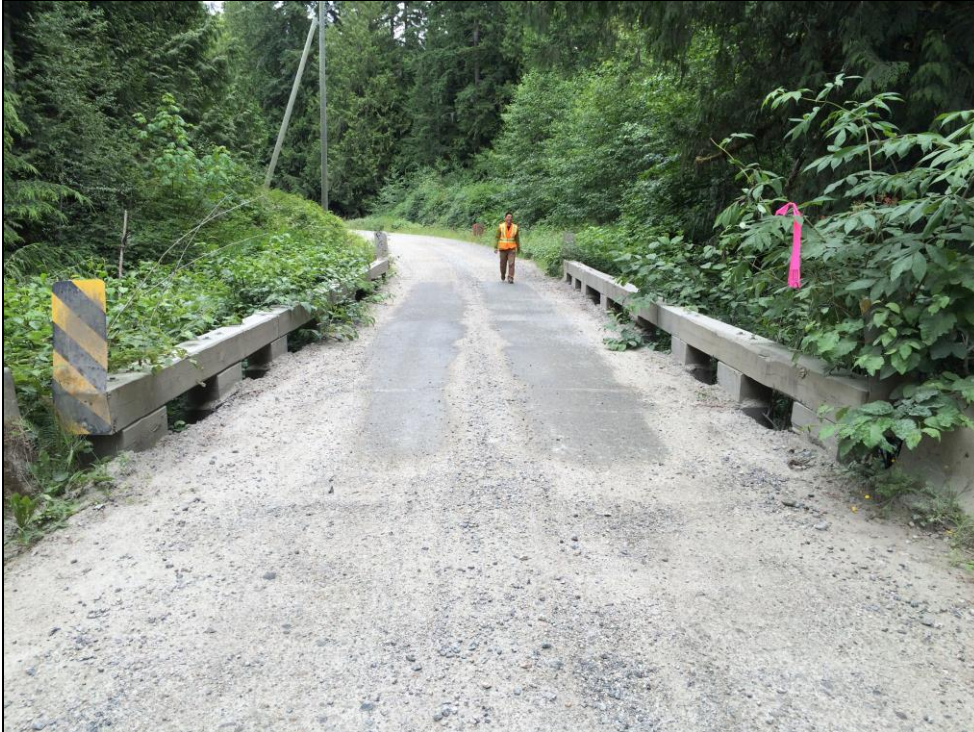
Photo #5  
Camp End (A2) Approach

-Foliage overgrowth obscuring  
bridge marker

| ITEM | DESCRIPTION | PRIORITY |
|---|---|---|
| 1 | Brushing at approaches. | High |

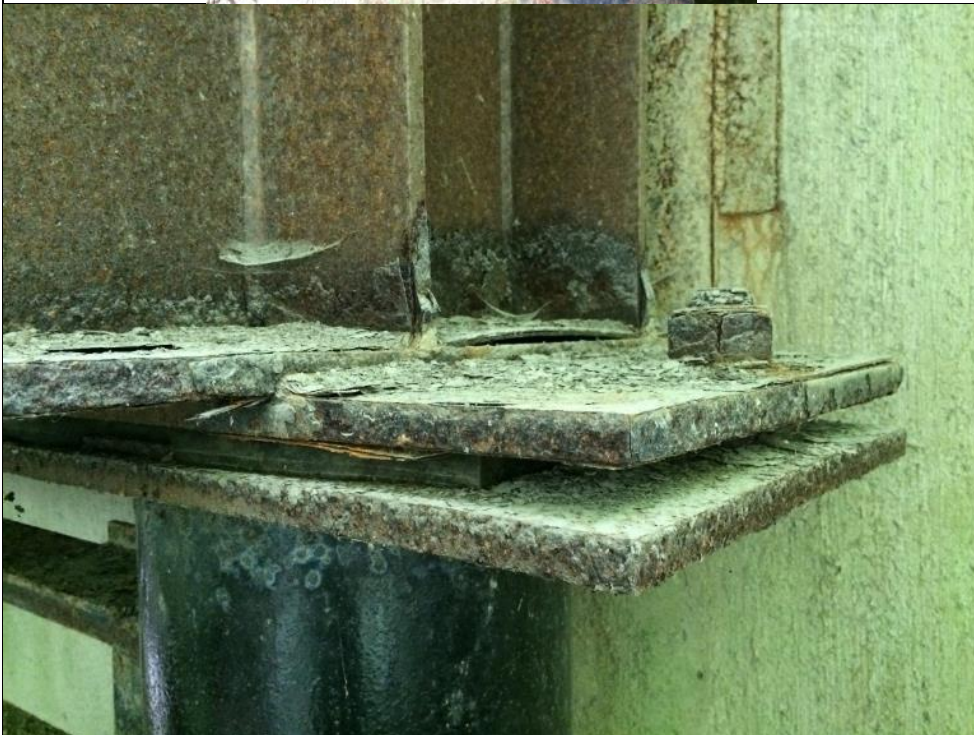
| | <p>Photo #10<br/>Camp end (A2) U.S bearing</p> <p>-Light laminating corrosion</p> | | |

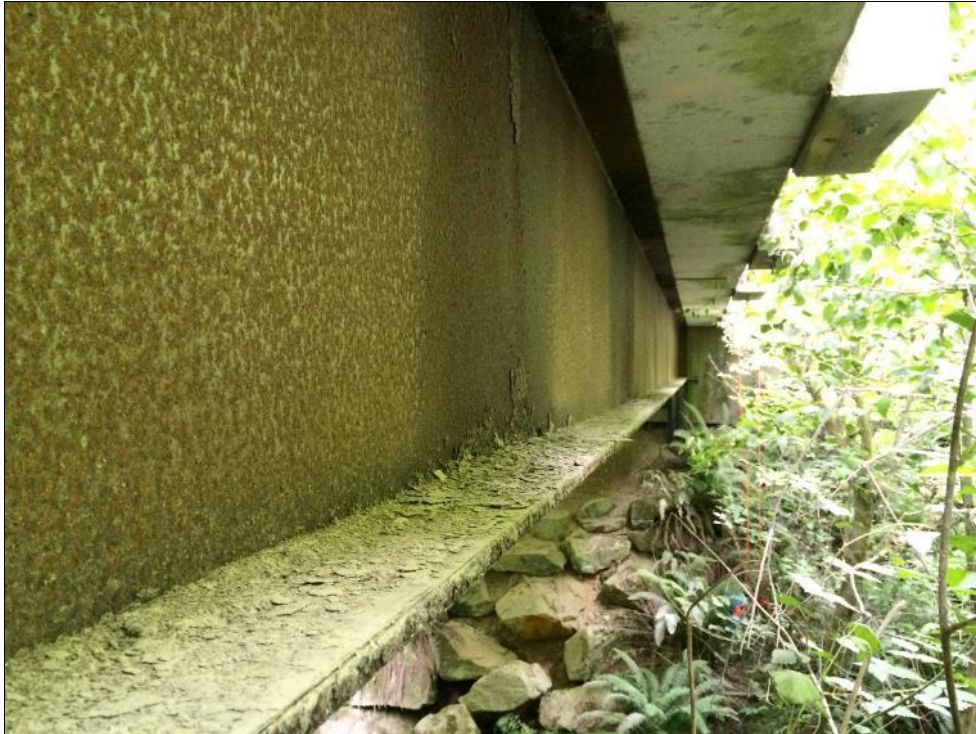
Photo #15  
Girder 2 exterior / D.S face  
looking to woods end

- Light to moderate surficial corrosion throughout with isolated areas of light to moderate laminating corrosion that appear to be concentrated at deck panel joints, with an estimated section loss of  $\leq 5\%$  in localized areas.
- Minor accumulation of debris along top of bottom flanges.
- Light to moderate surficial corrosion of steel angle diaphragms.

-Light to moderate surficial corrosion throughout, with light laminating corrosion near deck panel joints.

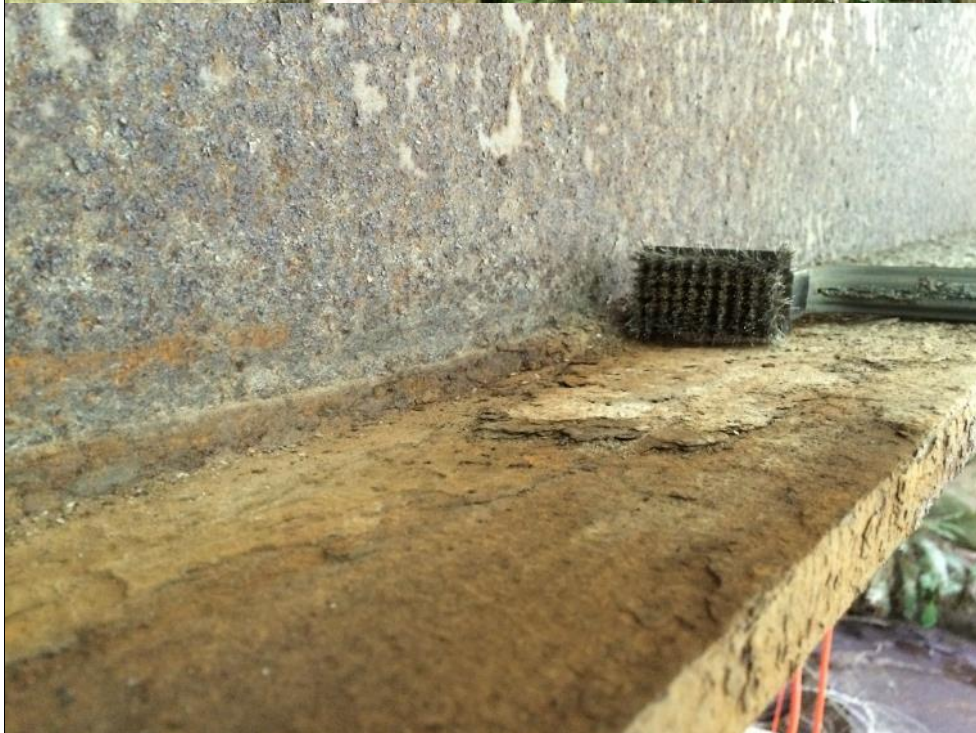
Photo #16  
Girder 2 exterior / D.S face

-Close view of top of bottom flange of girder with area of laminating corrosion cleaned off.

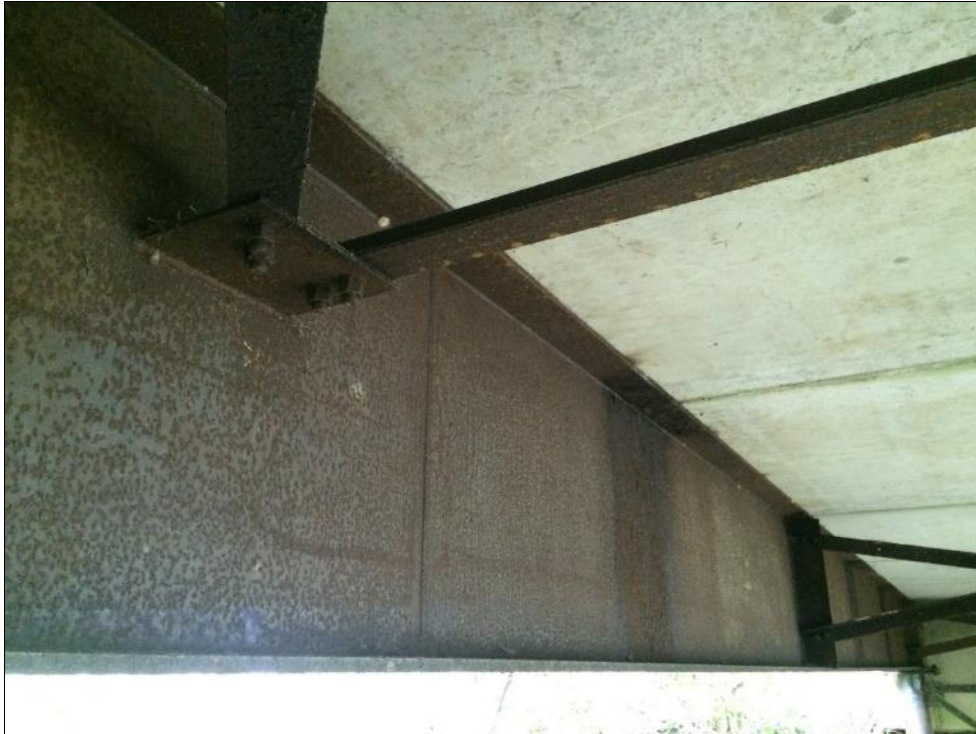
Photo #17  
Interior face of girder /underside  
of deck

-Typical condition of interior face  
of girder, bracing, and underside  
of deck.

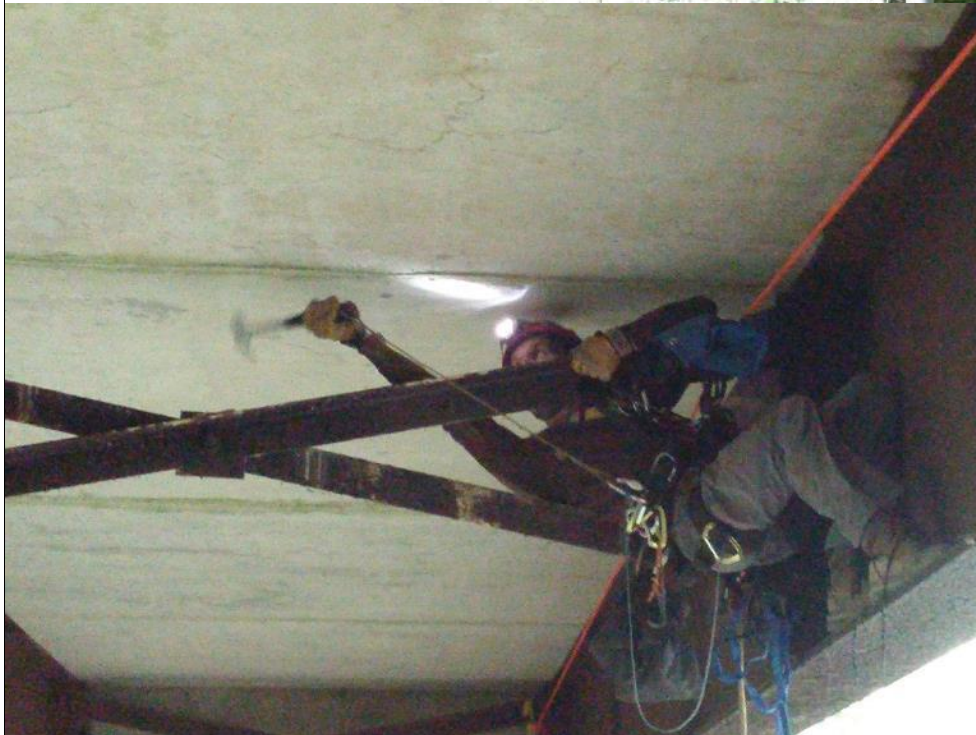
Photo #18  
Underside of deck

-Inspection of underside of deck  
and interior faces of girders.

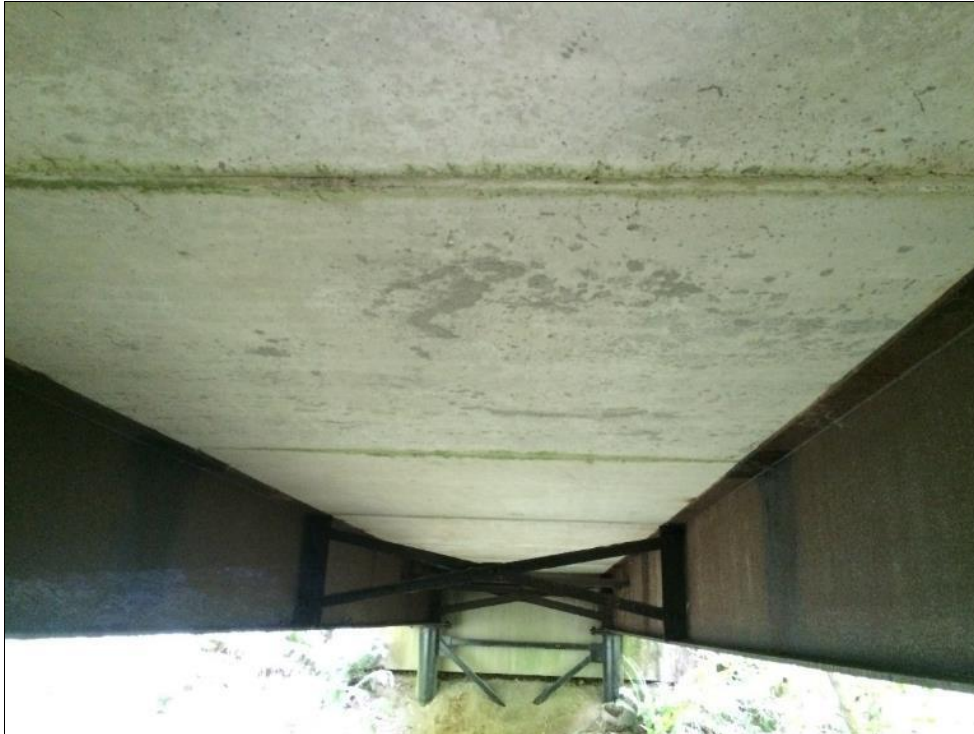
Photo #19  
Underside of deck

-Typical condition of underside of deck panels.

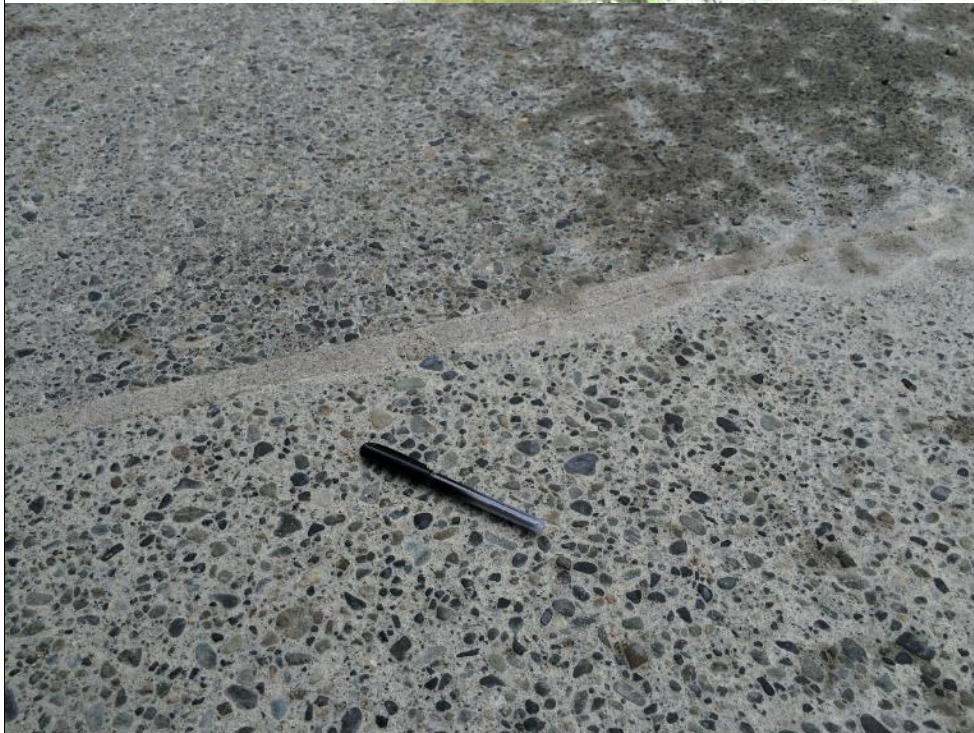
Photo #20  
Wearing surface

- Moderate amount of gravel debris accumulated on deck.
- Moderate abrasion wearing of concrete deck panels, with exposed aggregate throughout. No exposed reinforcing.

-Typical condition of wearing surface with exposed aggregate, and deck panel grouted joint.

| ITEM | DESCRIPTION | PRIORITY |
|---|---|---|
| 5 | Clear off accumulated gravel debris from wearing surface. | Low |

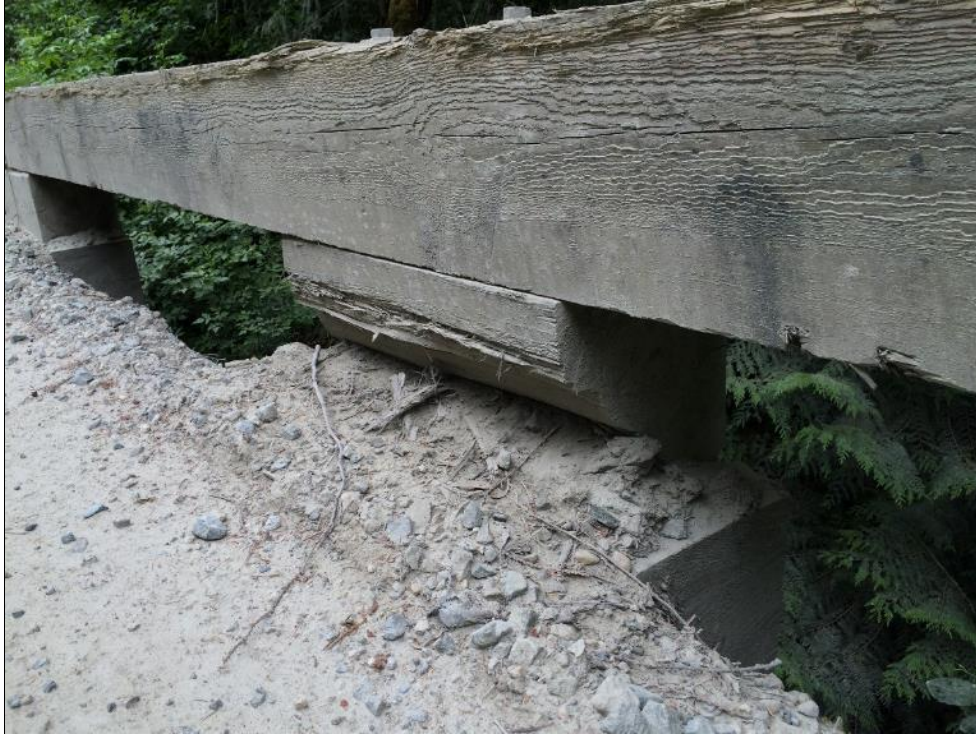
Photo #21  
Curb rail riser (DS)

-Damaged curb riser

| ITEM | DESCRIPTION | PRIORITY |
|---|---|---|
| 2 | Tighten curb rail bolts and replace damaged curb riser block. | High |
