## BRIDGE DATA:

| Bridge No./Name: | SI – 3041: Mt Brenton FSR / Humbird Creek (6.5 KM) |
| Inspection Date: | June 22, 2015 |

## INSPECTION NOTES

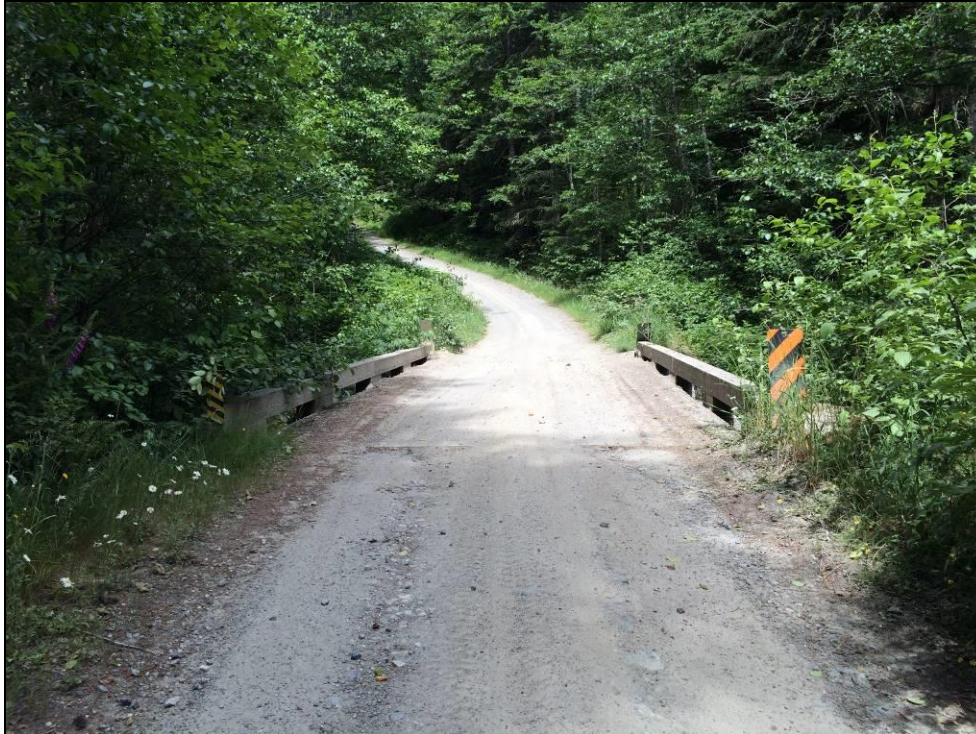
Photo #3  
Camp End Approach

- The approaches are overgrown with vegetation.
- Camp end approach road is rutted below top of running planks. Woods end approach road is also rutted.
- All guide logs are heavily rotted.
- Woods end guide logs are misaligned, falling down side slopes and ineffective. Camp end upstream guide log is displaced.
- Camp end upstream delineator is small. All other delineators are present but damaged.
- There are no load posting signs present.

- Rutting of approach road
- Obscured and unequal size of hazard markers
- Guide logs misaligned and not visible in picture

| ITEM | DESCRIPTION | PRIORITY |
|---|---|---|
| 1 | Replace and re-position the approach guide logs. | High |
| 2 | Clear brush at approaches to expose bridge hazard markers. | High |
| 3 | Re-grade approach roadways to allow for better drainage of the bridge deck, and clear off the debris accumulation from the wearing surface. | Medium |

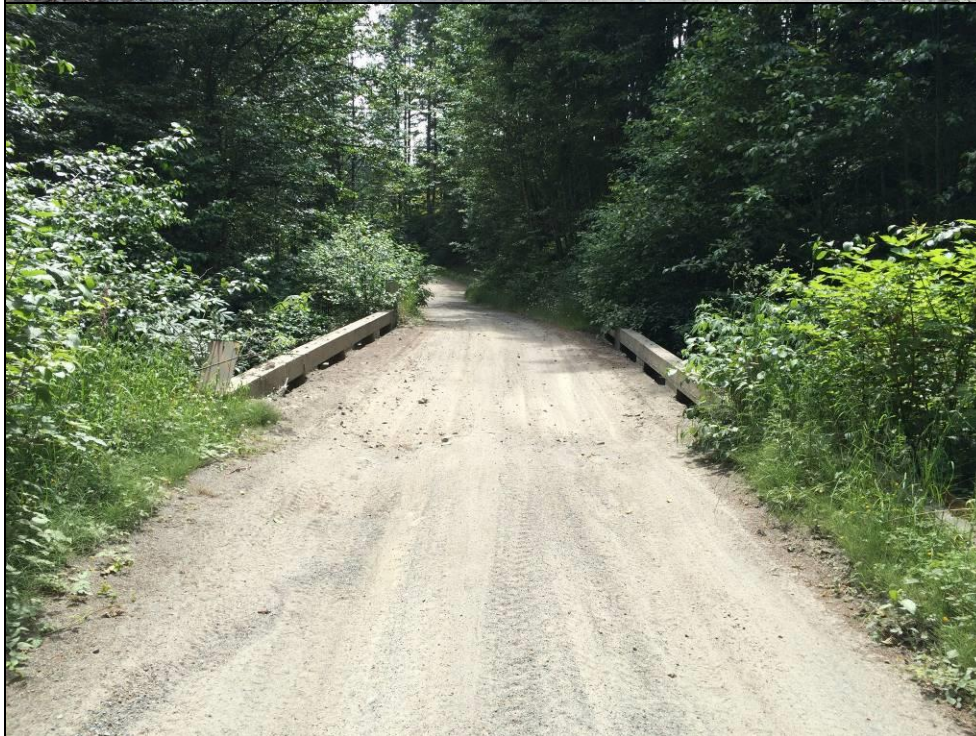
Photo #4  
Woods End Approach

- Significant accumulation of debris on deck
- Rutting on approach road
- Guide logs misaligned and not visible
- Hazard markers completely obscured by foliage

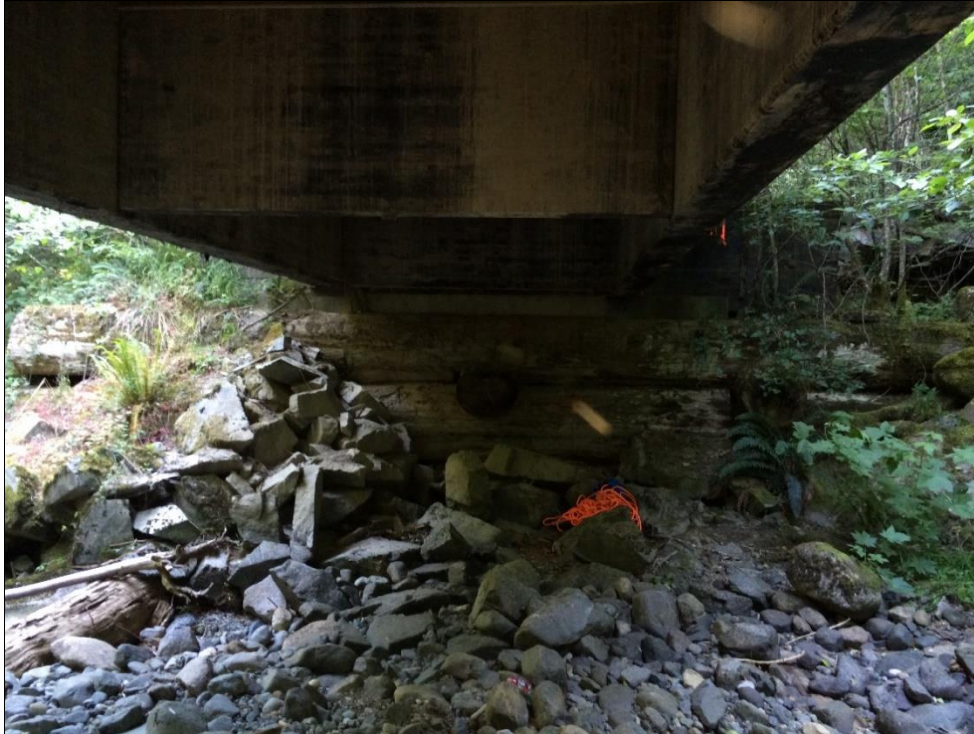
Photo #5  
Camp End Abutment (A2)

- Generally in fair to good condition.
- Creosote treated timber bearing sills appear to be in good condition.
- Creosote treated ballast wall and wingwalls were in good condition where visible and accessible.
- Surficial (approx. 25mm deep) deterioration on cedar crib logs noted.
- Wood shavings/dust on top of the abutment cribbing noted at camp end suggests possible presence of wood burrowing insects, though a specific source was not observed.
- Riprap coverage upstream of both abutments appears sufficient, however, riprap armoring in front of the log cribs was lacking in areas, as shown in Photos #5 & 6 of the photo log.

-Portion of log crib not well armored by riprap.

| ITEM | DESCRIPTION | PRIORITY |
|---|---|---|
| 4 | Replace / place additional rip rap in front of abutment cribs. | Medium |

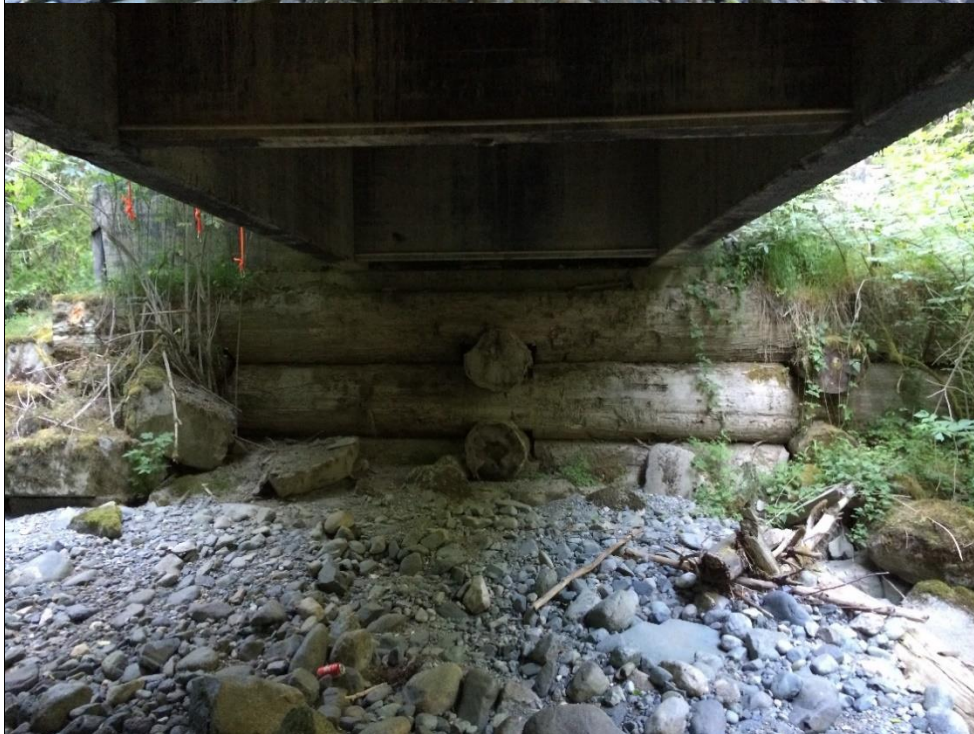
Photo #6  
Woods End Abutment (A1)

-Majority of log crib not well armored by riprap.

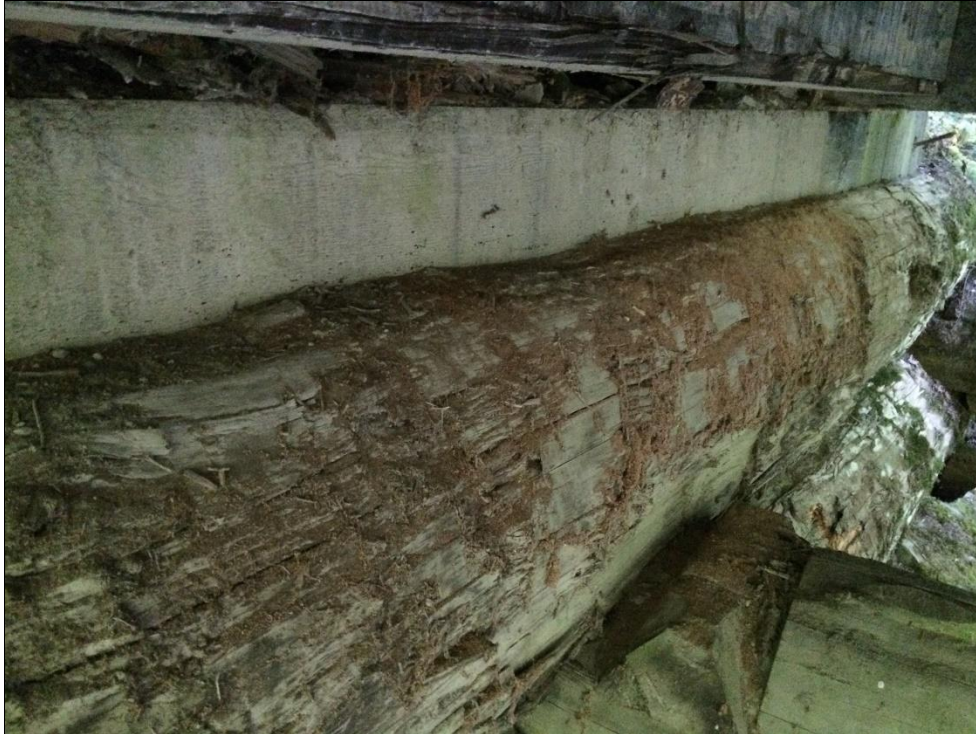
Photo #7  
Camp End Abutment (A2)

-Note wood debris and wood shavings at top of abutment. Signs of insect infestation of timber crib.

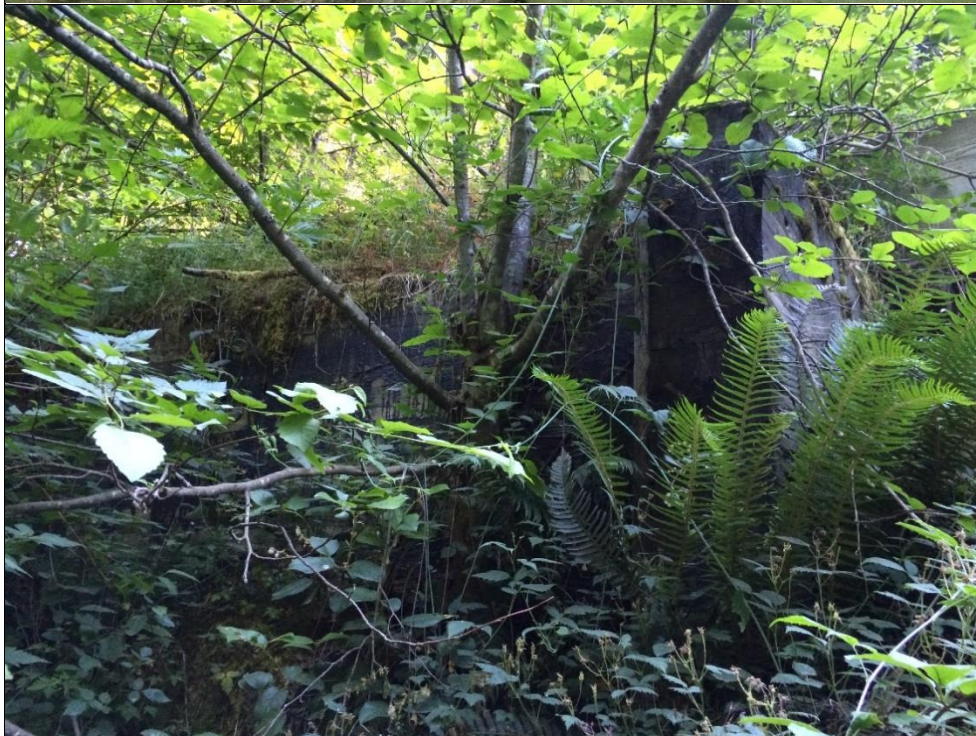
Photo #8  
Camp End (A2), D.S. Wingwall /  
end of Ballast Wall

-Appeared to be in good condition, though heavily overgrown.

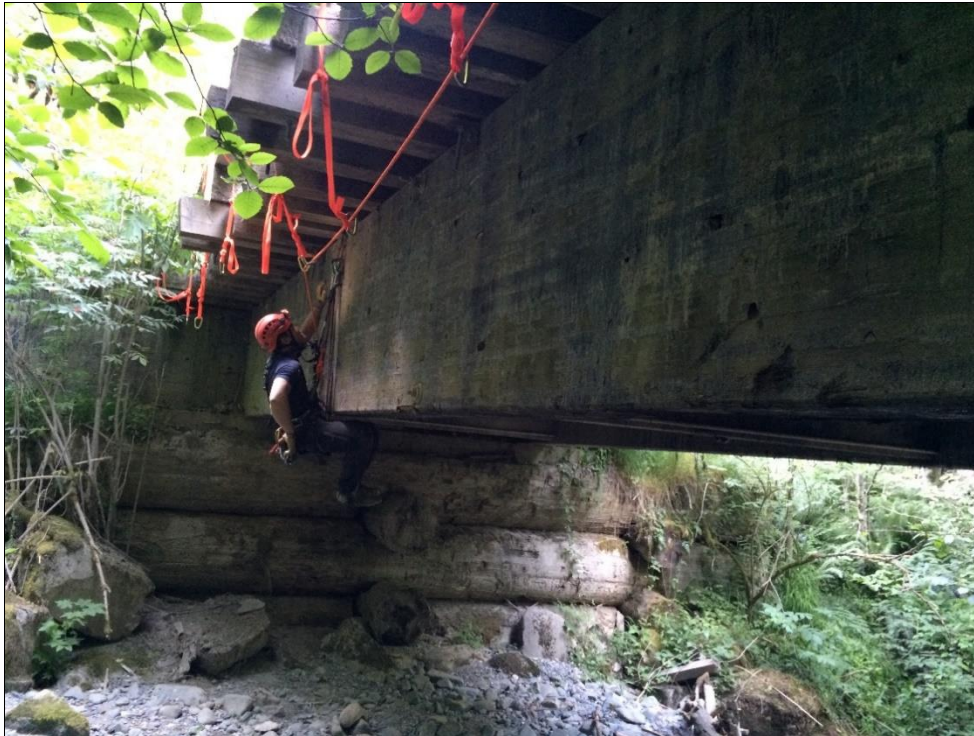
Photo #9  
Girder 1, Exterior face

- Creosote coverage of approx. 75 % remaining.
- Isolated narrow ( $\leq 1$ mm), shallow, short checks.

-Approx >75% creosote coverage remaining

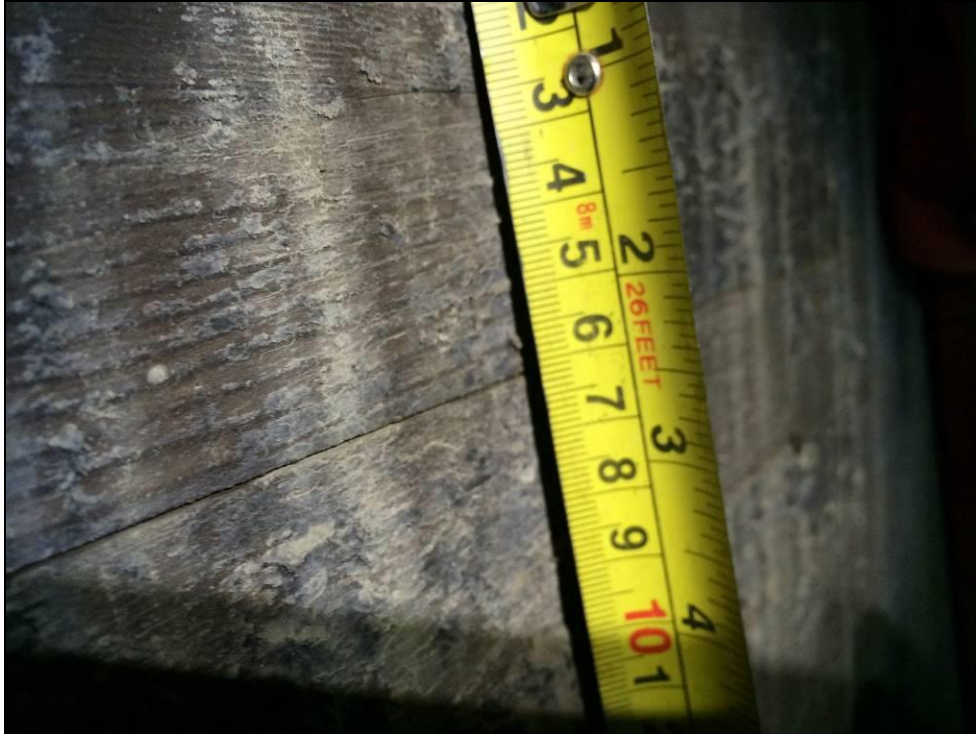
Photo #11  
Girder 1, Interior face

-Example of regular, narrow  
check on interior face.

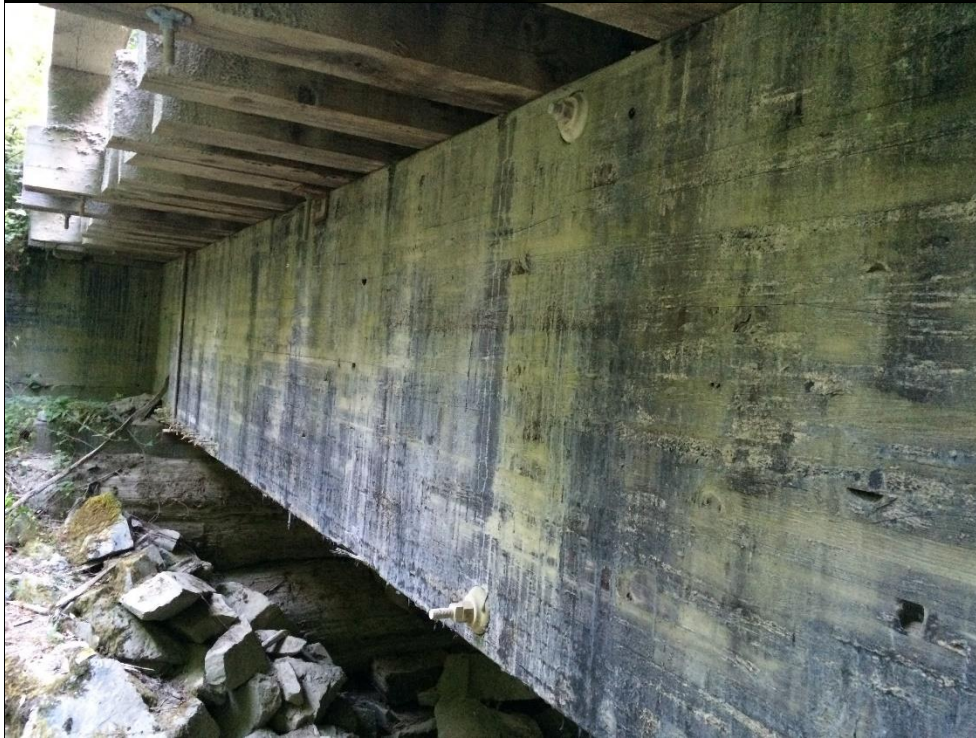
Photo #12  
Girder 2, Exterior face

The downstream girder has a vertical steel tie rod clamp installed at approximately 1000 mm from the camp end abutment, as seen from a distance in Photo #12 of the photo log. It appears this clamp is associated with several epoxy injection tubes located at approximately 75 mm from the bottom of the downstream girder (on both faces), extending 2500 mm from the camp end abutment. The repair performed to this check appears to be functioning as intended.

-Note epoxy injection tubes at  
camp end  
-Note creosote leaching, with  
approx. 50% creosote coverage  
remaining

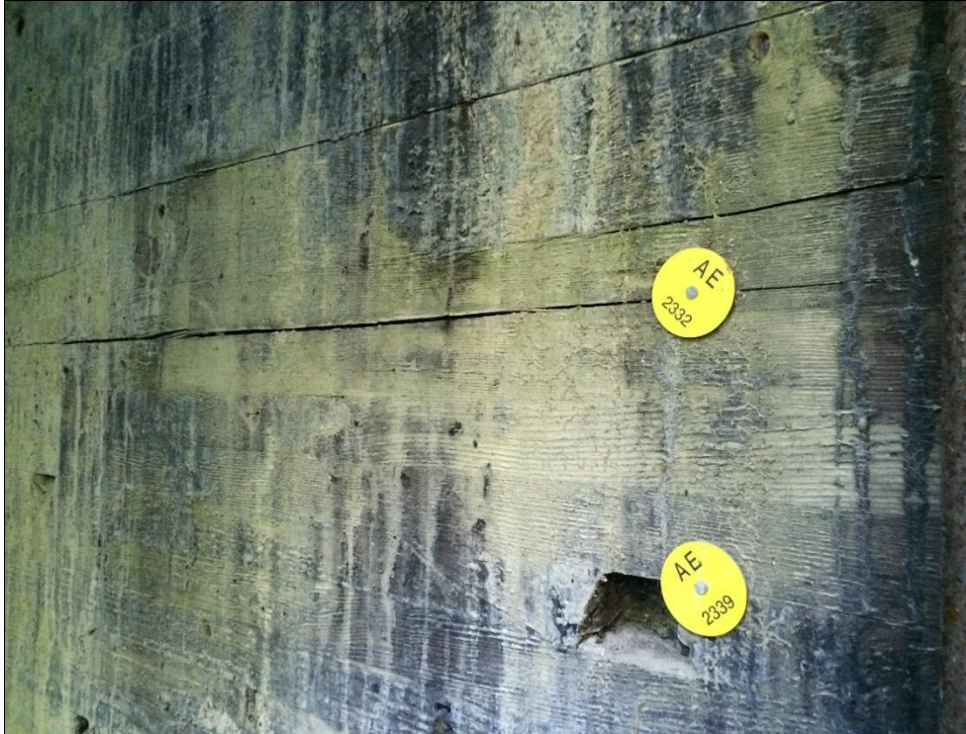
Photo #13  
Girder 2, Exterior face

-Check propagation noted since placement of tags, however still not of significant concern

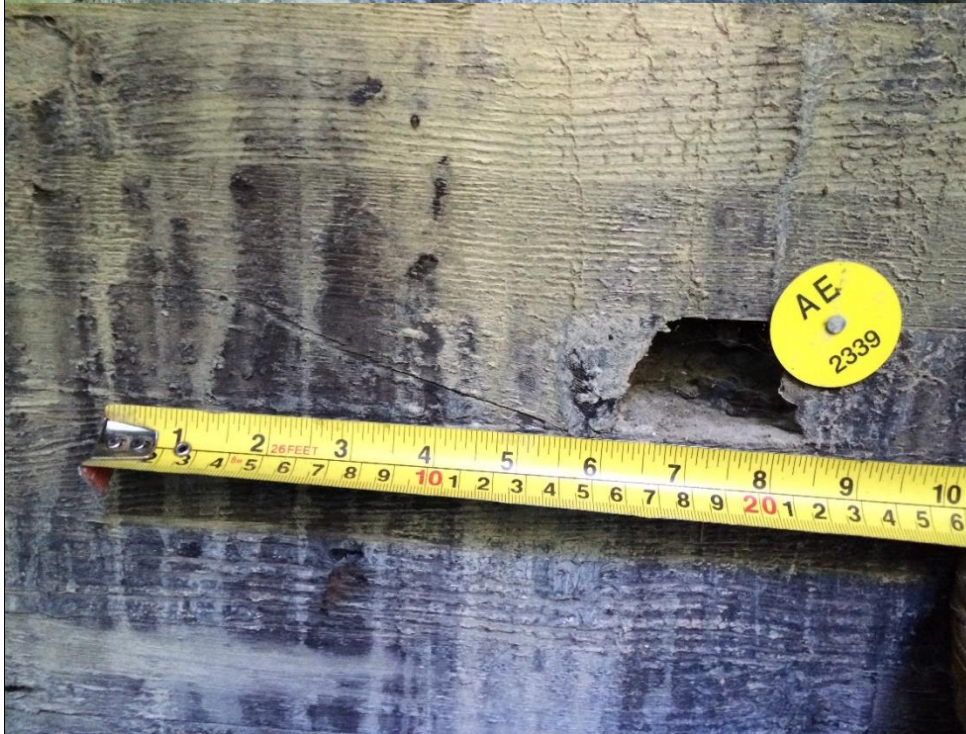
Photo #14  
Girder 2, Exterior face

-Diagonal check propagating out near AE 2339. Depth of check is still not of concern.

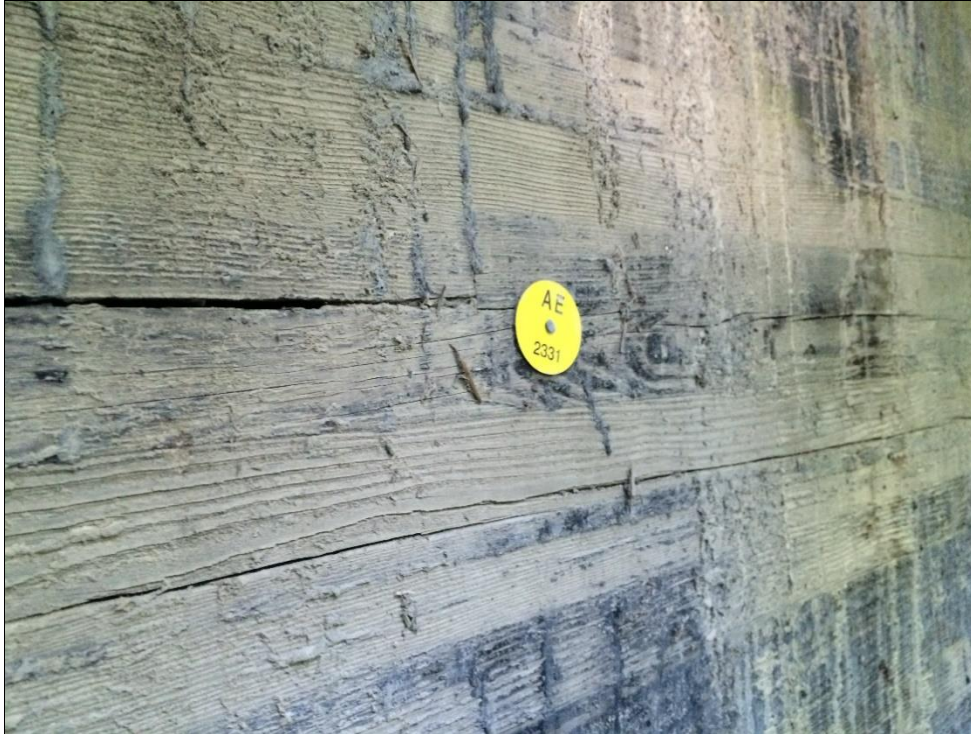
Photo #15  
Girder 2, Exterior face

-Check propagation noted since placement of tags, however still not of significant concern.

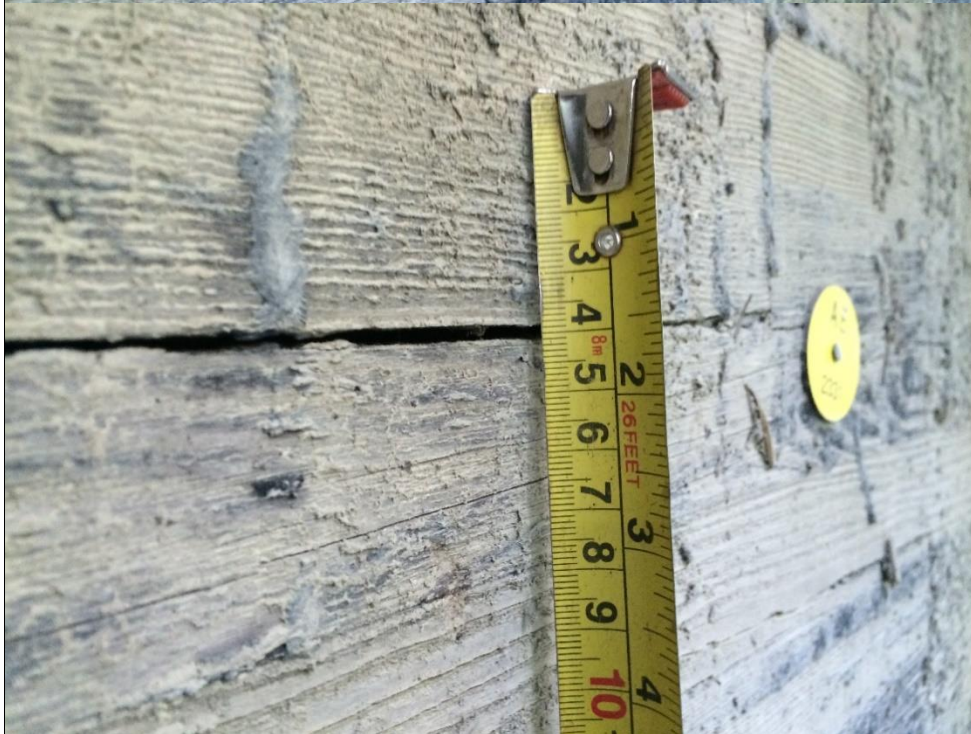
Photo #16  
Girder 2, Exterior face

-Widest check noted at 2mm wide and approx. 60mm deep.

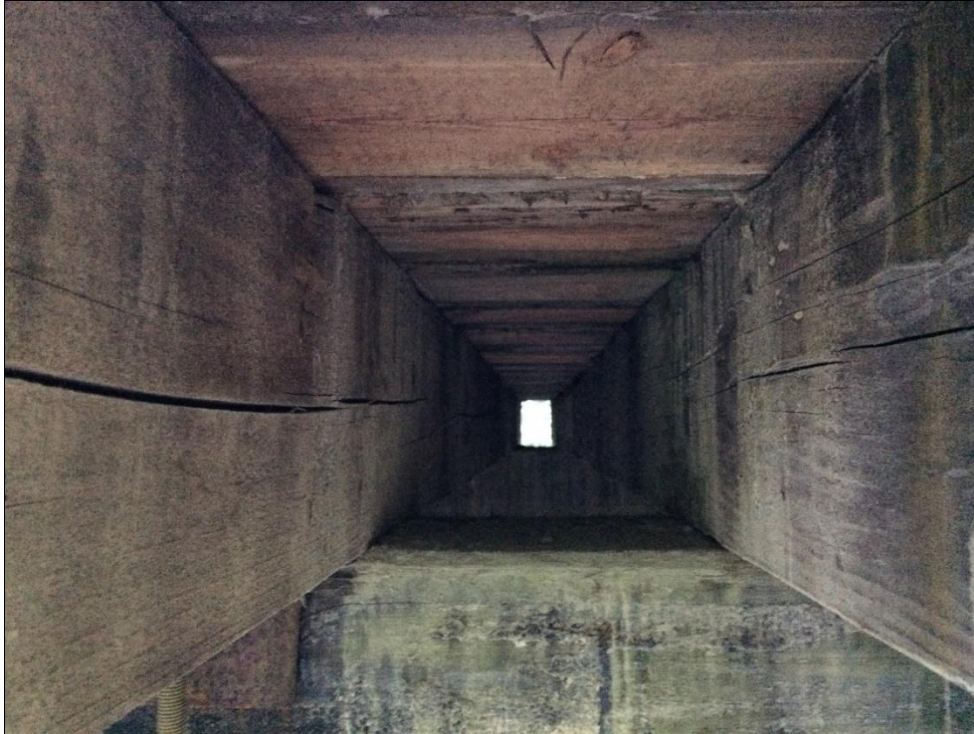
Photo #17  
Typical space between  
transverse deck ties

-Typical condition of ties with  
regular checks

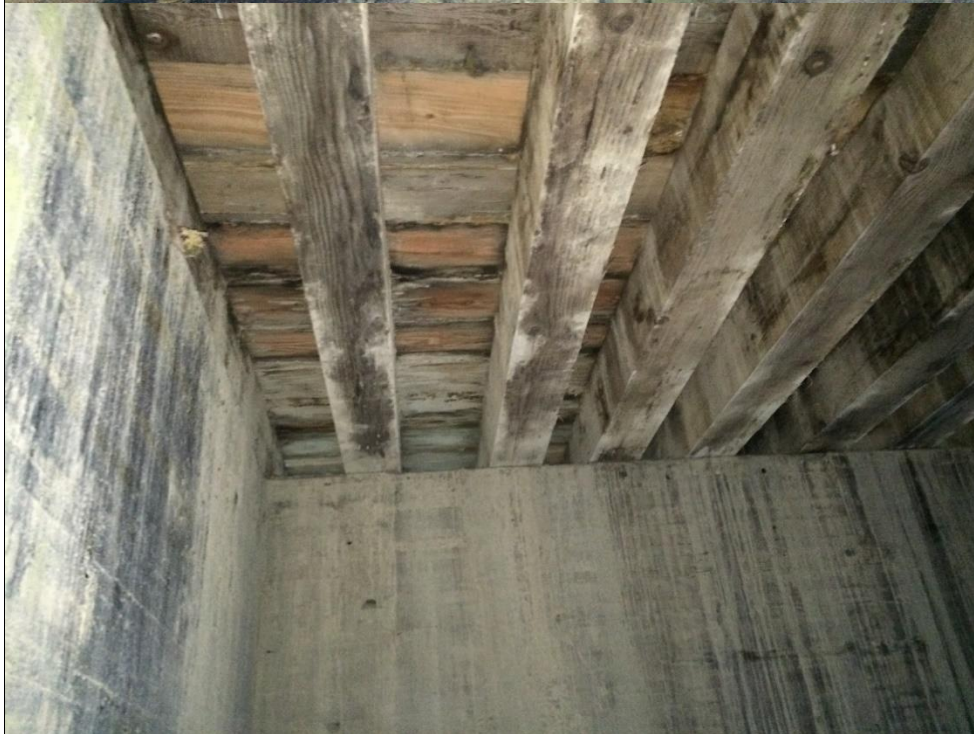
Photo #18  
Typical underside of deck

-Typical condition of underside  
of deck
