# BRIDGE INSPECTION REPORT

## **BRIDGE FSR:** **SI-5559 Nahmint River Lake Main 0.5 km**

**Inspection Date:** August 16<sup>th</sup> 2016

**Inspected By:** M. Horner, P.Eng., J. Rupar Gilliatt, P.Eng.

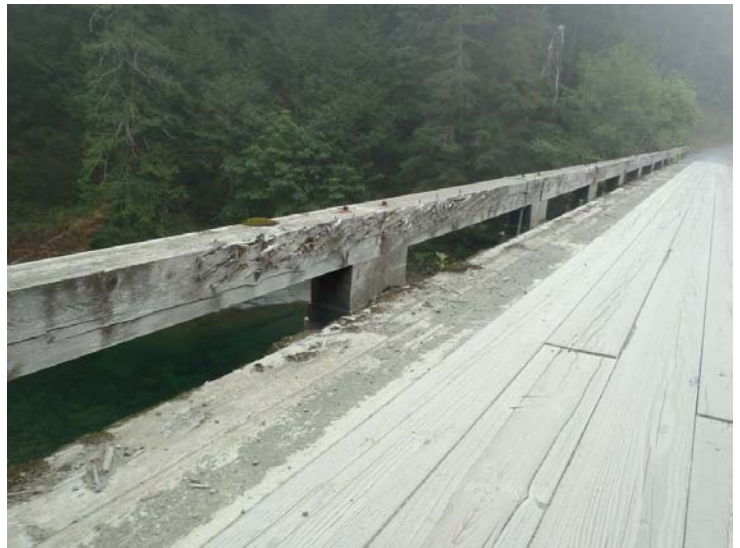
- Curb rail, risers, and blocking are in fair condition. Curb rails are starting to deteriorate with moss growth, a few pockets of rot at ends of curb sections, and some mechanical damage. A few risers have pockets of rot.
- Ties and structural planks are in good condition with no deterioration noted.
- Debris accumulation and moss growth along deck edge.

Photo 08: Typical Curb Rail Condition

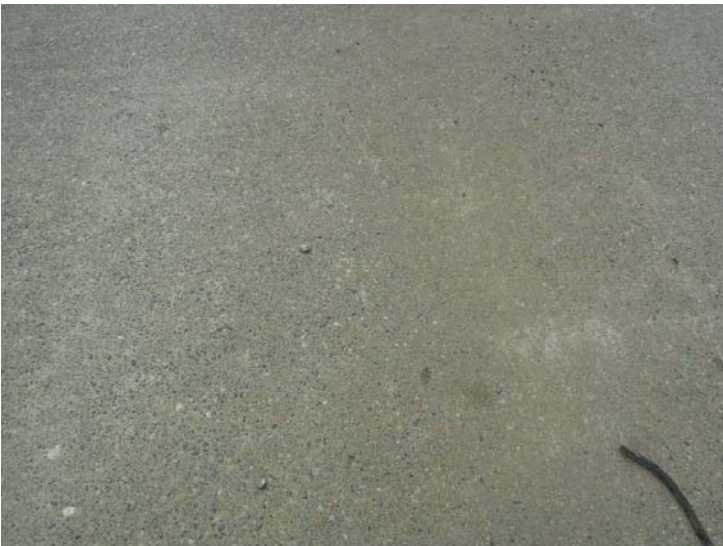
- Non-composite deck panels over the jump spans are in good condition showing minor wear.
- Joints between concrete deck panels are full of debris and appear to have been left vacant resulting in leaking and staining on underside of panels.
- Light map cracking on underside of concrete deck panels.
- Debris accumulation and moss growth along deck edge.

Photo 09: Typical Deck Panel Condition

| Item | Description | Priority |
|---|---|---|
| 5 | Seal joints between concrete deck panels with sealant. | Medium |

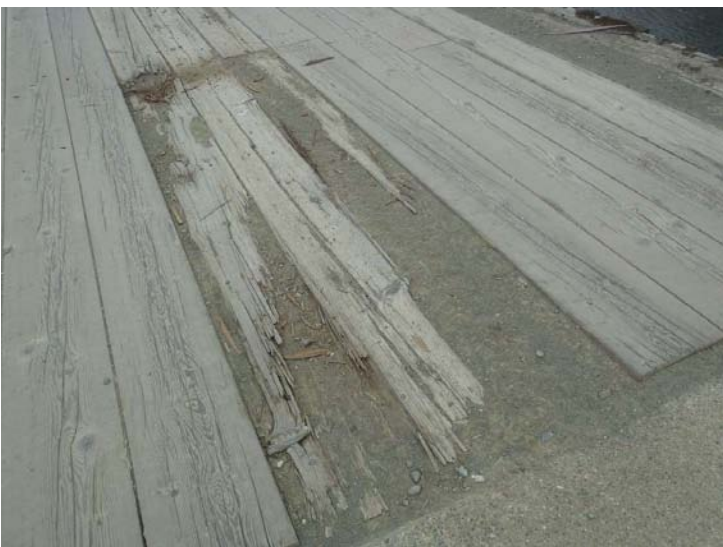
- Running planks over the main span are in fair to poor condition. Four running planks in upstream wheel track and three running planks downstream wheel tracks are in fair condition with localized small pockets of rot, remaining planks are in poor condition with large pockets of rot.

Photo 11: Typical Wear/Deterioration in Centre Running Planks

| Item | Description | Priority |
|---|---|---|
| 4 | Plan to replace rotten running planks for industrial use, or install additional plank (3 x 300 x 6200 mm) on downstream running strip and remove rotten running planks that are adjacent to wheel paths. | Medium |

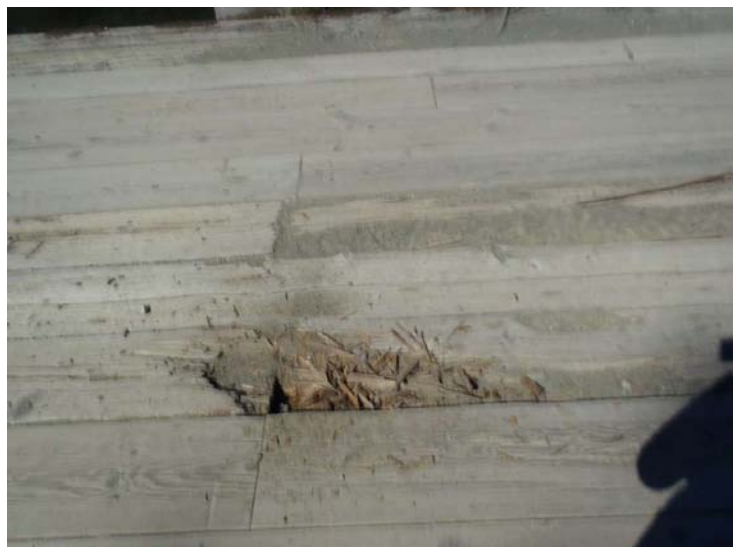
Photo 12: Pocket of Rot in Centre Running Planks

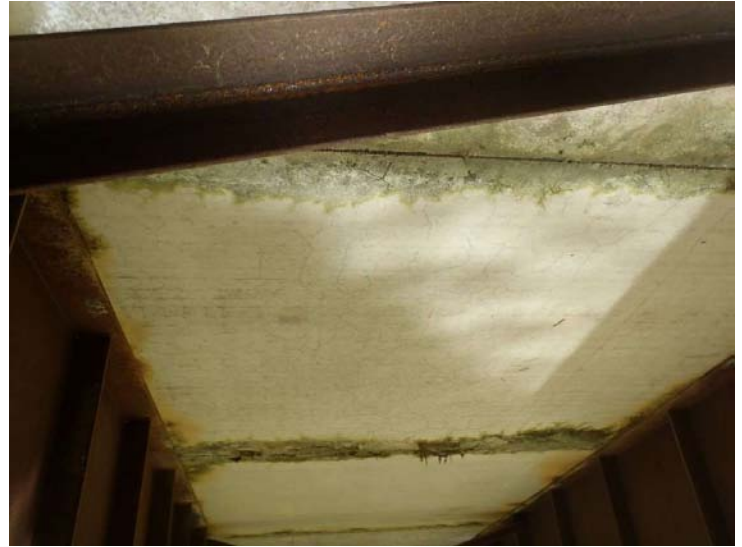
Photo 14: Typical Light Map Cracking on Underside of Concrete Deck

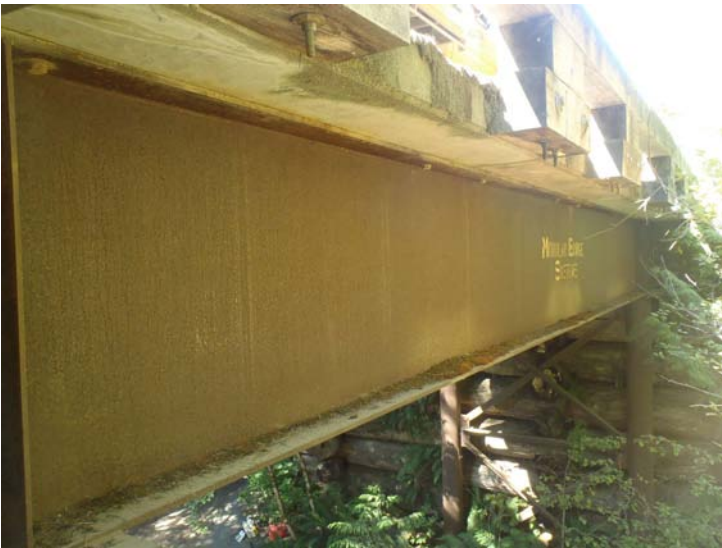
- Steel girders are in good condition with light surface corrosion and no measurable section loss.
- Minor flaking on bottom flanges.
- Girders cantilever over steel posts at each abutment.
- Diaphragms are in good condition.
- Minor debris accumulation on girder 2, downstream bottom flange.

Photo 15: Typical Span 1 & 3 Girder Condition

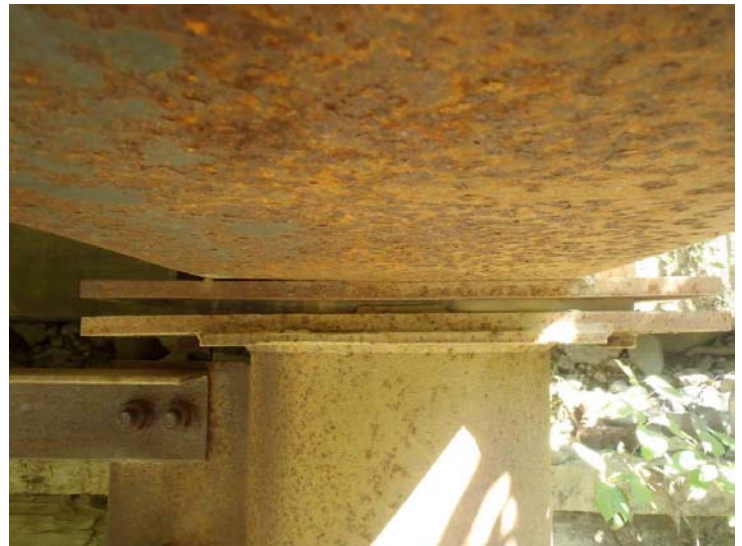
Photo 18: Typical Steel Span Bearing Condition

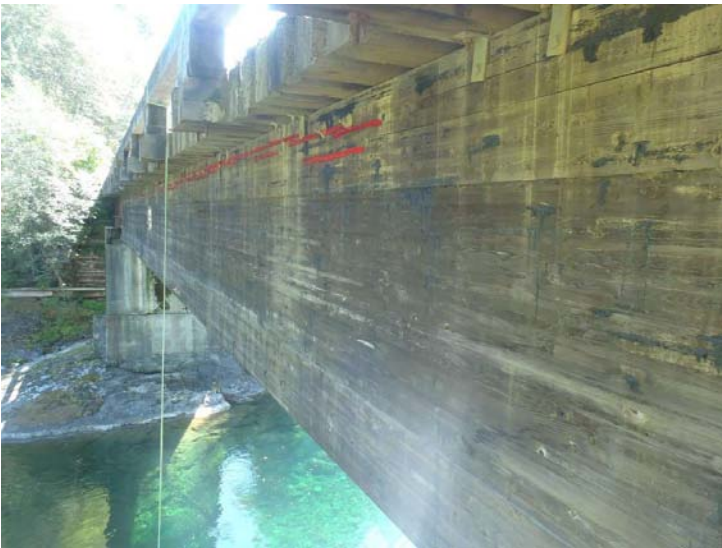
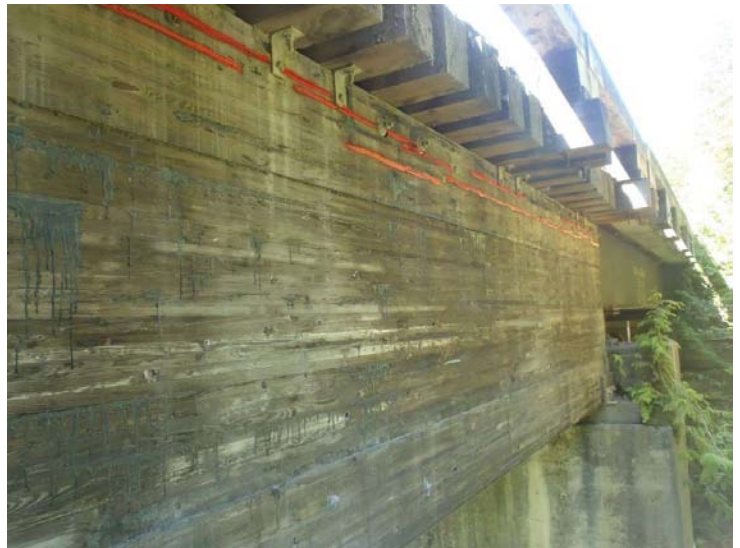
| Check | Span | Girder | Face | Tag 1 | Tag 2 | Length (mm) | Max Depth (mm) | Max Width (mm) | Comment |
|---|---|---|---|---|---|---|---|---|---|
| 5 | 2 | 1 | U/S | SNT009 | Pier 2 | 16850 | 180 | 5 | Marks a series of checks in top 7 laminations average 1500 mm long 90 mm deep and 3 mm wide. 180 mm deep at x = 28170 mm y = 1985 mm. Longest check 6400 mm. |

Photo 21: Span 2 Girder 1 Upstream Face Top Flange Series of Checks Along Whole Length

Photo 22: Span 2 Girder 1 Upstream Face Top Flange Series of Checks Along Whole Length

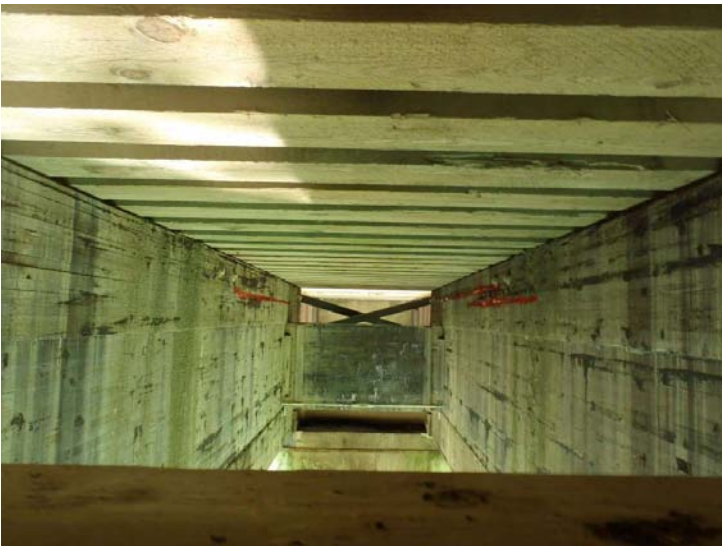
Photo 23: Span 2 Diaphragm 1 at Pier 1 Note Checking in Top Flanges Of Girders 2 & 3

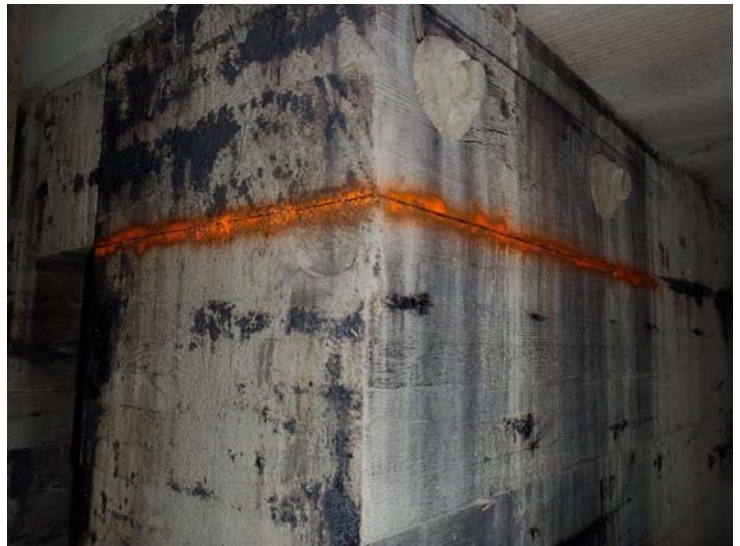
| Check | Span | Girder | Face | Tag 1 | Tag 2 | Length (mm) | Max Depth (mm) | Max Width (mm) | Comment |
|---|---|---|---|---|---|---|---|---|---|
| 9 | 2 | 2 | D/S | Pier 2 | - | 700 | 425 | 3 | End split in top flange at right end. Extends 700 mm on D/S face and 130 mm on U/S face. Average 80 mm deep. |

Photo 24: Span 2 Girder 2 at Pier 2 Full Width End Split

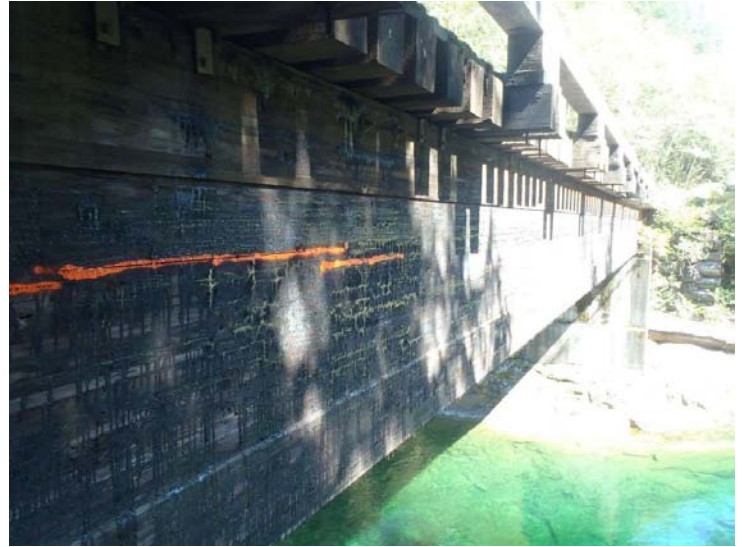
Checks 16 and 17 in Table 3. We did not identify any indications of rot in the girder. Based on the depth and location of the series of checks we immediately contacted the Ministry and recommend reviewing the load rating of the glulam girder span. The increase in girder weathering is not unusual and the size of the significant series of checks in Girder 4 has not increased notably since the 2013 inspection. We therefore recommend the Ministry maintain the existing three year inspection schedule for the bridge and monitor the girder condition during future inspections.

| Check | Span | Girder | Face | Tag 1 | Tag 2 | Length (mm) | Max Depth (mm) | Max Width (mm) | Comment |
|---|---|---|---|---|---|---|---|---|---|
| 16* | 2 | 4 | D/S | AE251 | AE280 | 2370 | 145 | 4 | Continuous series of checks linking to check AE1439-Pier 2. 145 deep at x = 29770 mm y = 1310 mm. Propagated 750 mm left of AE251. Average 130 mm deep. |

Photo 26: Significant Check AE251-AE280

| Item | Description | Priority |
|---|---|---|
| 1 | Post bridge prior to review of glulam girder load rating. | High |
| 2 | Perform load rating to confirm bridge capacity. | High |

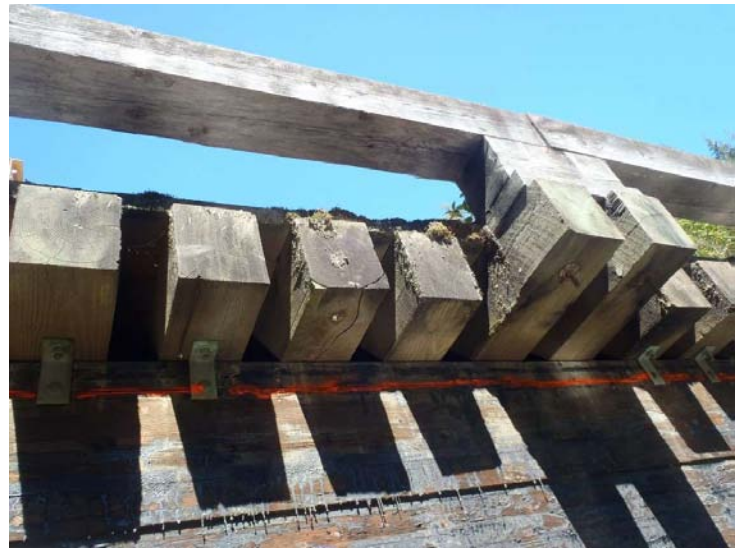
| Check | Span | Girder | Face | Tag 1 | Tag 2 | Length (mm) | Max Depth (mm) | Max Width (mm) | Comment |
|---|---|---|---|---|---|---|---|---|---|
| 15 | 2 | 4 | D/S | AE150 | AE212 | 15690 | 170 | 5 | A series of checks in Girder 4 top flange, near tie clips. |

Photo 28: Span 2 Girder 4 Typical Checking in Line with Tie Clips

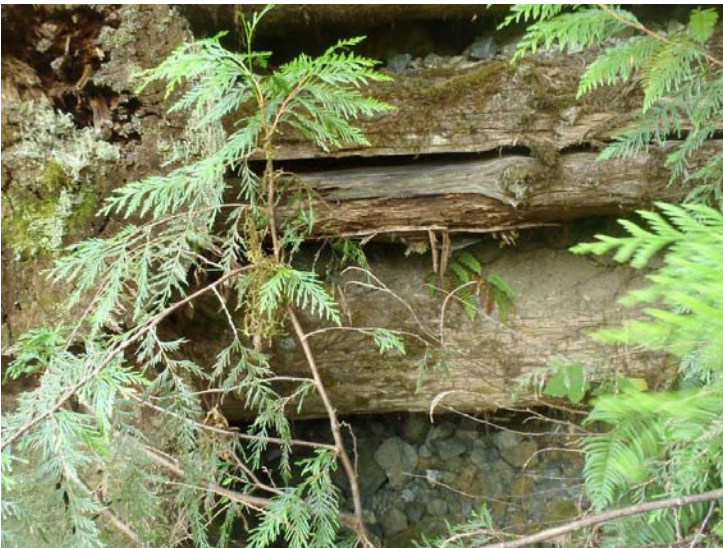
- Cribs are in fair condition with typical sap rot, up to 35 mm, and a number of logs with heart rot in the ends.
- Second log and fifth log from bottom of downstream wing wall have rotten ends.
- 75 mm wide split in 2<sup>nd</sup> log from bottom of left abutment downstream wing wall.
- Top log of upstream wing wall has rotten end.
- Previously noted rot in third face log could not be identified.
- No signs of crushing or distress noted in cribs.
- A 1300 mm deep, 1700 mm wide scour hole was noted at interface of left abutment breast wall and downstream wing wall. The scour is not a concern at this time.
- Newer creosote treated sawn timber ballast walls are in good condition.

Photo 33: Left Abutment Downstream Wingwall Wide Split in 2nd From Bottom Log and Minor Scour

1. Monitor condition of glulam girders.
2. Monitor deterioration of abutment cribs.
3. Monitor scour hole at interface of left abutment breast wall and downstream wing wall.

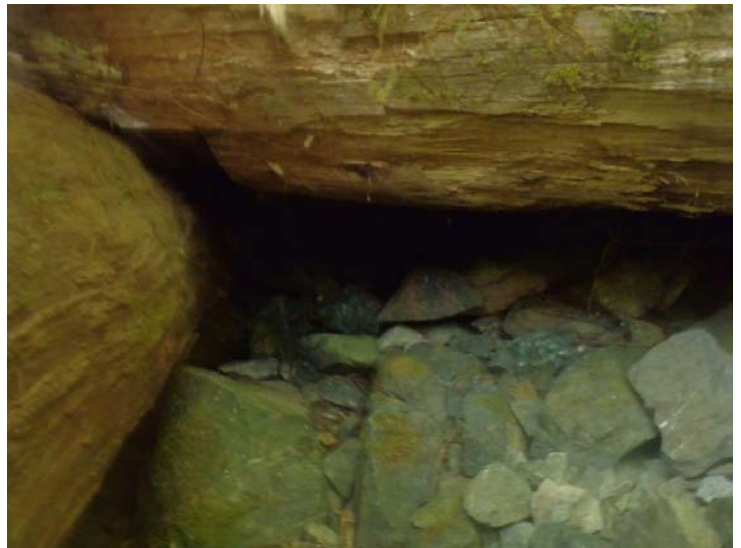
- Substructure components are founded on the river banks and were above the PWL at the time of inspection.
- Tall steel pipe columns and concrete piers provide adequate high water clearance for bridge.
- A large tree deposited on the bank below Span 1 indicates the river sees significant high water flows.
- No scour of the substructure was noted with the exception of the left abutment log crib at the interface between the breast wall and downstream wing wall.

Photo 34: Left Abutment Downstream Wingwall Minor Scour

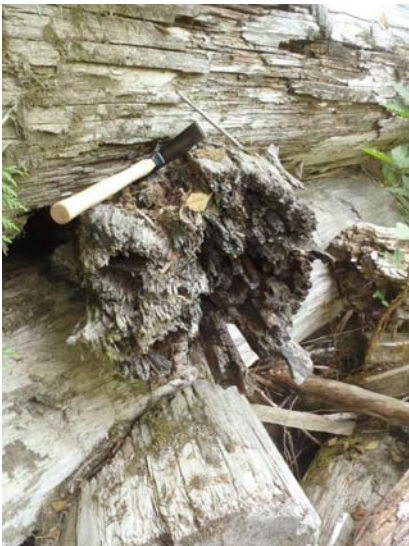
Photo 35: Left Abutment Downstream Corner 2nd Tieback From Bottom End Rot

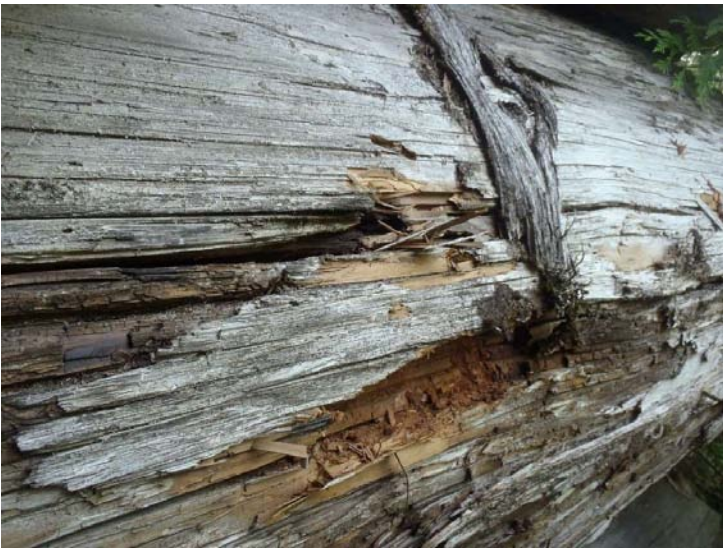
Old log cribs at the abutments retain road fill and are generally in fair condition. A few logs were noted with rotten ends indicating that the crib is starting to deteriorate. The bridge is supported independently of the cribs, and the structure is currently serving its purpose. The log cribs should be monitored during future inspections.

Photo 39: Typical Sap Rot in Cedar Crib Logs

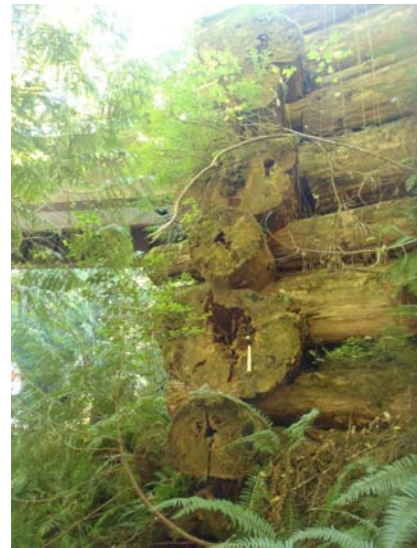
Photo 40: Typical Core Rot in Crib Face Log

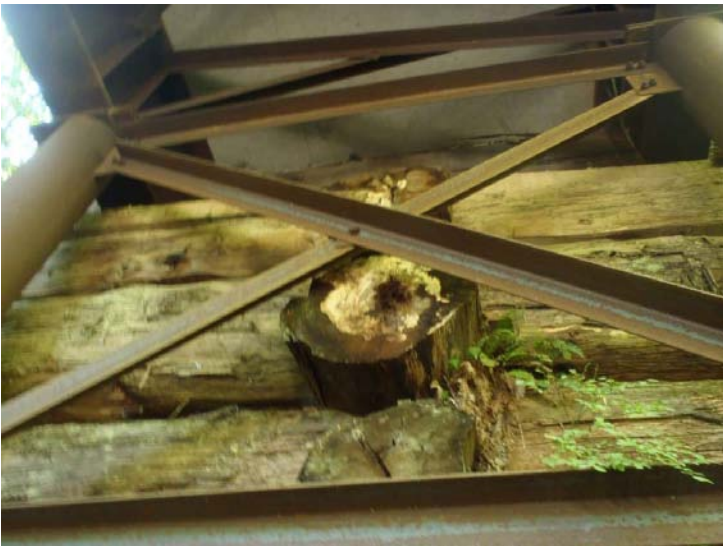
- Cribs are in fair condition with typical sap rot, up to 35 mm, and typical heart rot in the ends of logs.
- White fungal growth on ends of tie backs in centre of abutment.
- Second log from bottom of upstream wing wall has rotten end.
- No signs of crushing or distress noted in cribs.
- Log cribs are founded on the river bank with no signs of scour noted.
- Newer creosote treated sawn timber ballast walls are in good condition.

Photo 41: Right Abutment Fungal Growth On Tiebacks

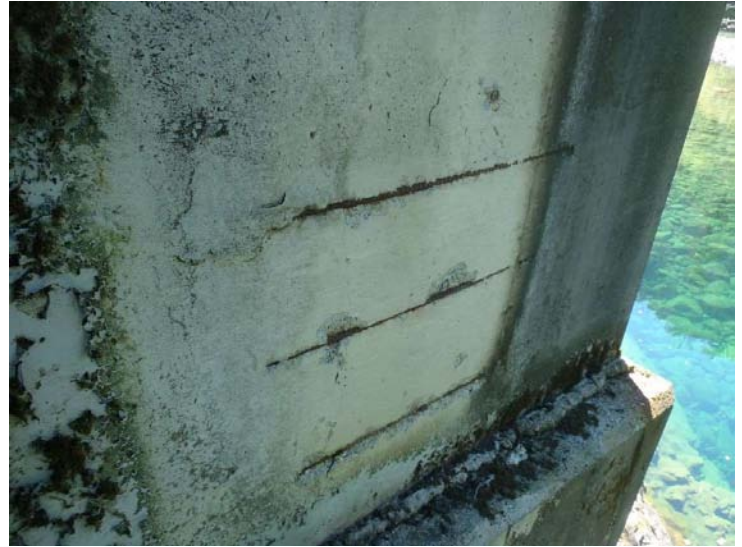
- Concrete pier is in fair condition with  $\sim 1 \text{ m}^2$  of right face with exposed rebar due to inadequate concrete cover.
- Staining on faces of pier from water migrating through gap between timber and concrete decks.
- Timber sill is in fair condition.
- Steel posts are in good condition.
- Span 1 rubber bearings are bulging between keeper bars and are in fair condition.

Photo 44: Pier 1 Right Face Exposed Reinforcing

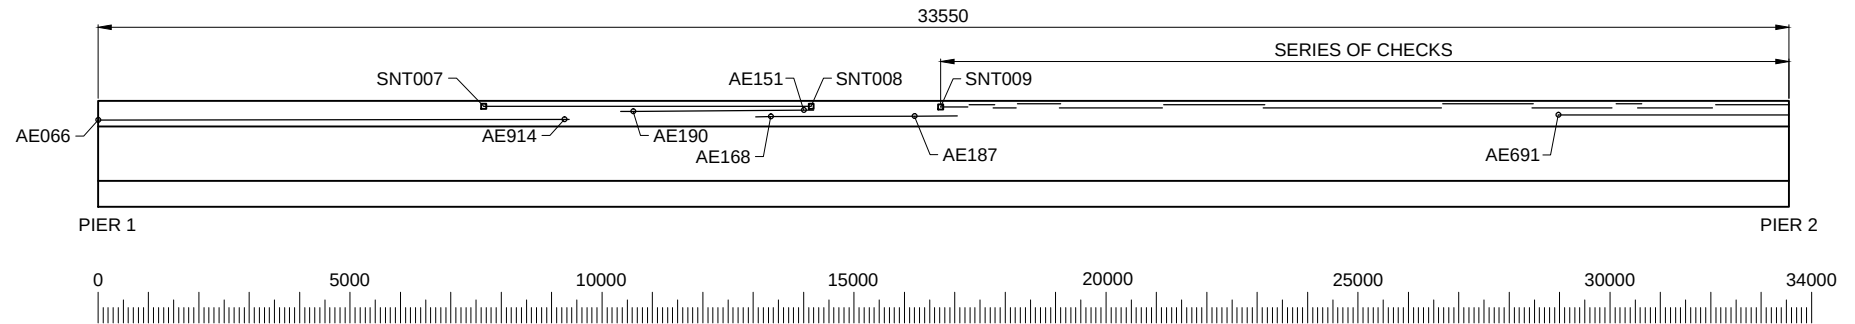
ELEVATION SPAN #2 - GIRDER #1 - US FACE  
SCALE 1:150

| Check | Span | Girder | Face | Tag 1 | Tag 2 | Length (mm) | Max Depth (mm) | Max Width (mm) | Comment |
|---|---|---|---|---|---|---|---|---|---|
| 1 | 2 | 1 | U/S | AE066 | AE914 | 9250 | 150 | 8 | Propagated 100 mm to the right since previous inspection. |
| 2 | 2 | 1 | U/S | SNT007 | SNT008 | 6500 | 200 | 7 | New check at level of tie clips under 3 adjacent pairs of clips. 200 mm deep at x = 11070 mm. Average 140 mm deep. |
| 3 | 2 | 1 | U/S | AE190 | AE151 | 3380 | 130 | 7 | Minor propagation since previous inspection: 200 mm right & 250 mm left. |
| 4 | 2 | 1 | U/S | AE168 | AE187 | 2850 | 115 | 4 | Propagation since previous inspection: 300 mm left and 850 mm right in 1 lamination up from original check. Average 80 mm deep. |
| 6 | 2 | 1 | U/S | AE691 | Pier 2 | 4600 | 100 | 6 | Increased in depth by 40 mm. Has not propagated. Average 70 mm deep. |

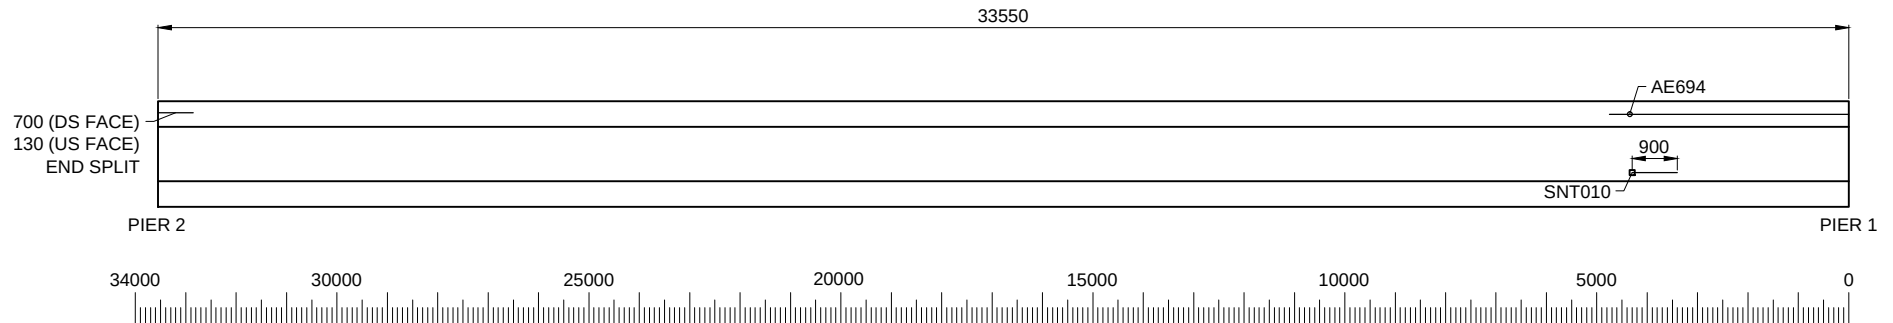
ELEVATION SPAN #2 - GIRDER #2 - DS FACE  
SCALE 1:150

| Check | Span | Girder | Face | Tag 1 | Tag 2 | Length (mm) | Max Depth (mm) | Max Width (mm) | Comment |
|---|---|---|---|---|---|---|---|---|---|
| 7 | 2 | 2 | D/S | AE694 | Pier 1 | 4350 | 110 | 4 | Propagated 400 mm to the right since previous inspection. No close access to left end due to bats and guano. |
| 8 | 2 | 2 | D/S | SNT010 | - | 900 | 80 | 1 | New check extends to right of tag. |

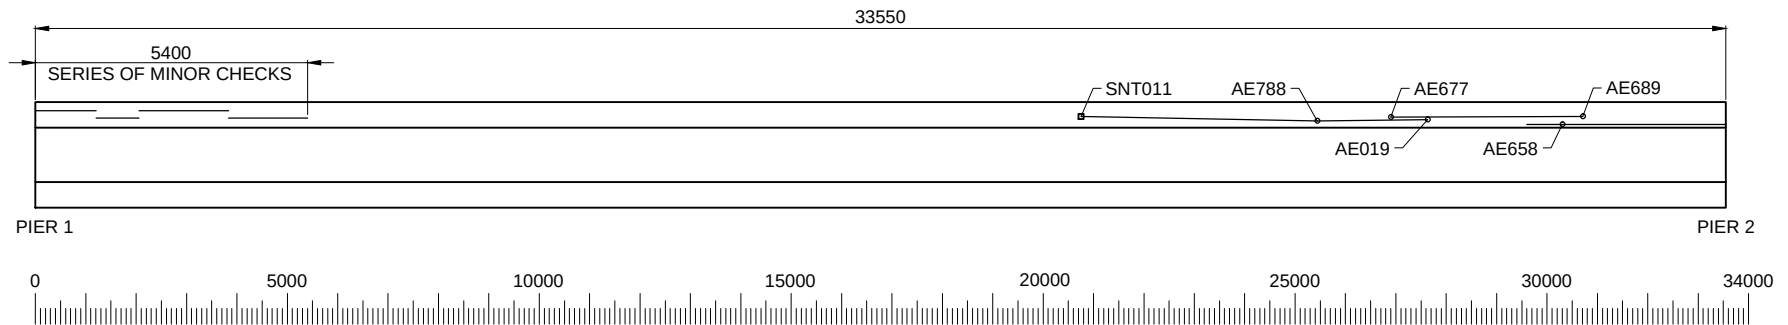
**ELEVATION SPAN #2 - GIRDER #3 - US FACE**  
SCALE 1:150

| Check | Span | Girder | Face | Tag 1 | Tag 2 | Length (mm) | Max Depth (mm) | Max Width (mm) | Comment |
|---|---|---|---|---|---|---|---|---|---|
| 10 | 2 | 3 | U/S | SNT011 | AE788 | 4690 | 160 | 4 | Extension to check AE788-AE019 one lamination up, 160 mm deep at x = 22340 mm y = 1875 mm. |
| 11 | 2 | 3 | U/S | AE788 | AE019 | 2190 | 80 | 5 | Propagated 2690 mm to the left to SNT 011 one lamination up. |
| 12 | 2 | 3 | U/S | AE677 | AE689 | 3810 | 100 | 6 | Has not propagated. |
| 13 | 2 | 3 | U/S | AE658 | Pier 2 | 3270 | 120 | 7 | Propagated 700 mm to the left. |
| 14 | 2 | 3 | U/S | Pier 1 | - | 5400 | 60 | 2 | Series of minor checks extend 5400 mm from Pier 1. Typically 60 mm deep with varying length. |

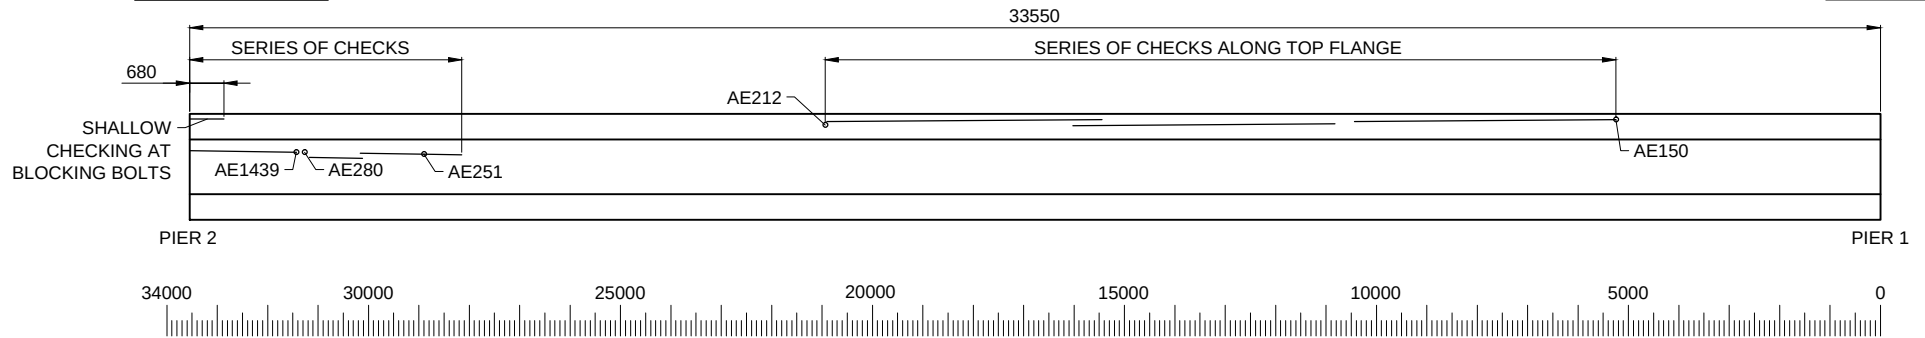
**ELEVATION SPAN #2 - GIRDER #4 - DS FACE**  
SCALE 1:150

| Check | Span | Girder | Face | Tag 1 | Tag 2 | Length (mm) | Max Depth (mm) | Max Width (mm) | Comment |
|---|---|---|---|---|---|---|---|---|---|
| 17 | 2 | 4 | D/S | AE1439 | Pier 2 | 2115 | 130 | 4 | 100 mm deep at Pier 2. Average 130 mm deep. |

| 18 | 2 | 4 | D/S | Pier 2 | - | 680 | 55 | 4 | Wide but shallow checking in top flange at blocking bolts. |
