| Bridge No. | SQ-3145 | Road Name | Ashlu River FSR | | | | | | | Inspection Date | 2014-08-14 | | | |
| 87 m | Squamish River | | | | | | | M. Hanson / D. Harrison | | | | | | |
| Comments | 4 span bridge (3 steel spans and one log stringer span) with a timber deck. | | | | | | | | | | | | | |

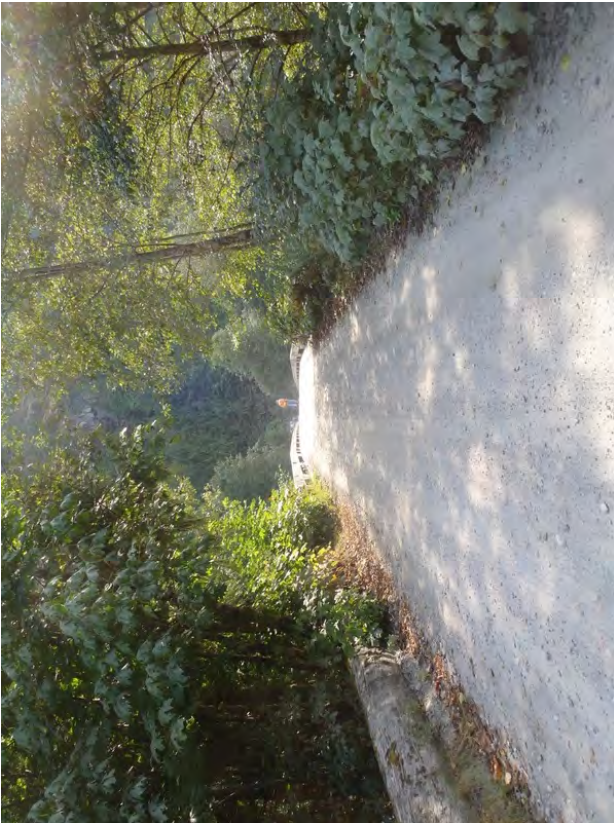
Figure 6: Right end approach.

| Signage | Poor | | | <p>Bridge ahead signs missing at both approaches.</p> <p>Load posting sign at left approach only.</p> | | | | | | | | | | |

| Bridge No. | SQ-3145 | Road Name | Ashlu River FSR | Inspection Date | 2014-08-14 |
|---|---|---|---|---|---|
| 1 | Install load posting sign at right approach. | High | \$500.00 | | |
| 2 | Install bridge ahead signs at both approaches. | High | \$500.00 | | |

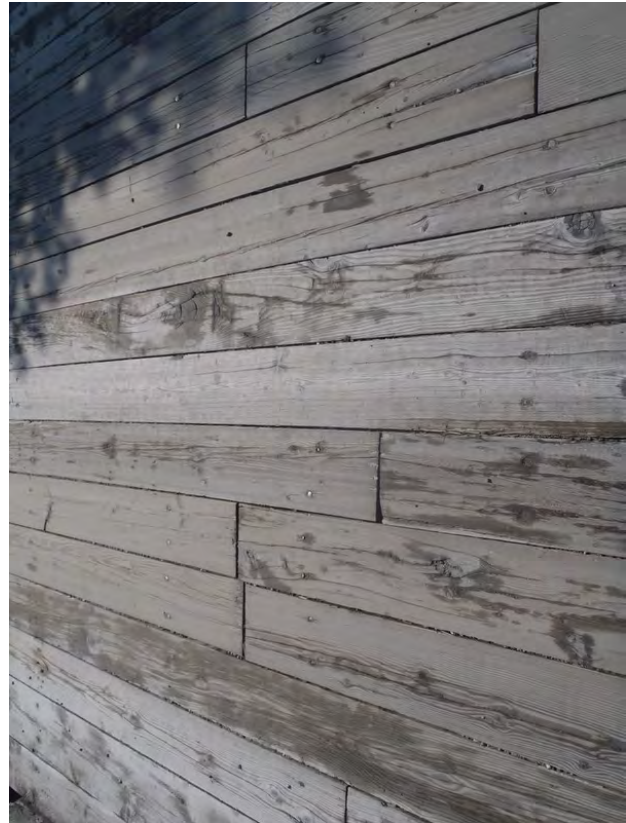
| Nails | Fair | | | Timber planks nailed at substandard spacing. | | | | | | | | | | |

Figure 8: General deck condition - Note substandard nail spacing.

| Bridge No. | SQ-3145 | Road Name | Ashlu River FSR | Inspection Date | 2014-08-14 |
|---|---|---|---|---|---|
| 8 | Re-space and re-spike ties at Span 1. | Low | \$5,000.00 | | |

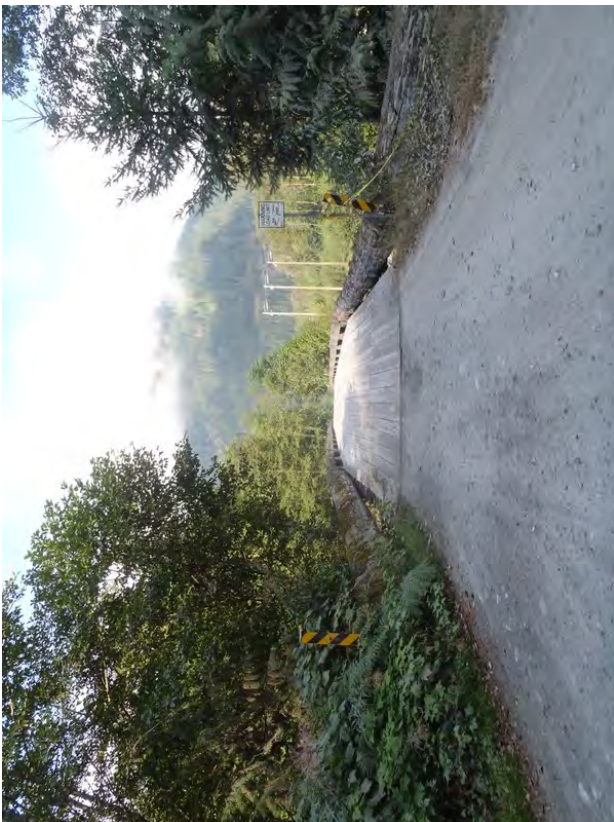
Figure 5: Left end approach.

| Alignment | Fair | | | T-intersection at left end approach. | | | | | | | | | | |

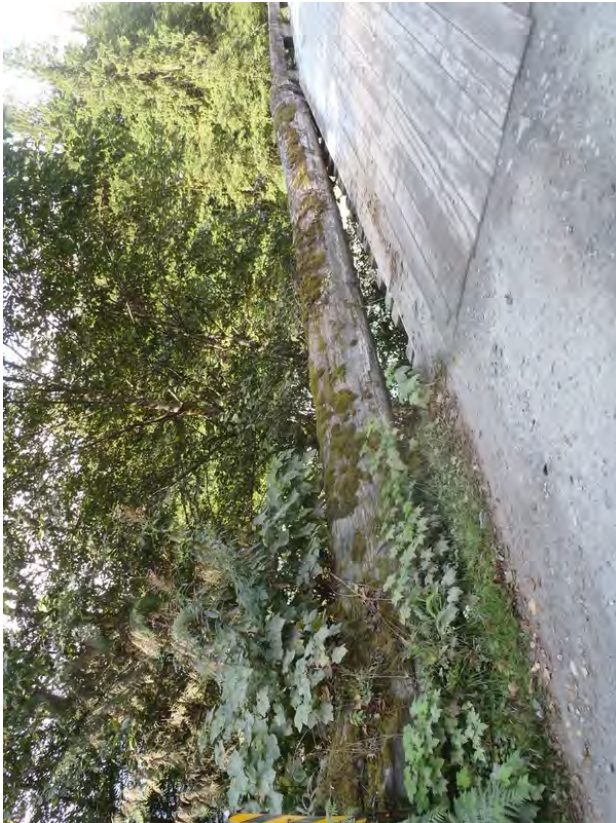
| Curb Rails and Risers | Poor | | | <p>Cedar logs as curbs both upstream and downstream.</p> <p>Downstream log is pushed outwards (downstream)</p> | | | | | | | | | | |

Figure 10: Span 1 downstream curb log - Note gap between log and edge of deck.

| Bridge No. | SQ-3145 | Road Name | Ashlu River FSR | Inspection Date | 2014-08-14 |
|---|---|---|---|---|---|
| 3 | Reset Span 1 downstream curb log. | High | \$1,000.00 | | |

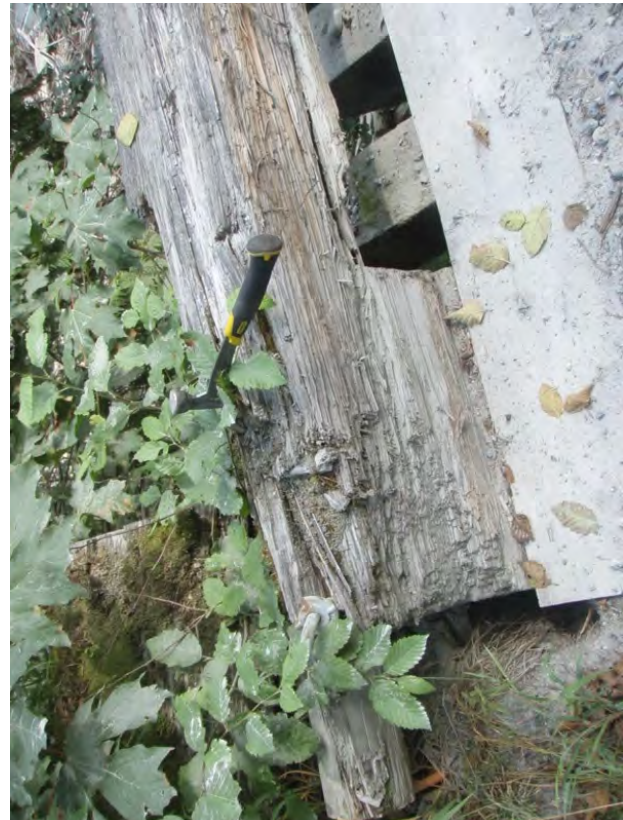
| Curb Rails and Risers | Poor | All curbs and risers sounded and cored in multiple locations; severe rot and impact damage noted in 4 curb rails (Left end of Span 2 and Right end of Span 4). | | | |

Figure 11: Typical rot in curb rail - Span 4 upstream right corner shown.

| Bridge No. | SQ-3145 | Road Name | Ashlu River FSR | Inspection Date | 2014-08-14 |
|---|---|---|---|---|---|
| 4 | Replace 4 sections of timber curb (see report). | High | \$2,500.00 | | |

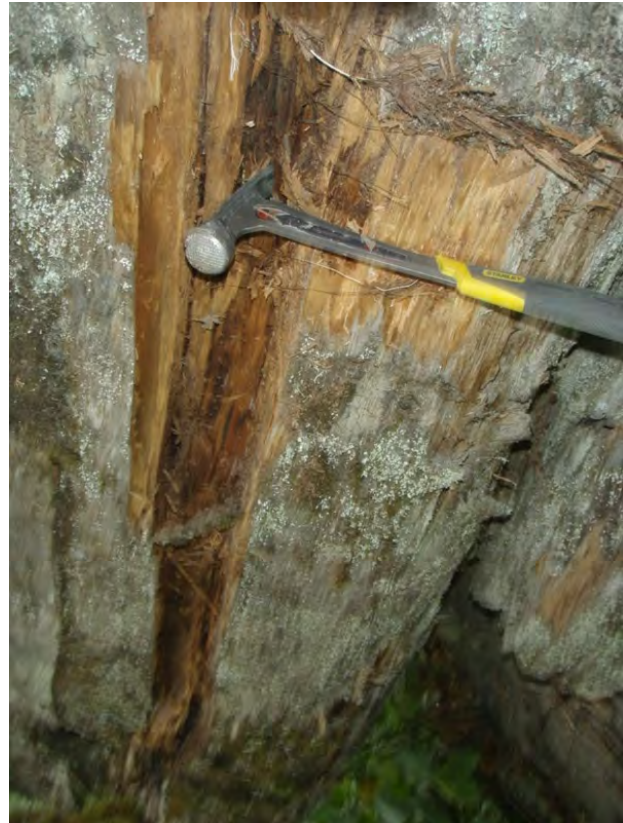
| Ballast Wall | Fair | Cedar log ballast wall; sapwood rot noted throughout. | | | |

Figure 16: Outer heartwood rot in right abutment ballast wall.

| Bridge No. | SQ-3145 | Road Name | Ashlu River FSR | Inspection Date | 2014-08-14 |
|---|---|---|---|---|---|
| 3 | Monitor condition of left abutment log crib and right abutment log ballast wall. | | | | |

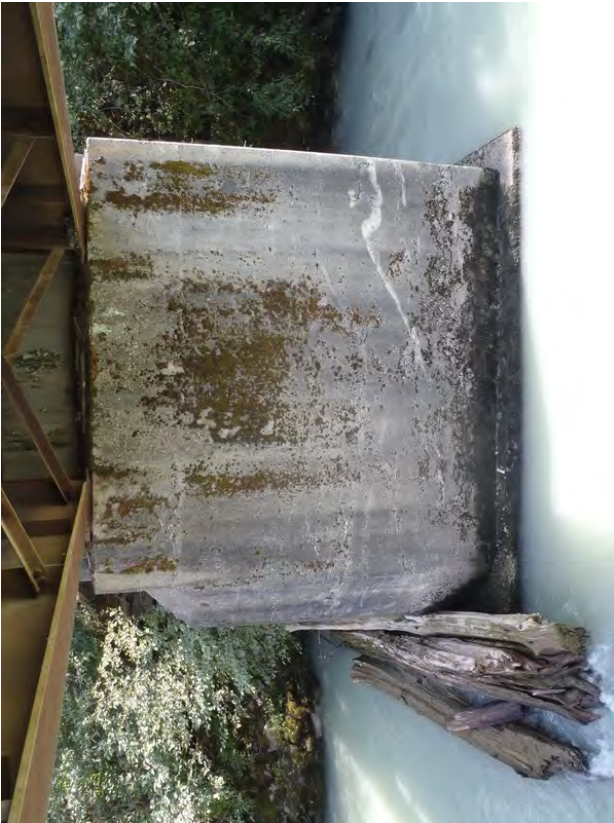
| Debris | | YES | Debris jam at piers. | | |

Figure 18: Pier 1 right end face - Note debris jam upstream.

| Bridge No. | SQ-3145 | Road Name | Ashlu River FSR | Inspection Date | 2014-08-14 |
|---|---|---|---|---|---|
| 7 | Remove debris jam from around Piers. | Medium | \$5,000.00 | | |

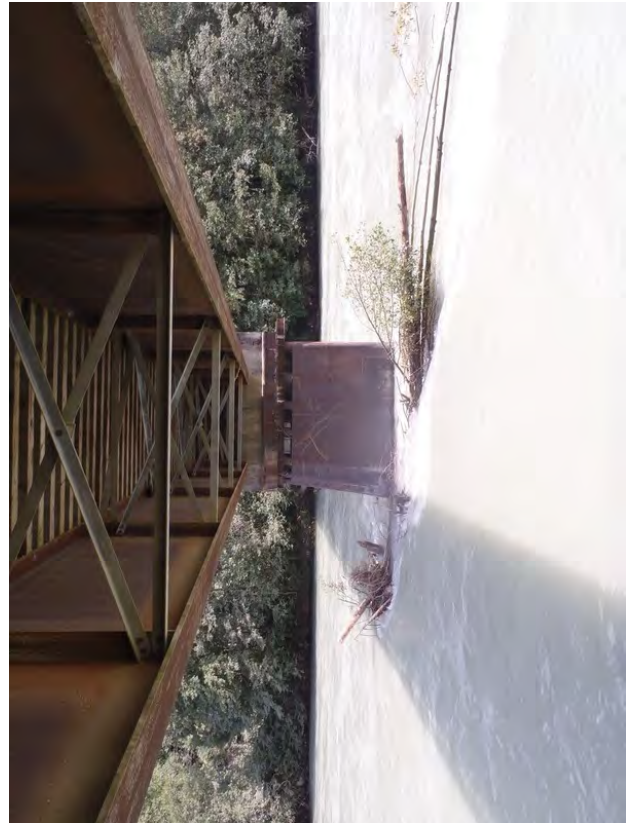
Figure 20: Pier 2 right end face - Note debris jam upstream.

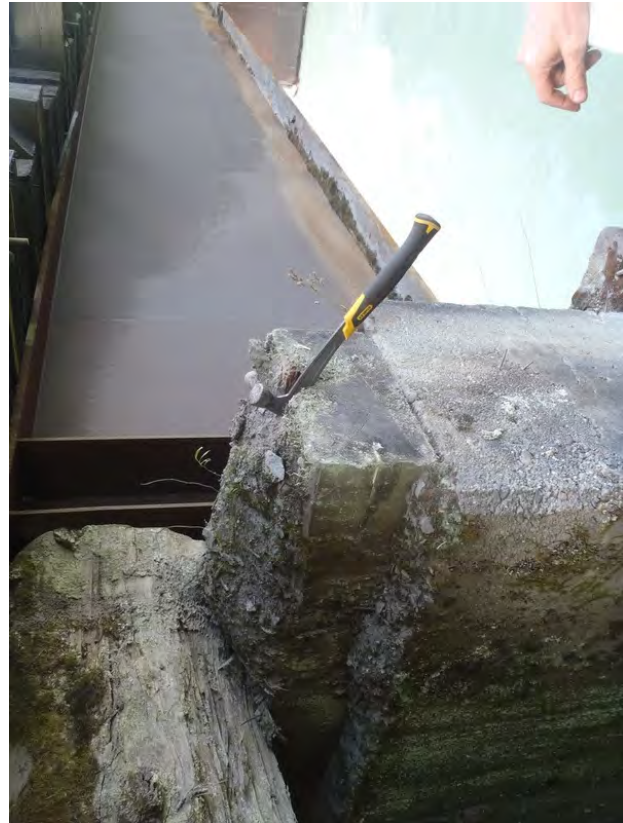
| Caps | Poor | Advanced rot noted in Span 1 timber still; minor bulging noted below stringer 1. | | | |

Figure 24: Pier 1 Span 1 timber sill - Note rot in end of sill.

| Bridge No. | SQ-3145 | Road Name | Ashlu River FSR | Inspection Date | 2014-08-14 |
|---|---|---|---|---|---|
| 6 | Replace log stringer approach span and timber sill. | Medium | \$90,000.00 | | |
| 2 | Monitor condition of Pier 1 timber sill prior to replacement. | | | | |

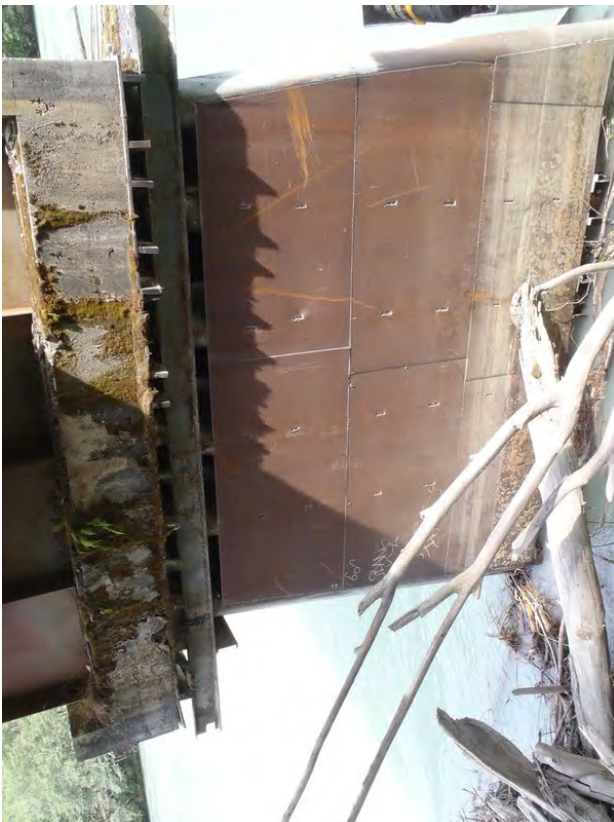
Figure 21: Pier 3 right end face - Note debris jam upstream.

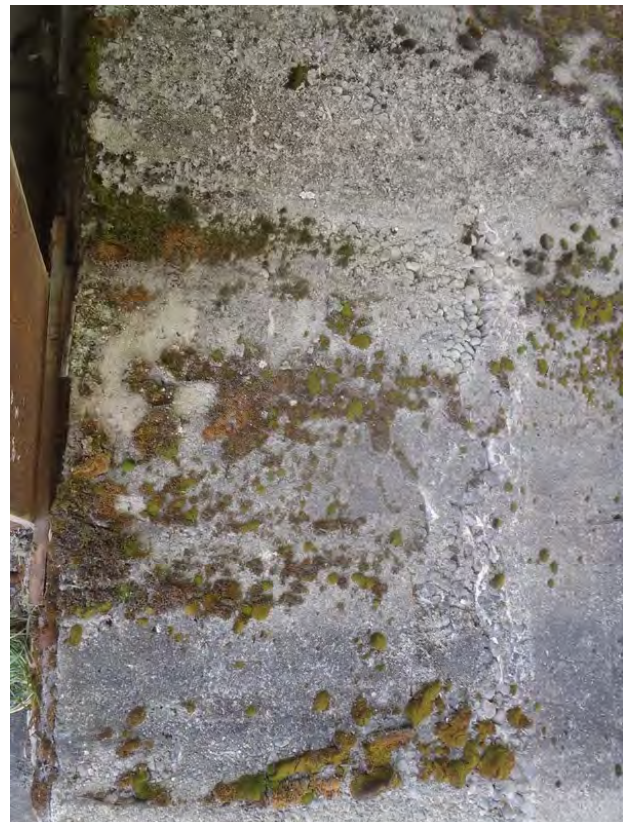
| Wall | Fair | Cast-in-place concrete wall; sections on right face with exposed aggregate and poor consolidation.<br><br>Unable to inspect pier wall below water line. | | | |

Figure 23: Right face of Pier 1 concrete wall - Note exposed aggregate and poor consolidation.

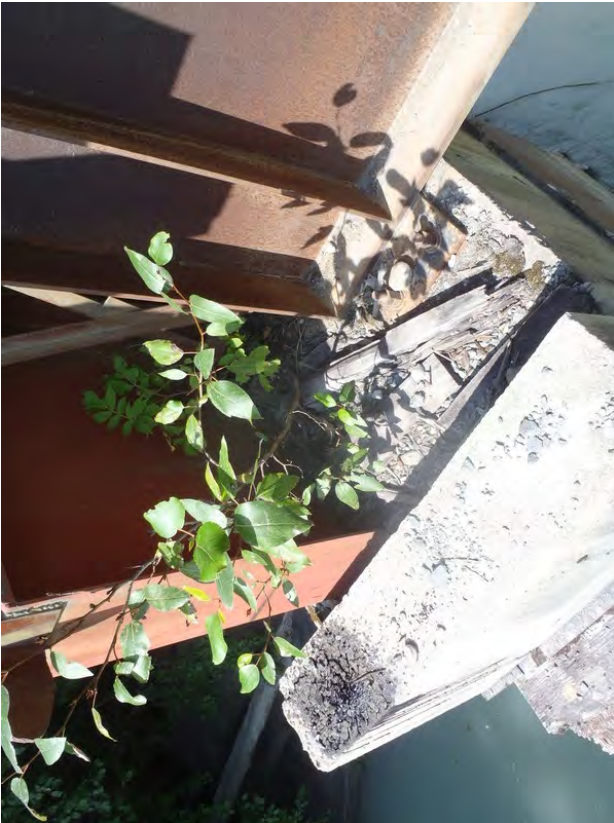
| Caps | Fair | Minor delamination on upstream face of concrete cap.<br><br>Debris accumulation and some vegetation growth along top of cap. | | | |

Figure 26: Pier 2 concrete cap - Note debris and vegetation.

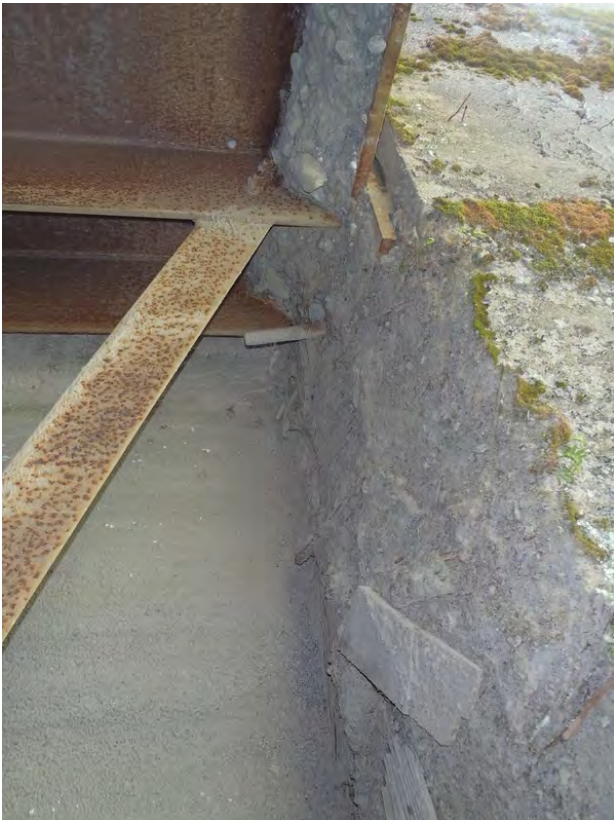
Figure 25: Debris accumulation on Pier 1.

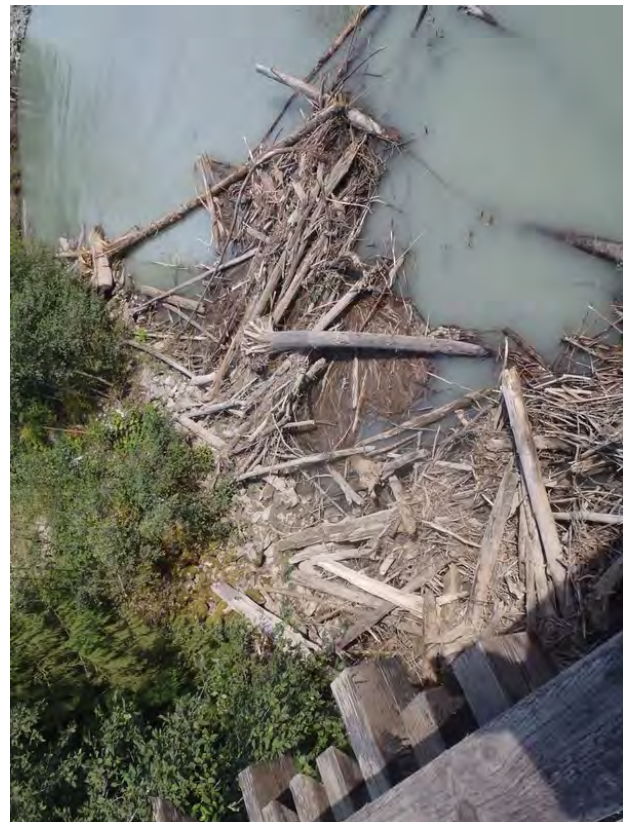
Figure 31: Debris jam at right end upstream.
