# Rails to Trails

## Routine Condition Culvert Inspection Form

| WEIRD CREEK | KV-014 | KV-014 | ~60m | 11/348737 | 5491869 |

Structure # : KV-014

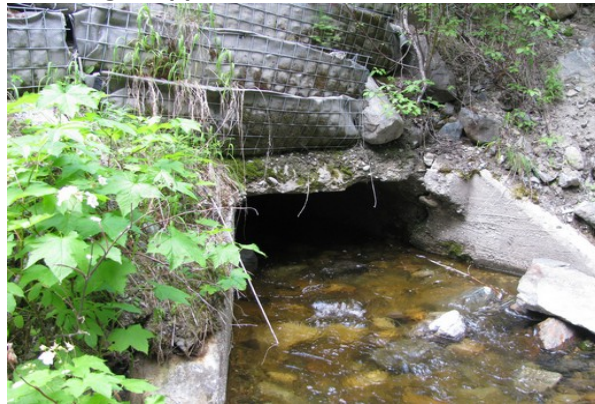
| Outlet | E | G | F | P | N/A | flare to 1800 wide 7% gradient, aggraded |

| # | Description |
|---|---|
| 2 | Aggradation at outlet, velocity of water through pipe should keep outlet clear. |

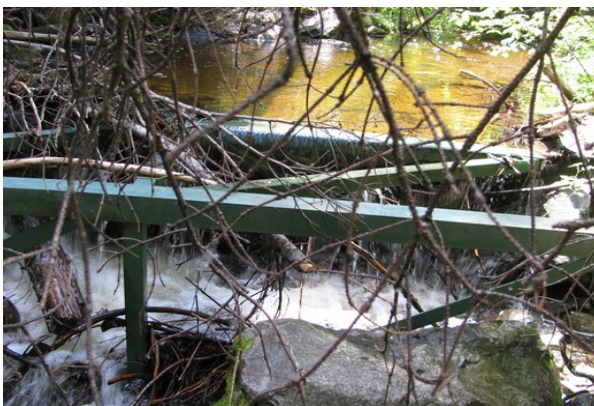
Trashrack

| Trash Rack | E | G | F | P | N/A | Debris build up on trash rack |

| <b>Hazard Comments</b> | <b>heavy bed-load and debris buildup on trash-rack, aggradation at outlet 850 clearance</b> |

| # | Description |
|---|---|
| 1 | Debris build-up on trash-rack due to high fill for crossing. |

| # | Priority | Description | Estimate (\$) |
|---|---|---|---|
| 1 | <b>M</b> | Clear Debris from trash rack | |

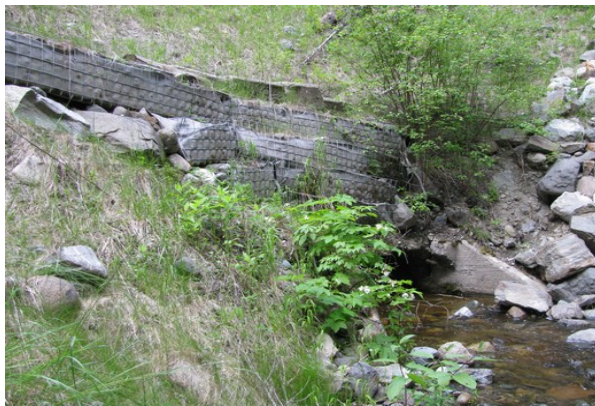
Outlet 2

| # | Description |
|---|---|
| 3 | Monitor stability of gabion headwalls at outlet, original walls have failed |
