Rails to Trails  
Routine Condition Culvert Inspection Form

| Crossing<br>Weird Creek | Structure #<br>KV-014 | Site #<br>5-2 | Km<br>94.2 | UTM Zone<br>11 N | UTM E<br>348684 | UTM N<br>5491808 |

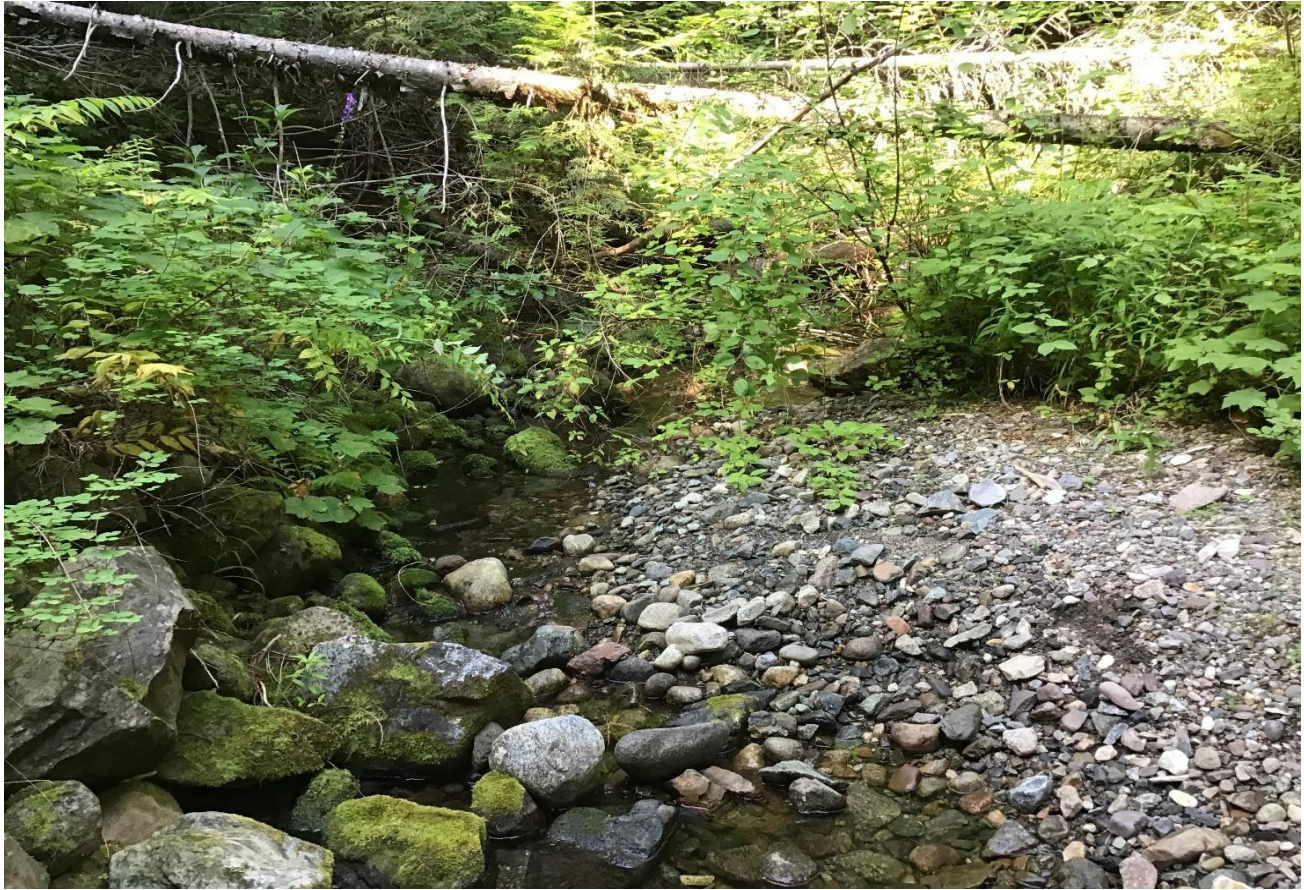
Upstream flume

| Upstream Flume | Good | |

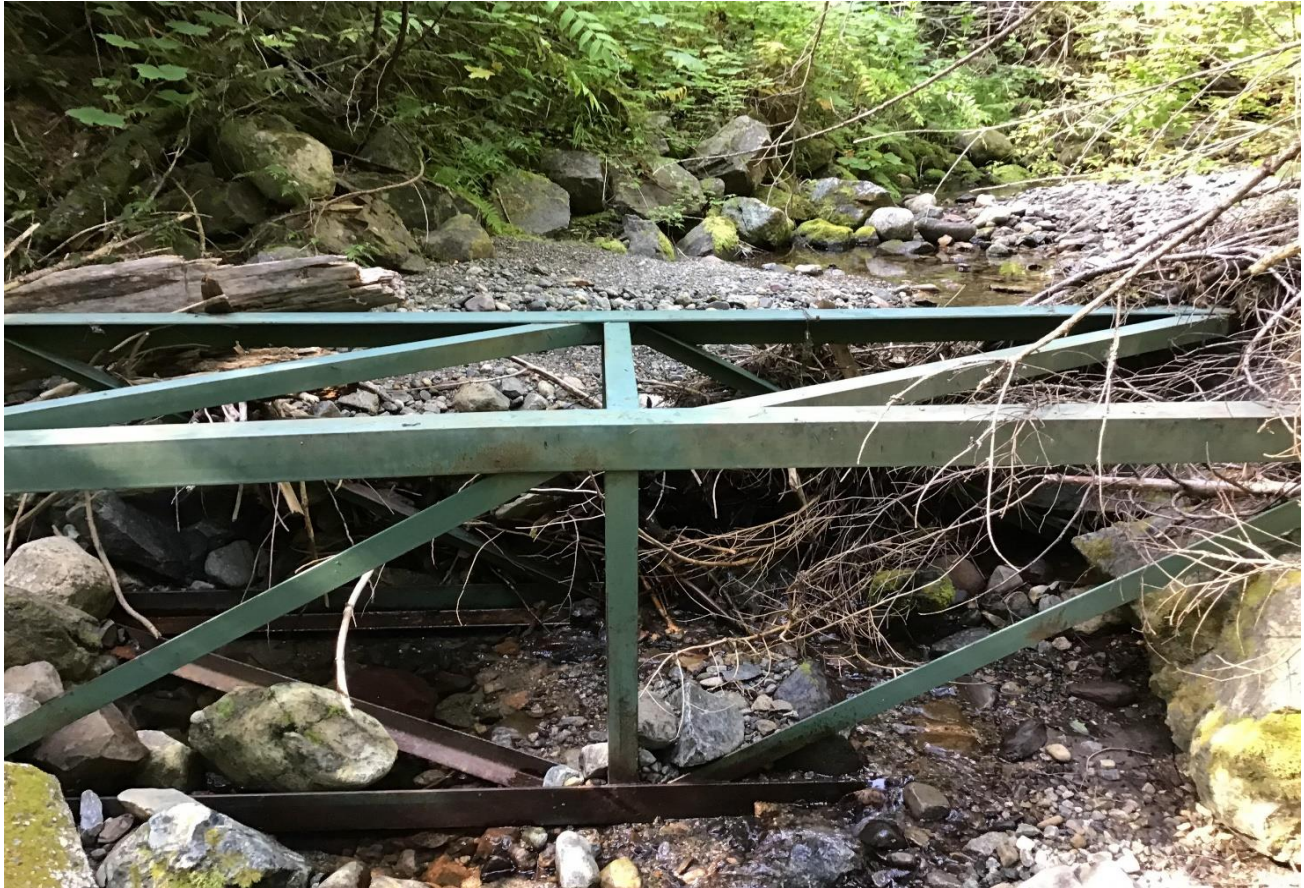
| Trash Rack | Good | Angle iron tower laid perpendicular to flow at inlet acting as trash rack. Minor debris accumulated. Needs monitoring and maintenance during freshet | | | | |

Assumed trash rack

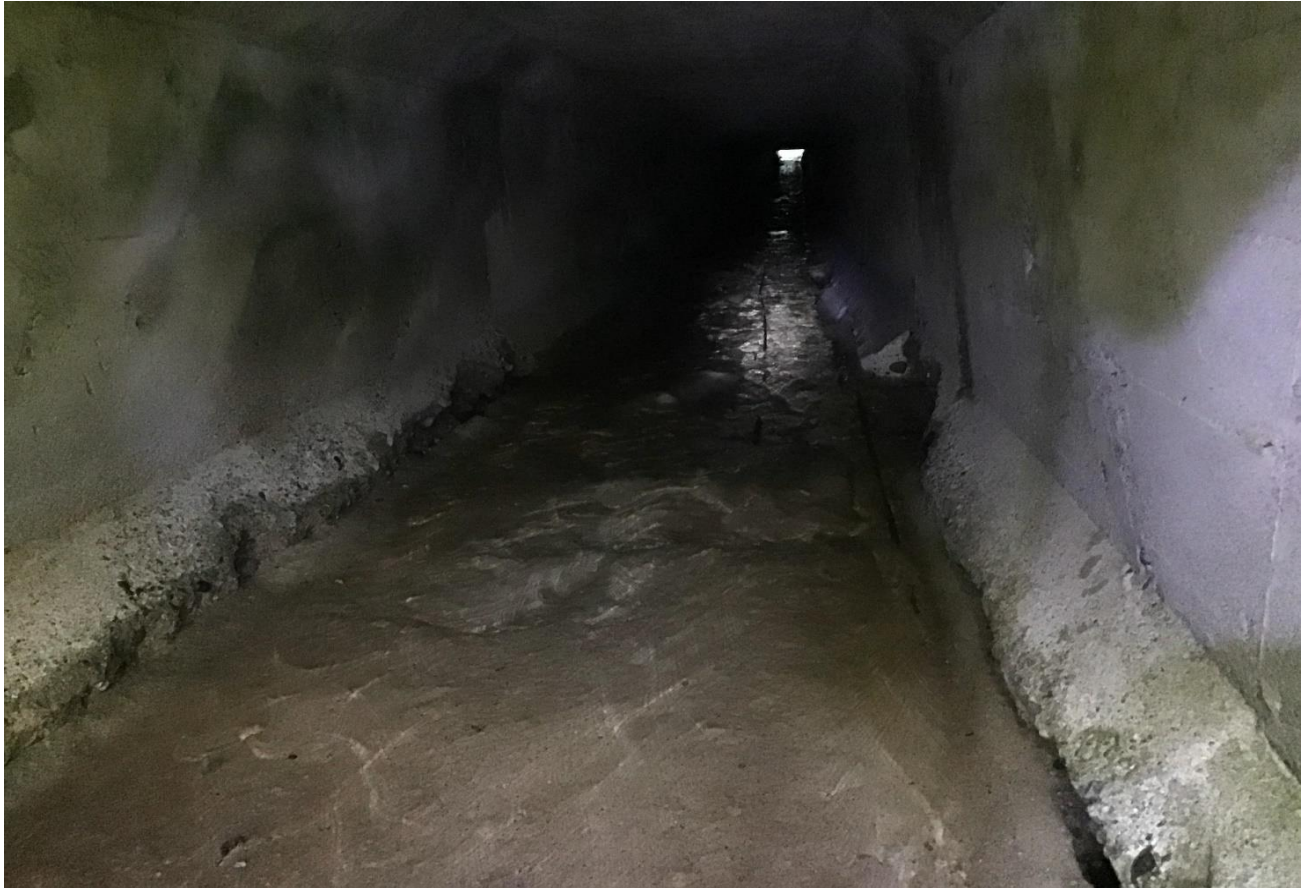
| Crossing<br>Weird Creek | Structure #<br>KV-014 | Site #<br>5-2 | Km<br>94.2 | UTM Zone<br>11 N | UTM E<br>348684 | UTM N<br>5491808 |
|---|---|---|---|---|---|---|
| Floor | Fair | Scouring of concrete floor approx 50mm | | | | |

Channel floor scouring

| 2 | Floor scouring | | | | | |

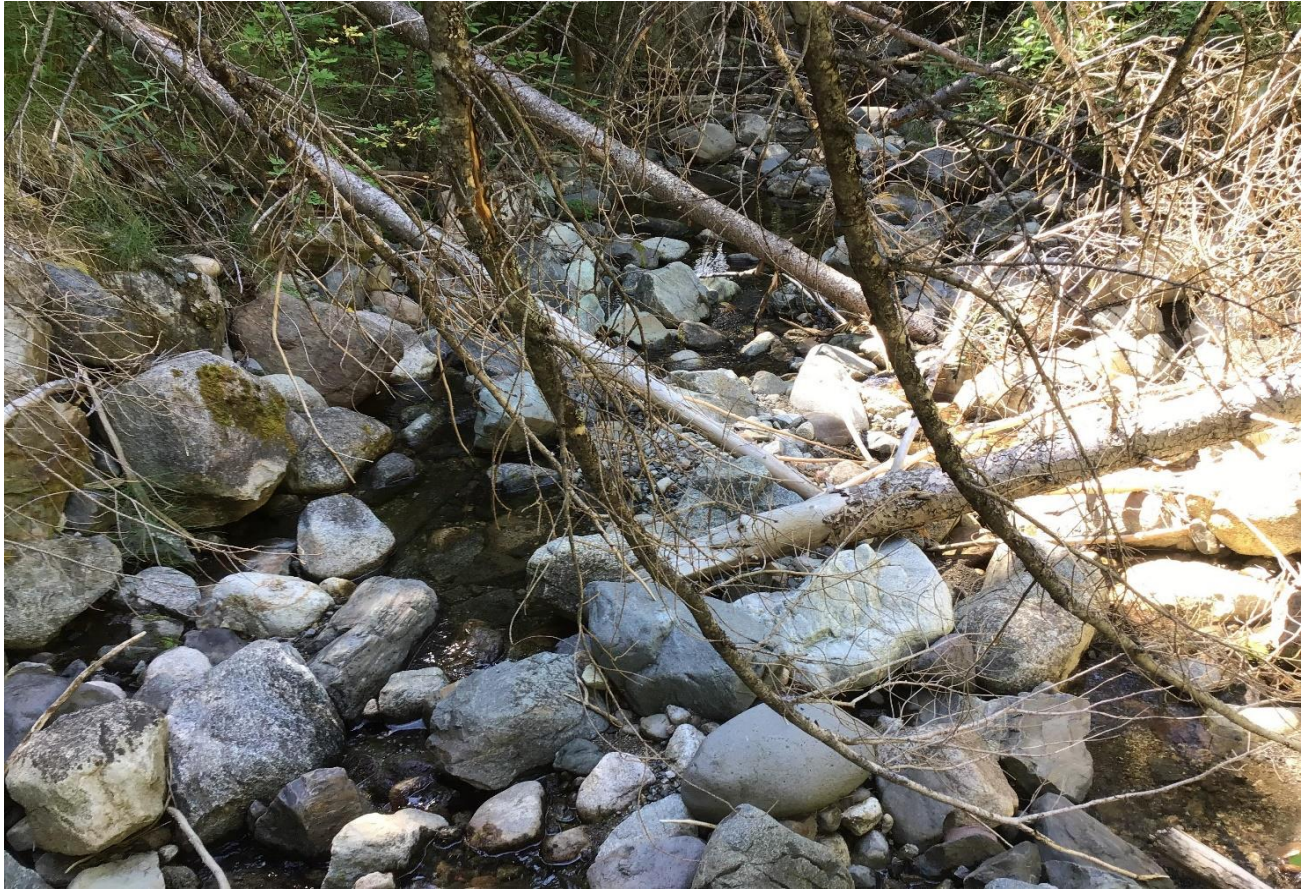
Outlet flume

| Downstream Flume | Good | |

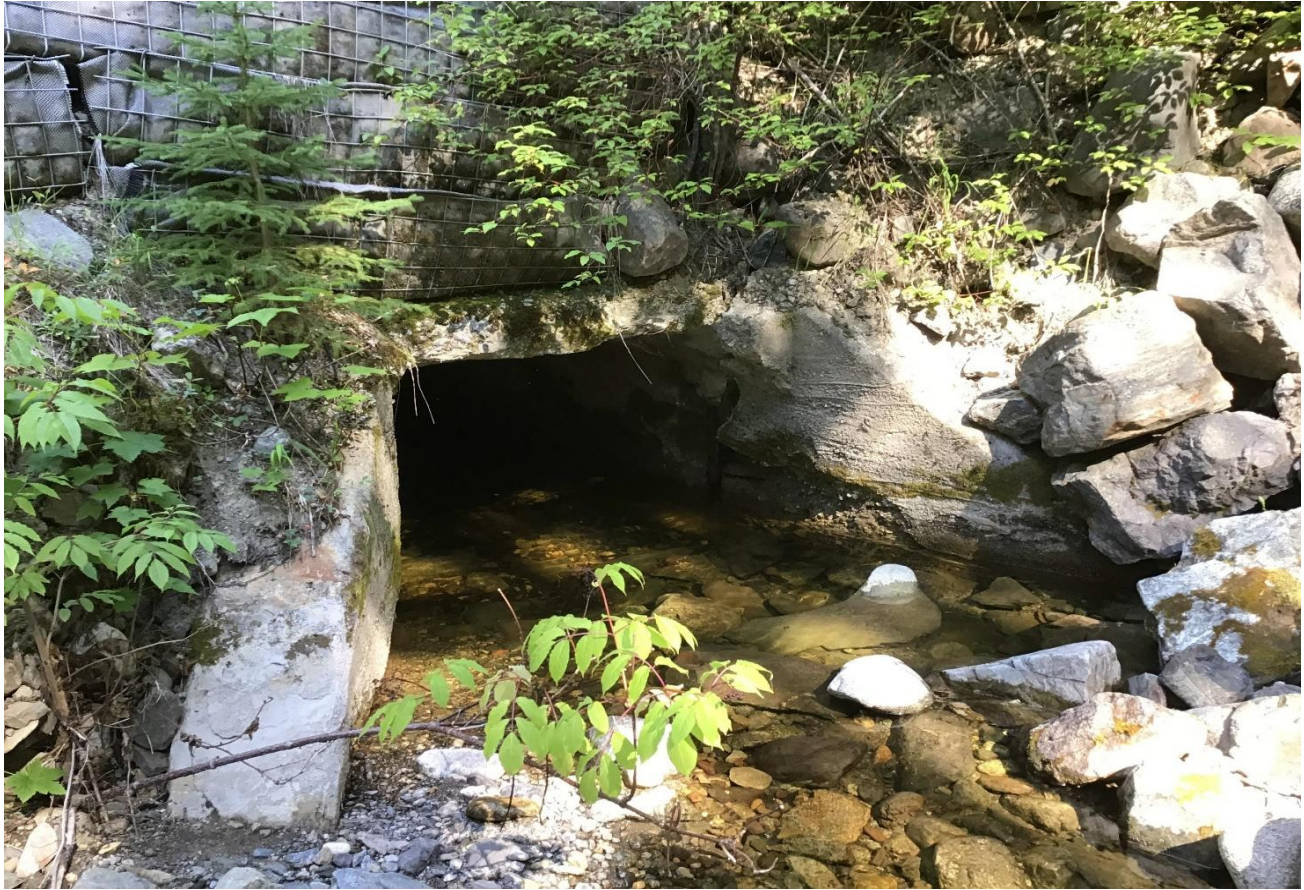
| Outlet | Fair | Gabian baskets and concrete blocks placed on top of head wall to extend retention element vertically. It appears that the weight of these gabian baskets is causing the CIP Concrete outlet to degrade and deflect. Risk of collapse is increased. | | | | |

| 1 | Outlet structural integrity. | | | | | |

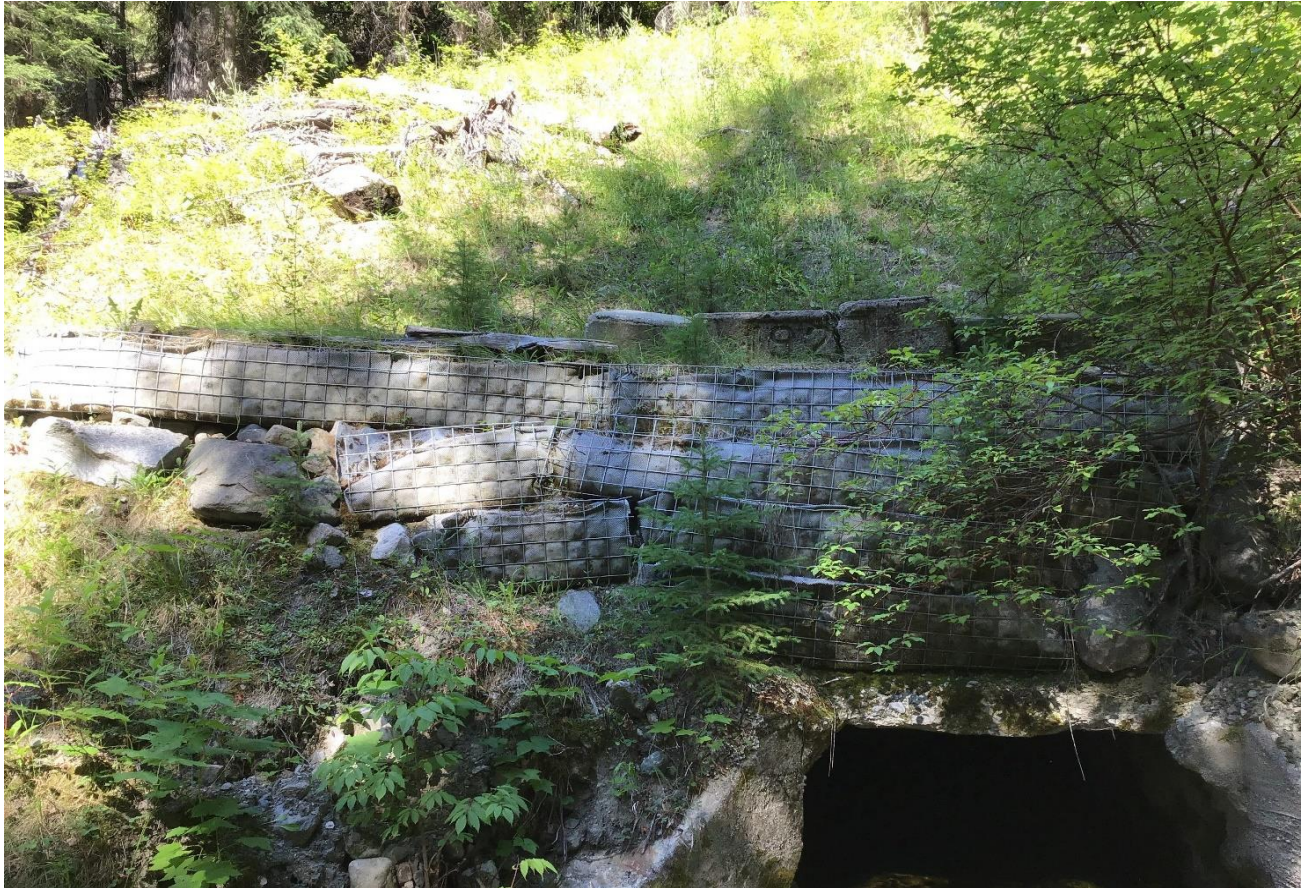
| Concrete culvert is in good condition. Outlet is starting to fail due to gabian basket wall constructed on top of outlet head wall. Culvert length is approximate | | | | | | |

Fabian basket headwall at outlet

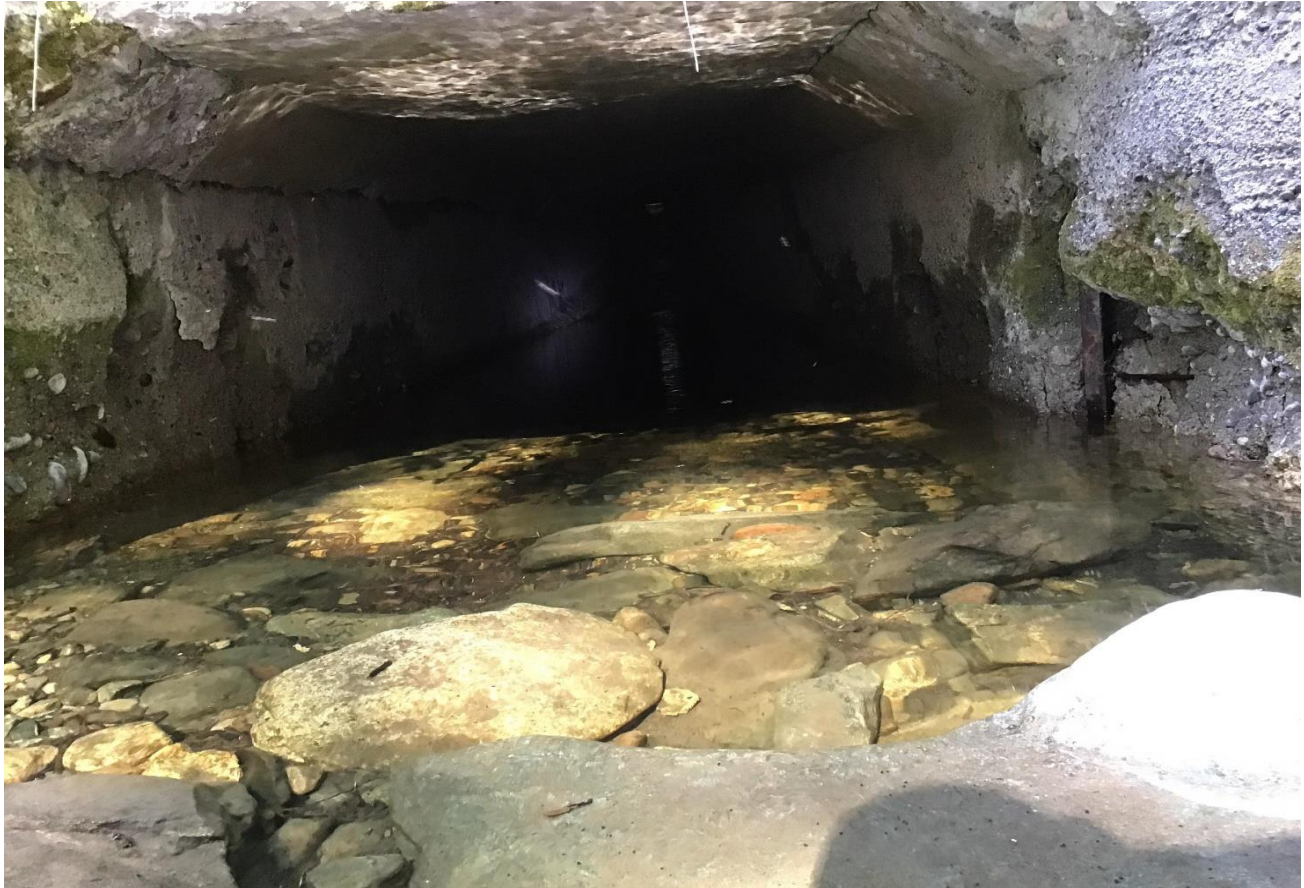
| Overall Condition | Fair | If outlet failure condition worsens, condition will be downgraded. Surcharging observed in final 6m of culvert, to a maximum depth of 0.3m. Caused by deposition at outlet and vertical deflection in culvert alignment | | | | |

0.3m surcharge at outlet.

| 3 | Surcharging at outlet | | | | | |

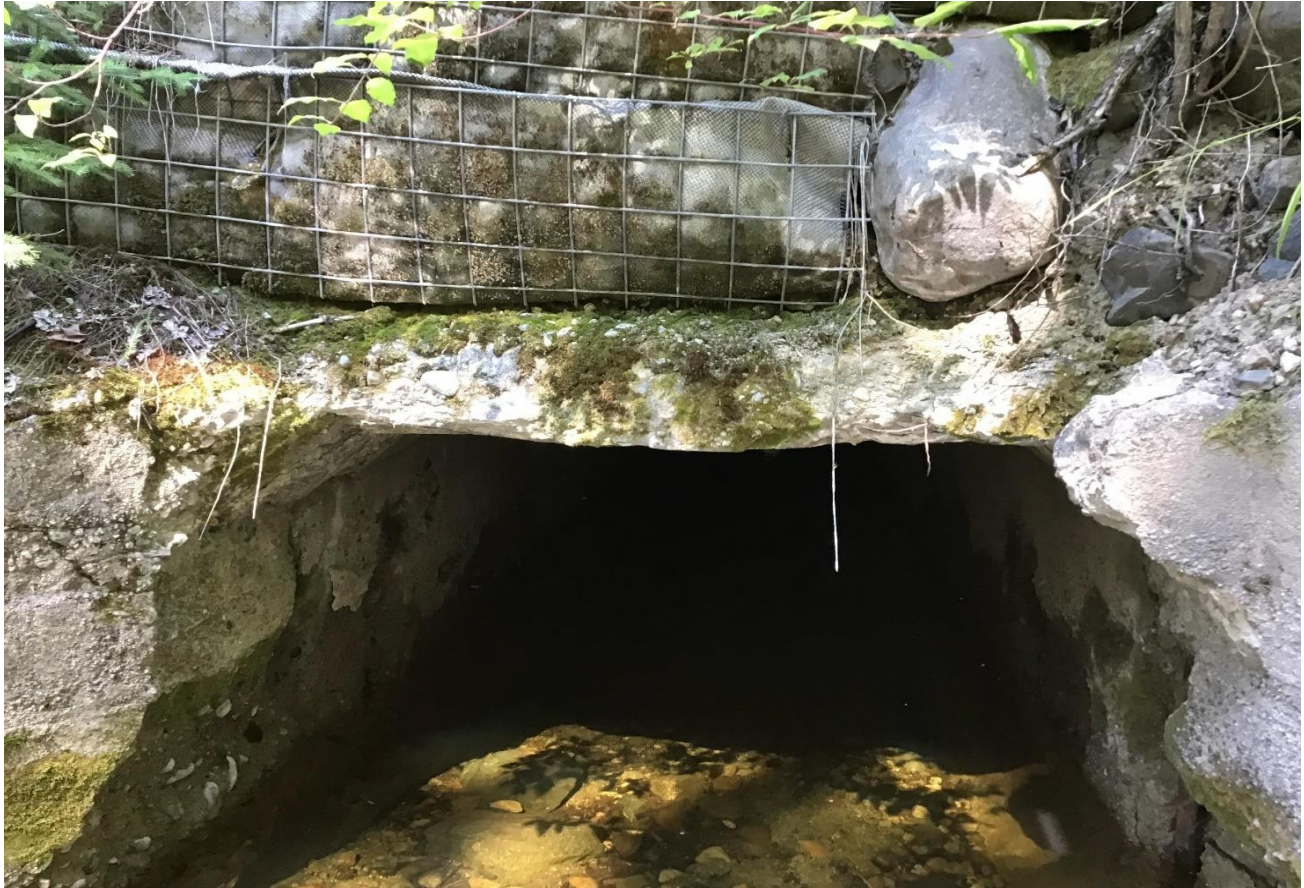
| Headwalls | Fair | Inlet head wall good, outlet head wall fair, all CIP Concrete | | | | |

Headwall degradation at outlet

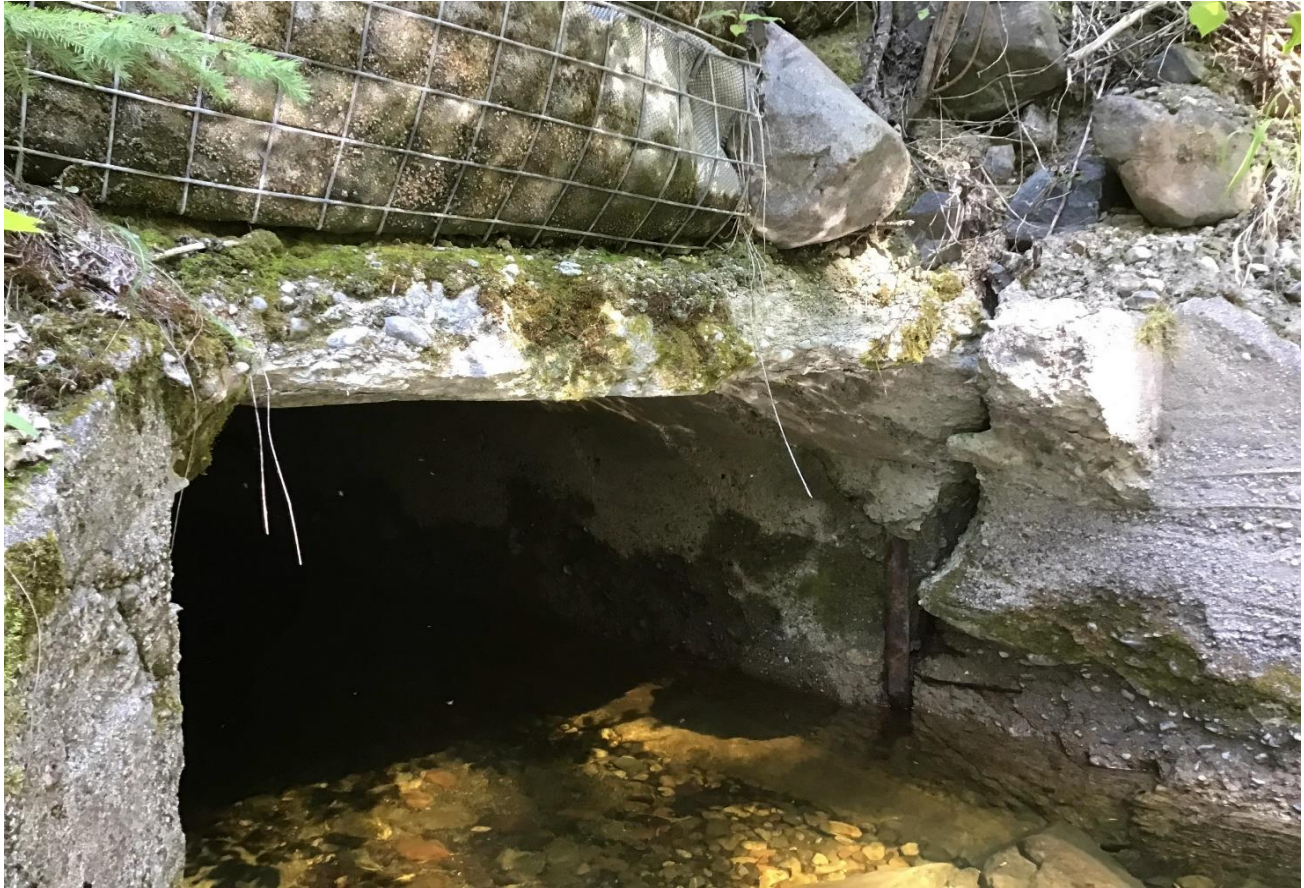
| Wing Walls | Fair | Inlet wing walls good, outlet wing walls fair, all CIP Concrete | | | | |

Shear Crack in headwall/wingwall connection at outlet

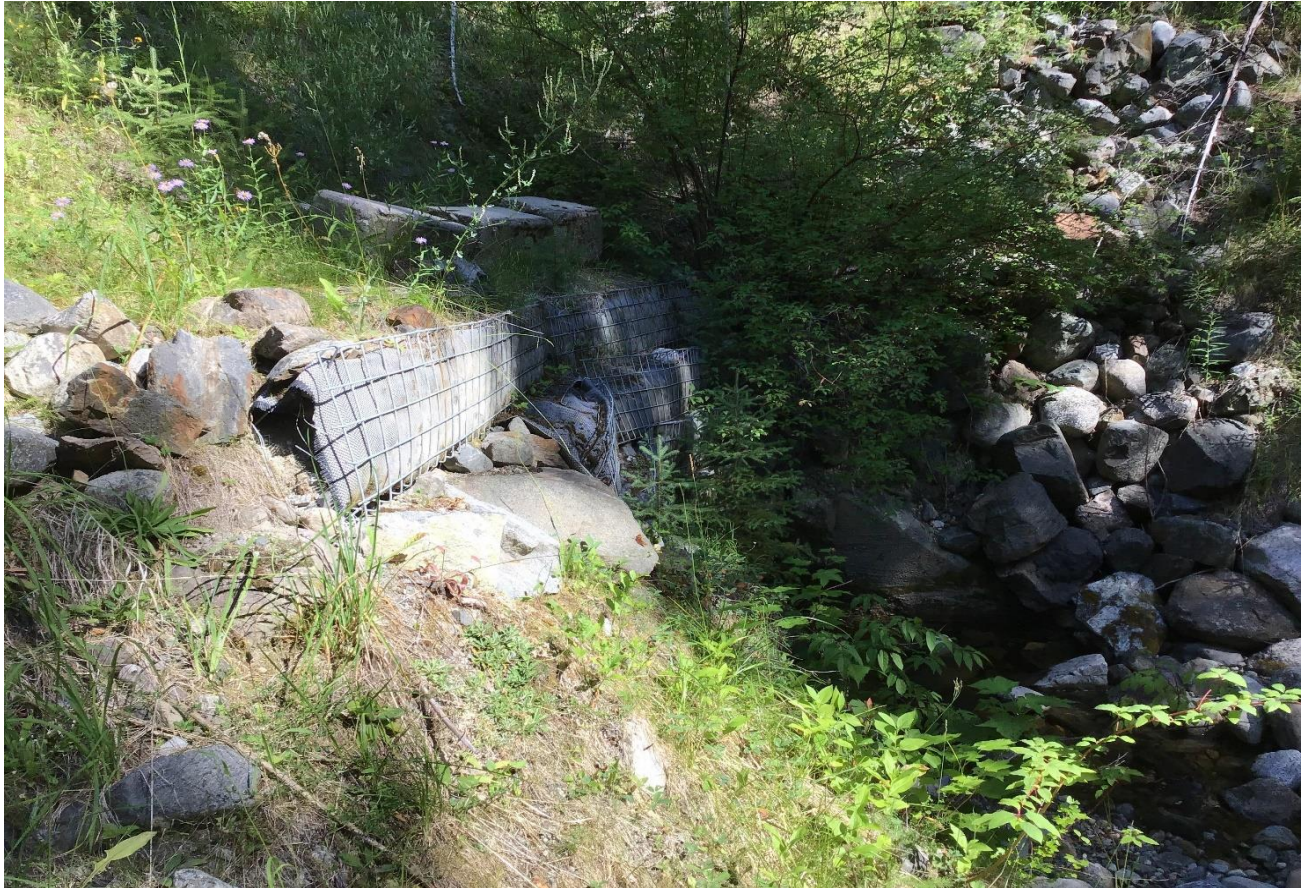
Gabian baskets above outlet
