Rails to Trails  
Routine Condition Culvert Inspection Form

| Crossing | Structure #<br>KV-054 | Site #<br>5-3 | Km<br>109.2 | UTM Zone<br>11 N | UTM E<br>247843 | UTM N<br>5487063 |
| Inspection Co. Name<br>Sean Annan | Inspector's Signature<br> | | | Inspection Date<br>September 13, 2019 | Next Inspection | |

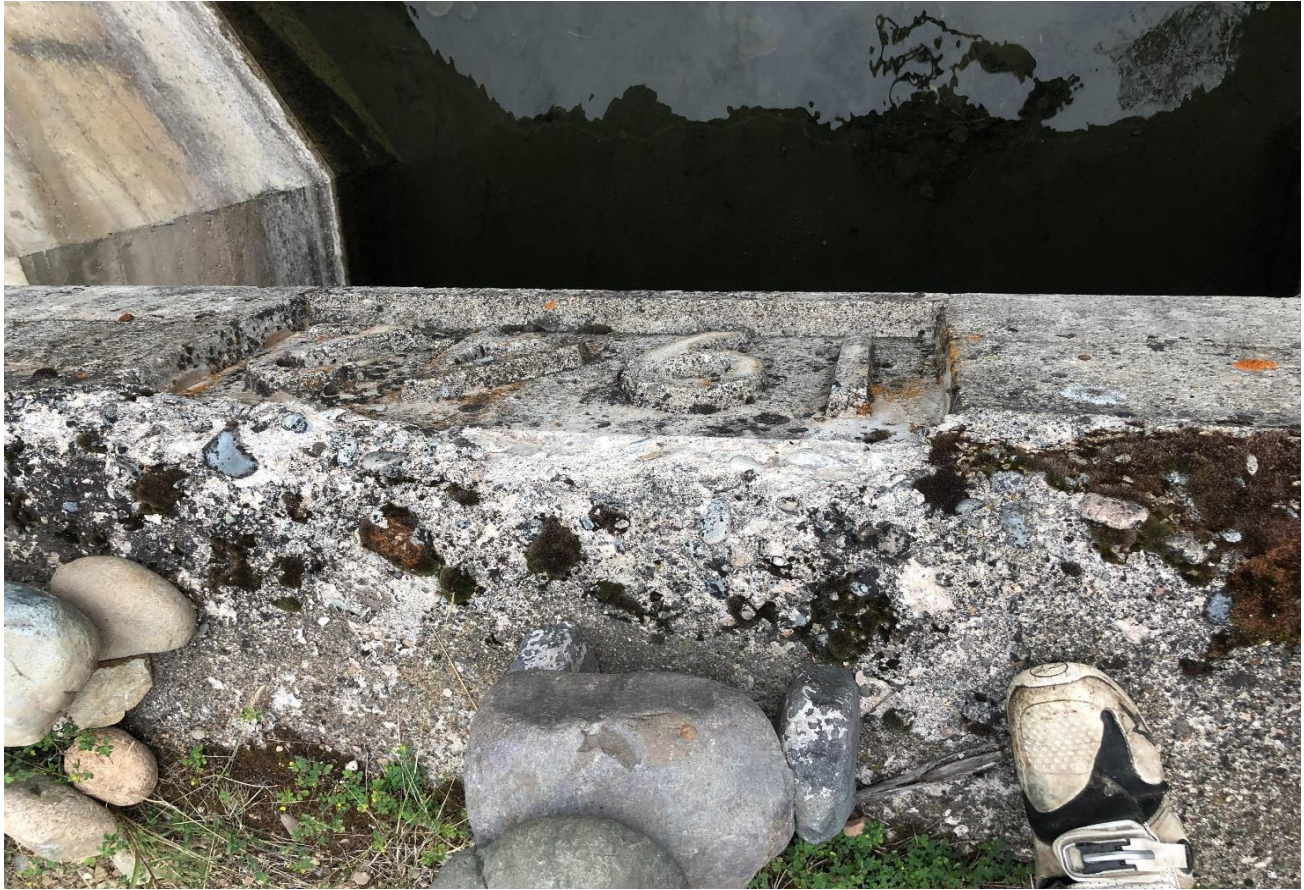
| Item | Present Condition | Comments |
|---|---|---|
| Headwalls | Good | CIP Concrete at inlet and outlet. Minor spalling at front-top edge of middle of culvert 0.8m wide |

Spalling on top of headwall

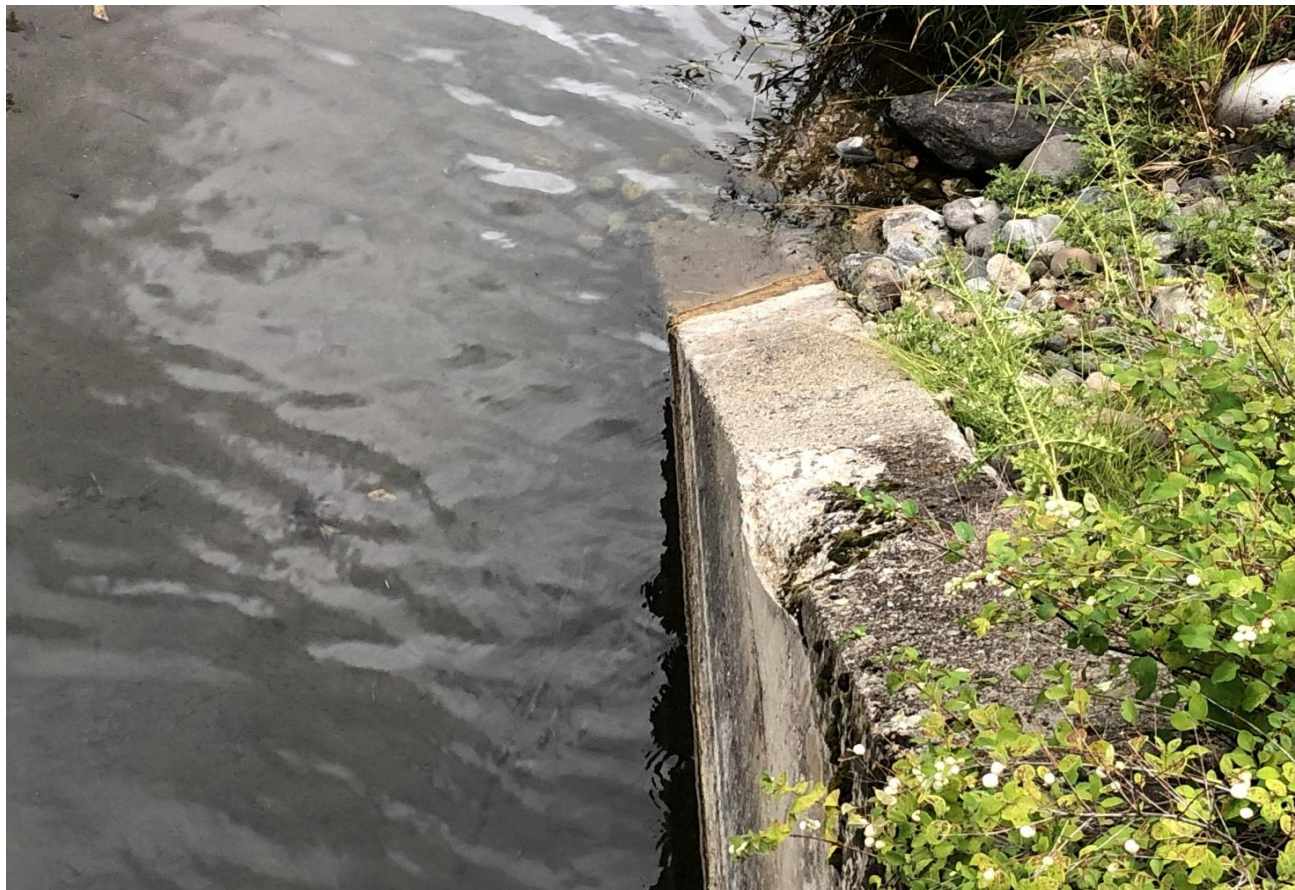
| Item | Present Condition | Comments |
|---|---|---|
| Wing Walls | Good | CIP Concrete at inlet and outlet minor spalling in inlet right hand wing wall. |

Spalling in wingwall at inlet

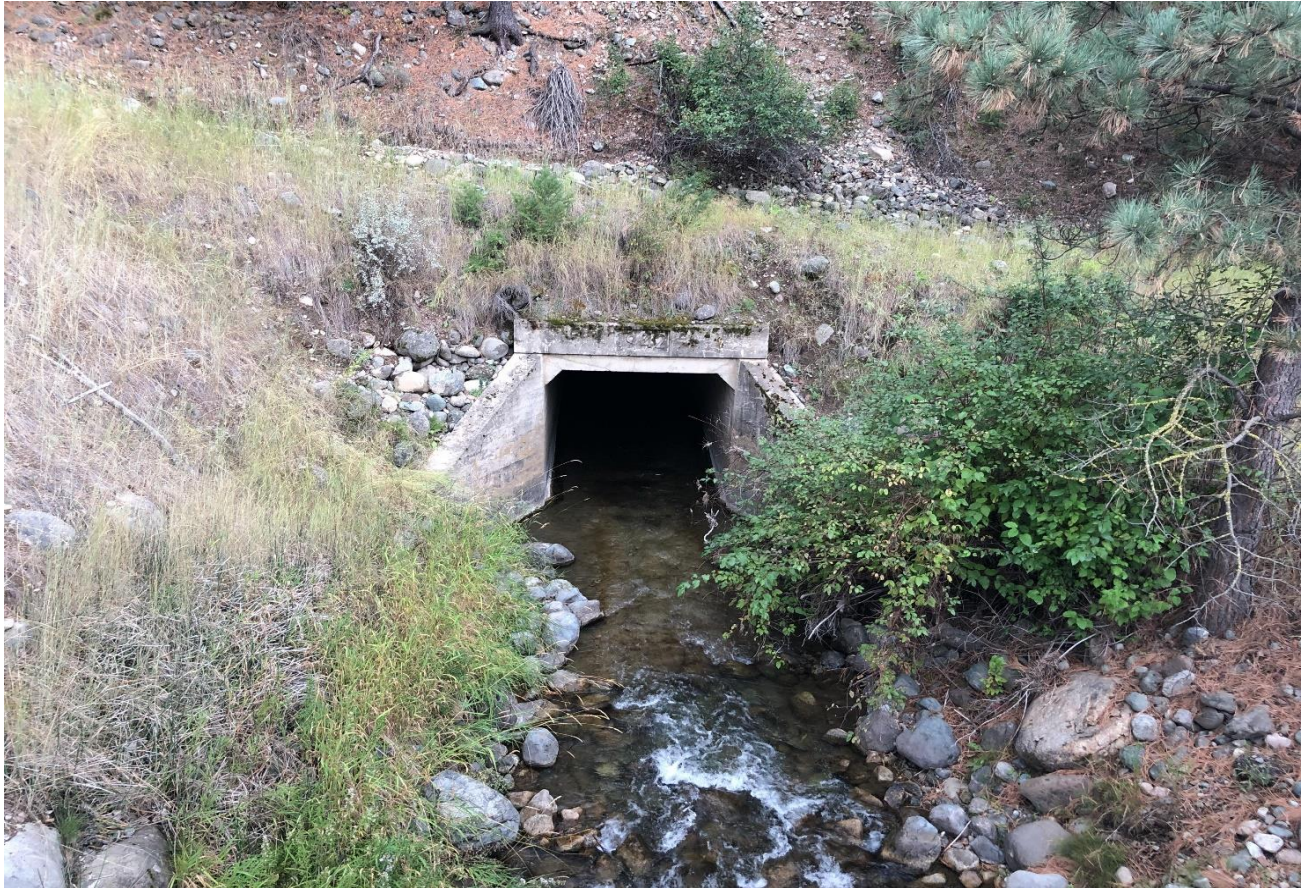
Inlet

| Crossing | Structure #<br>KV-054 | Site #<br>5-3 | Km<br>109.2 | UTM Zone<br>11 N | UTM E<br>247843 | UTM N<br>5487063 |
|---|---|---|---|---|---|---|
| Floor | Poor | Sand debris as observed from outlet. At inlet, scouring has exposed horizontal floor bars. | | | | |

| 1 | Medium | Replace concrete floor | | | 45000 | |
