Rails to Trails  
Routine Condition Culvert Inspection Form

| Crossing<br>Boundary Creek | Structure #<br>CW-064 | Site #<br>5-2 | Km<br>145.4 | UTM Zone<br>11 N | UTM E<br>377538 | UTM N<br>5441192 |
| Inspection Co. Name<br>Sean Annan | Inspector's Signature<br> | | | Inspection Date<br>September 9, 2019 | | Next Inspection |

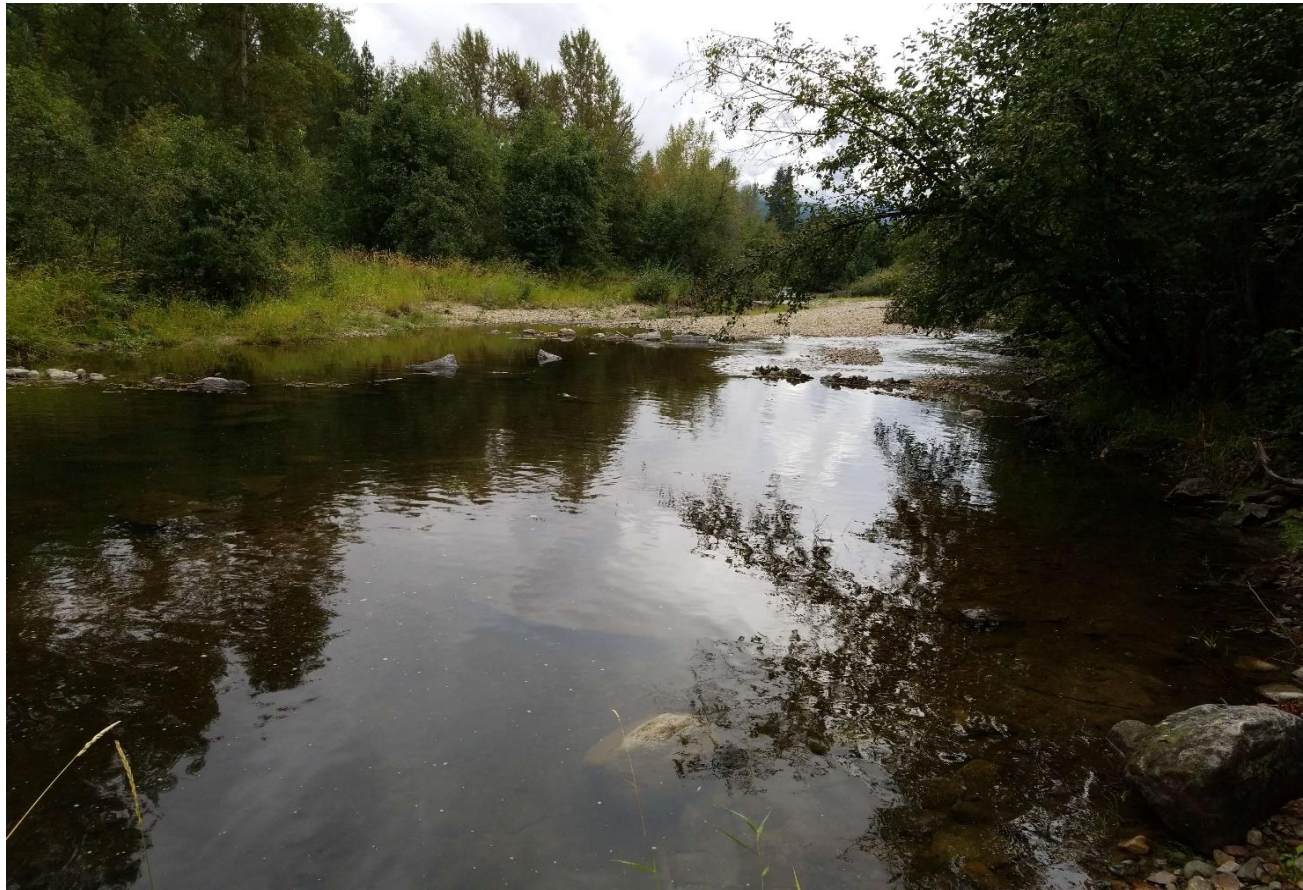
Outlet flume - Boundary Creek

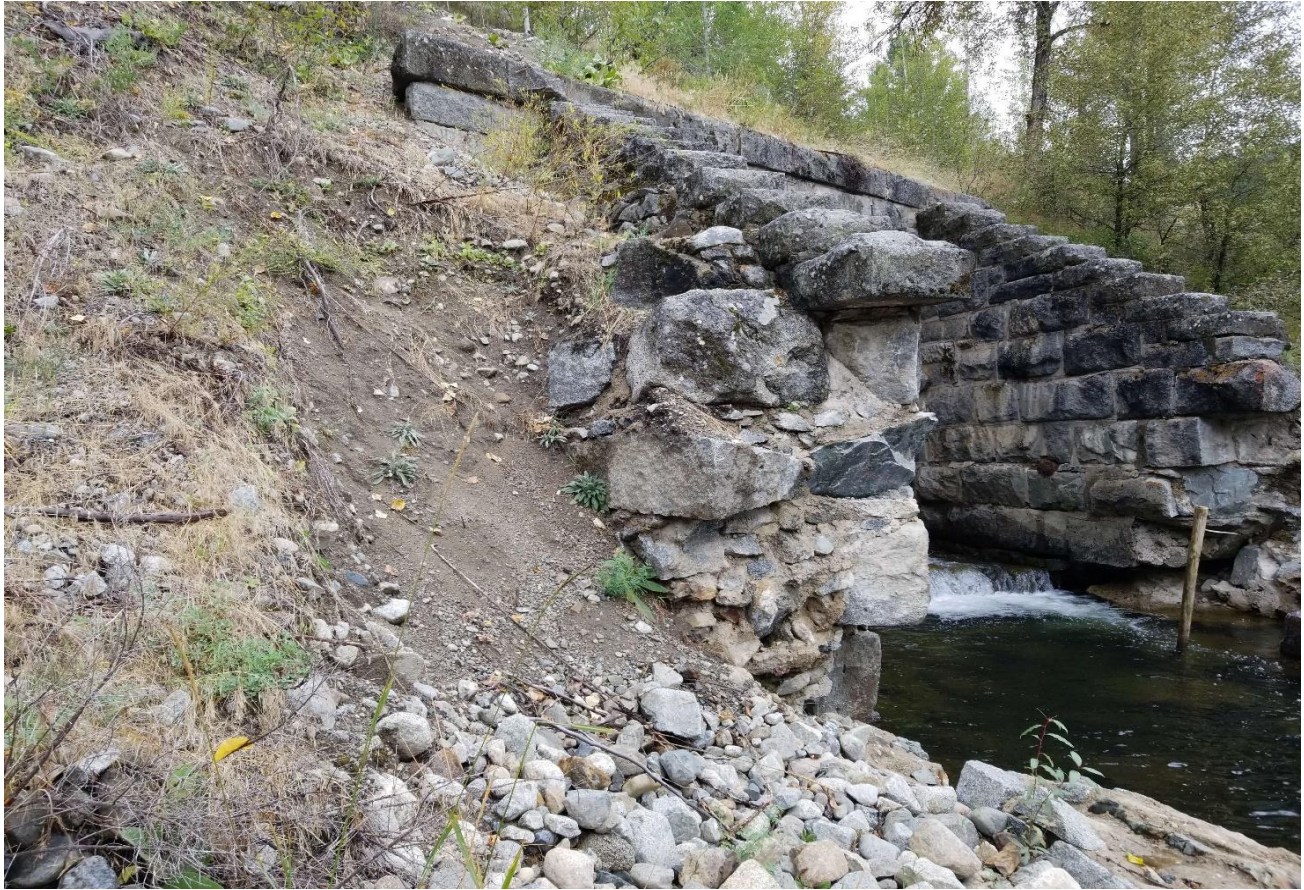
| Item | Present Condition | Comments |
|---|---|---|
| Wing Walls | Poor | Inlet wing walls good. Outlet wing walls failing on both sides. Bank scouring has occurred as a result. Wing wall ends have sheared off and dropped as a result of suspected undercutting by flow |

Culvert floor significantly scoured. Outlet wing walls collapsed due to undercutting by flow. Sloughing present on outlet upslope as a result.

Outlet wingwall failure and sloughing

| # | Priority | Description | Estimate (\$) |
|---|---|---|---|
| 1 | High | Add slope retention element to outlet wingwalls to prevent further slope sloughing | 50000 |

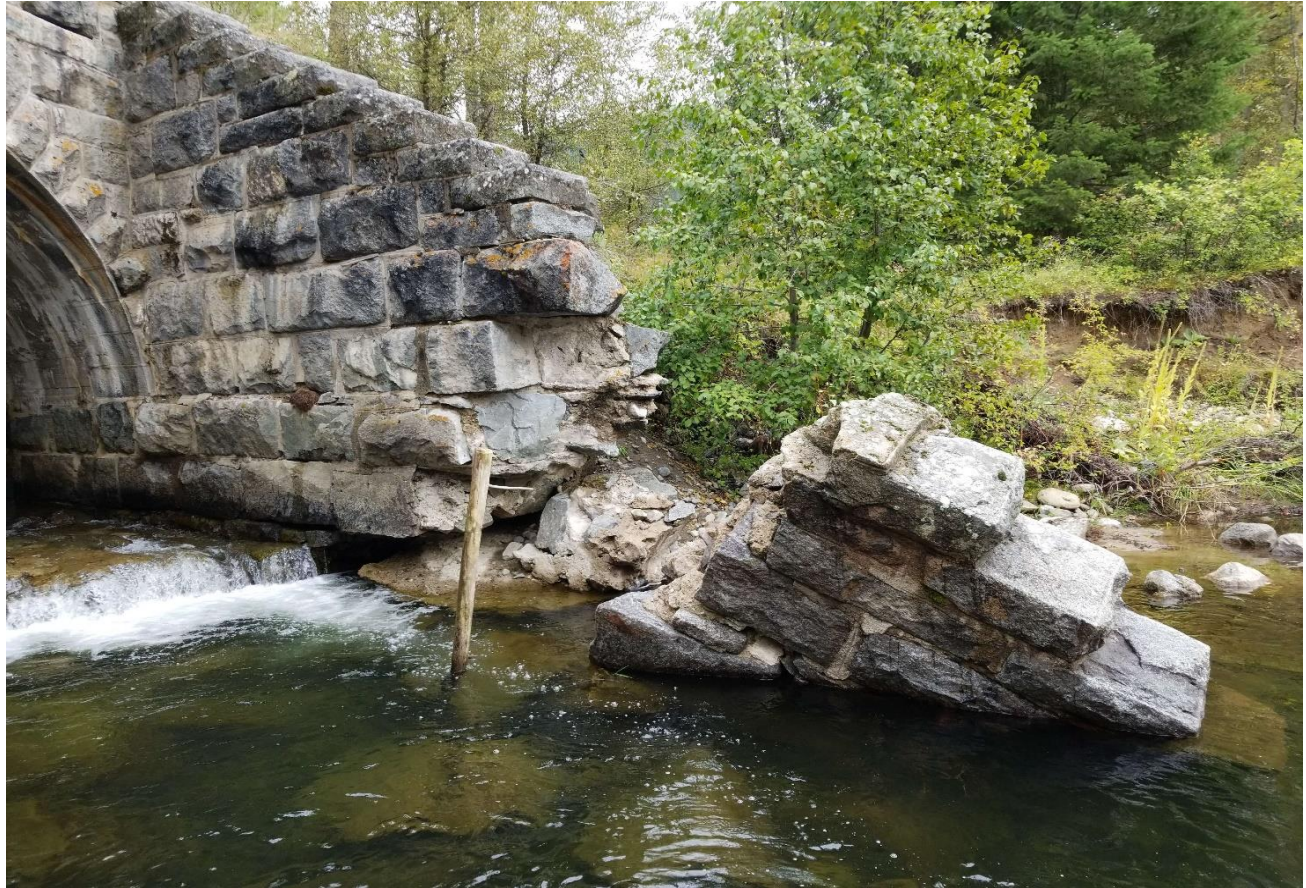
Outlet wingwall failure
