# Rails to Trails

## Routine Condition Culvert Inspection Form

| Boundary Creek | CW-064 | CW-064 | 60.0 | 11 377510 | 5441184 |
| SNT Engineering Ltd. | R.Johnson | | | Next Inspection: | 1-Jun-14 |

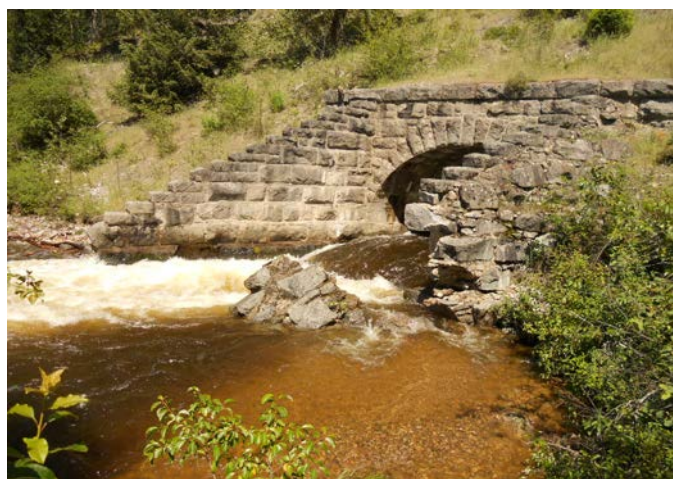
| Wing Walls | E | G | F | P | N/A | DS LB: 3m section has failed and RB is scouring with cracks in wingwall |
| Outlet | E | G | F | P | N/A | Scour on LB behind failed wing wall |

| Hazard Comments | Scour is active on DS LB behind failed wing wall; monitor. | | | |

| Solid structure but downstream wingwalls are failing, which is creating scour on left bank behind the wall. |

**Downstream View, showing failed wingwall**

| # | Description |
|---|---|
| 1 | Check downstream wing walls and scour behind Left wall |
