## Post-Wildfire Risk Analysis, Fire N50196, Perry Ridge – further details

Peter Jordan, P.Geo., MFLNRO, Nelson 15 Aug 2013

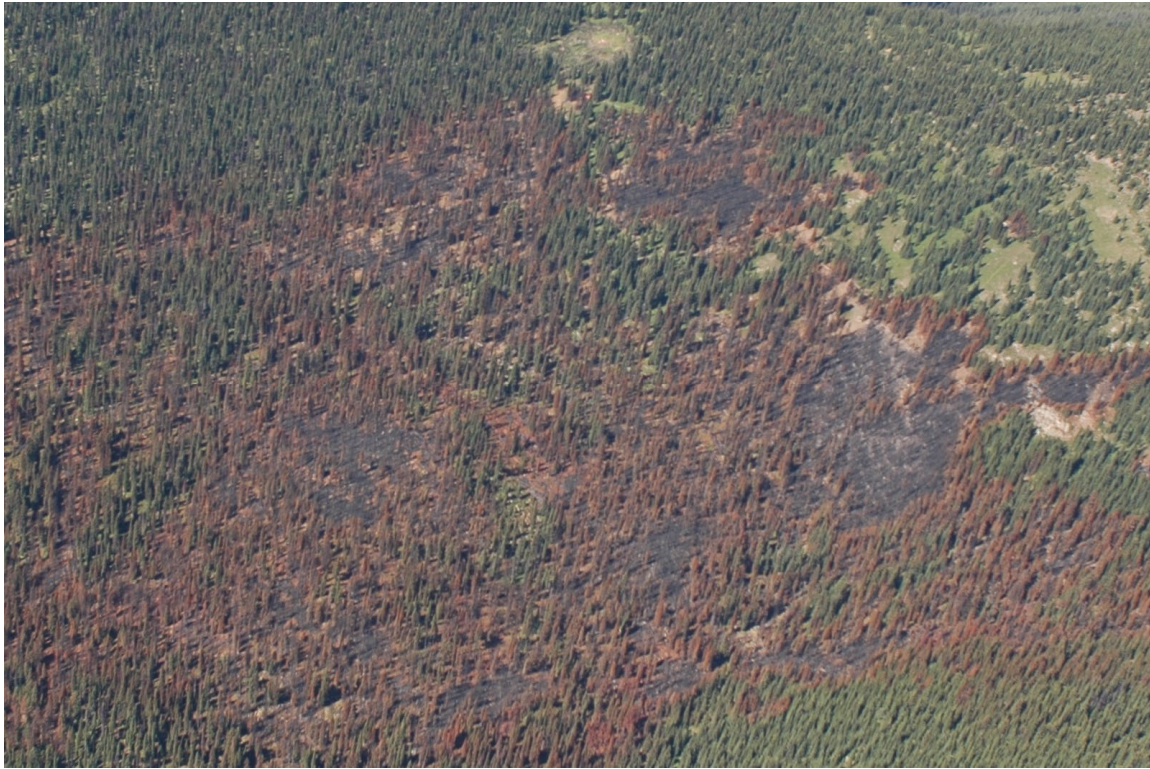
Figure 1 is a map of the Benninger Creek watershed, and of the fire showing burn severity, mapped from photographs taken from the helicopter (Photo 1) and ground data. The fire occupies 11.6% of the watershed area, of which about 12% of the fire (or 1.4% of the watershed) is burned at high severity. The table below summarizes the burned area and burn severity by sub-watershed.

Photo 1. Central part of fire N50196 from the air.

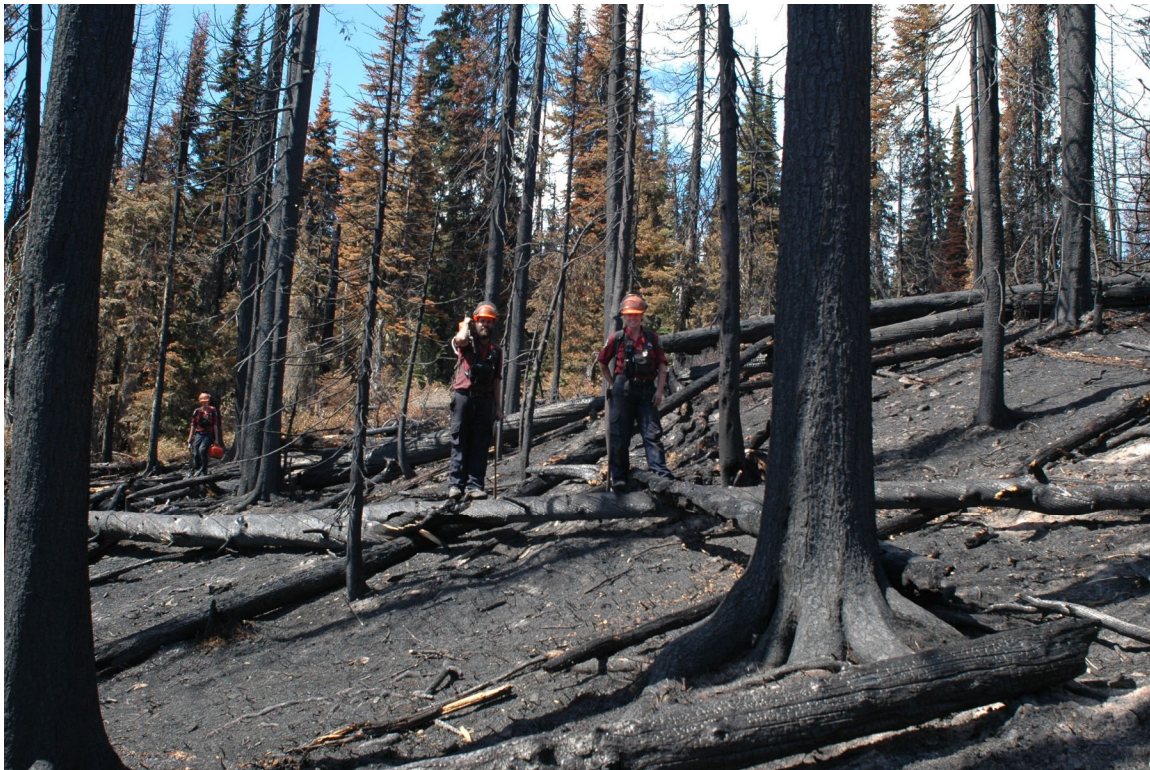
Photo 2. High burn severity (foreground) – needles and small branches consumed; understory, fine fuels, and forest floor consumed. Moderate and low burn severity in background.

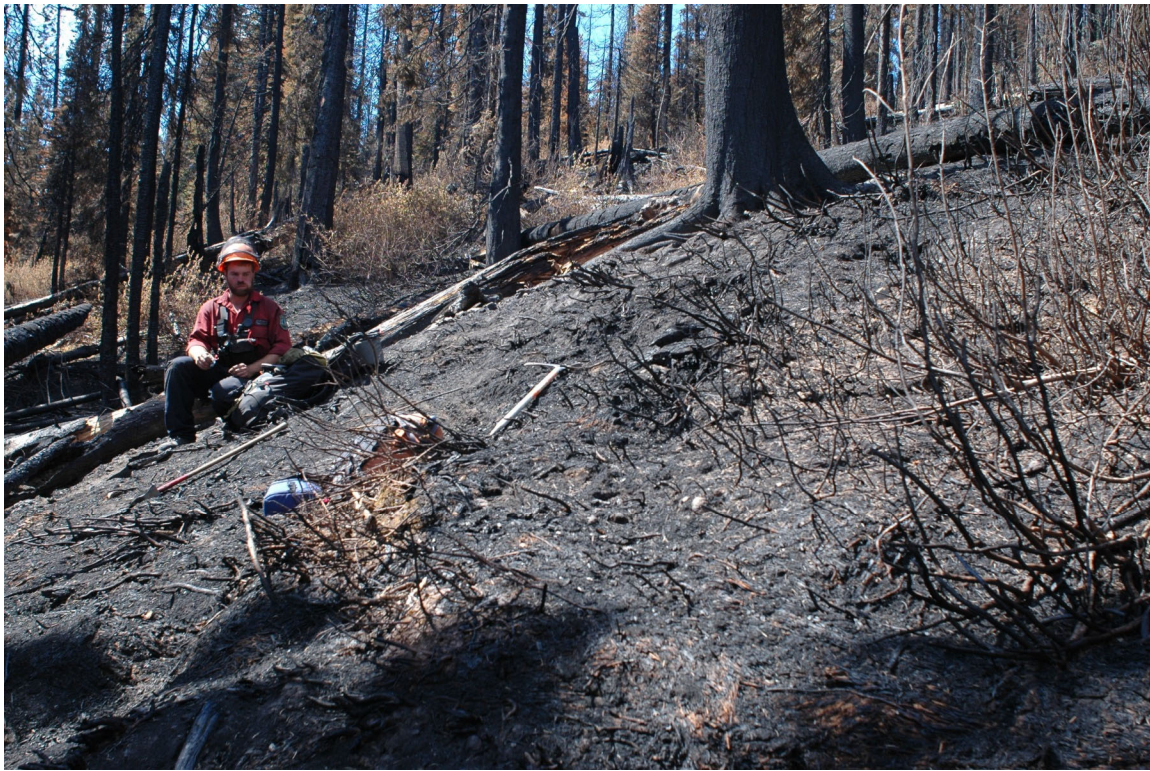
Photo 3. Moderate burn severity – trees killed but needles remain; understory and forest floor are partly consumed.

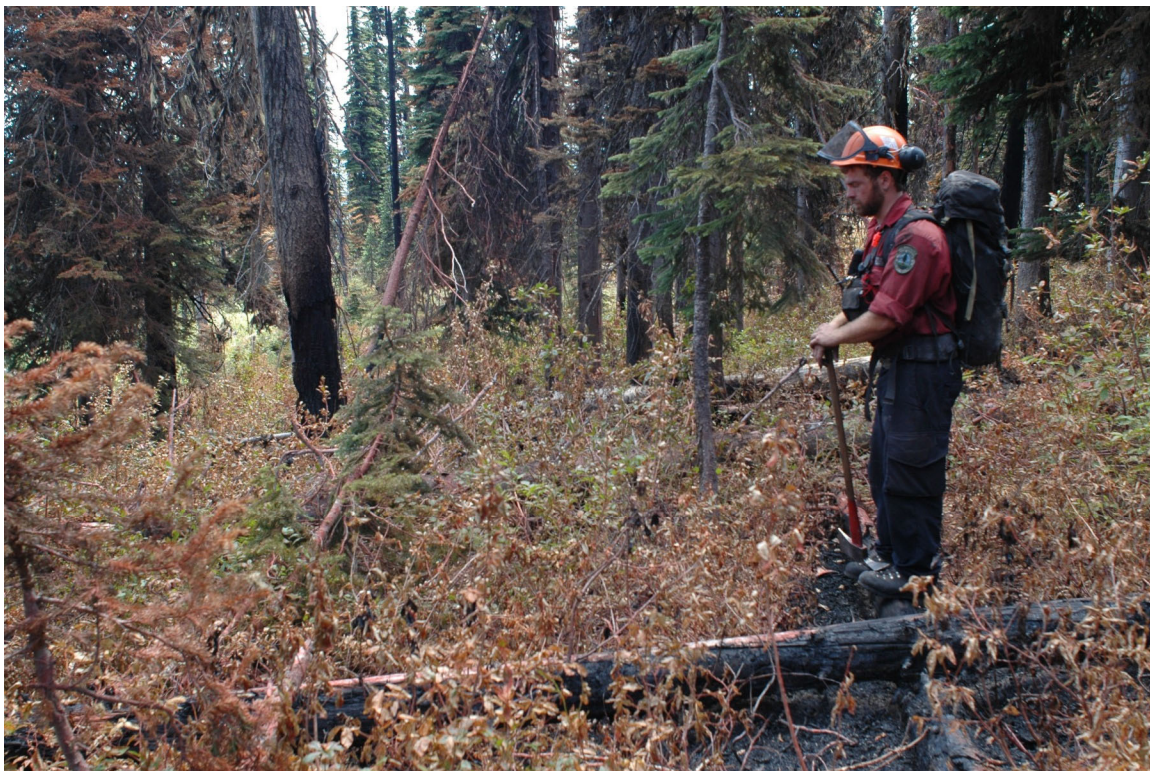
Photo 4. Low burn severity – trees, understory, and litter partially burned; duff and mineral soil are unaltered.

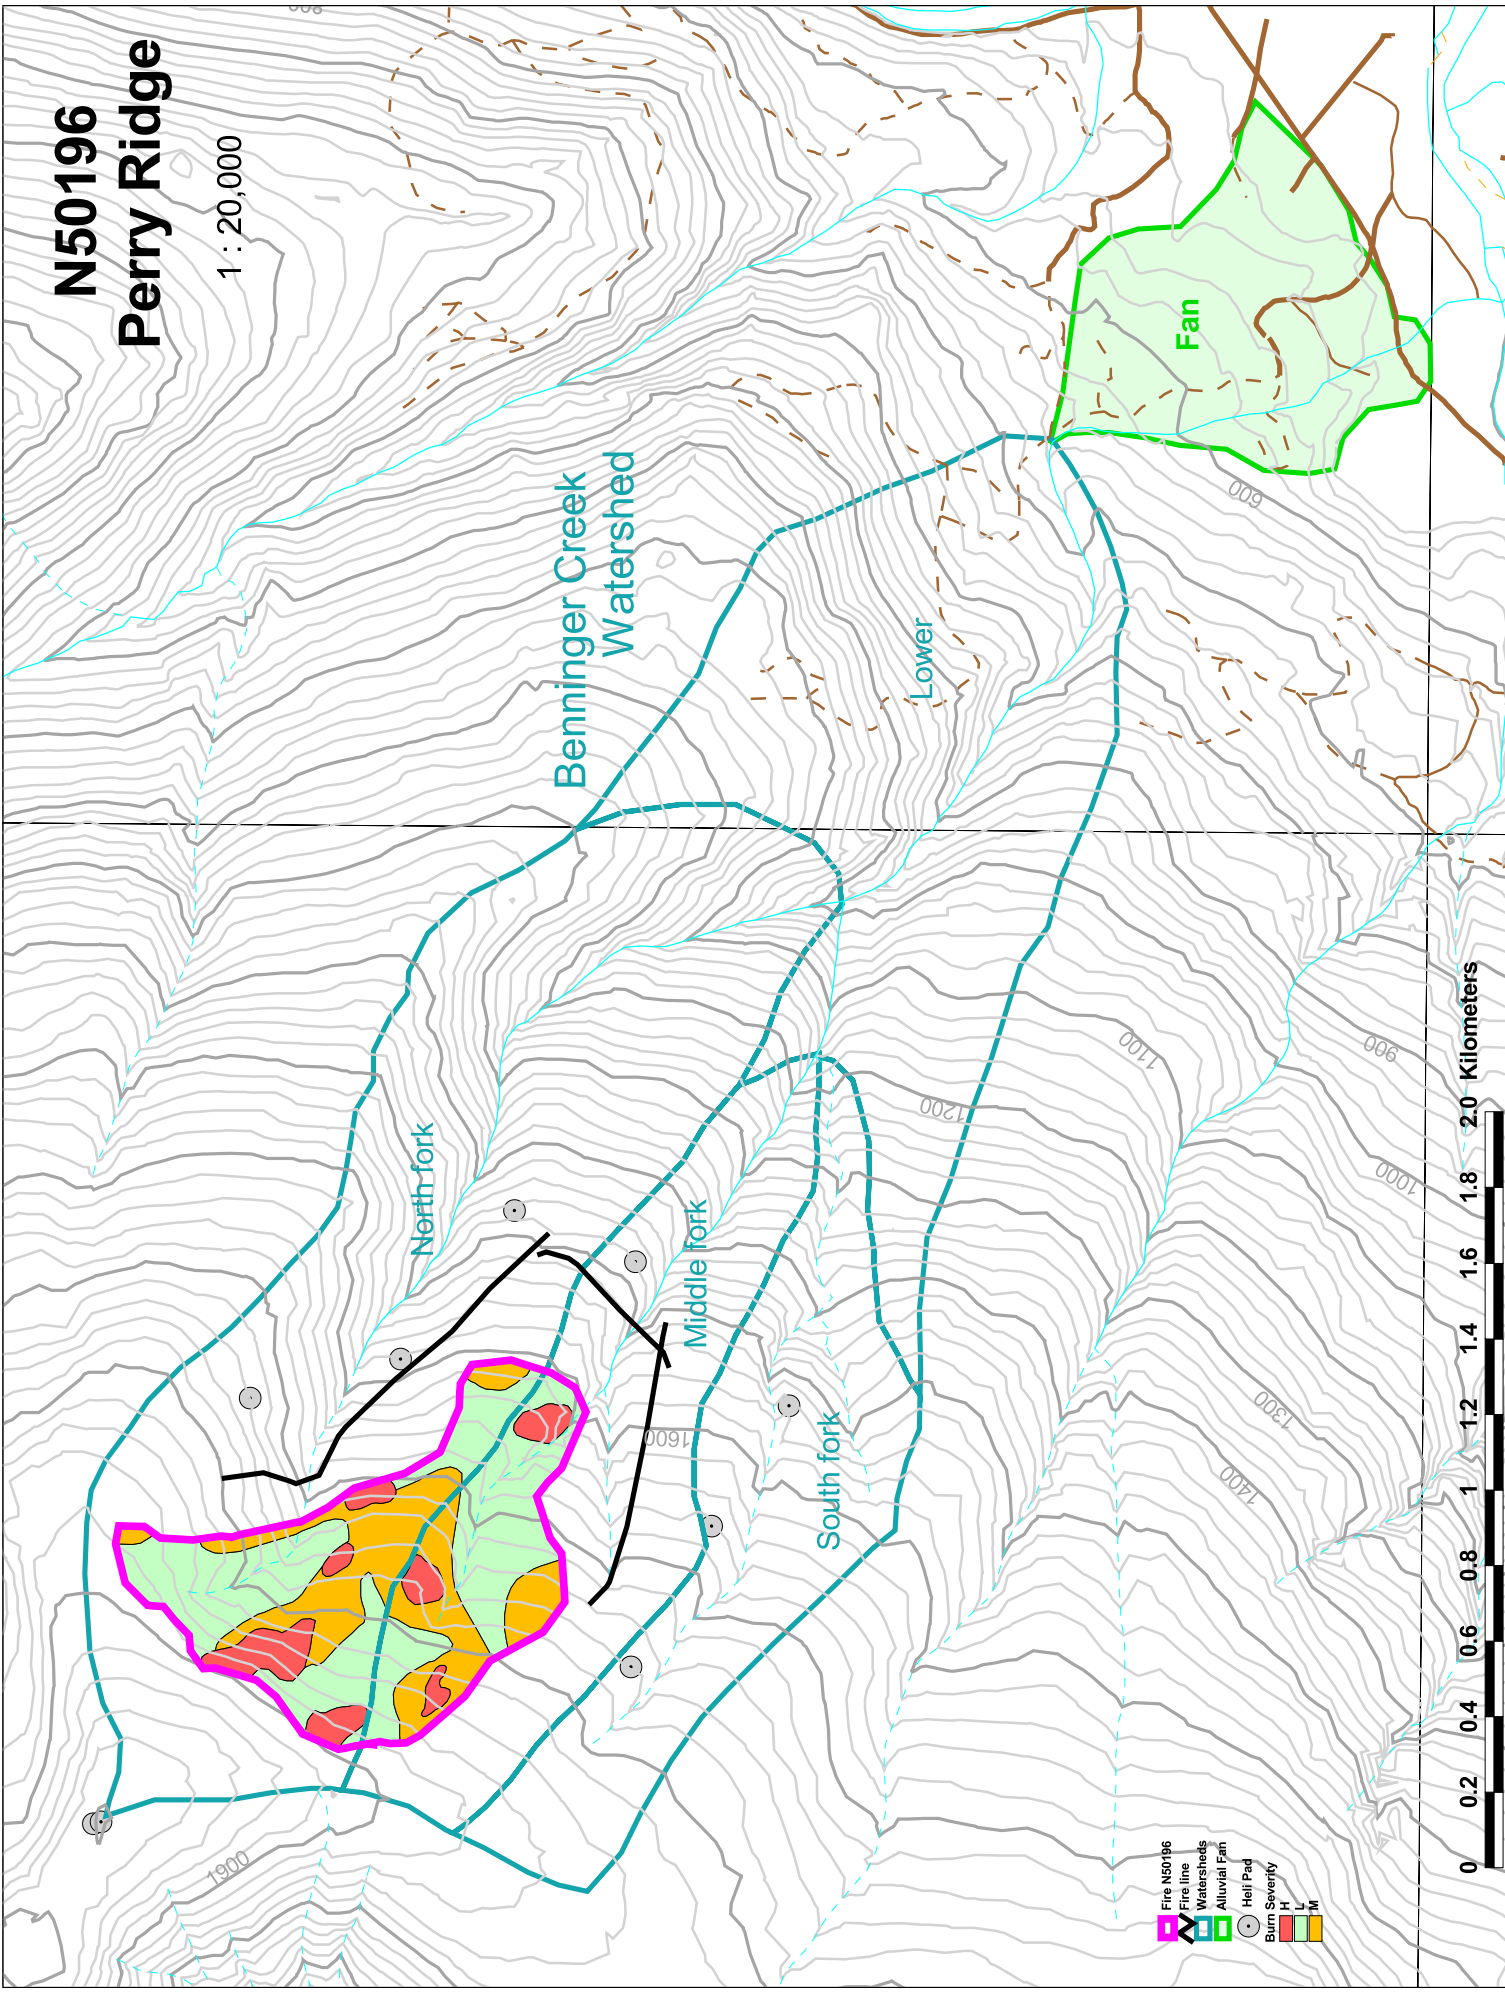
Figure 1. Map of Perry Ridge fire and Benninger Creek watershed. (at end of report)

There appear to be two properties near the apex of the fan, which could be directly affected by a debris flow; these properties and the houses on them are considered to be at high risk. (I visited one property closest to the water intakes at the fan apex; otherwise, I only drove Wishloff and Kazakoff Roads.) Other properties lower on the fan are unlikely to be directly affected by debris flows; however, they could be affected by flooding. Whether an individual house is at risk or not depends on local site factors, especially its location relative to old channels on the fan.

1. Residents of the Benninger Creek fan should be informed of the debris flow risk that exists on the fan. This applies especially to residents of properties on the upper part of the fan.
