## NOTES FROM MAY 16, 1990 FIELD INSPECTION

## PROPERTY LOCATION

The subject property is located approximately 18 km south of Golden, near Drybed Creek (Figure 1). Drybed Creek is one of many drainages in the Golden area which are debris torrent prone. A debris torrent can be described as the rapid movement of saturated soil, rock, and other debris down a steep channel (Swanston and Swanson).

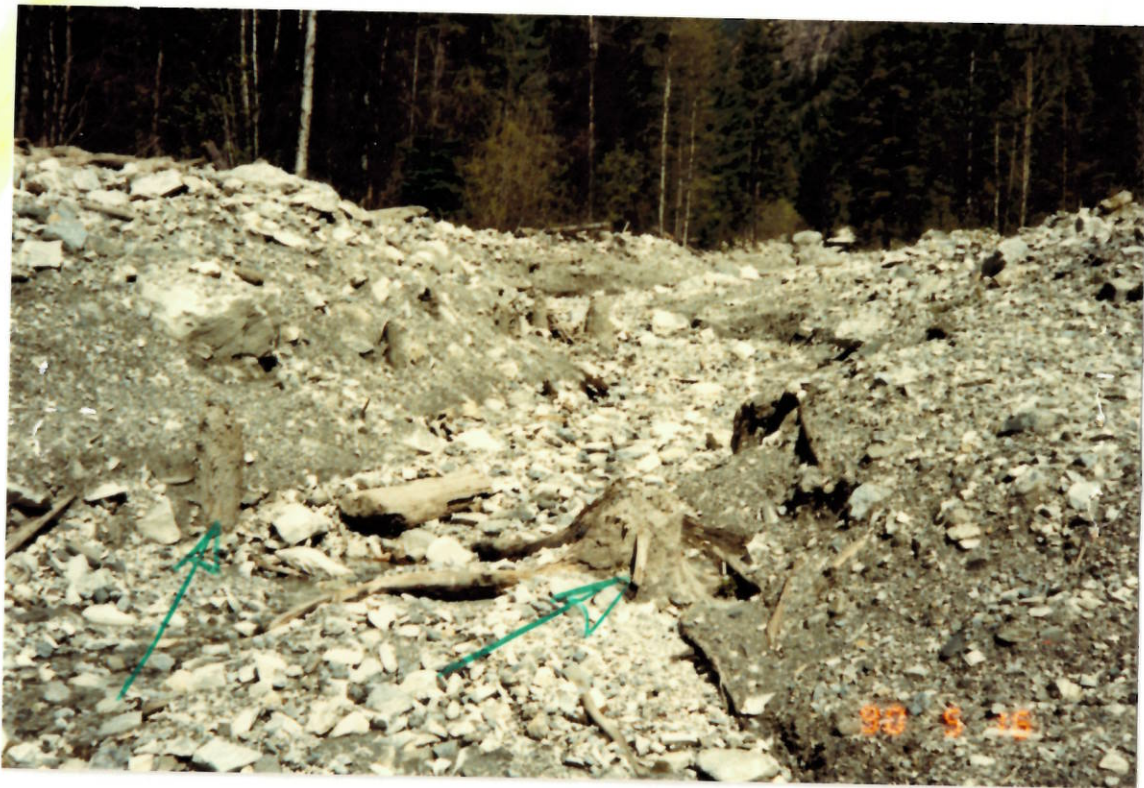
2. **The middle deposition zone:** Coarse debris deposits (large boulders and trees), levees and other lobal features were observed on the land surface where the torrent(s) leave the confines of the canyon (Photos 1 to 3). Scarred and broken-off trees also provided

PHOTO 1: View looking upstream. Note the buried tree stumps unearthed by recent events. Trees were sheared off by previous debris torrent(s). Stumps are approximately 1.5 m below the surrounding level.

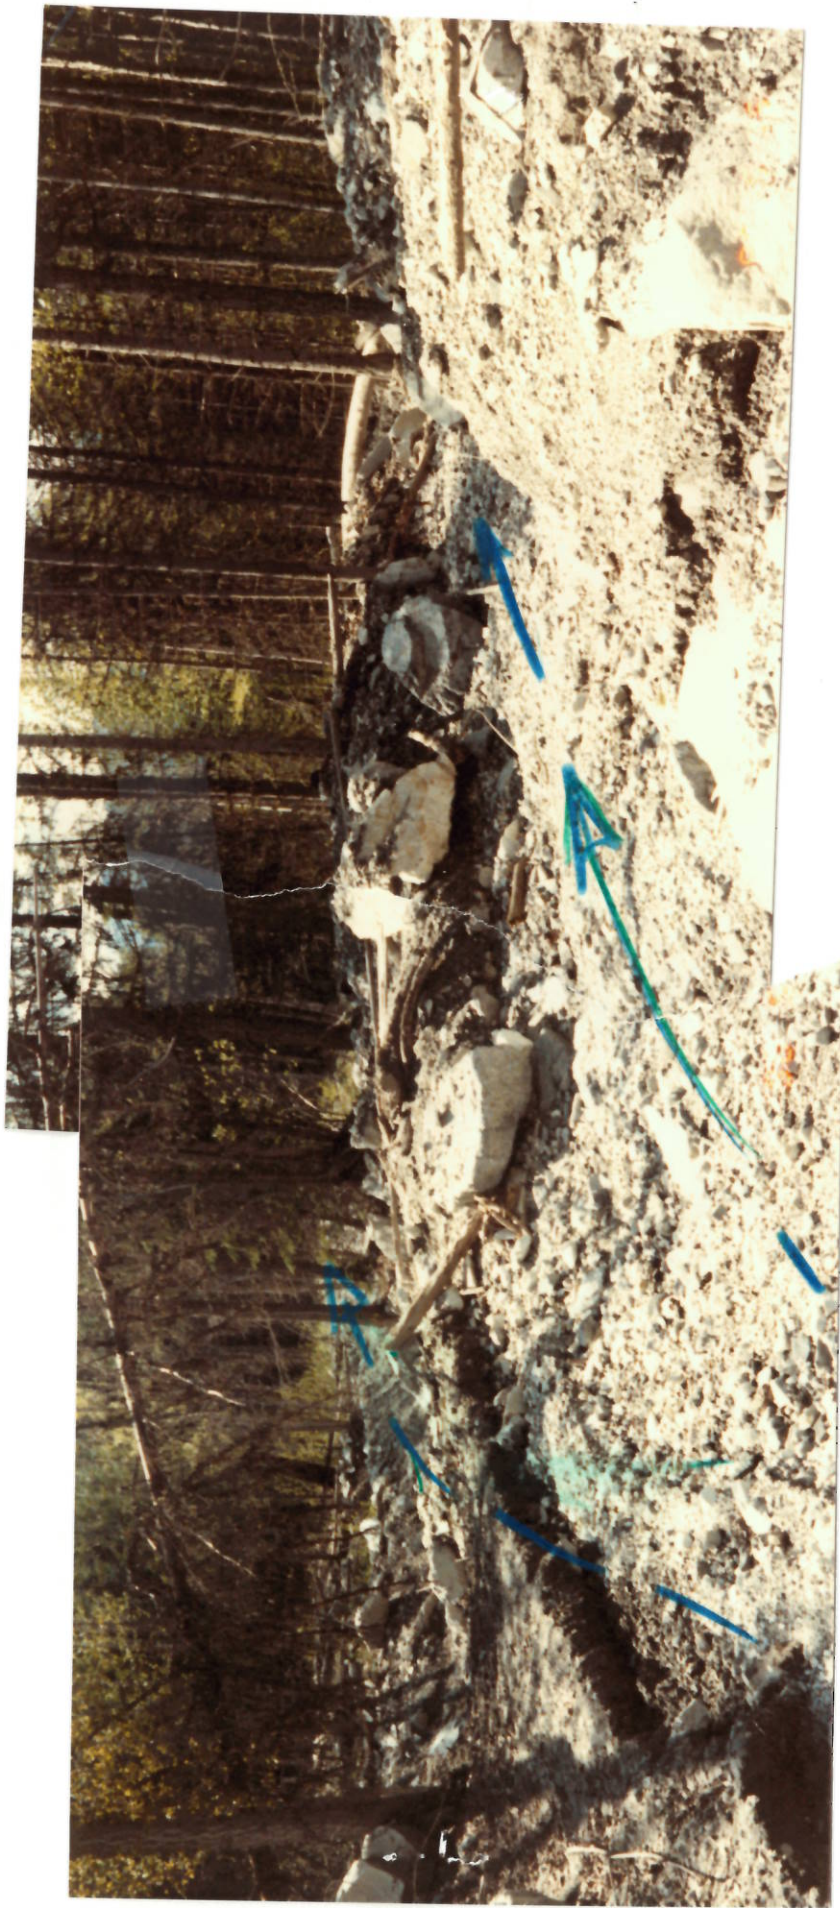
PHOTO 2: Looking downstream. This is a good example of a recent channel shift. There is a clear abandoned channel heading downslope as indicated by dashed line.

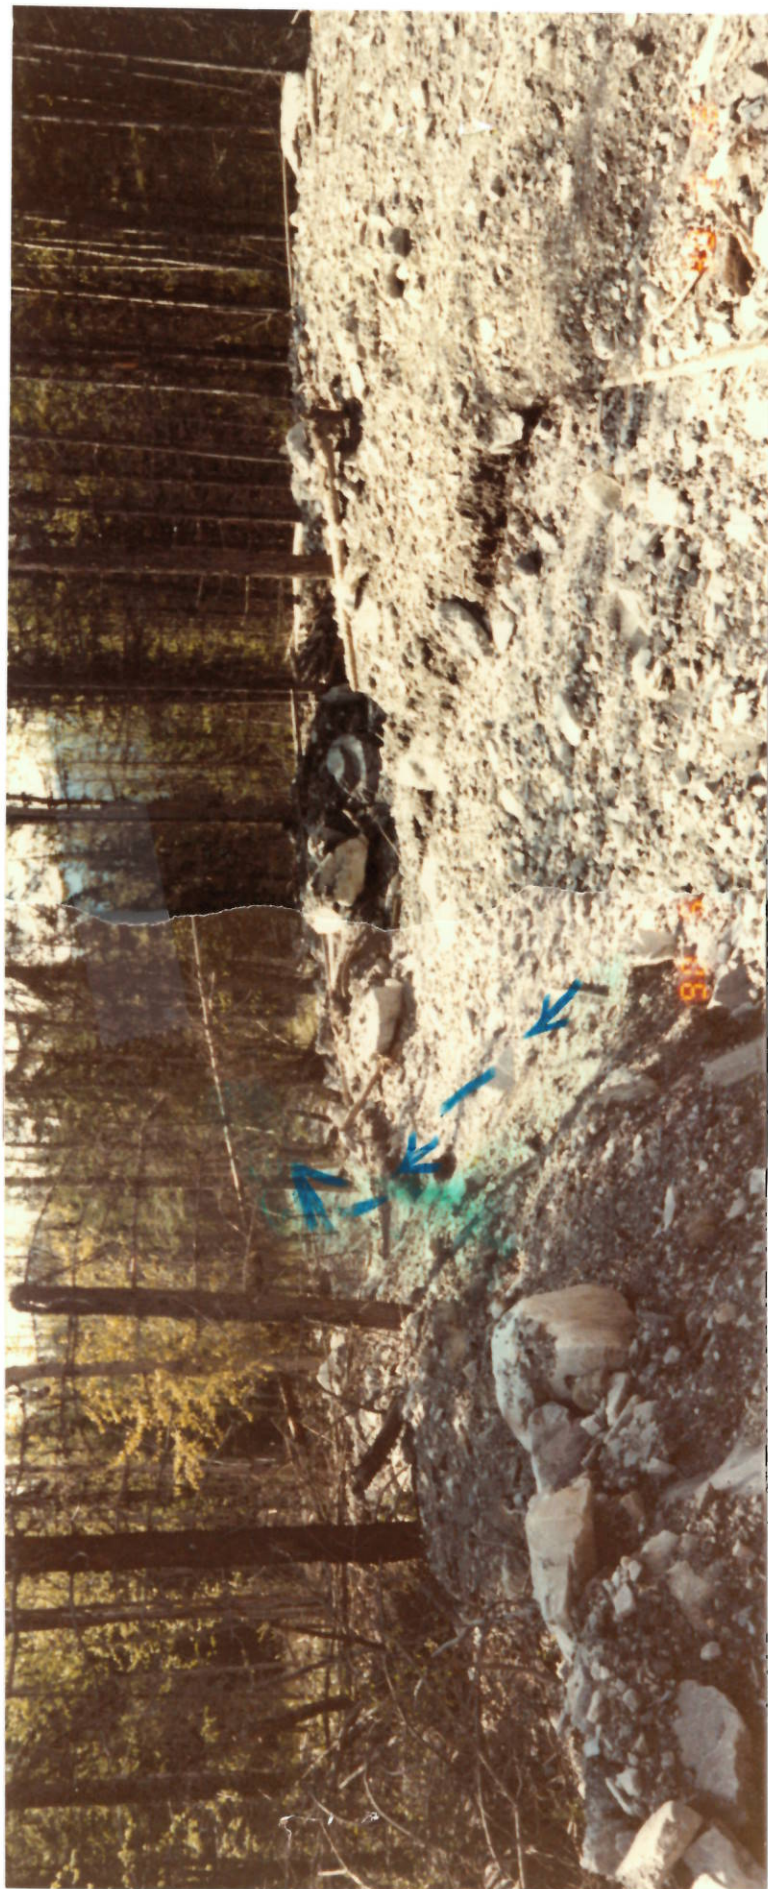
PHOTO 3: Another view of channel shift shown in photo 2. The old course of the stream and debris flow is shown.

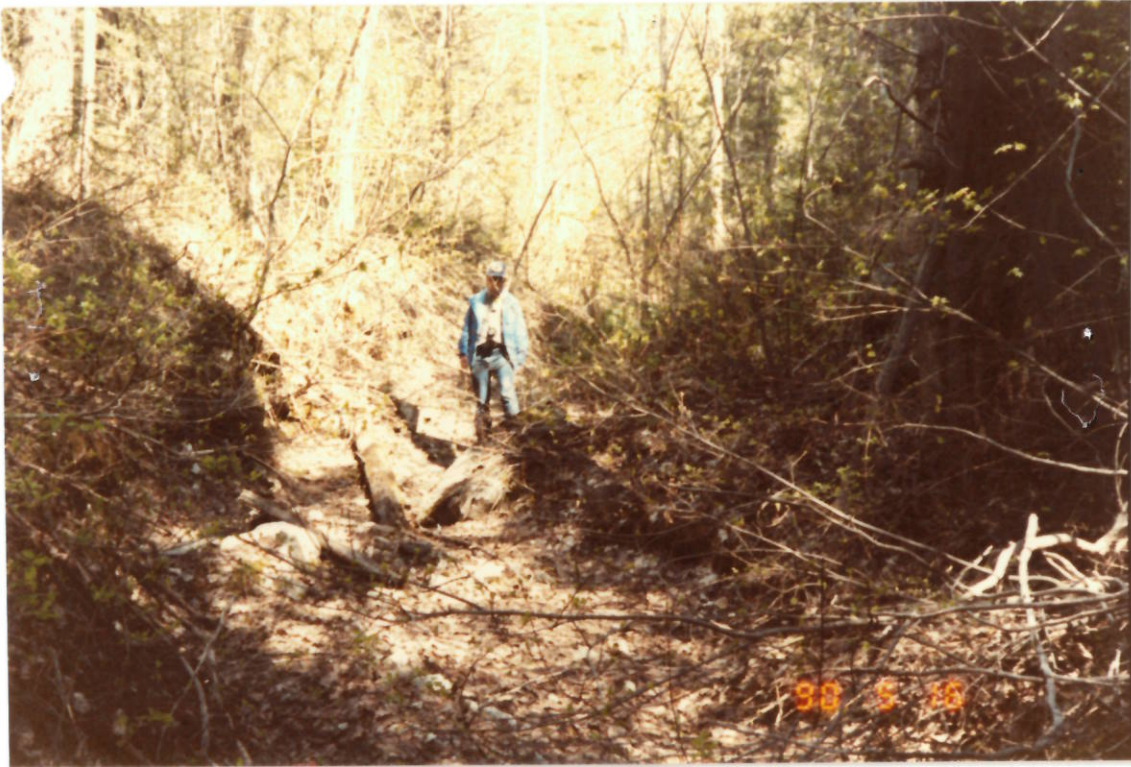
3. **The runout zone:** The stream and land surface gradient is milder downstream of the main deposition zone. Material including mud, debris and rock have settled on the land to depths of 0.5 to 1.0 m (Photos 4 & 5). Massive debris torrent deposits were observed on an exposed face of a gravel pit adjacent to Campbell Road (located in Figure 1). Carbon dating procedures would be required to date these deposits.

PHOTO 4: View of abandoned channel

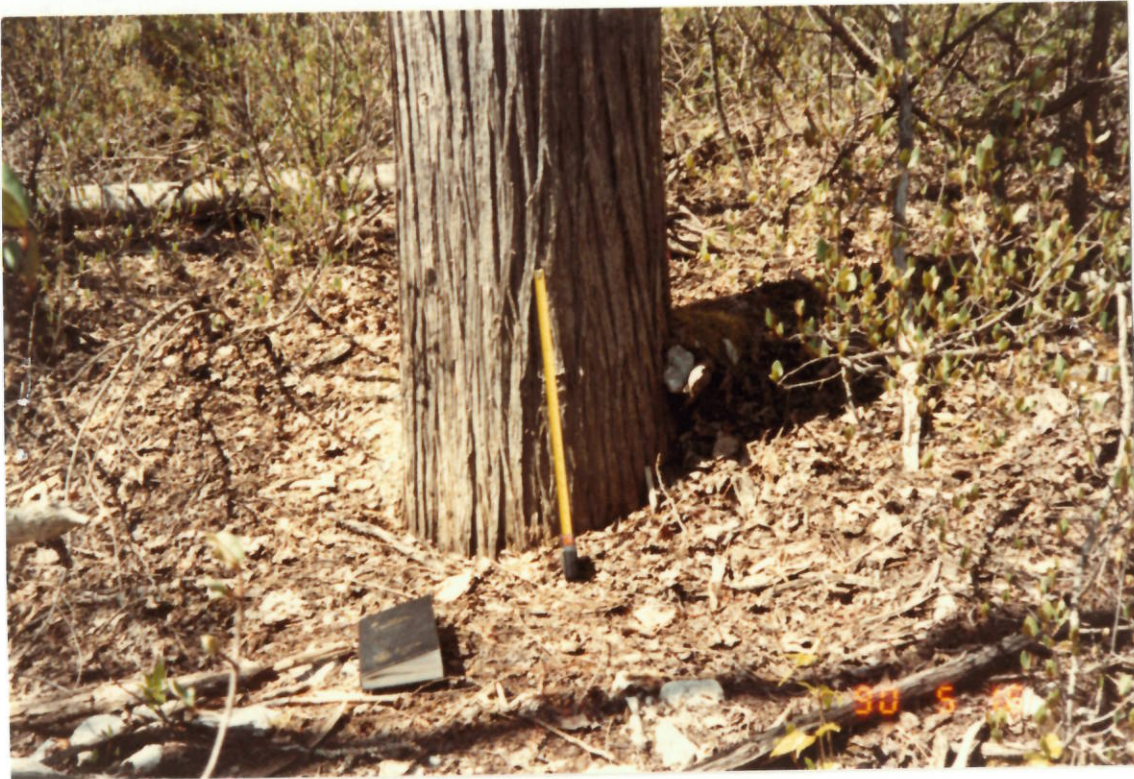
PHOTO 5: Recent debris deposits around and against tree.

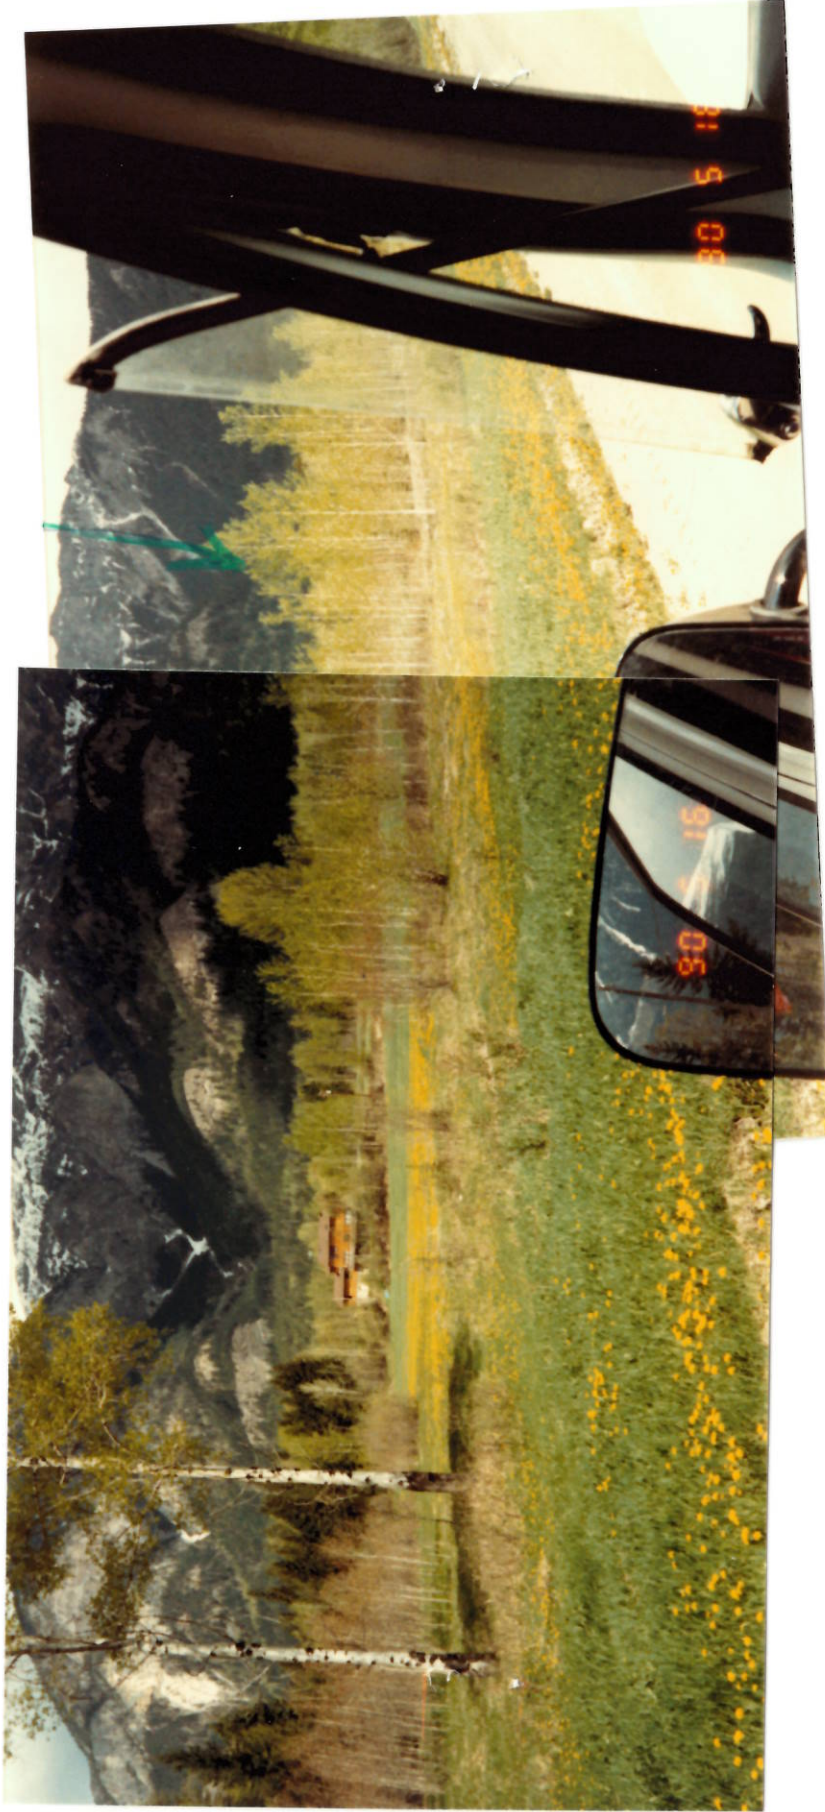
PHOTO 6: View of the remainder from Mitchell Road. Note Drybed Creek originates from valley to the right.
