REPORT# 1520

FILE REPORT: BIRCHLAND/ DRYBED CREEKS- SITE  
INSPECTION

Birchlands/Drybed Creeks - Site Inspection

Floodplain Development Control

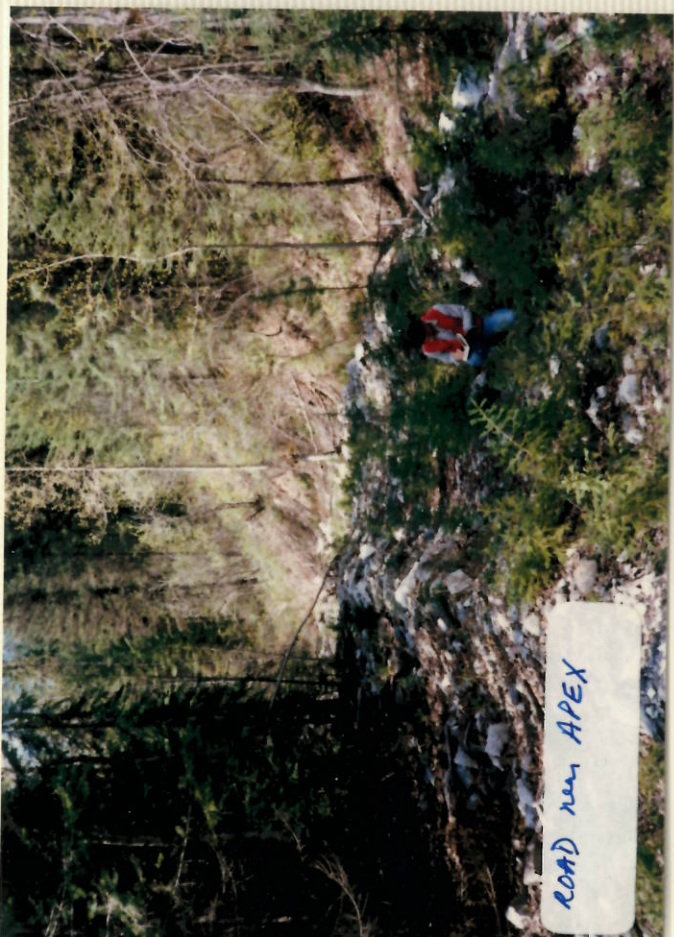
ROAD near APEX

4. The fan apex contains coarse rubble to occasional pieces larger than one metre in diameter, and numerous parallel levees and lobes indicating frequent activity. There is a potential avulsion route down the right side of the fan where an old road was bulldozed into the area.

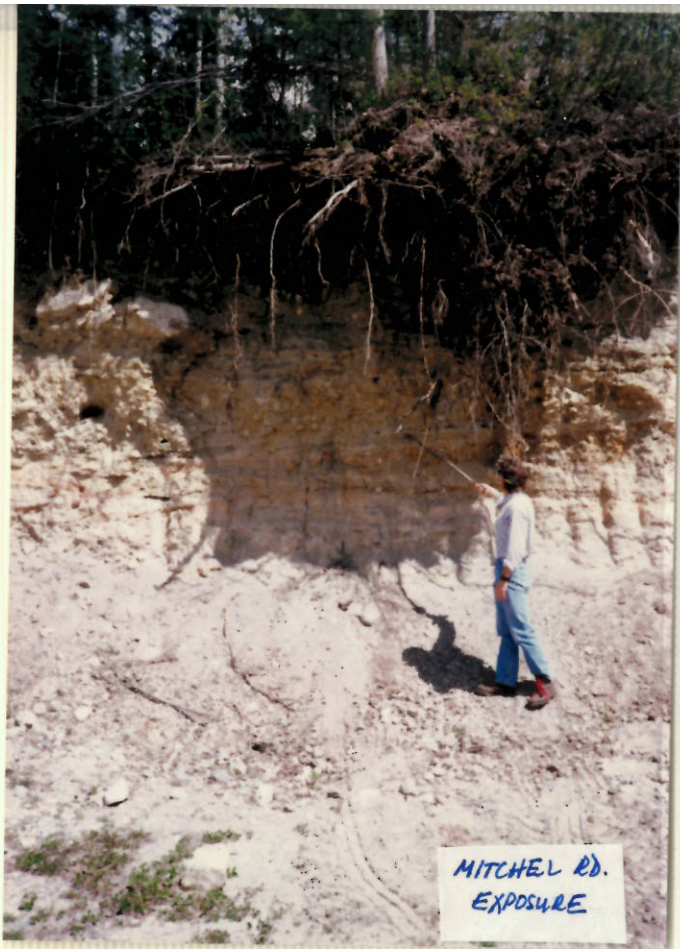
MITCHEL RD.  
EXPOSURE

5. A borrow excavation above Mitchell Road near the subject property shows an exposure of about four large scale debris flow events plus intervening fluvial processes. A buried burned organic layer 2.2 m below the fan surface was sampled. There are layers of buried organic surface and possible ash layers evident.

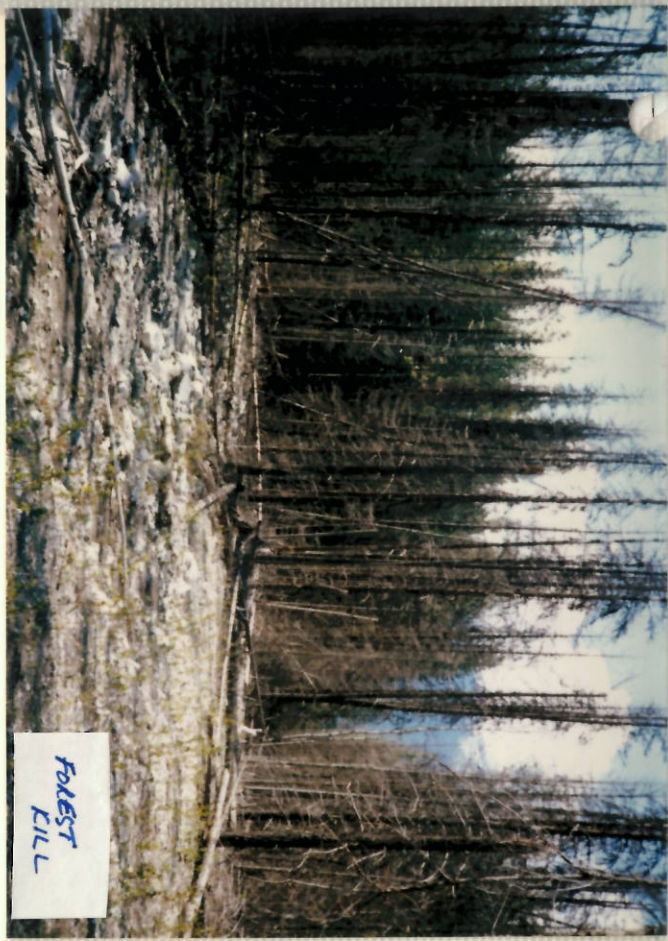
FOREST  
FILL

2. The present inspection included walking the stream channel down the left side of the Drybed Creek fan and also a traverse across the mid portion of the fan. Transported rock and mud debris was observed just above the Birchlands Creek confluence. There were observed areas of previous inundation of the forest causing extensive tree kills (about 1 m depth of rubble over +/- 30 m width along the channel). Also, the present channel near the apex has scoured out about 1.8 m below the fan surface to reveal buried tree stumps. There is evidence of radial fossil channels throughout the upper fan and at least one additional flow channel defined by debris inundation and modern tree kills.
