# TERRAIN STABILITY HAZARD ASSESSMENT

## Blocks NK020, NK021, and NK022

### Kookipi Creek

Project Number: 19-174

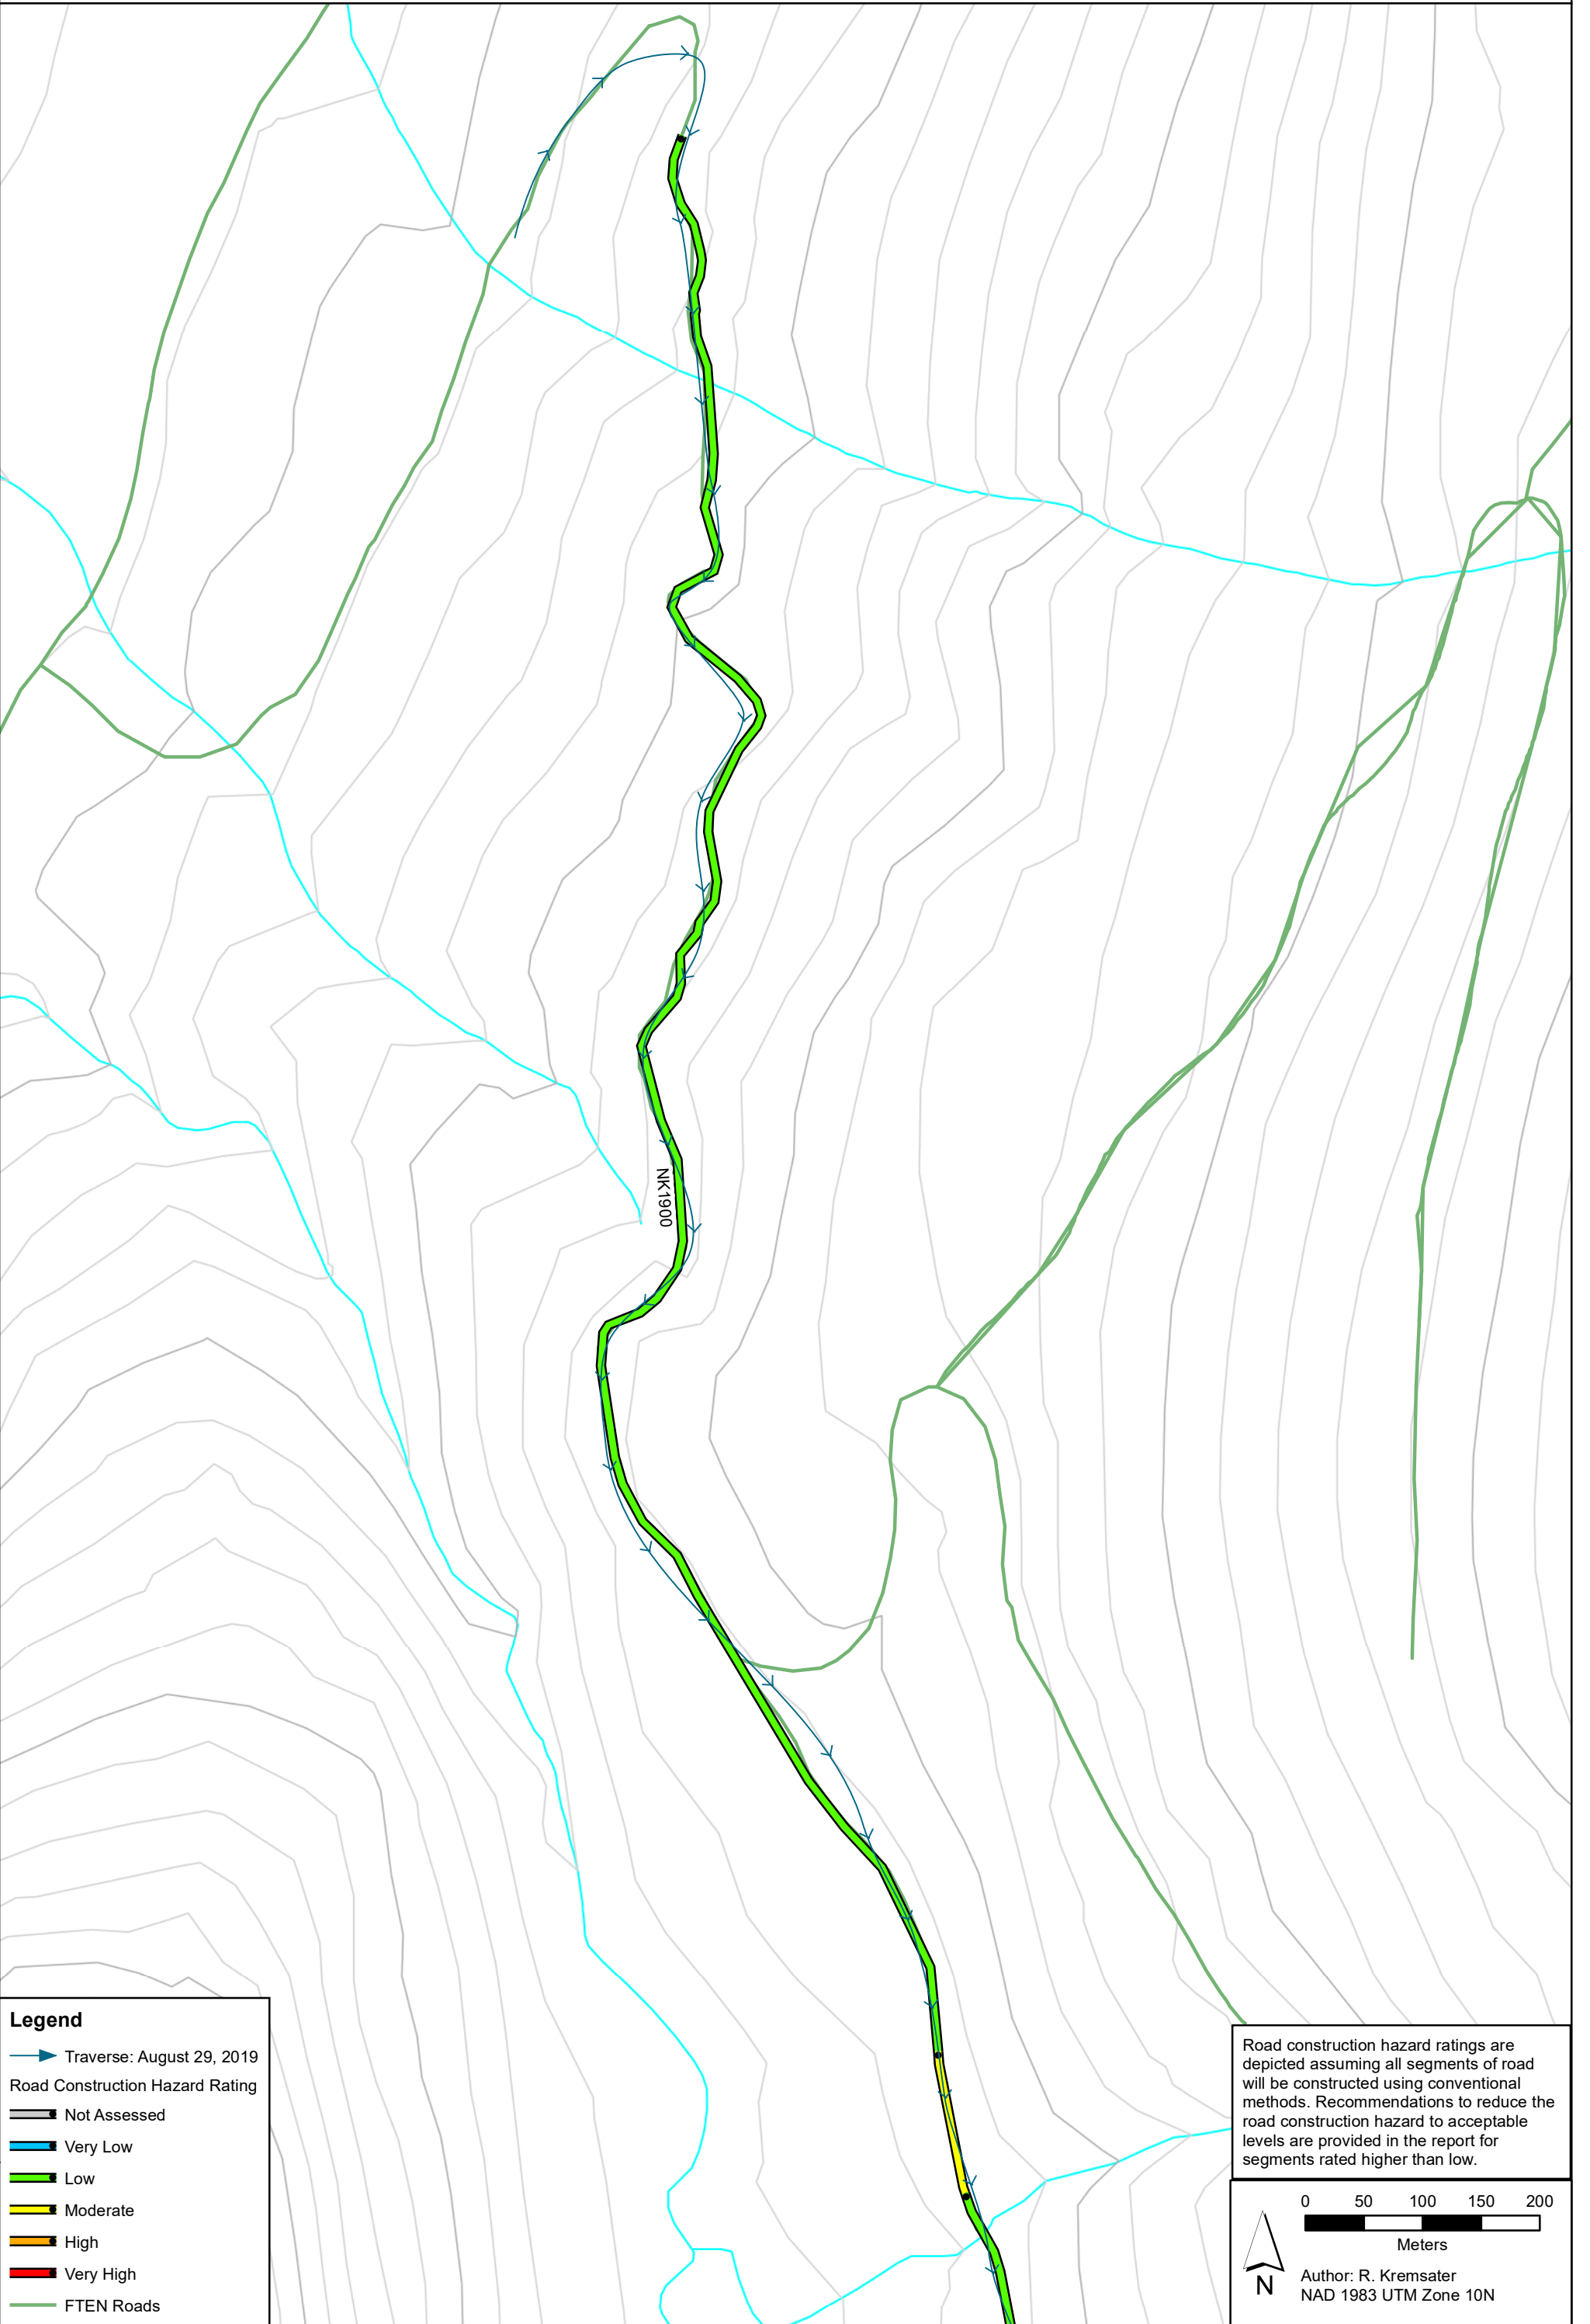
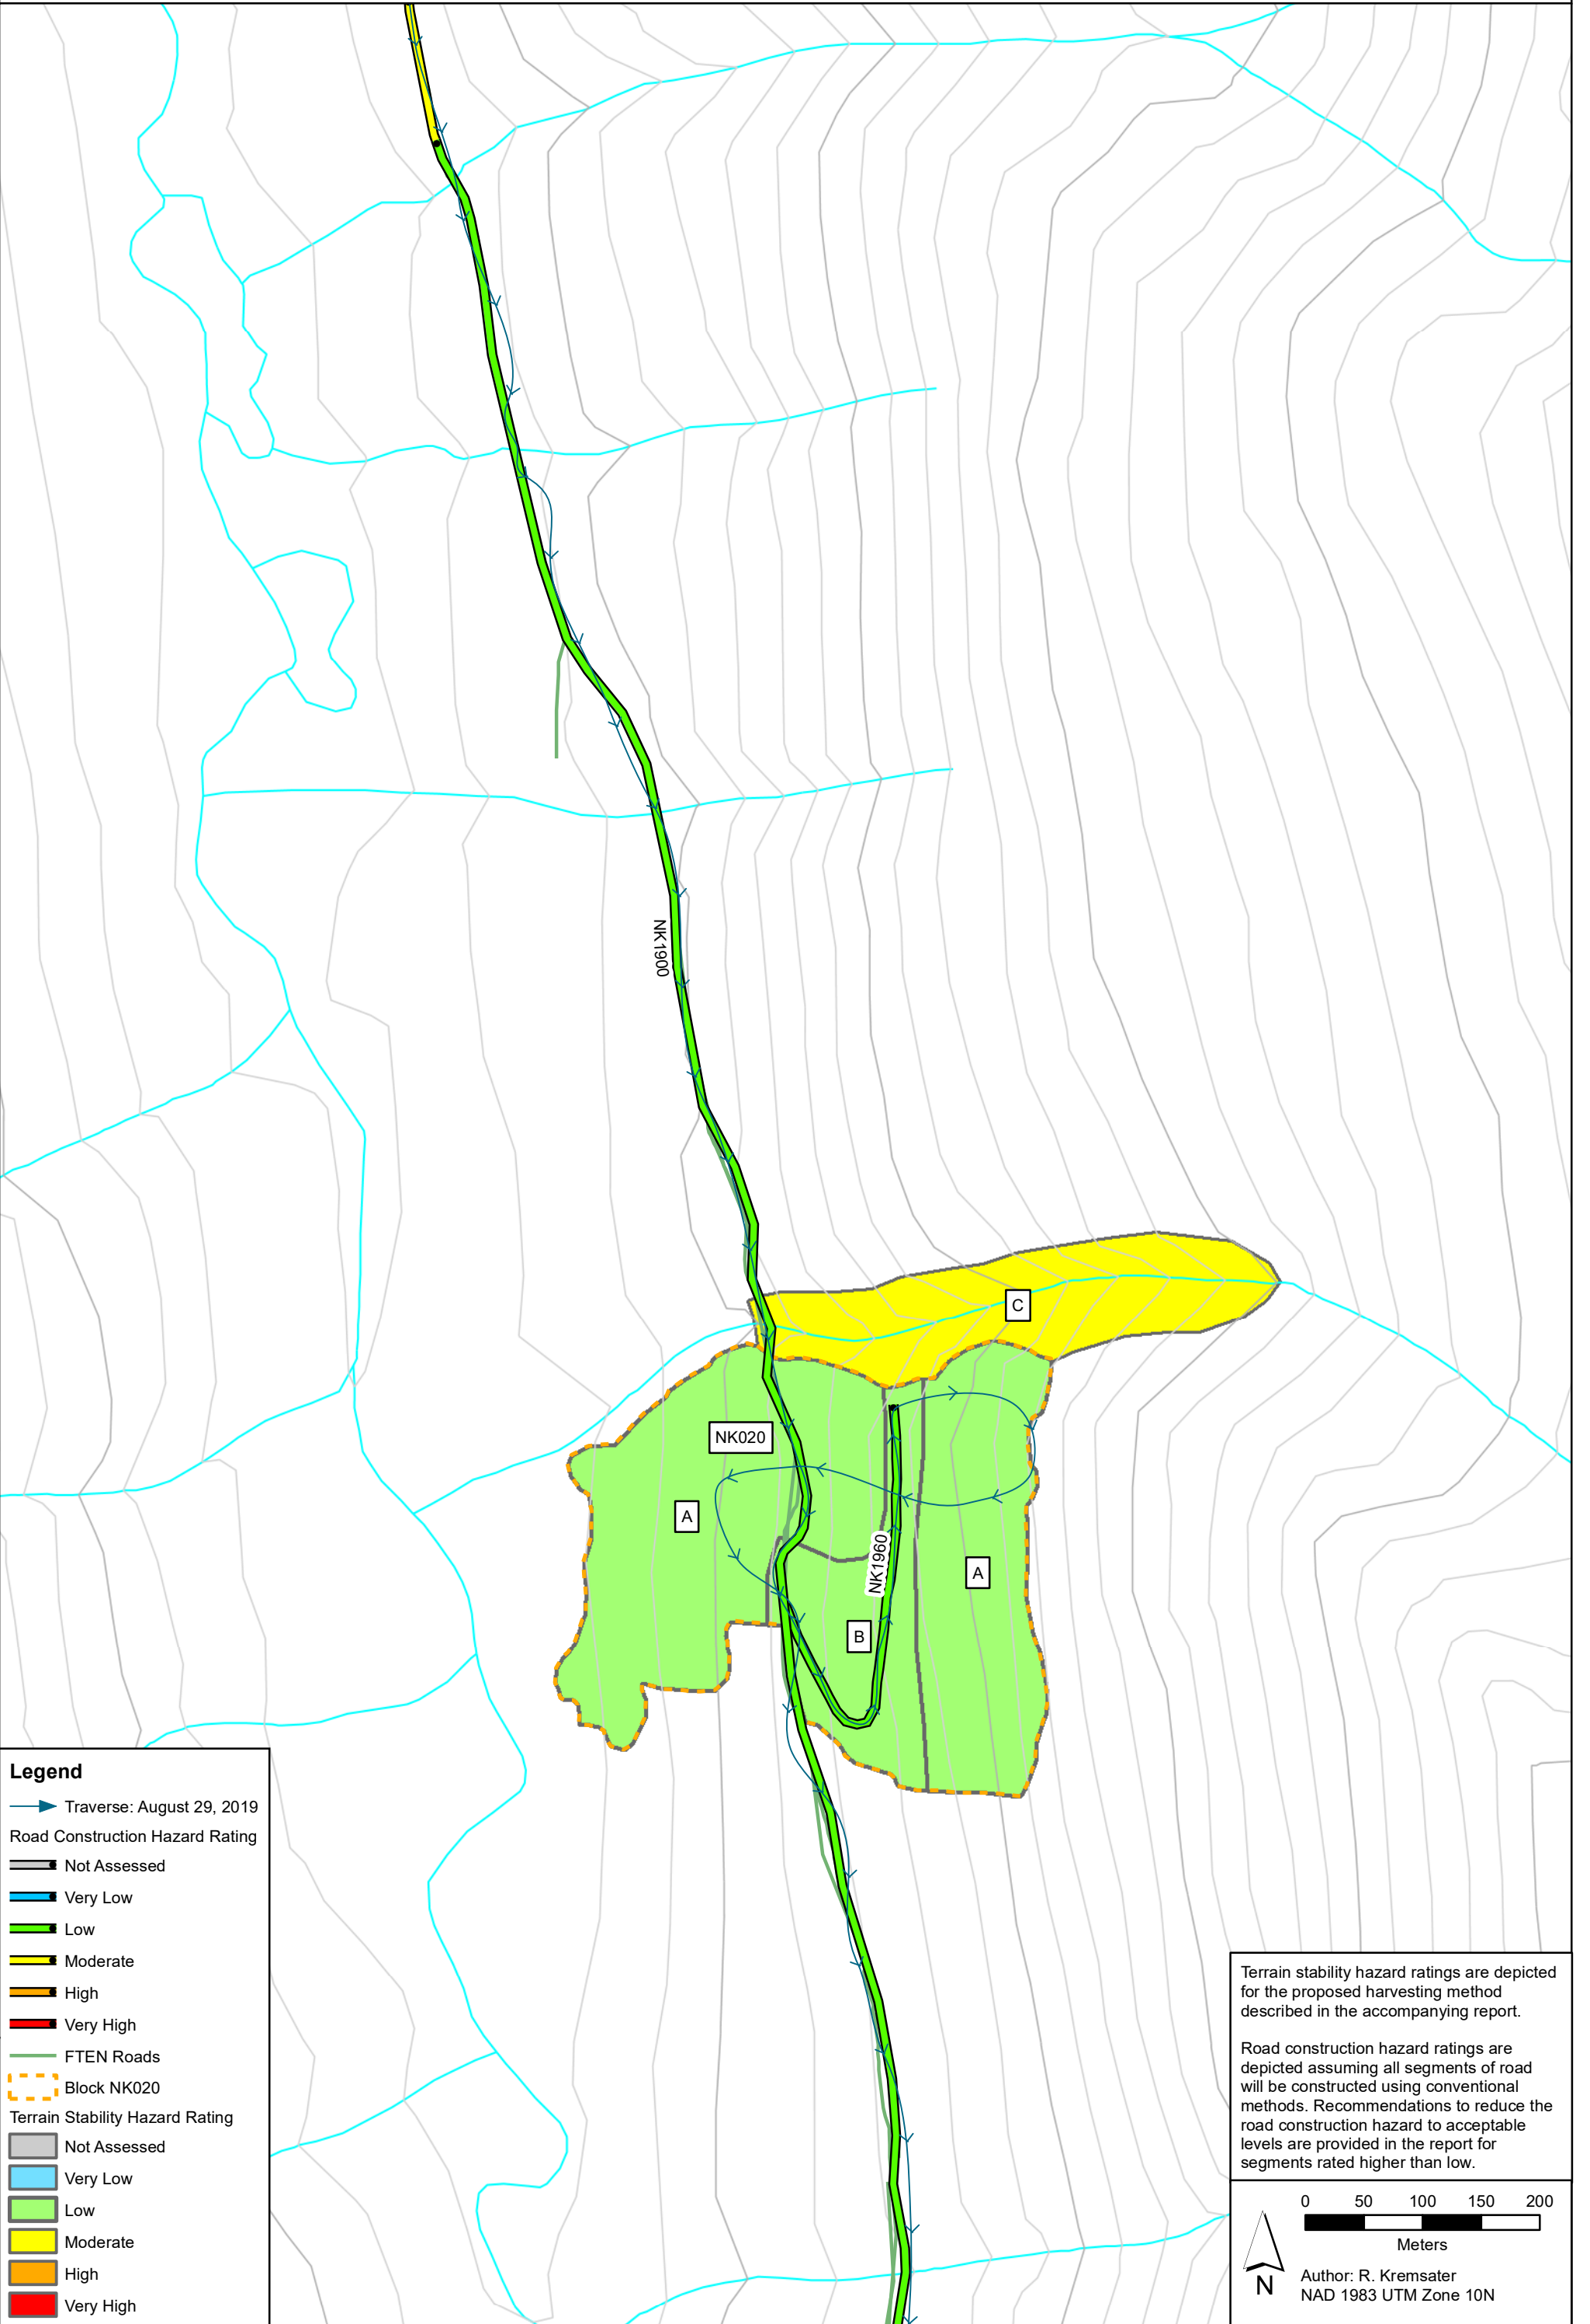
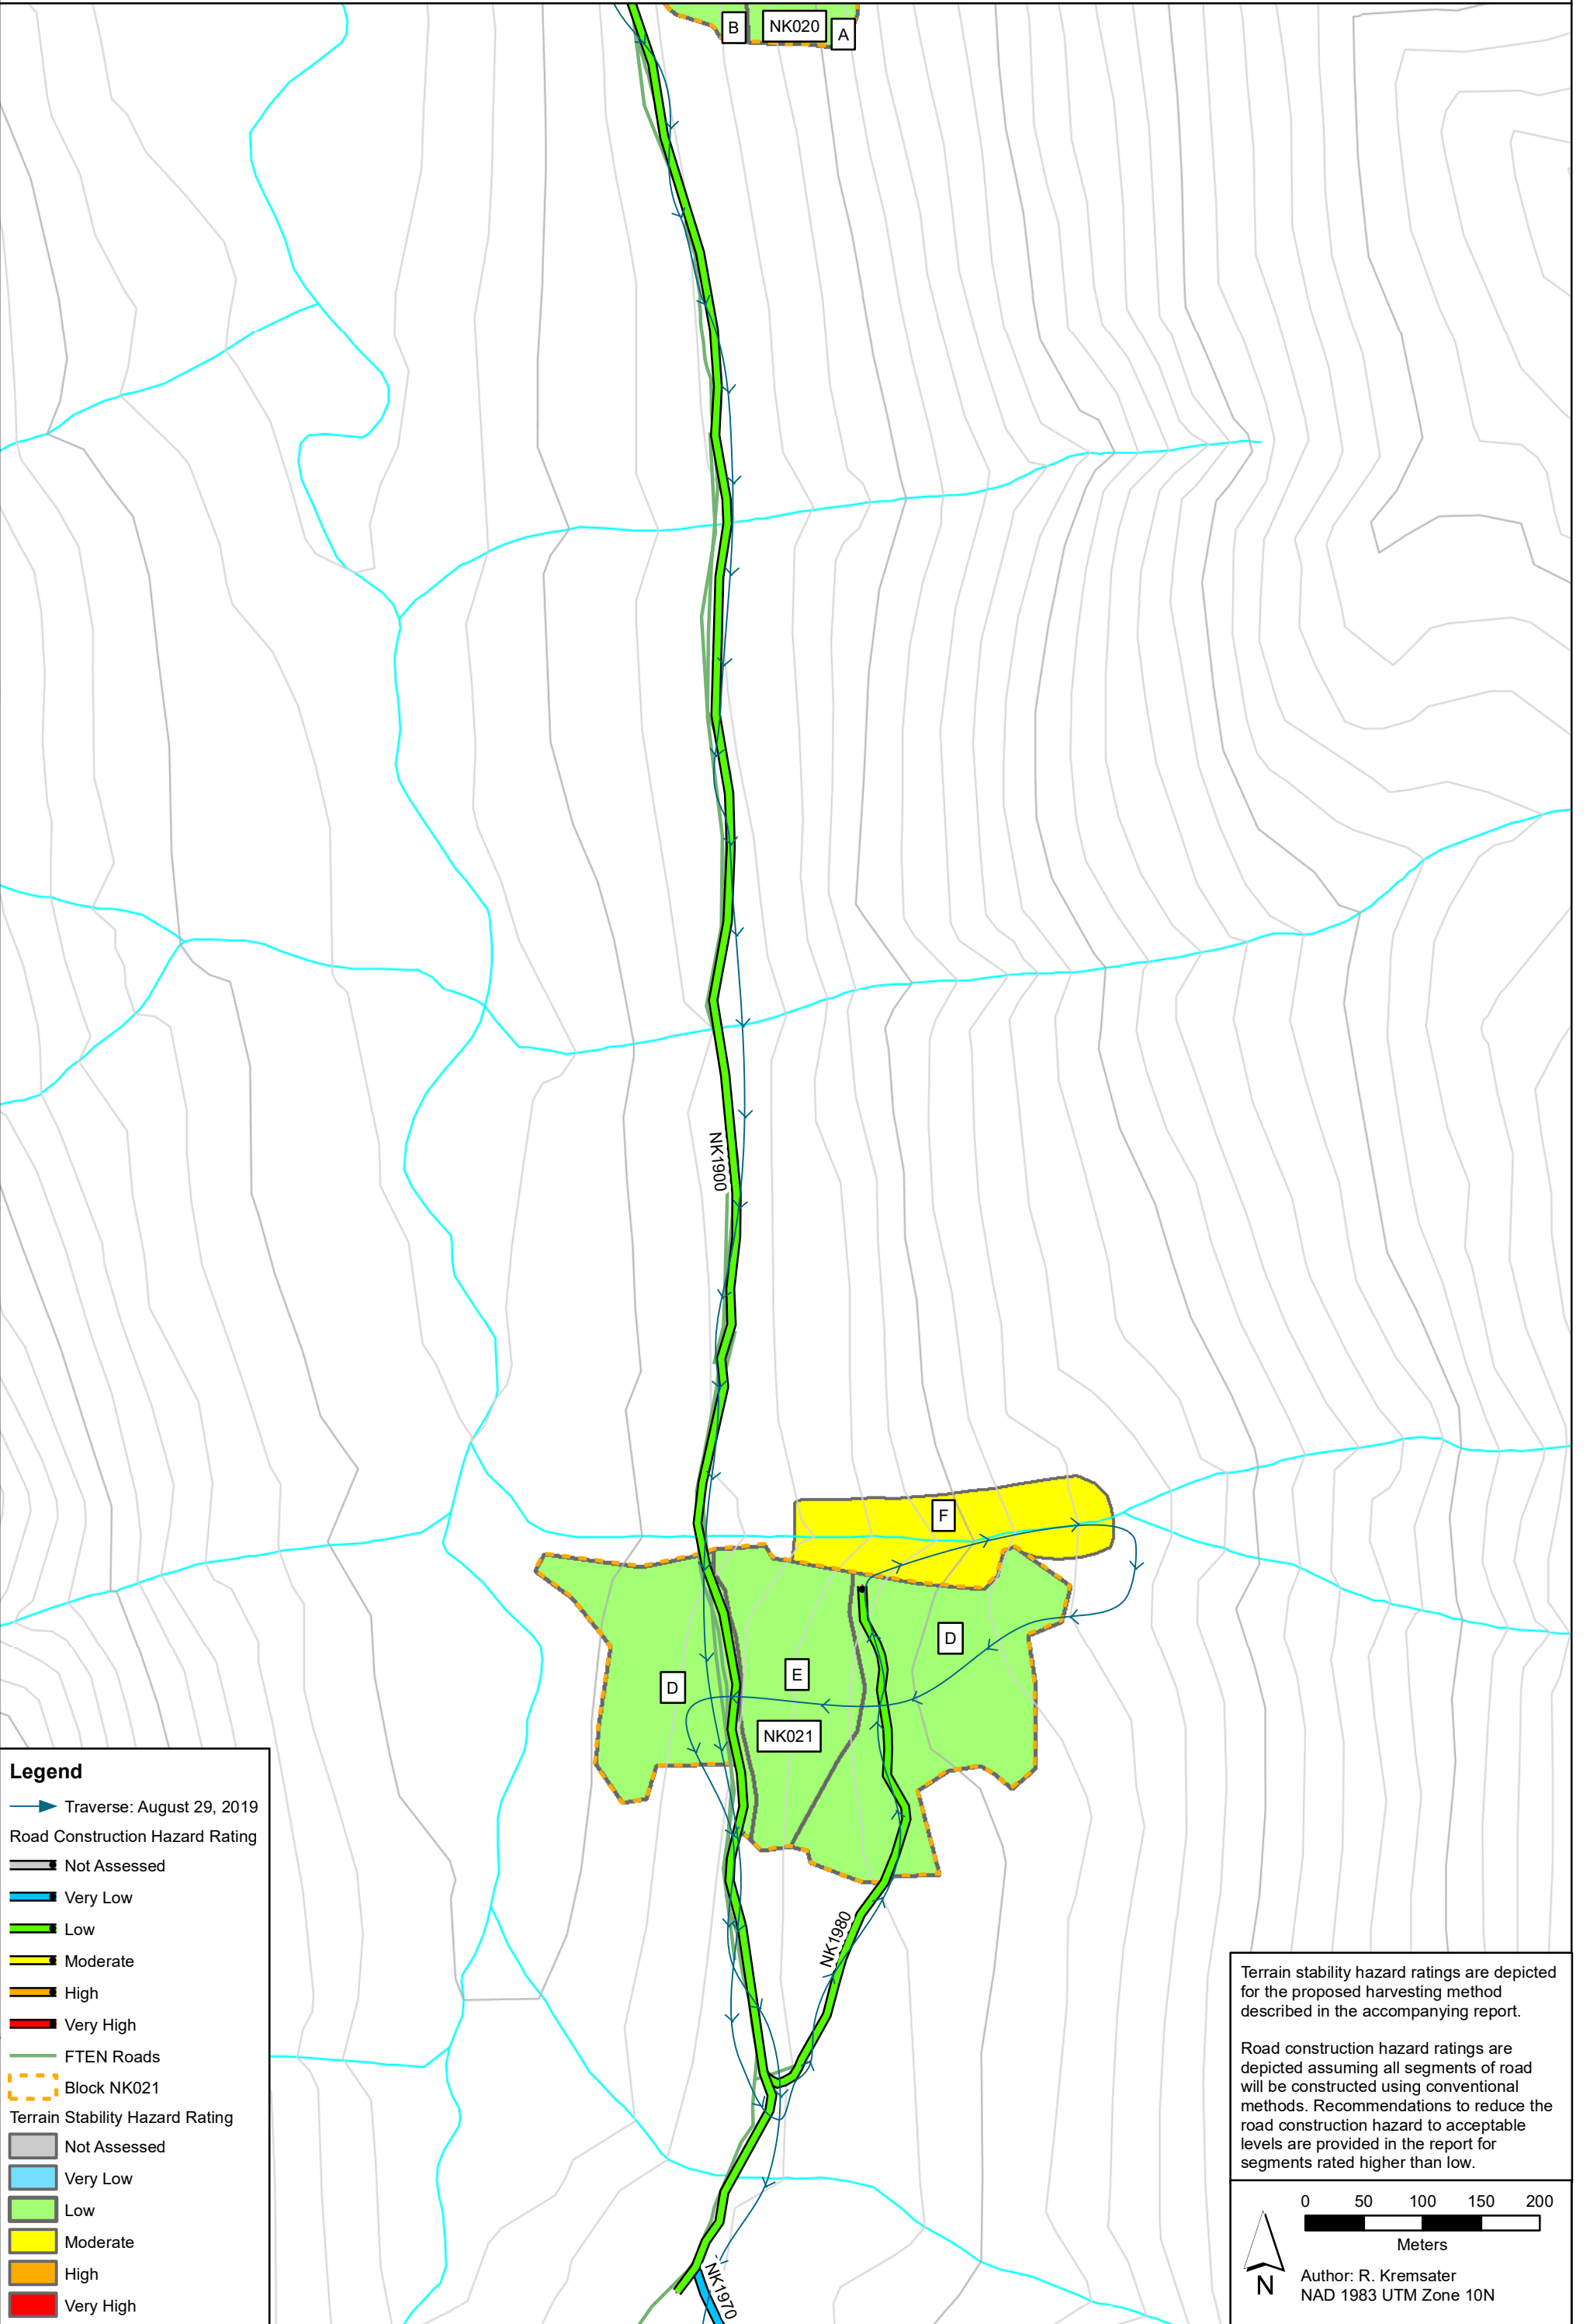
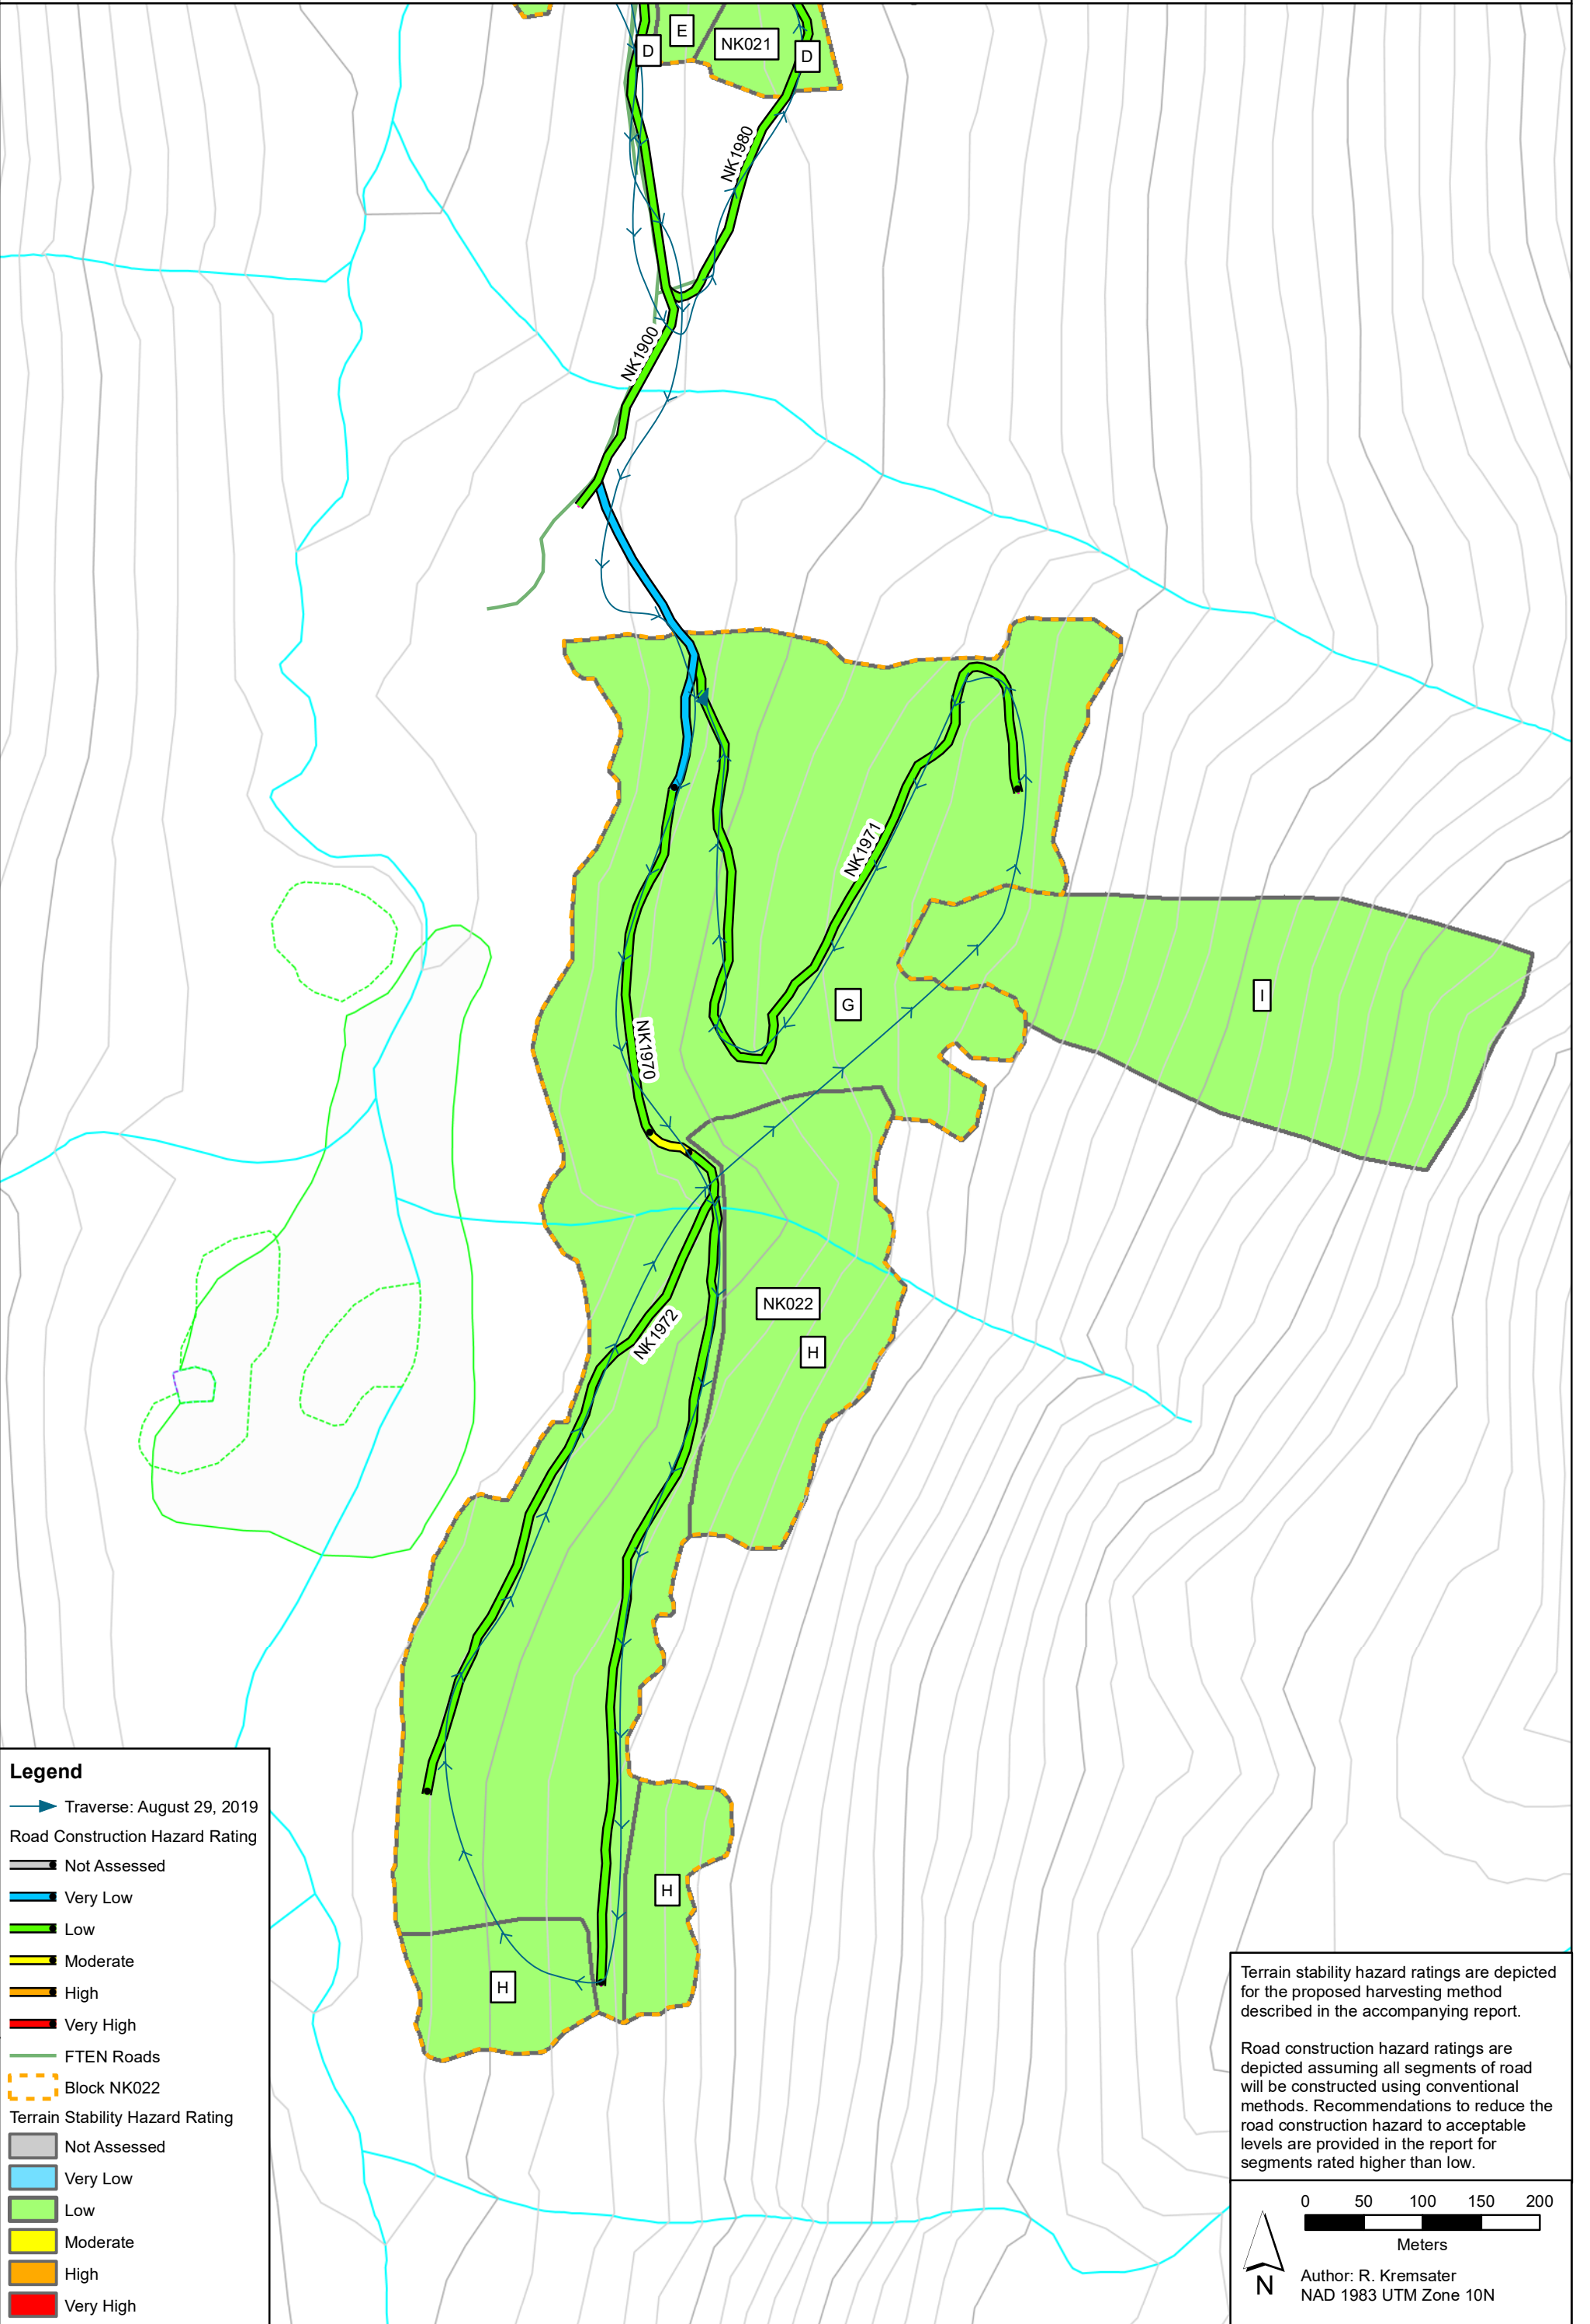
Terrain in the blocks was divided into polygons based on homogenous terrain stability hazard, surficial materials, slope gradients, topography, and proposed harvesting method (Figures 1, 2, 3, and 4).
