**TERRAIN STABILITY ASSESSMENT  
&  
SOIL EROSION ASSESSMENT**

**Proposed TSL TA0915  
Blocks 1, 2 and 3**

**Smallwood Creek and Garrity Creek  
Selkirk Forest District**

**Prepared by:  
Sitkum Consulting Ltd.  
Project No. 20-1561**

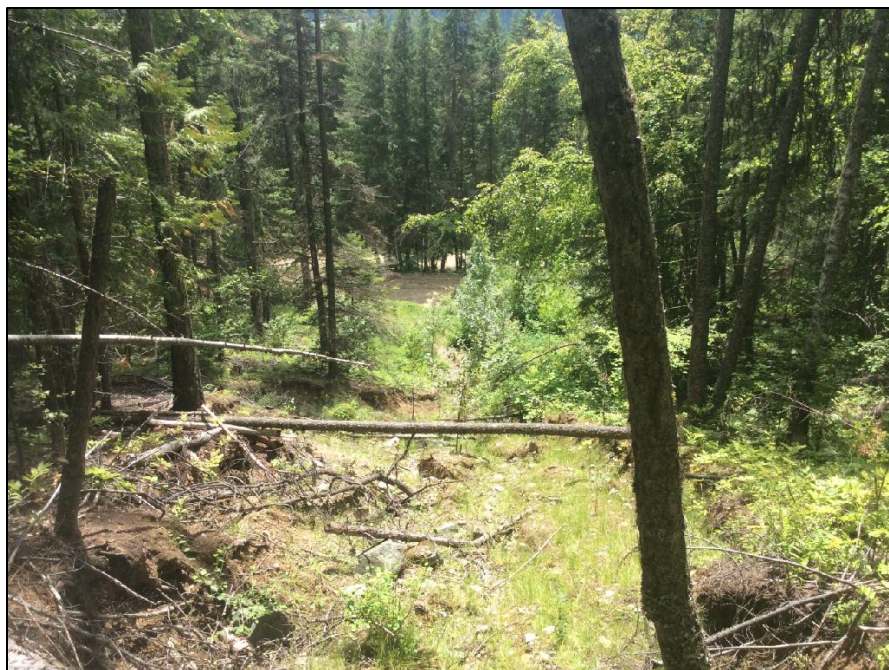
A small debris slide, estimated to have involved 200 m<sup>3</sup> of material, occurred 85 m downslope of Block 1 approximately five years ago, depositing some material on Smallwood FSR (refer to Figure 3 for location, and Image 3 below). While the cause is unconfirmed, the debris slide appears likely related to a waterline break associated with PD27201, as indicated by a broken 3" diameter plastic pipe that is shallowly buried at the top of the headscarp. The landslide scoured a path that averages 5 m wide and 1 m deep down the 50% gradient slope.

**Image 3:** View down the path of the debris slide that impacted Smallwood FSR approximately 5 years ago; the road is visible in the distance.

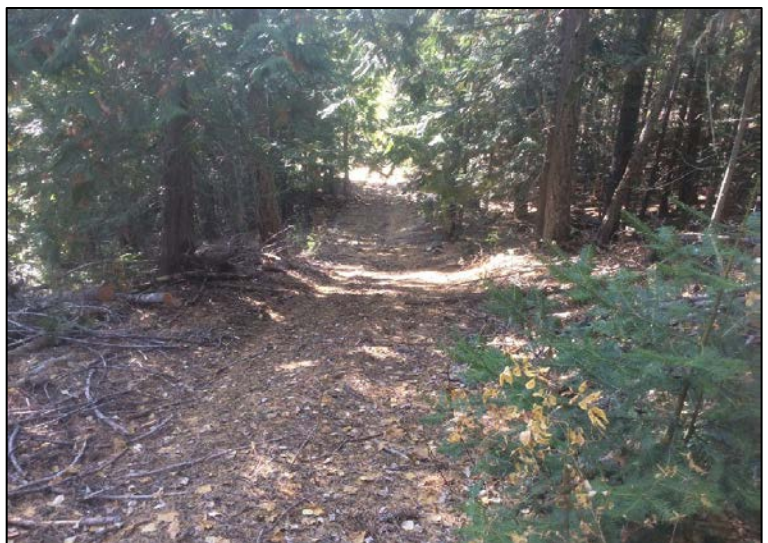
**Image 5:** looking southwest, down the existing trail in the northeast portion of Block 2. Outsloping of the trail presently prevents the significant redirection of runoff down the steep grade.

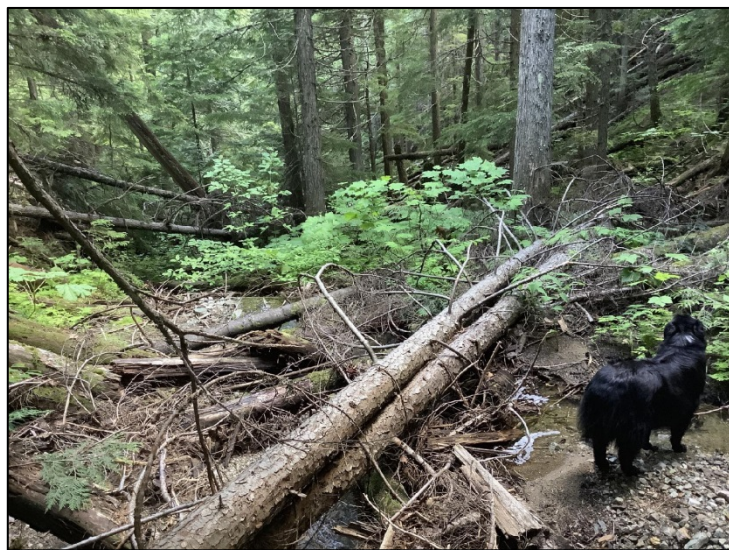
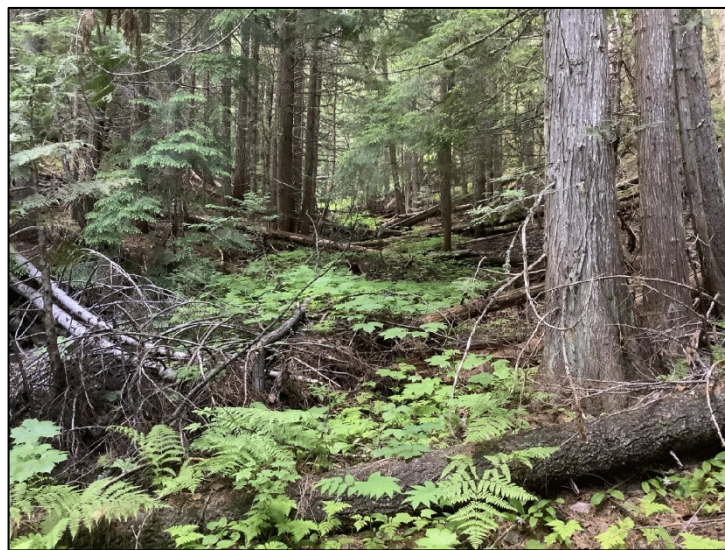
Where Garrity Creek was observed in the field near 1100 m elevation the channel gradient is 10% to 17% gradient, with commonly a 5 m to 10 m wide floodplain in the gully bottom (refer to Images 6 and 7). No signs of debris flows were observed within Garrity Creek at this site despite impact from the gully side wall failures upstream.

**Images 6 and 7:** looking downstream (left) and upstream (right) at the gentle gradient Garrity Creek within the broad gully bottom near 1100 m elevation, downslope of the northern portion of Block 2.

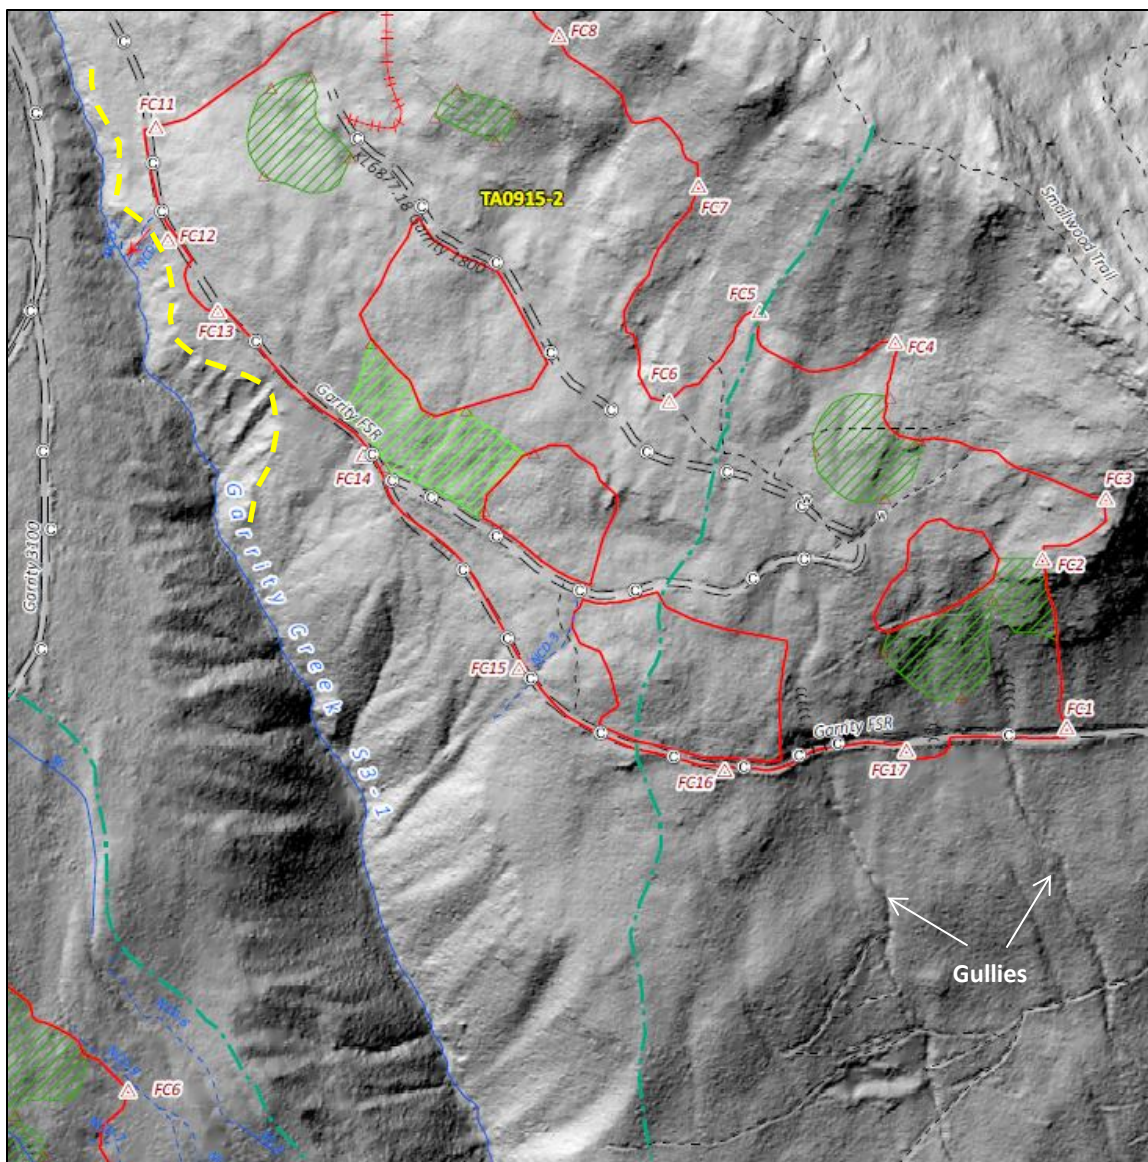
**Image 8:** LiDAR hillshade image showing the gullied terrain on the sidewall of Garrity Creek downslope of Block 2, as well as the gullies downslope of the eastern portion of the block. The green dashed line denotes the drainage divide between Garrity Creek and the face unit to the east. The dashed yellow line in the upper left of the image denotes the slope break where multiple headscarps are present from landslides that have occurred in the 50 to 100 years on the sidewall of Garrity Creek. Note the multiple roads and trails crossing the gully downslope of the area between FC16 and FC17. Actual culvert locations on Garrity FSR differ slightly from culvert locations shown on the image.

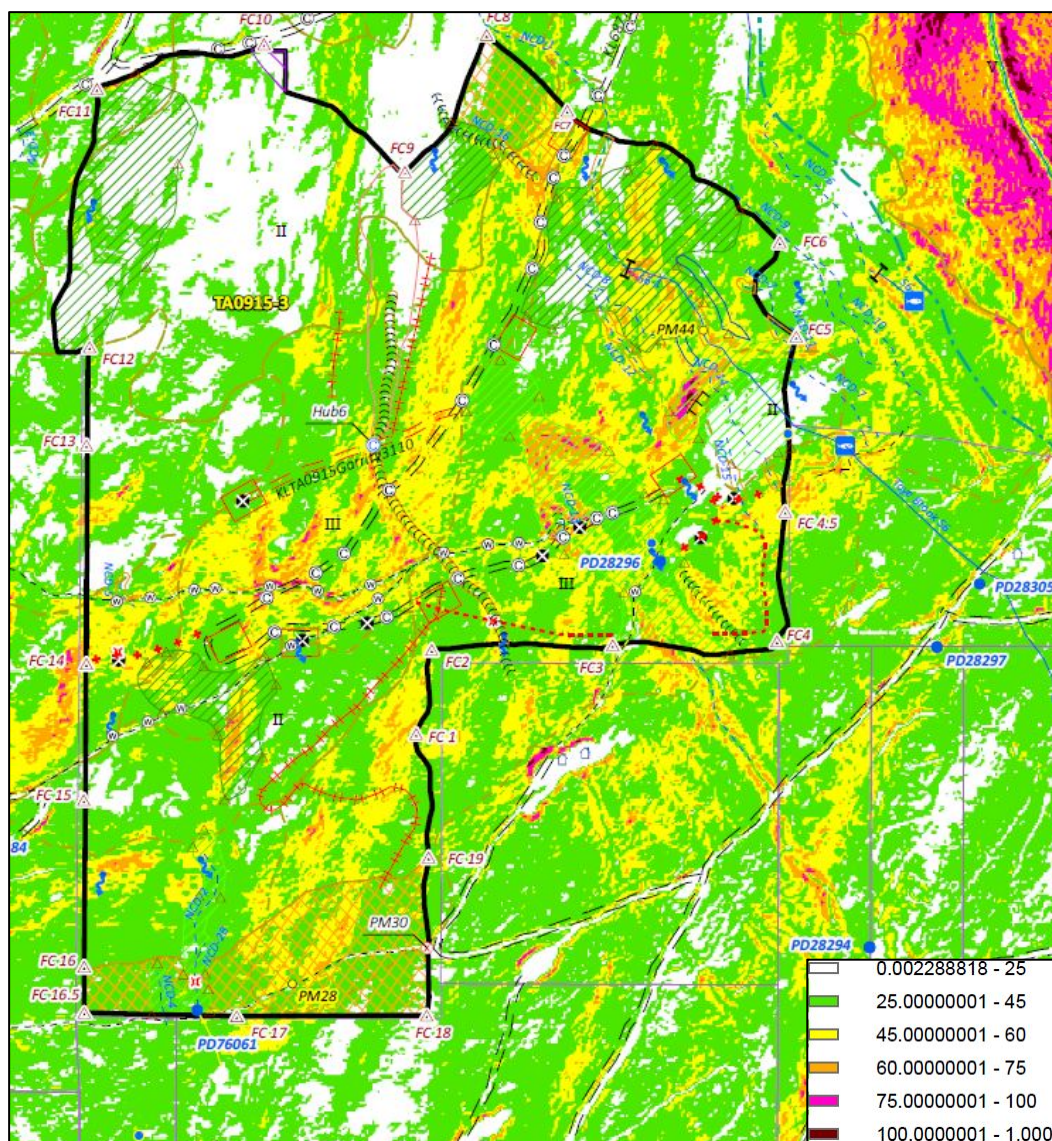
**Image 10:** LiDAR slope themed image of Block 3. Colour shaded areas depict slope gradient ranges as shown by the legend in the lower right. Note the areal extent of terrain less than 25% and 45% gradient (white and green respectively) within the block and downslope.

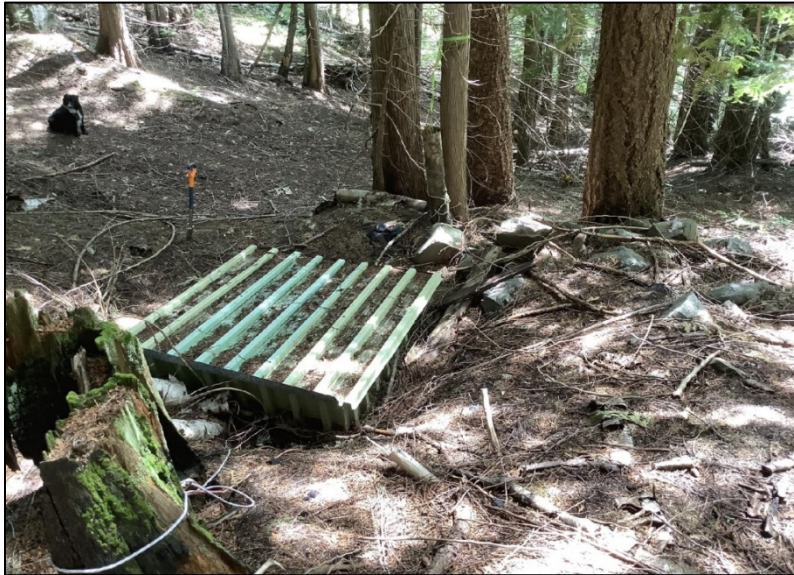
**Image 11:** Looking downslope at the covered well of licensed POD PD28296, located in a gully within Block 3, approximately 70 m downslope of the final section of Garrity 3100 FSR.

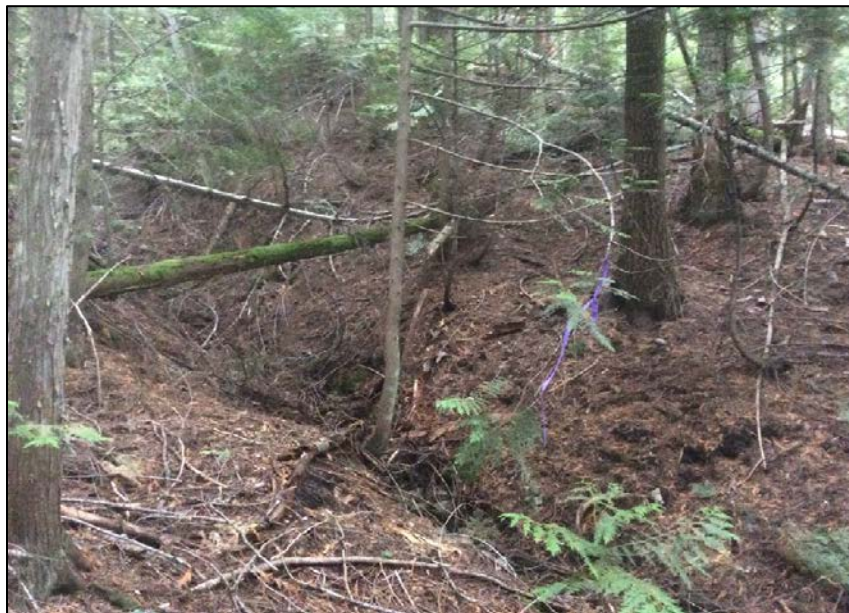
Stream S6-1 flows through the eastern portion of the block and continues to two POD's licensed for domestic use situated 270 m and 420 m distance downstream of the lower harvest boundary (Toye Brook, PD28305 and PD28302). Within the block, the stream is largely within a reserve and WTRA, except along a 40 m length where repeated crossing will be required to bring timber felled from the area near FC5 and FC6 to the landing at the POT of Garrity 3100 FSR (refer to Image 12). Short sections of the tributary NCDs to this stream are also present within the upper harvest area (NCD-1 and NCD-16). Refer to the specific recommendations in Section 5.3 regarding crossings of the stream and NCD tributaries. As noted above, machine free zones have been designated along all watercourses (including NCDs) within the harvest area. A machine free zone has also been designated along S6-1 within the reserve area (which is already treated as MFZ) to emphasize the additional consideration required in working around this stream due to the connectivity to domestic PODs.

**Image 12:** looking northeast across the shallow gully containing S6-1 (Toye Brook). This portion of the stream is within the proposed harvest area and has direct surface flow connectivity to domestic water intakes downstream.

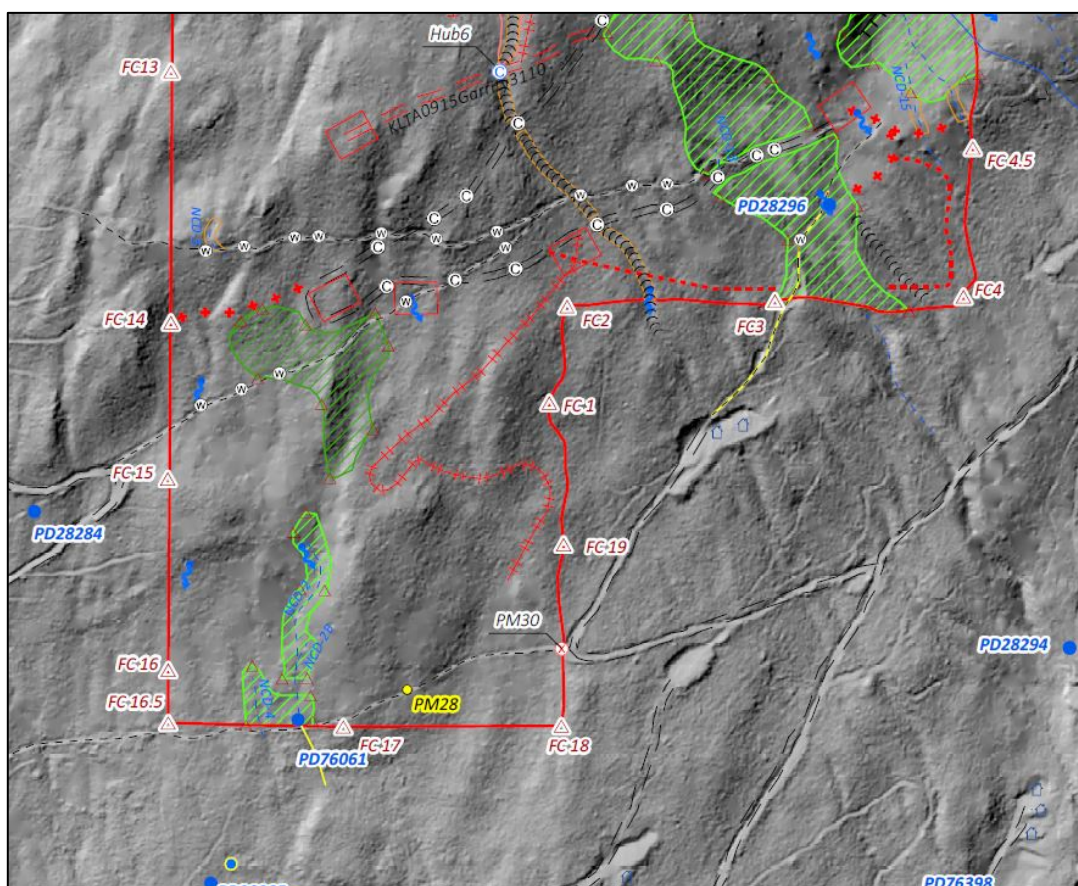
One existing trail enters the block from private land near FC3, passes the shallow well and water intake of PD28296 and ascends to a switchback near the POT of Garrity 3100. Two trails are present east of the switchback on gentle ground while the main trail continues to ascend west across the block. Another spur descends from the main trail across the western portion of the block, crossing the harvest boundary north of FC15. In most cases these old trails are not currently redirecting runoff; however, it is likely occurring during periods of high runoff in some locations and there is potential for the trails to interfere with the intended drainage from culverts on the new section of Garrity 3100 FSR. As a result, waterbars or constructed swales at gully crossings were recommended in the TSA report for Garrity 3100 FSR to eliminate the potential for redirected runoff in the vicinity of the road. These drainage structures have been shown as existing on Figure 3 as they are to be installed by BCTS prior to the timber sale. Refer to the specific recommendation in Section 5.3 to maintain or restore these drainage structures during and following harvesting.

**Image 13:** LiDAR hillshade image showing the existing trails within the middle to lower elevations of Block 3 and downslope.

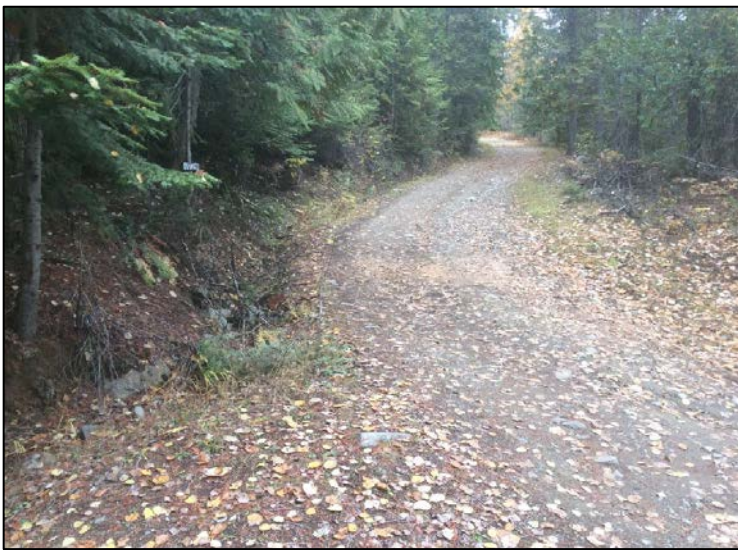
**Image 14:** looking northeast up the steep grade of the private road from the switchback immediately east of Block 3 (PM 30 on Figure 3).

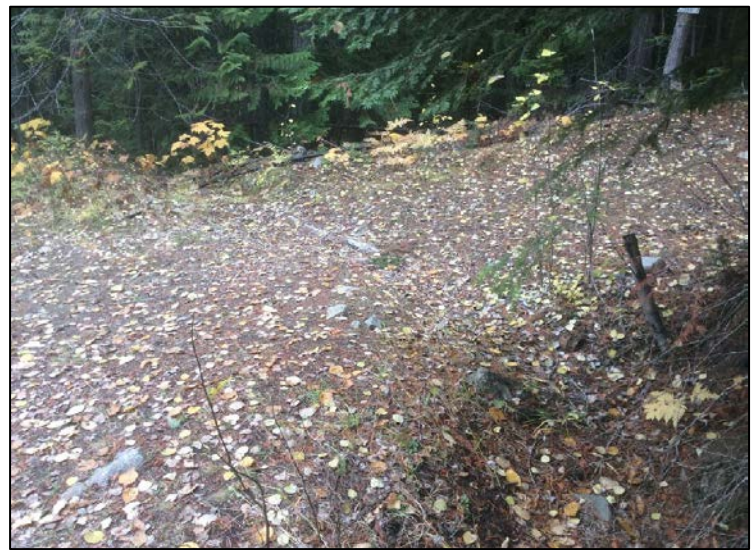
transported sediment and as a result, some runoff escapes the cross ditch onto the private road. The existing trail has no ditch and there is noticeable erosion of the trail surface over the final 50 m from seasonal runoff that is redirected down the 10% grade prior to the junction with the private road. Most of the redirected runoff flows downslope just before the junction due to a subtle outslope; however, it appears that some of the redirected runoff continues to the road junction. Given the southerly aspect and mid-slope elevation, a localized increase in spring runoff following harvesting may occur which in turn could result in an increase in the amount of runoff redirected down the section of road within the block. Also, subtle drainage paths like this are easily disrupted, especially if this trail is used during harvesting. Refer to the specific recommendations in Section 5.3 for recommended improvement of the cross ditch at the road junction as well as additional waterbars along the trail to disperse runoff.

**Image 15:** looking downslope at the shallow cross-ditch at the start of the trail that heads west from the switchback of the private road (PM 30 on Figure 3).

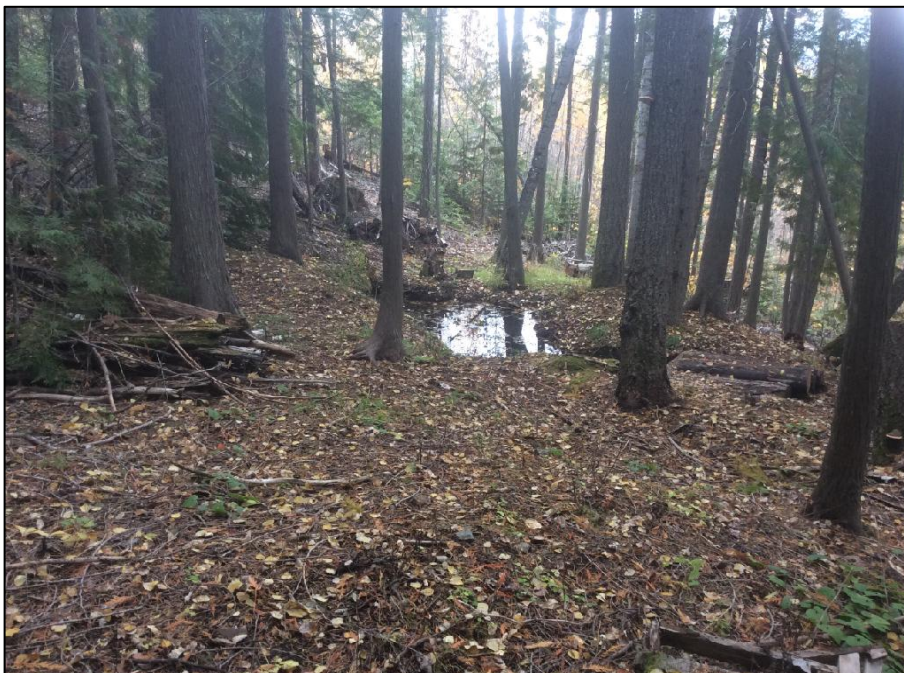
POD PD28285 (Husum Spring) is licensed for domestic use and is located 135 m downslope of the southwest corner of the block. There are two dug wells approximately 10 m apart, one covered and one mostly uncovered (refer to Image 16). There is no apparent surface flow input to the wells; wet site indicator plants are present on the gentle gradient bench between the two wells. POD PD28297 (Craft Spring) is licensed for domestic and irrigation uses and is located approximately 250 m downslope of the eastern harvest boundary.

**Image 16:** looking east at the uncovered well at PD28285, located approximately 135 m downslope of the southwest portion of Block 3. The photo was taken from the location of the covered well that is also present.
